INVESTIGATION REPORT No 23U-AR0075

| Circumstances | During the preliminary assessment of M/S Estonia in the period from 19 July to 25 July 2023, a piece of metal was cut out of the edge of a hole in the starboard side of the wreck of the vessel. |
| Investigation type | Metals survey |
| Assignment | Does the submitted metal piece show any signs of contact or collision with a metal item/object? |

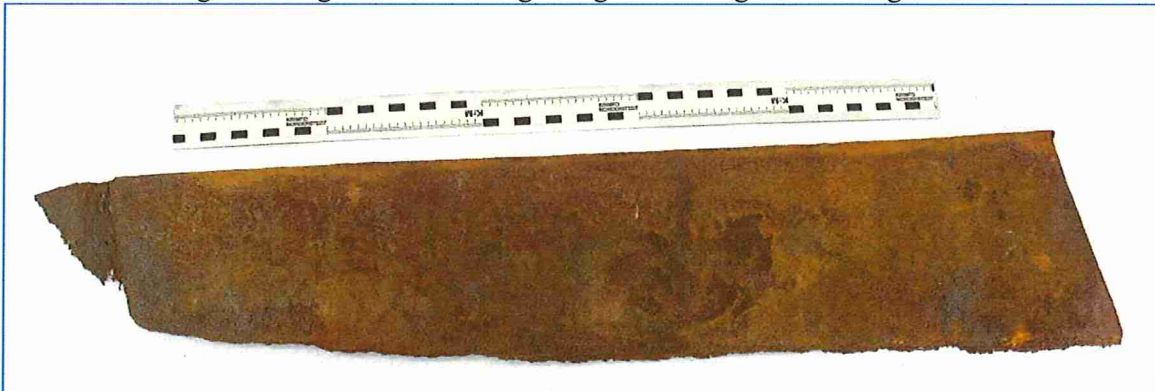
An elongated strip-shaped piece of a metal plate was submitted for examination (Figure 1). The thickness of the plate is between 13–13.5 mm, the approximate length is 66.5 cm and the width at the widest point is 14.5 cm. The strip is rectangular in shape, with one longer straight cut edge and one shorter straight cut edge. The other longer edge shows signs of tearing.

Photo 1. Piece of metal submitted for examination, view from the curved side

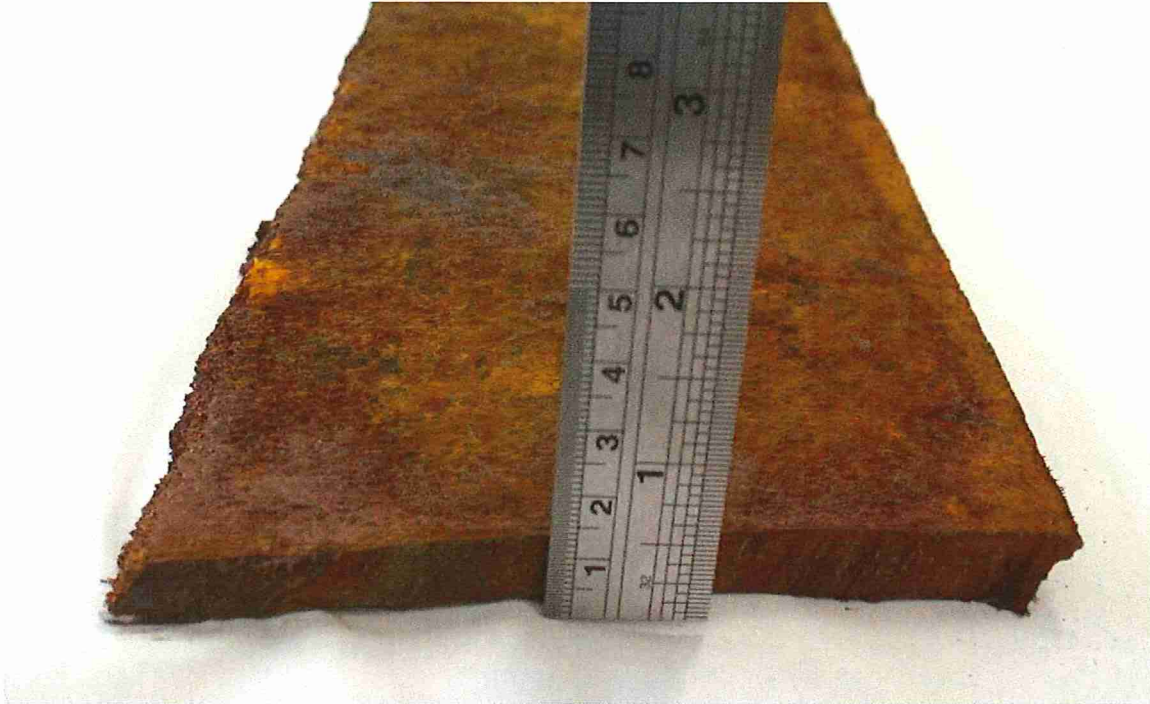
strip is curved and the paint coating has probably separated (Photo 2).

Photo 2. Curvature of the metal strip

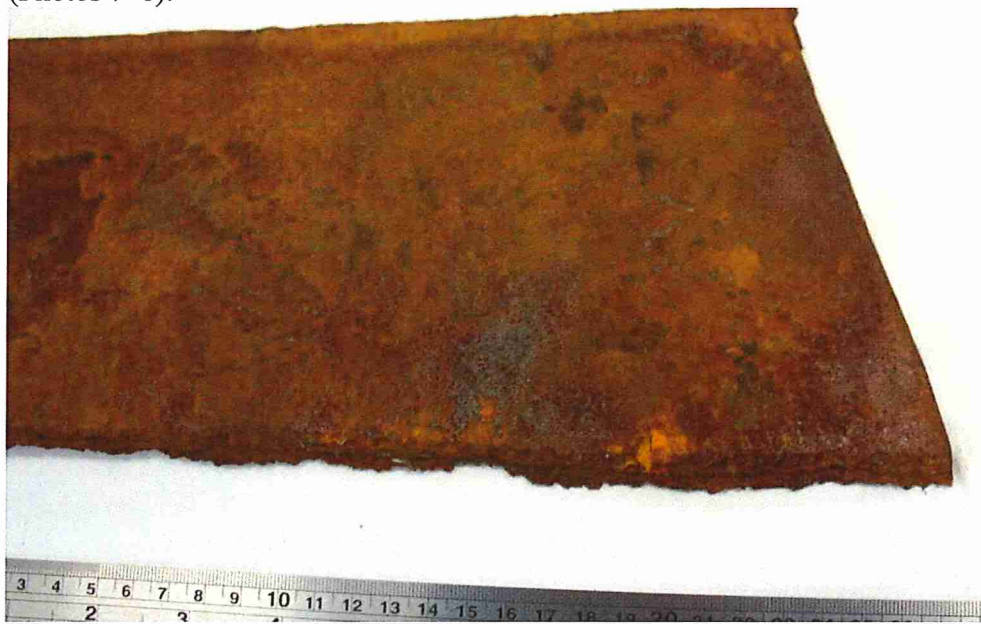
Photo 3. Torn edge of metal strip, view of hull exterior.

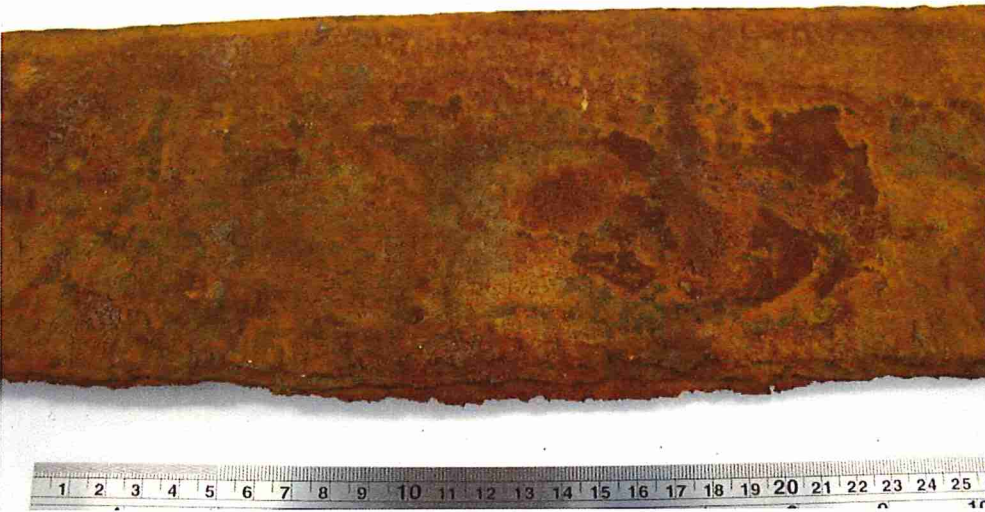
Photo 5. Torn edge of metal strip, view of hull exterior.

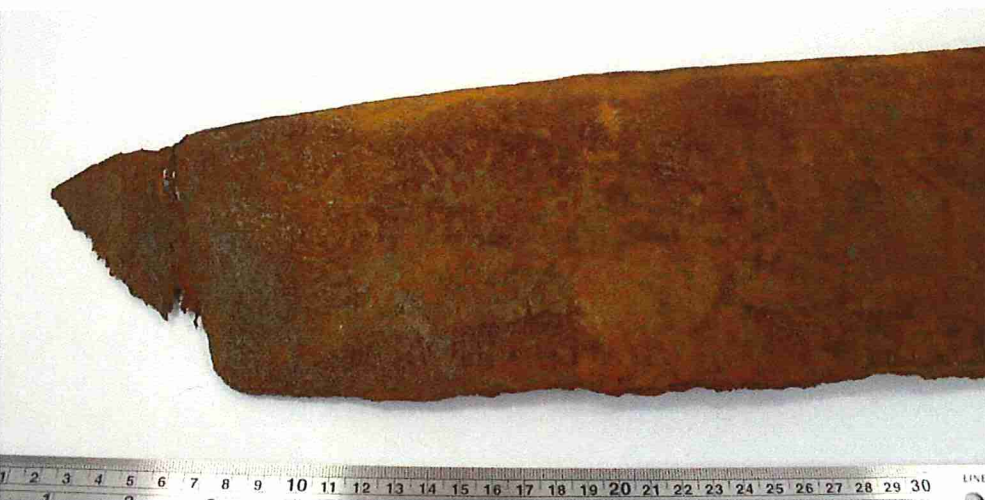
Photo 6. Torn edge of metal strip, view of hull exterior.
