# Aircraft preparation and foreign object damage event involving Saab 340B, VH-VEQ

Canberra Airport, Australian Capital Territory, on 10 November 2022

Aviation Occurrence Investigation (Defined)

AO-2022-055

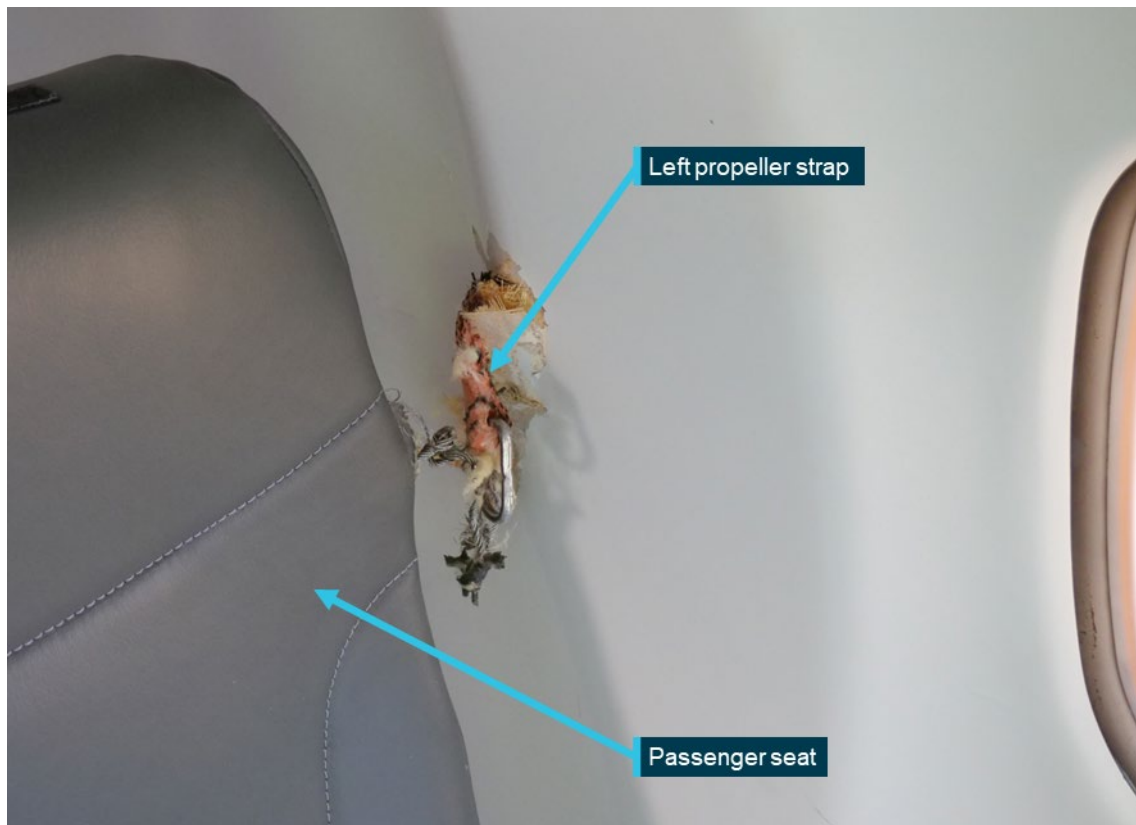
During the take-off, about the time the aircraft became airborne (according to the CM's recollection), the propeller strap was thrown free of the blade and into the fuselage (Figure 1). The strap itself became embedded in the fuselage, but the two failed cowling pins that were attached to the strap broke free and entered the cabin. One fragment struck the leg of the passenger in seat 2A, resulting in a minor injury (bruising).

**Figure 1: Part of the left propeller strap that entered the fuselage adjacent to seat 2A**

The aircraft was quarantined in Canberra pending the ATSB's attendance. A remnant of the propeller strap was recovered from the fuselage (Figure 1) where it had caught on a stringer.<sup>7</sup> The cowling pins were no longer attached to the strap. Sections of both cowling pins were still secured in the engine cowling following the occurrence (Figure 2). Other parts breached the fuselage and were recovered from the cabin floor (Figure 3). A small section of one cowling pin was not located. The strap extension was still stowed on the flight deck.

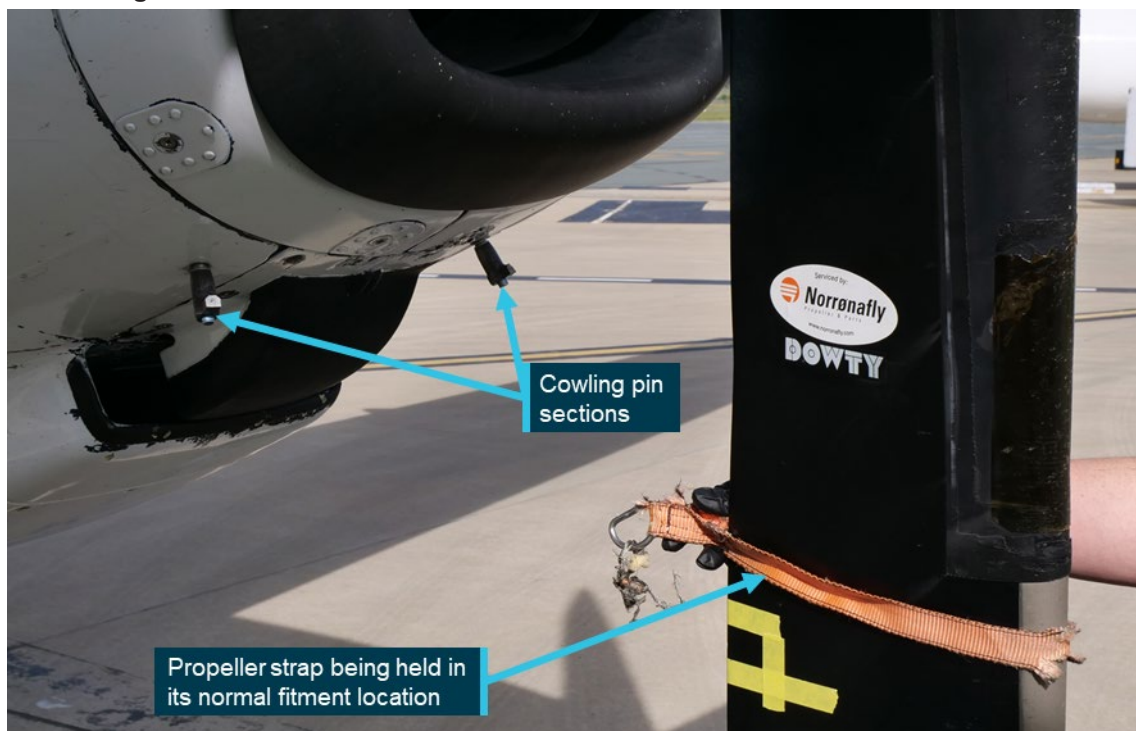
The engine continued to build torque with the propeller restrained, and 33 seconds after the initial movement the propeller began to turn. Subsequent investigation established that the propeller torque caused the pins securing the strap to the engine cowling to fail with the strap remaining secured to one of the blades.

**Figure 2: Cowling pin sections that remained secured in the engine cowling, and the damaged propeller strap shown in the normal fitment location after being recovered from the fuselage**

The aircraft was released for flight with the propeller strap still attached to the left propeller. Rotational torque during the engine start broke the 2 pins securing the strap to the engine cowling, leaving the strap webbing (with broken fragments of the pins still connected) attached to the propeller blade. The partial strap assembly was flung off the propeller during the take-off, penetrating the fuselage and injuring one passenger.

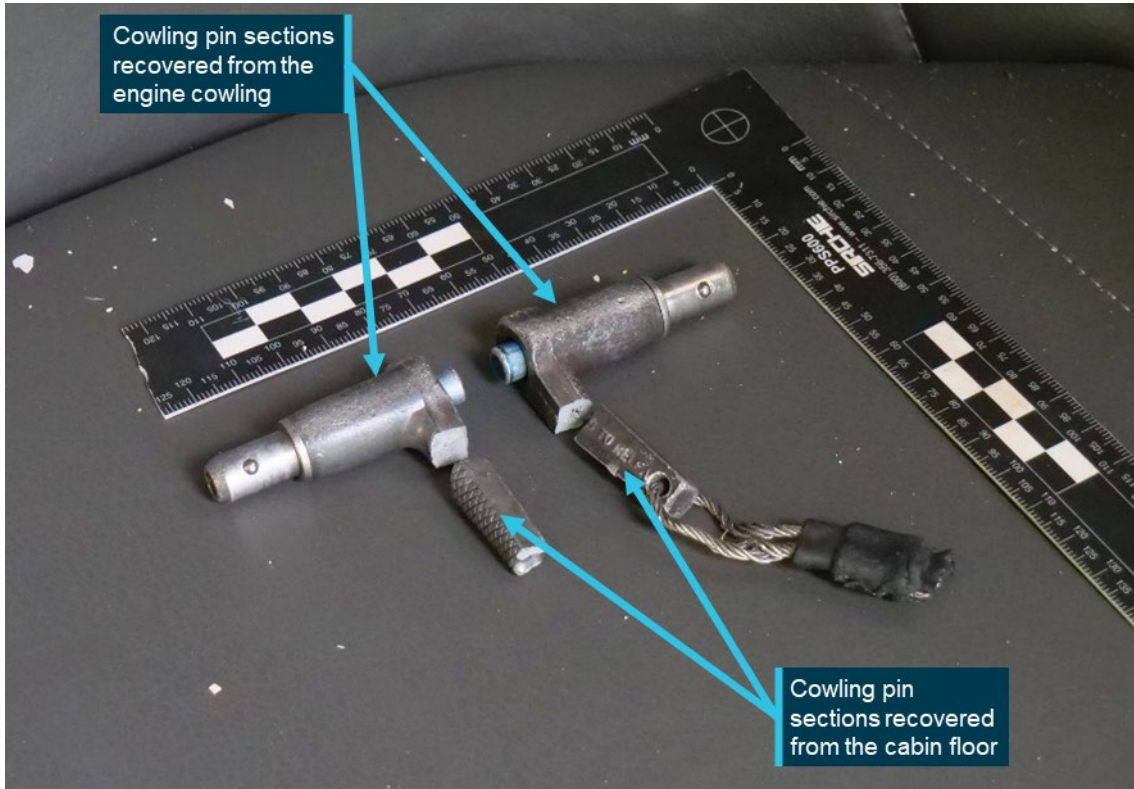
Figure 3: Parts of the cowling pins recovered from the cabin floor and the engine cowling

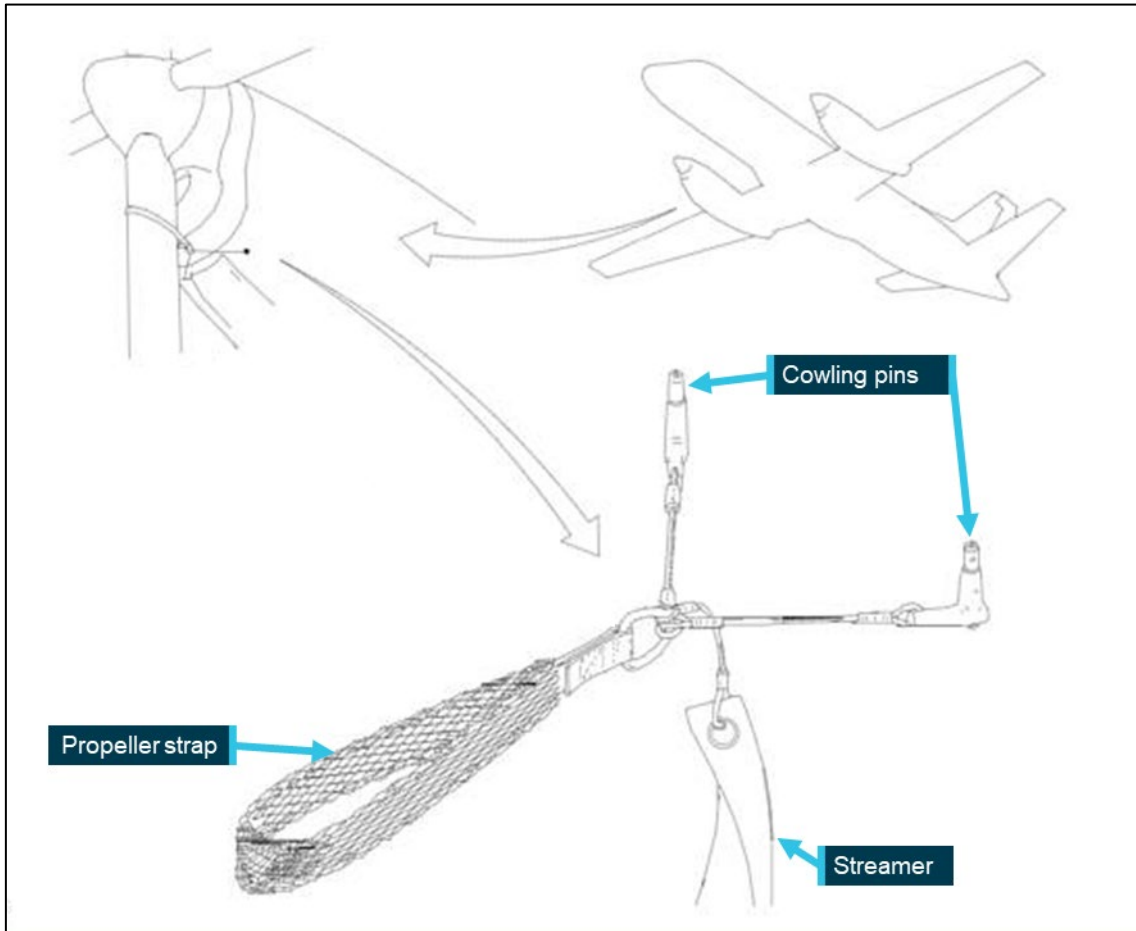
The propeller strap assembly, also referred to as the 'propeller restraining bridle' by Saab, was intended for use in preventing propeller movement when the aircraft was parked. The strap assembly provided by Saab consisted of a loop to slide over the propeller blade, two cables with pip pins for securing to the engine cowling, and a streamer to aid visibility (Figure 4).

**Figure 4: Propeller strap assembly as issued by Saab**

The propeller strap involved in the occurrence had bright orange webbing. Closed-circuit television (CCTV) footage showed that there was no 'remove before flight' streamer attached to it.

- **The propeller strap did not have a high-visibility streamer attached, and Link Airways did not effectively manage the condition of propeller straps for its Saab 340B fleet. This affected the visibility of the straps during ground operations.** (Safety issue)

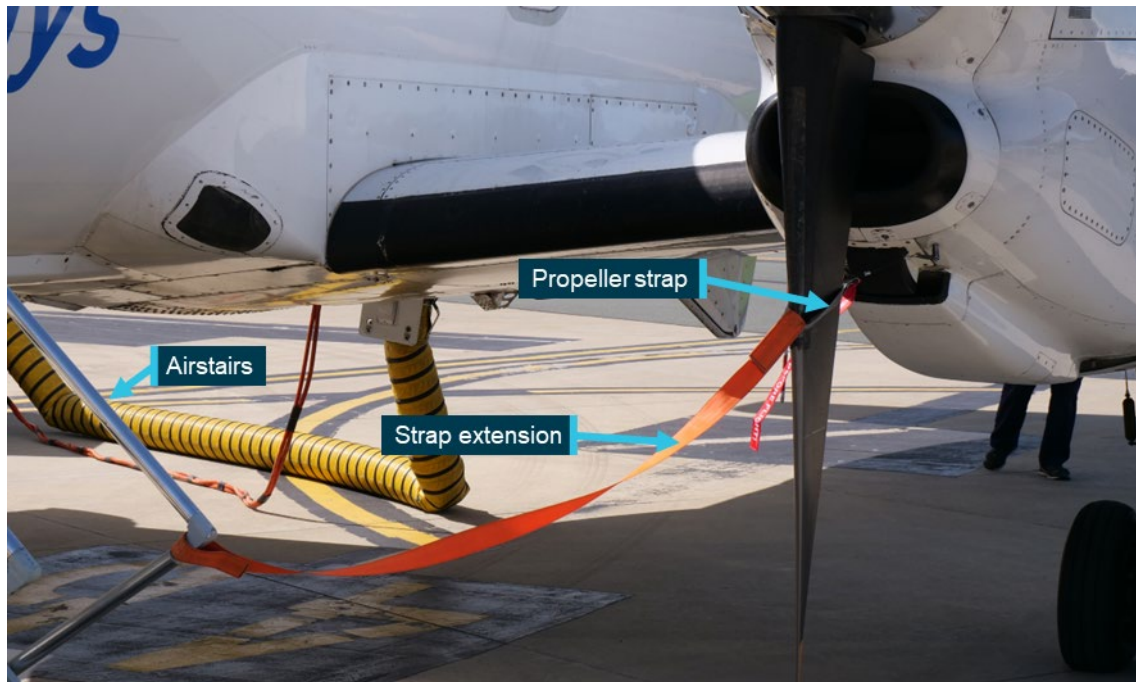
Link also used a strap extension, made with fluorescent webbing and connecting between the handrail on the airstairs and the left propeller strap. The strap extension was not designed or supplied by the aircraft manufacturer, but a similar product was used by other Saab 340B operators. According to the Link *Flight crew operating manual* (FCOM), it was intended to 'provide a visual indication of a restricted area around the propeller' and a 'safety mechanism restricting the passenger door stairs from being closed without removing the extension and prop strap.' An example of the fitment of a strap extension in accordance with the FCOM is shown in Figure 5.

**Figure 5: Exemplar strap extension fitted between airstairs and propeller strap**
