Final report RS 2017:01e

NORDIC STANI – Man-over-board in the
Sea of Åland 09 April 2016

File no. S-56/16

16 March 2017

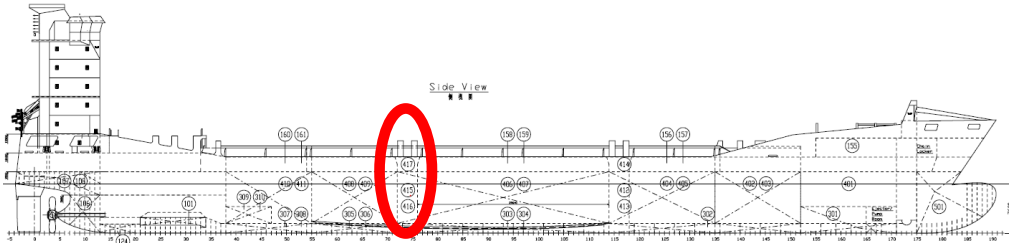
Figure 5. Marked area shows the deck area concerned.

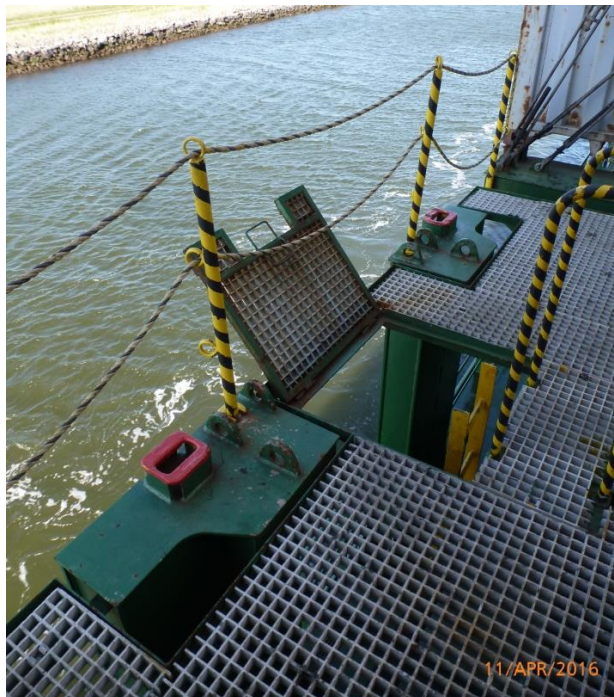
The cargo openings are all surrounded by hatch coamings on which the hatches rest when closed. The hatch coamings, strengthened to stand also the load of the deck-cargo containers, are about 1.7 m high and continue longitudinally from the stern part to the forward part of deck, i.e. also crossing the cross-bays between the holds. Some half meter above the coamings there are gratings from side to side, making it possible to reach and walk in the cross-bays. At the far end of this grating, reaching the vessel's side there are tip-up railing poles and ropes, acting as protection from falling overboard (see figure 6). This protection was mounted at the time of the occurrence.

Figure 6. The far end of the grating on top of the hatch coaming in the cross-bay area. The picture is, according to the master, taken after the occurrence without the railing poles and ropes, acting as protection from falling overboard, being changed. Image: Nordic Hamburg Shipmanagement (HK) Ltd.

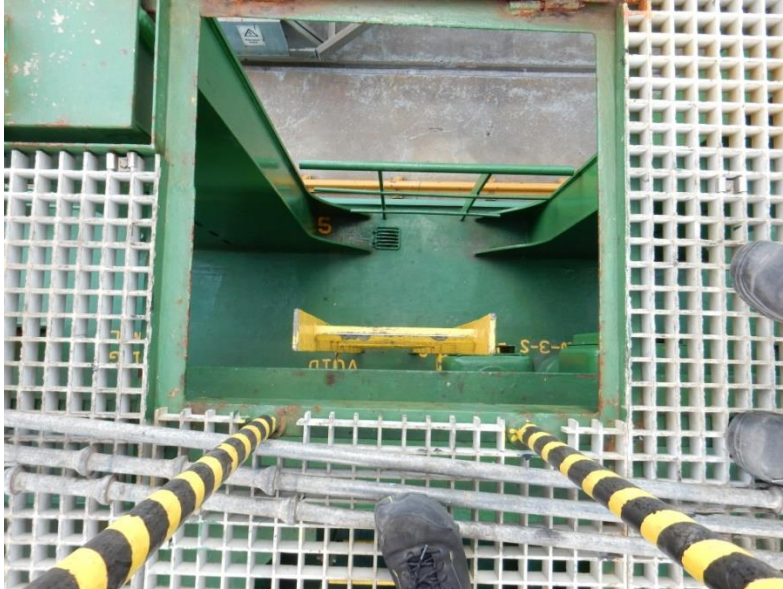
To reach the gratings from deck there is a ladder on the outside of the coaming, passing through a hatch in the grating (see figures 7 and 8). The distance between the ladder and the outside railing is about 72 cm (see fig. 12).

Figure 7. The ladder on the outside of the coaming, leading from deck to the grating, seen from up to down. On top and in the middle of the picture, the quay outside of the vessel is seen.

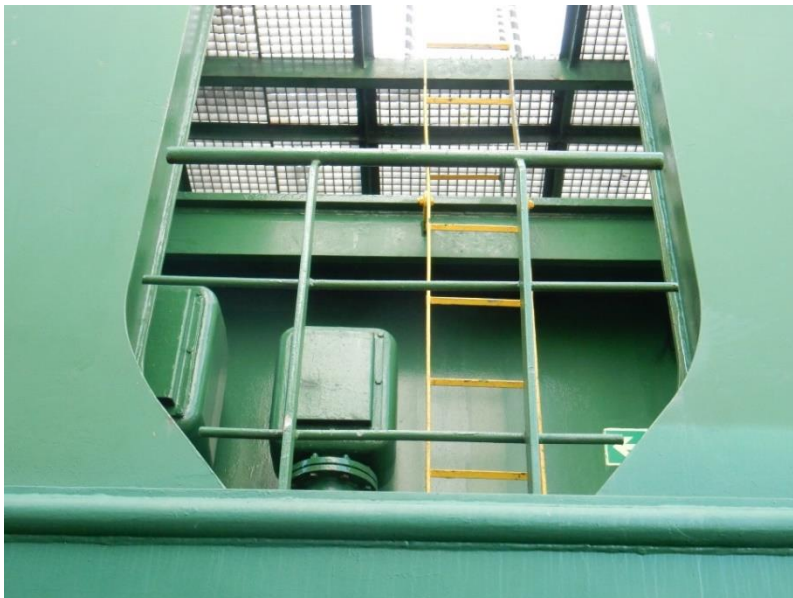
Yet another ladder on the inside of the coaming leads down to deck level in the cross-bay, i.e. under the grating (see figure 9). It is also possible to reach the cross-bay area by crossing the coaming beneath the grating. The normal way is however to use the ladders. At the time of the occurrence the ladders lacked protection from falling from these.

Figure 8. The ladder from deck to the grating, seen from the quay, i.e. from outside of the vessel.

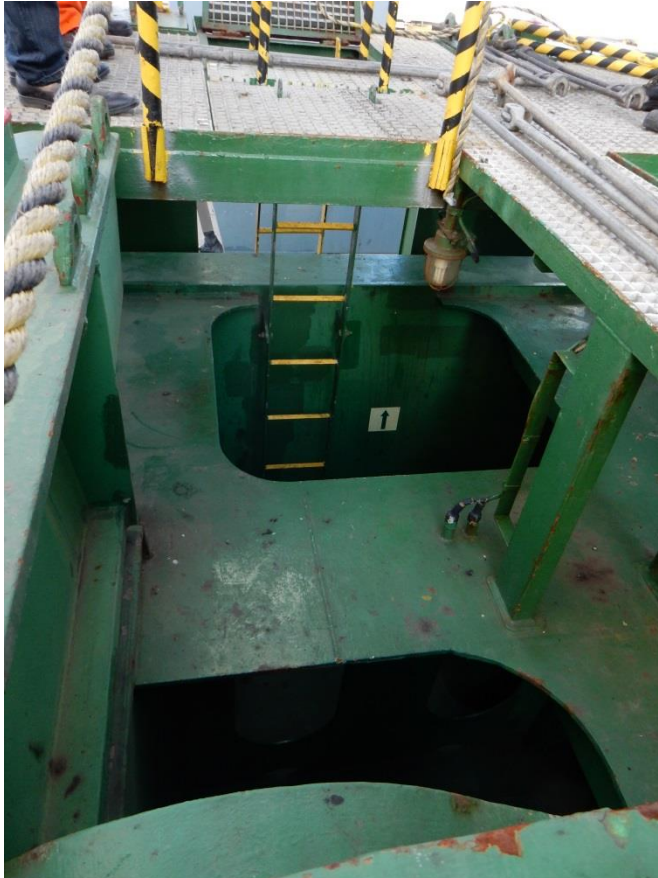
The area concerned is not seen from the bridge, neither is there any CCTV or other means for observation of the area.

Figure 9. The cross-bay and the ladder inside of the coaming. To the right and below the ladder, i.e. on deck, the hatch to the space from where the steam is controlled. The hatch is not shown in the picture.

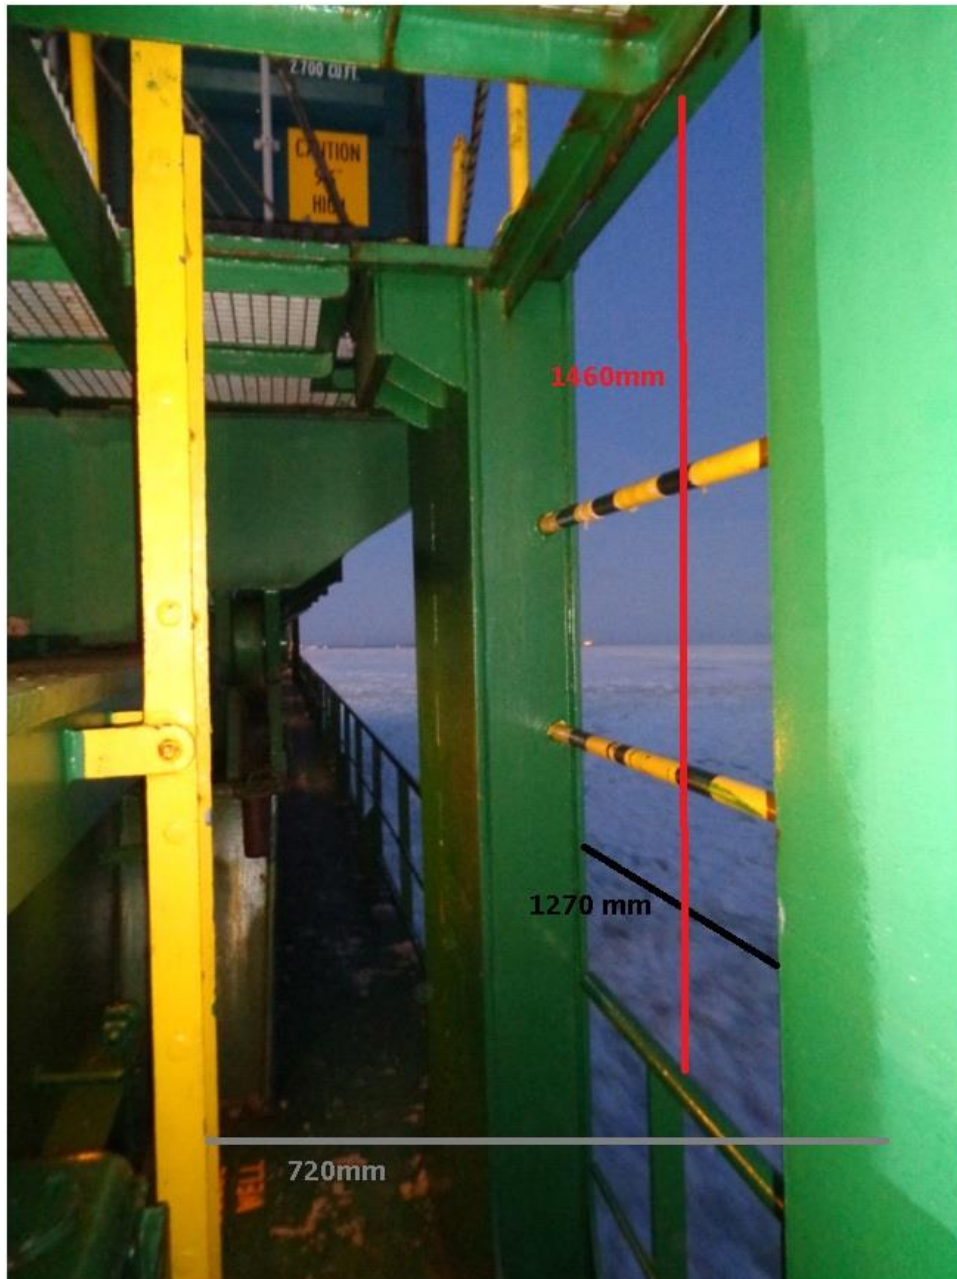
Figure 12. The picture shows the distance between the ladder and the railing (720 mm) and the measures above the railing (1460 x 1270 mm) before the protection was mounted. The black-and-yellow pipes on the right hand side of the picture is the new protection, mounted after the occurrence. Image: Nordic Hamburg Shipmanagement (HK) Ltd.

A certain cause of the CEN's disappearance has not been possible to establish. However, a possible cause is that he fell overboard as he attempted to move from the cross-bay between holds no. 2 and 3 to deck. A contributing factor to this fall may have been that the vessel turned to port, which caused the vessel to heel to starboard while the CEN was in an area where there was a risk of falling overboard. In the case he was on the ladder in question, such a fall may have been made possible due to the lack of protective arrangement.

The shipping company has decided to alter their procedures, by changing the priority between contacting the company and a rescue coordination centre. Furthermore, the company already after a week instructed their vessels to reassess the risk of falling overboard and to mount protections to fall overboard at ladders where such a risk lies (see fig. 12). The vessels in question have thereafter reported to the company that the actions have been completed.
