Interim statement

Serious incident at Torsby Airport, Värmland county on 31 January 2014 involving the aircraft ES-PJR of the model BAe Jetstream 3200 operated by AS Avies.

File no L-0018/14

30/01/2015

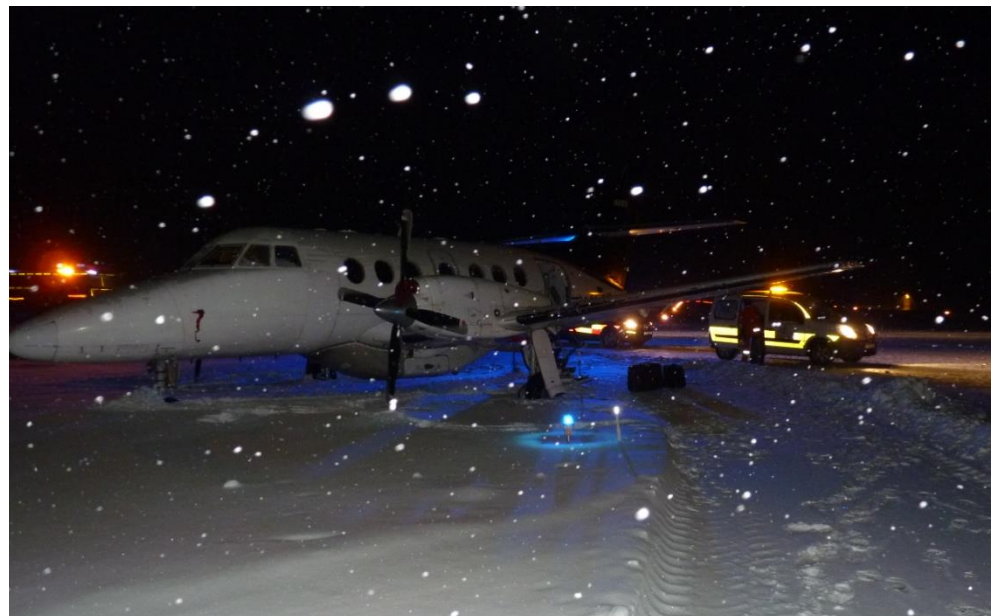
Figure 2. The aircraft after the excursion. Photo: Torsby Airport.

After having taken over control, the commander commenced braking and also set the engine controls at full thrust reversal. However, the aircraft could not be brought to a stop – or manoeuvrable speed – before the taxiway in to the station building. The commander attempted to turn off to the right onto the taxiway, but the aircraft ran off the runway in the corner between the landing runway and the taxiway and came to stand in a snowdrift with the nose 6-7 metres from the edge of the taxiway, see Figure 2.

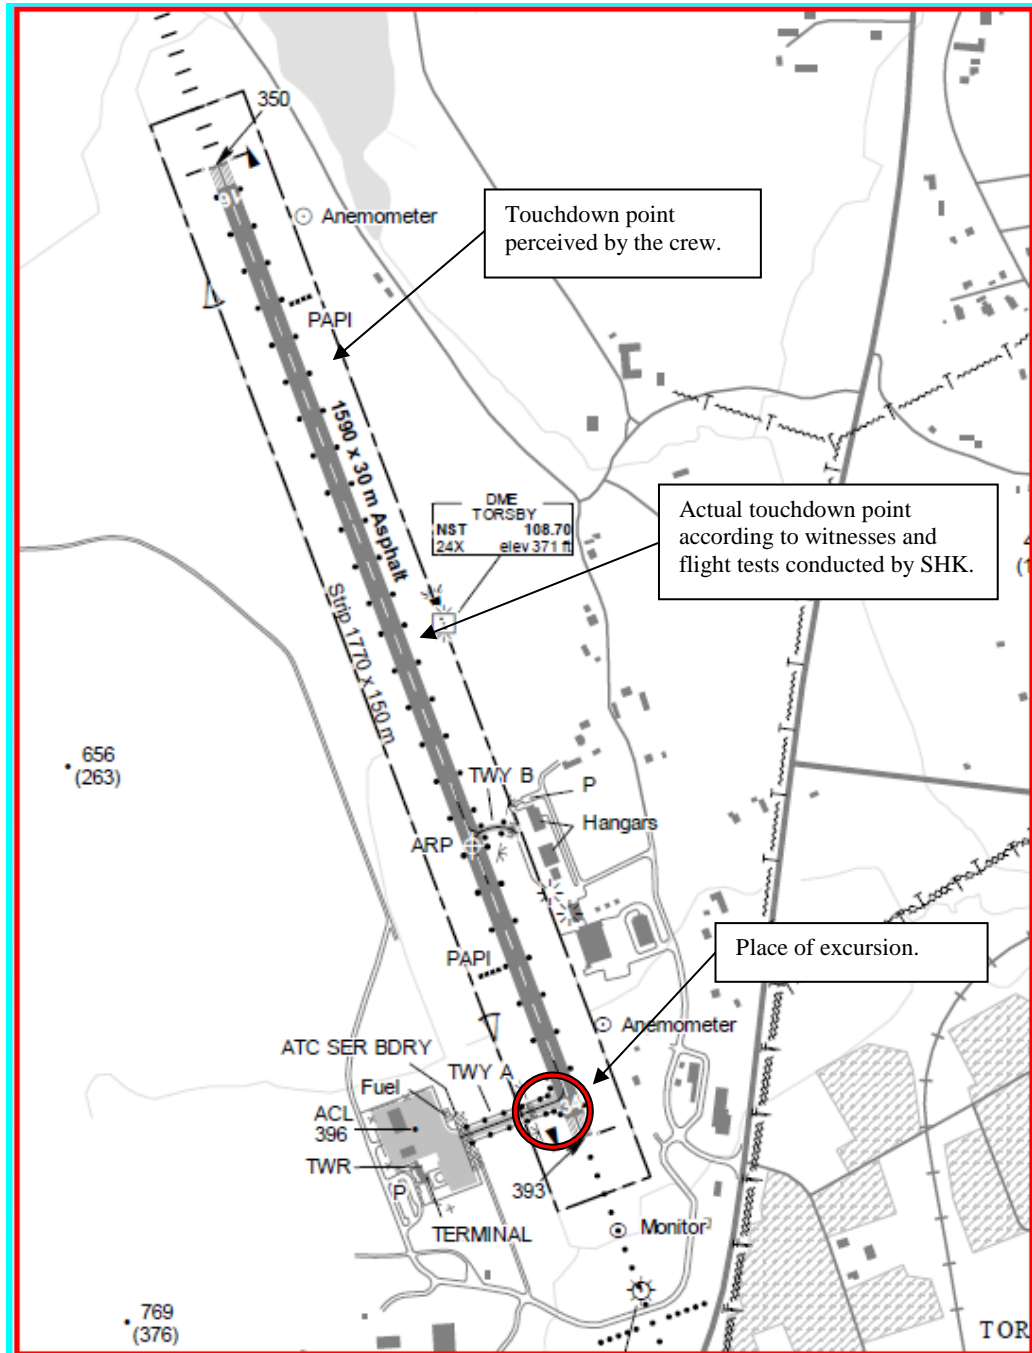
Figure 3. Map of Torsby Airport marked with facts of the event.

Torsby Airport has an asphalted runway with the dimensions 1,590 x 30 metres, see Figure 3. The runway is equipped with high-intensity runway edge and approach lights in both directions. For instrument approach, there are Non-Directional Beacons (NDB) and localiser transmitters (LLZ) installed in both approach directions.

By means of the completed flight tests, it has been possible to establish a probable touchdown point of about 800 metres from the end of runway 16.
