**Federal Democratic Republic of Ethiopia**  
**Ministry of Transport**  
**Aircraft Accident Investigation Bureau**

Aircraft Accident Investigation Preliminary Report  
Ethiopian Airlines Group  
B737-8 (MAX) Registered ET-AVJ  
28 NM South East of Addis Ababa, Bole International Airport  
March 10, 2019

Report No. AI-01/19

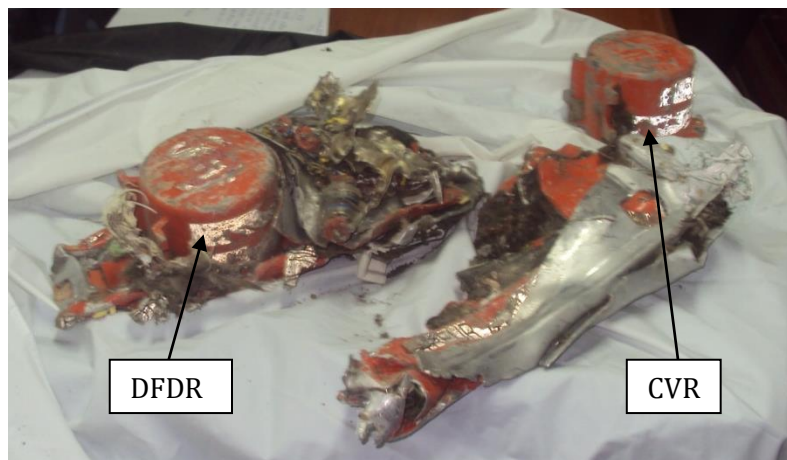
DFDR and CVR as discovered on the accident site.

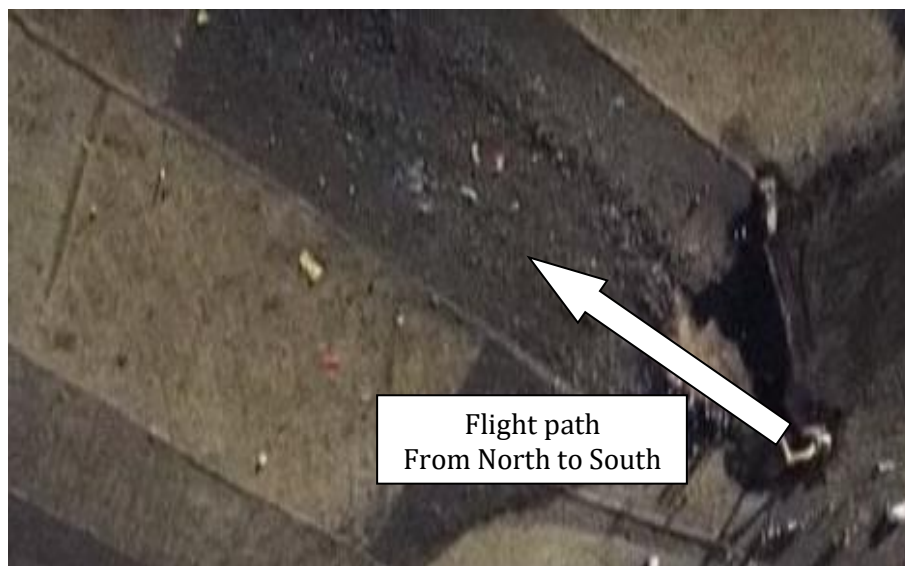
The Aircraft impacted in a farm field and created a crater approximately 10 meters deep (last aircraft part found) with a hole of about 28 meters width and 40 meters length. Most of the wreckage was found buried in the ground; small fragments of the aircraft were found scattered around the site in an area by about 200 meters width and 300 meters long.

The damages to the aircraft are consistent with a high energy impact.

Top view of the crater

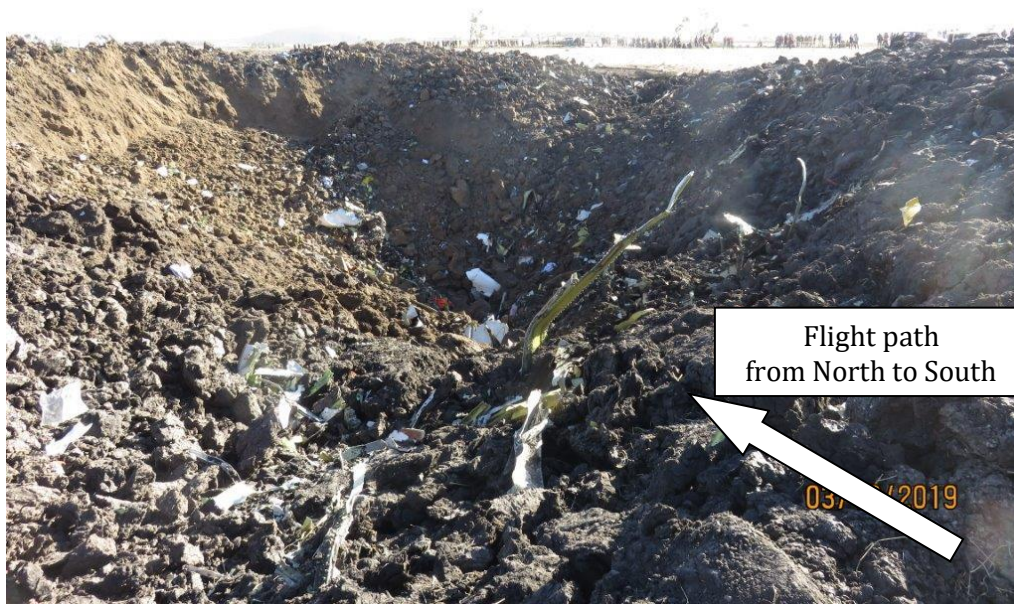
Close view of the crater before excavation

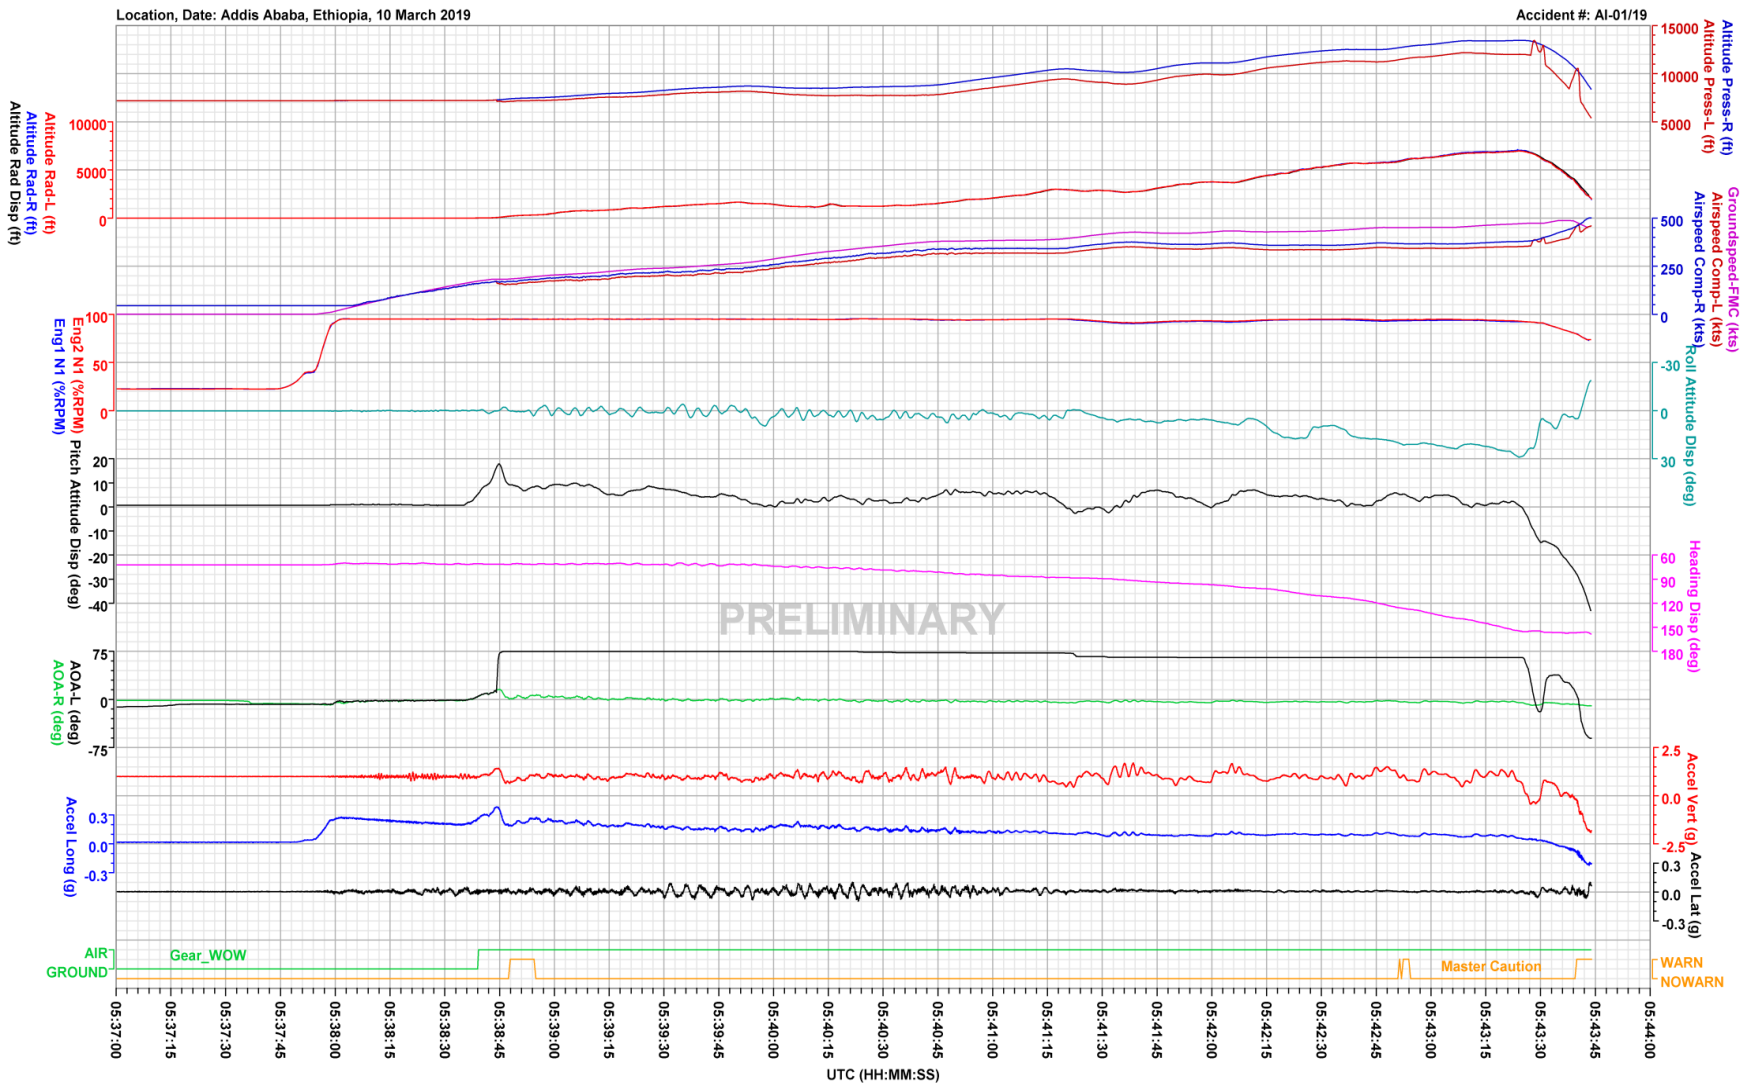
### General Overview of Flight

At 05:38:44, shortly after liftoff, the left and right recorded AOA values deviated. Left AOA decreased to 11.1° then increased to 35.7° while value of right AOA indicated 14.94°. Then after, the left AOA value reached 74.5° in  $\frac{3}{4}$  seconds while the right AOA reached a maximum value of 15.3°. At this time, the left stick shaker activated and remained active until near the end of the recording. Also, the airspeed, altitude and flight director pitch bar values from the left side noted deviating from the corresponding right side values. The left side values were lower than the right side values until near the end of the recording.

At 05:40:00 shortly after the autopilot disengaged, the FDR recorded an automatic aircraft nose down (AND) activated for 9.0 seconds and pitch trim moved from 4.60 to 2.1 units. The climb was arrested and the aircraft descended slightly.

At 05:40:20, approximately five seconds after the end of the ANU stabilizer motion, a second instance of automatic AND stabilizer trim occurred and the stabilizer moved down and reached 0.4 units.

At 05:43:20, approximately five seconds after the last manual electric trim input, an AND automatic trim command occurred and the stabilizer moved in the AND direction from 2.3 to 1.0 unit in approximately 5 seconds. The aircraft began pitching nose down. Additional simultaneous aft column force was applied, but the nose down pitch continues, eventually reaching 40° nose down. The stabilizer position varied between 1.1 and 0.8 units for the remainder of the recording.
