Final report *SHK 2023:01e*

Fire on the vessel ALMIRANTE STORNI in
December 2021, off Gothenburg

File no. S-302/21

18 January 2023

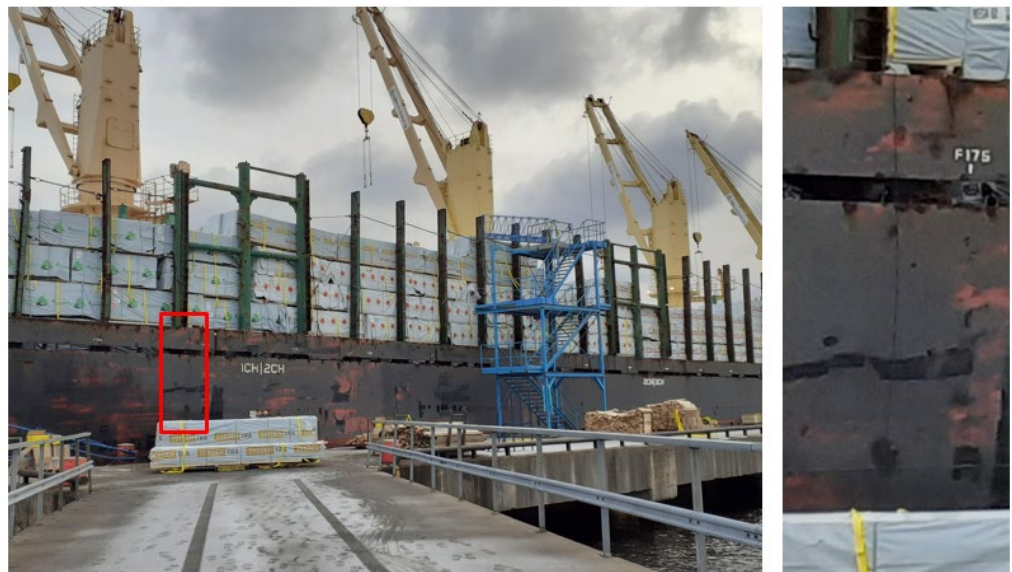
In conjunction with departure it was noted that there was an extension cable between the vessel and the quay that had not been disconnected (see Figure 12). The crew on the forecastle (foredeck) informed the master on the bridge, but it was not possible to prevent the cable from breaking off because the vessel was already in motion.

When the vessel departed from Orrskär on 1 December, the extension cable was still attached to both the vessel and the quay. The linesmen who untied the vessel notified the crew of this when the vessel departed. However, it was too late to take any action and the extension cable was stretched until it broke off. When the pilot left the vessel, he saw that a few metres of the extension cable were hanging down by the side of the vessel. No inspections of the cable were conducted after the vessel had departed.

Figure 12. Extension cable that was run from the port deckhouse by crane 1 on the vessel. Image: Photograph courtesy of the owner of ALMIRANTE STORNI.

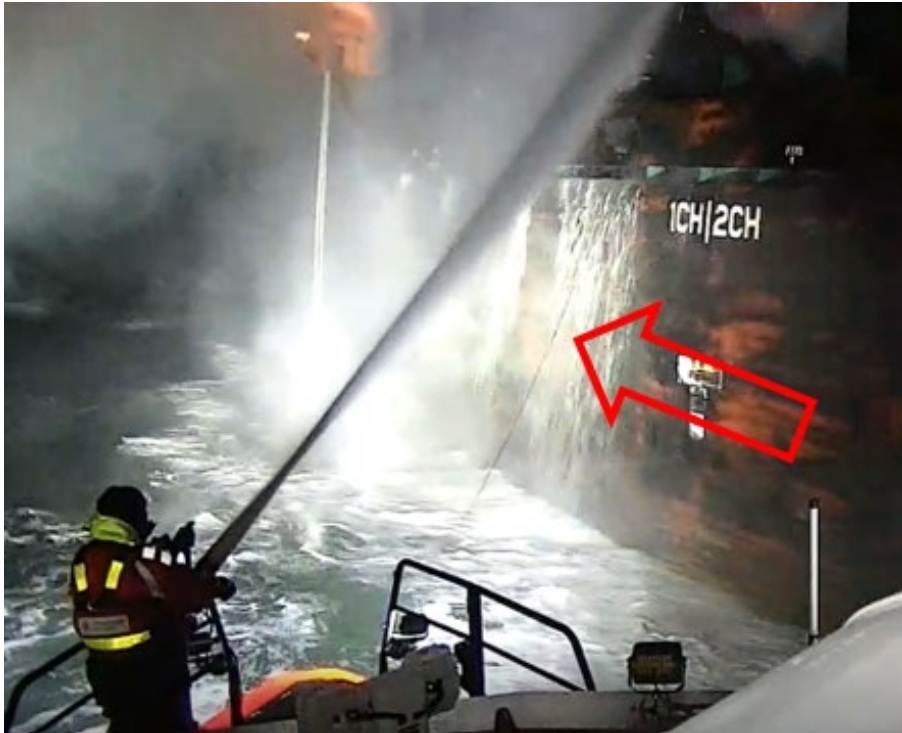
Video recordings were made from one of the Swedish Sea Rescue Society's boats during the firefighting operation on 4 December. When examining this video, something was detected that is probably the extension cable that broke off when ALMIRANTE STORNI departed from Orrskär (section 1.5.2). In a sequence in the video, the extension cable can be seen hanging over the gunwale down into the water (Figure 13).

Figure 13. Image from the video recorded on one of the Swedish Sea Rescue Society's boats on Saturday 4 December. The arrow points to the extension cable that is probably the one that was torn off when the vessel departed from Orrskär.

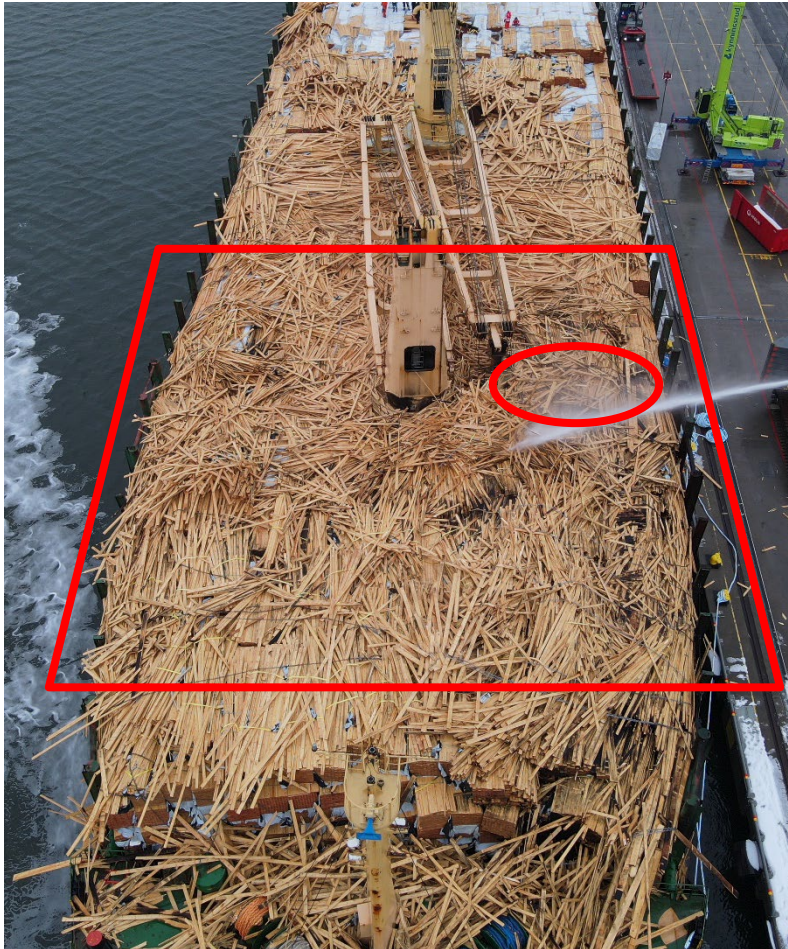
The fire-damaged area extended from between the gunwales in line with crane 1 and forward of this. The fire damage to the cargo out towards the starboard gunwale was relatively limited but increased in intensity towards the area surrounding the crane. Timber that was lying on the deck closest to cargo hold 1, forward of the crane, was completely burnt. The packages of timber aft of the crane sustained substantial fire damage. Several packages of timber had largely burnt up on the port side of the crane, out towards the gunwale and along the coaming of the cargo hold forward towards the foredeck. The most extensive fire damage was located at the level of the deck and two layers of timber packages above this. The packages of timber on top of the support structure above the deck surface next to the port side deckhouse were also largely burnt up. The area that sustained the most fire damage was located around the exposed deck surface between crane 1 and the starboard gunwale (see Figure 15). The fire damage to parts of the vessel was limited to soot covered surfaces, burned off paint and burned cables, hoses and seals. The largest areas with burnt off paint were forward of crane 1 and out towards the port gunwale.

Figure 65. The square indicates the area in which the fire spread to varying degrees. The ring indicates the area that suffered the most extensive fire damage. The bow of the vessel is at the bottom of the picture.

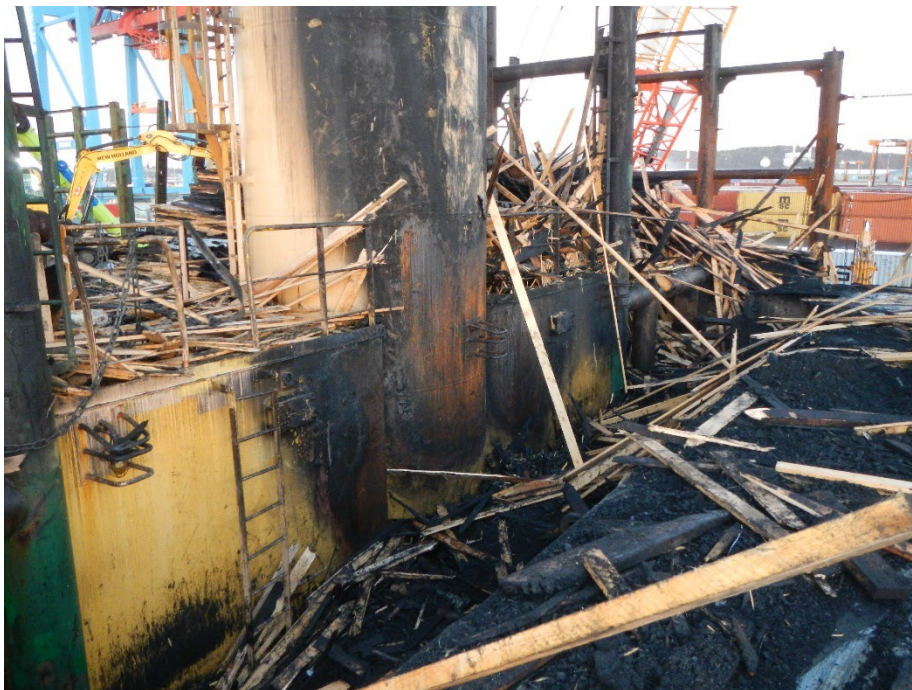
Figure 16. The deckhouses beside crane 1, with the port side deckhouse to the right of the base of the crane. The areas where the paint was burned off were larger forward and on the port side of the crane.

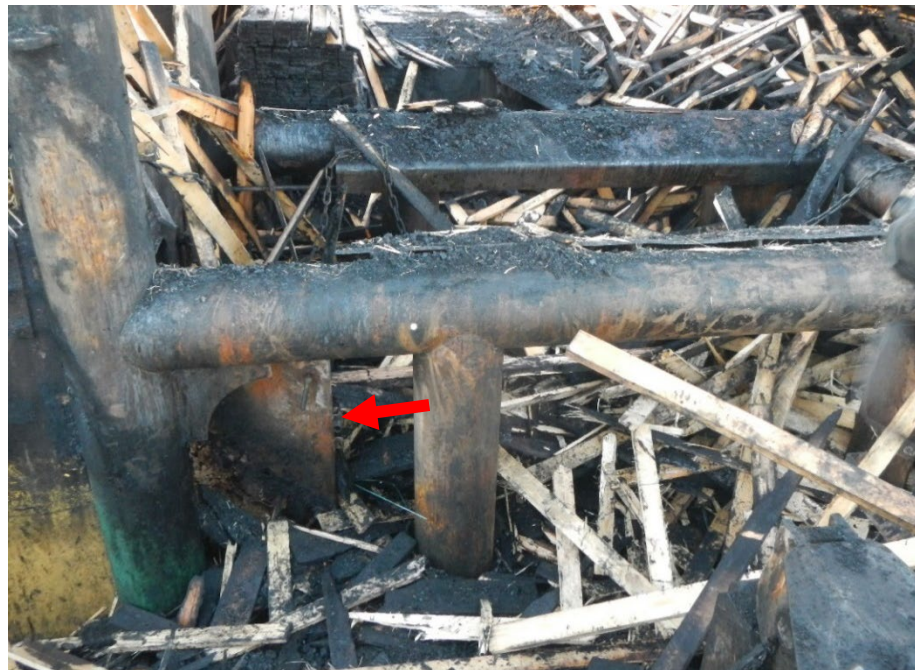
There was damage from soot and melting in the deckhouse but no signs of extensive fire.

Figure 17. The support structure for the cargo by the port side deckhouse. The arrow marks the open door to the deckhouse.

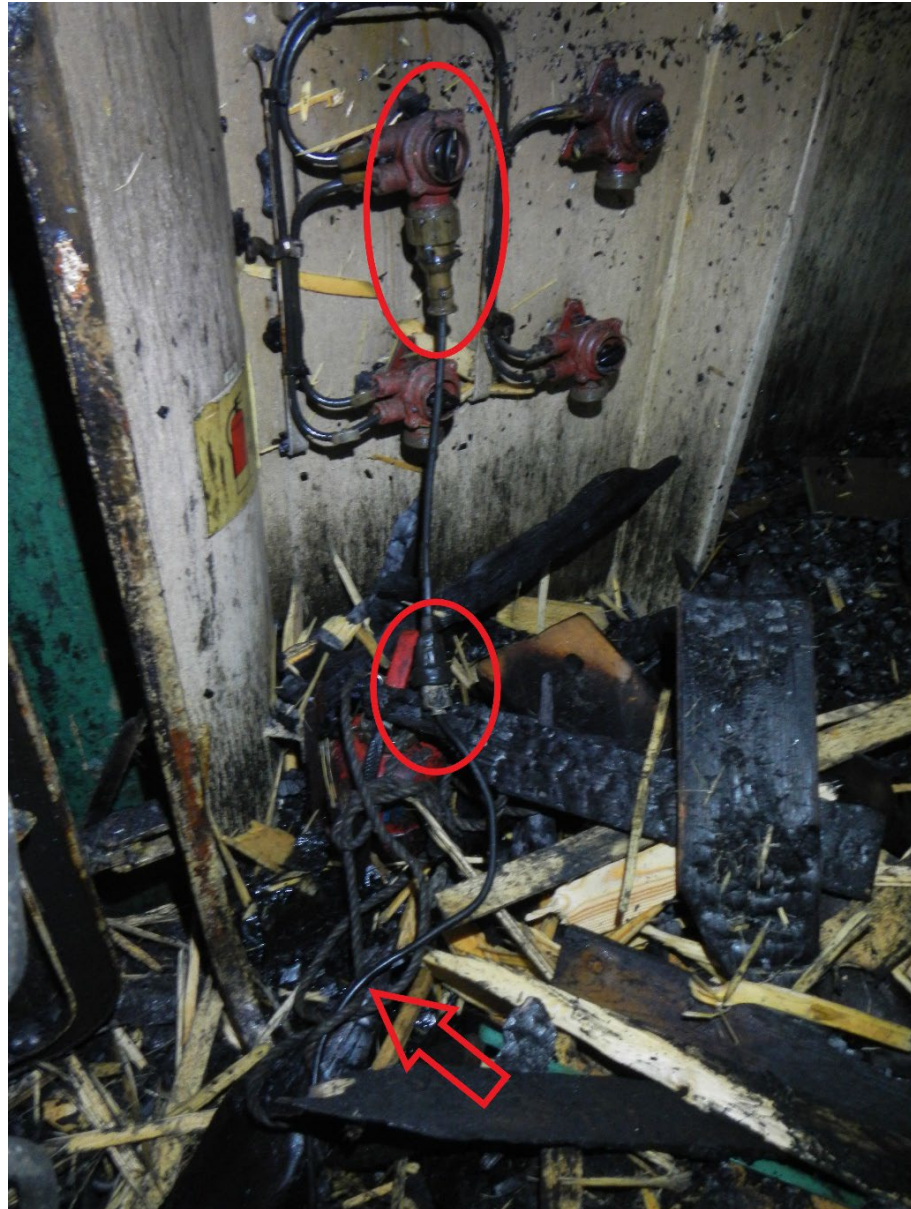
Figure 19. Shown in the upper ring is the electrical outlet with the switch in the 'on' position and the plugged-in extension cable in the deckhouse. In the lower ring, a connection can be seen between the cable from the electrical outlet and the extension cable that was out on the deck. The arrow points to the extension cable where it runs through the open door to the deckhouse on the left of the picture.

In the carbon residue, it was possible to follow the extension cable from the deckhouse out to the outermost part of the support structure on the port side. The cable lay in coils on the deck but also ran over a number of bundled chains that had been placed on the deck. The insulation was intact on those parts of the cable that had been lying on the deck closest to the deckhouse. The insulation was burnt off on those parts of the cable that had been lying on the piles of chain and on a pipe by the outer part of the support structure on the port side. The extension cable was cut off close to the deck by the outer side of the support structure on the port side. The end showed signs of carbonisation and melting. No

additional electric cable or objects that the extension cable could have been connected to were found.

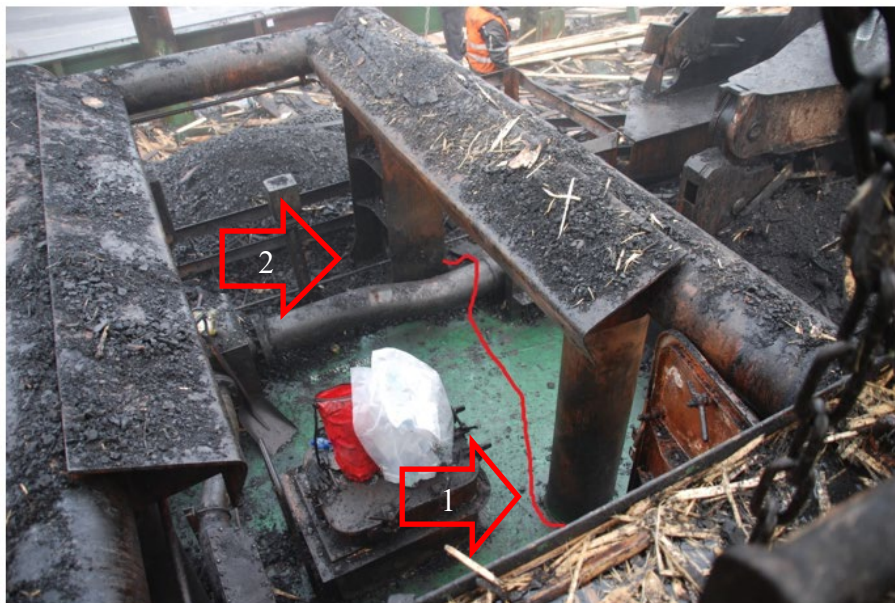
Figure 20. Photo from the topside of the port side deckhouse by crane 1. The deck has been cleared of carbon residue and the extension cable has been removed. The arrow marked with 1 points to the drawn line showing the approximate path of the cable when it was found in the carbon residue. The arrow marked with 2 points to the approximate position behind the steel pillar where the end of the extension cable was found.

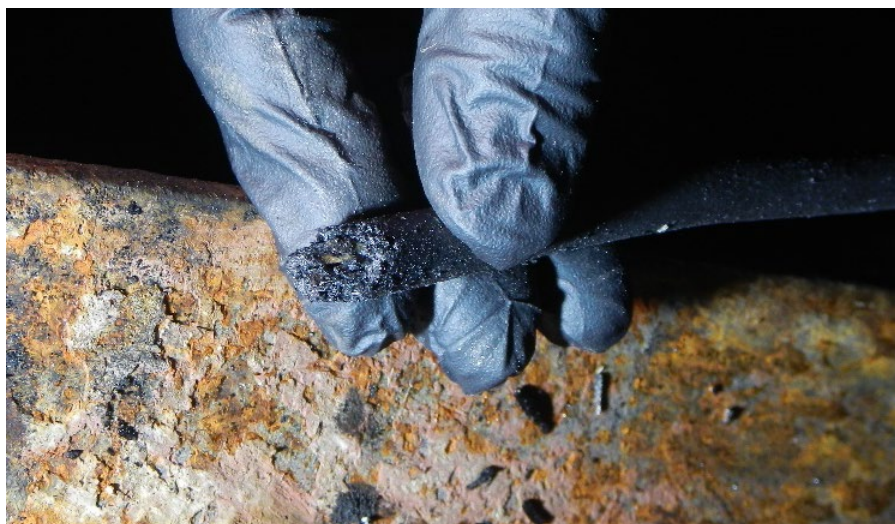
Figure 71. The torn off end of the extension cable that was plugged into an electrical outlet in the deckhouse on the port side of crane 1.

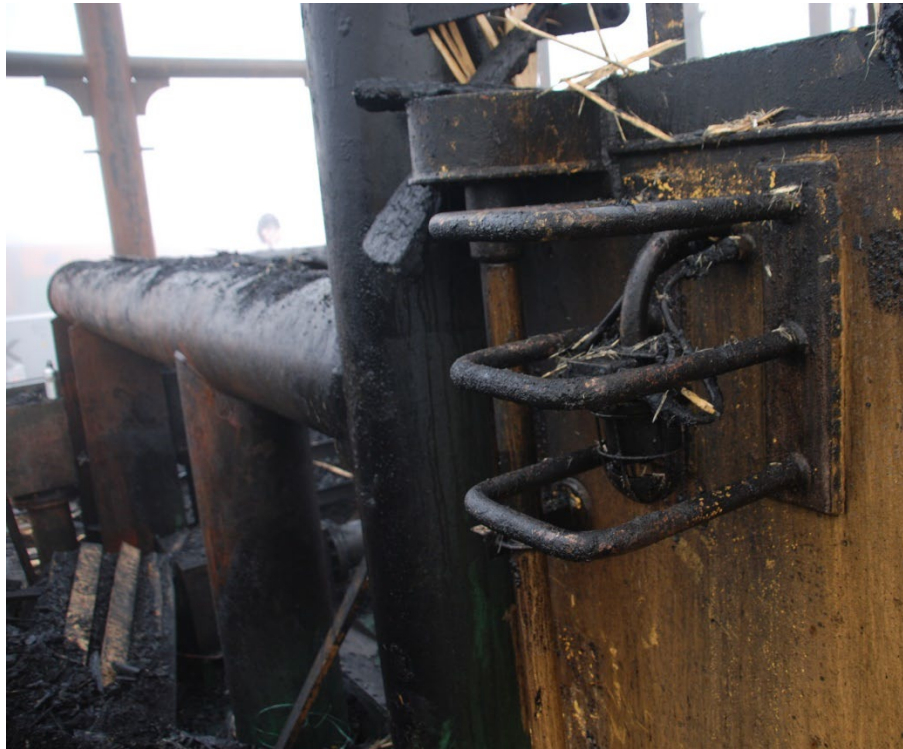
There were six fixed light fittings forward and aft of the outside of the base of the crane. These were located about two metres above the deck. There were protective metal frames surrounding the light fittings. On one light fitting the upper protective frame was bent but the light fitting undamaged. None of the other protective frames were damaged. Under the outer part of the support structure there were two light fittings that were similar but without the protective frames. The protective glass and

bulbs on all of the light fittings were broken and the exposed electric cables to the light fittings were burnt.

Figure 22. Fixed light fitting with protective frames on the port side deckhouse by crane 1.

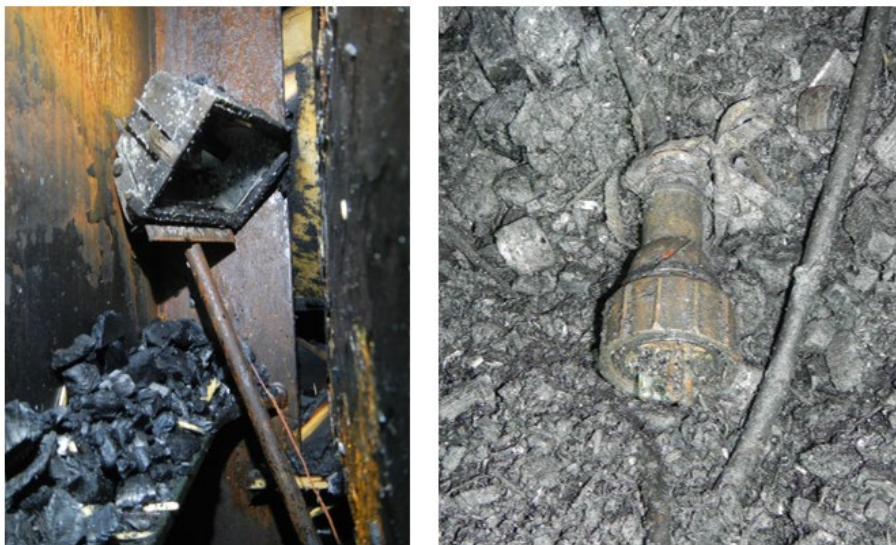
A floodlight with a stand was leaning against one of the stanchions of the support structure outside the deckhouse. The glass on the lamp was broken but the halogen bulb was intact. The insulation on the cable to the floodlight was burnt off in several places. The plug was not plugged into an electrical outlet and the pins on the plug were dirty, without clean metal surfaces, which suggests that it was not plugged in at the time of the fire. The floodlight was also not directed towards the timber cargo.

Figure 23. Portable floodlight that was leaning against one of the stanchions of the support structure on the port side of crane 1. The picture on the right shows the plug for the floodlight, which showed no signs of being plugged into an outlet during the fire.

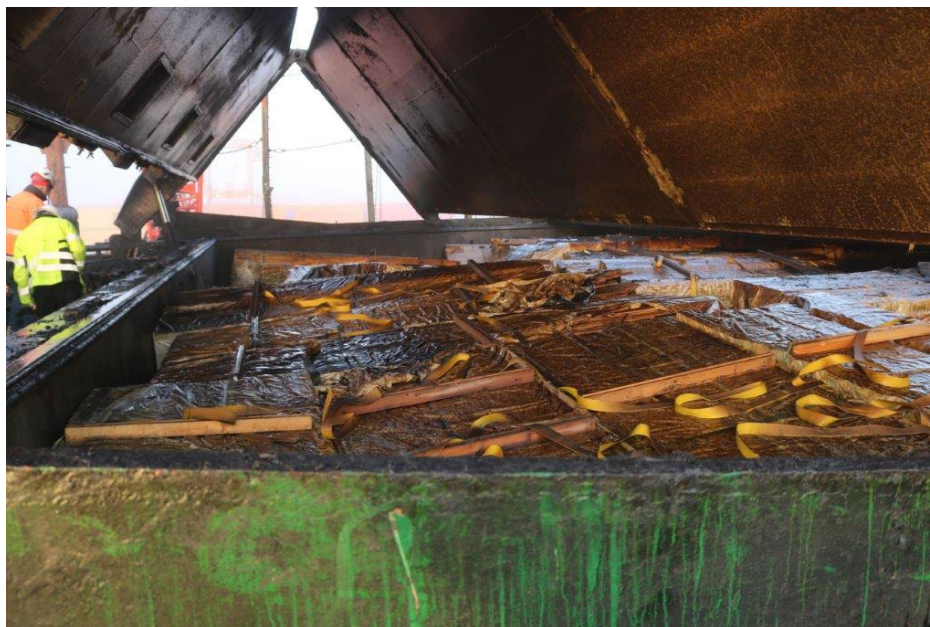
When the deck cargo had been removed, the hatches to cargo hold 1 were opened. Only a visual inspection of the upper layer of the timber cargo was conducted. The plastic packaging on all timber packages had melted, but no carbonisation of the timber was visible.

Figure 24. The timber cargo in cargo hold 1 when the hatches were opened and the deck cargo had been removed in Skandia Harbour in the Port of Gothenburg.

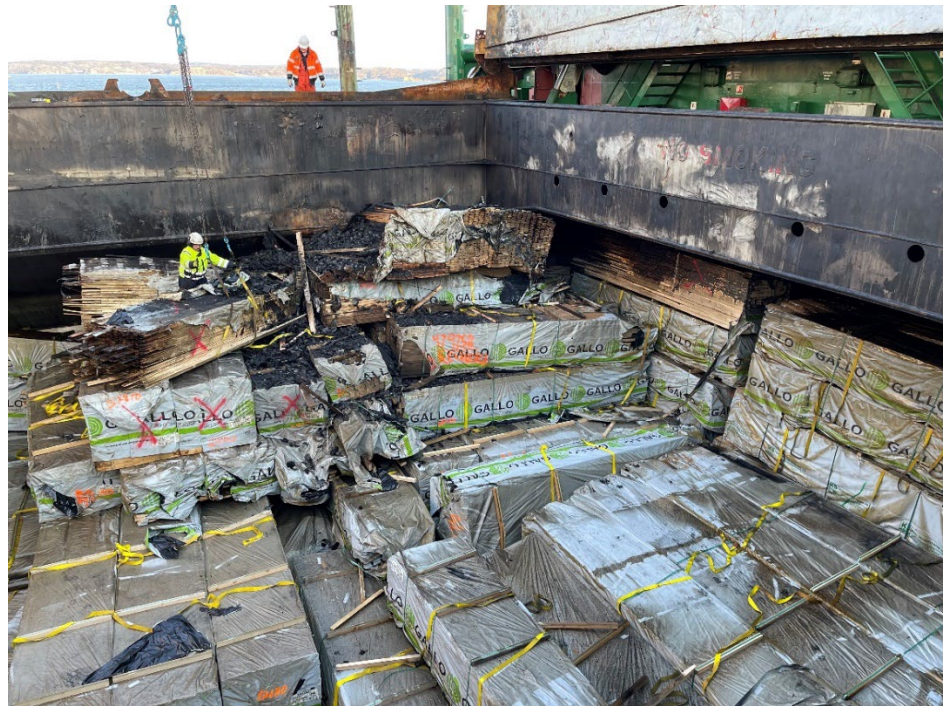
After the deck cargo had been unloaded in Skandia Harbour, the vessel went to Lysekil to unload the remainder of the cargo. A number of packages of timber that were heavily carbonised were observed in the forward half of the cargo hold on the port side, under the upper layer. The carbonisation went down to about half the depth of the cargo hold. On the same side there was soot and patches where the paint had burned

Figure 85. Cargo hold 1 during unloading in Lysekil. Some of the timber packages towards the port side of the cargo hold were heavily carbonised.

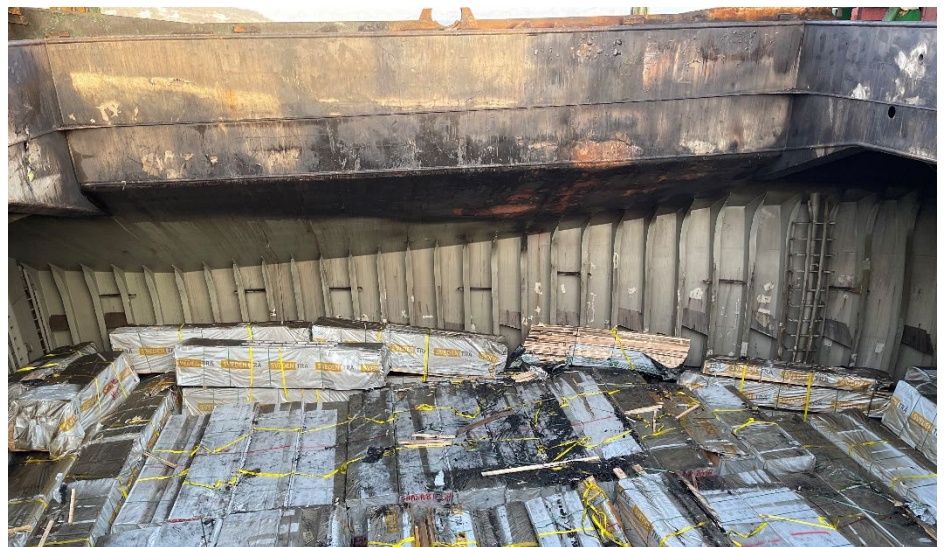
off on the roof of the cargo hold and part of the way up on the cargo hold coaming.

Figure 96. Soot and burned off paint on the port side of the cargo hold.

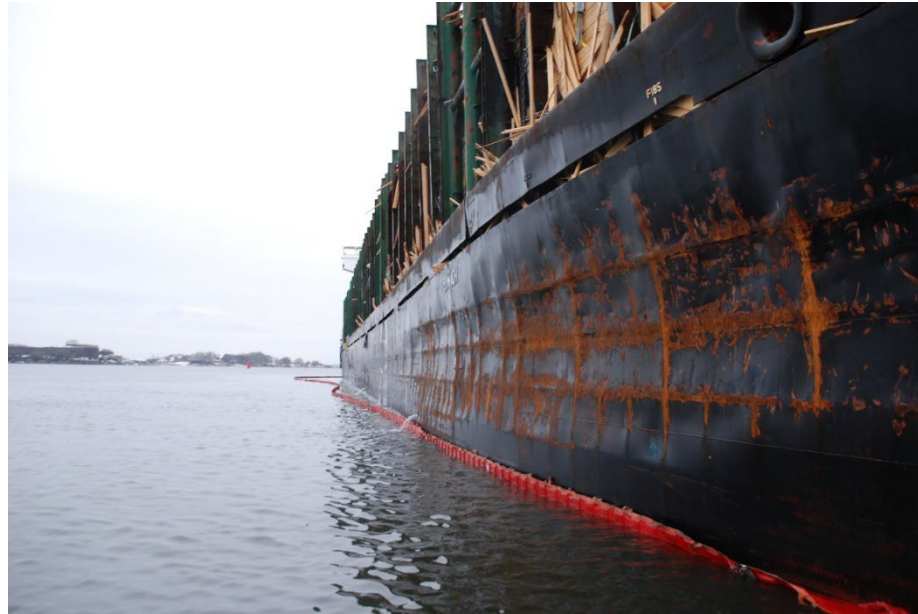
- The powerful water jets caused damage including to the cabins and equipment on cranes 1, 2 and 3.
- The Coast Guard vessels pushed their sterns against the side of the vessel, which caused indentations in the hull. The hull on the starboard side was indented approximately 0.5–3 m between frames 160 and 190 below the main deck. Two cracks in the hull that were approximately 1 m in length had formed along the longitudinal axis of the vessel (see Figure 29). There was also a smaller indentation on the port side between frames 185 and 187.

Figure 29. The hull damage on the starboard side.

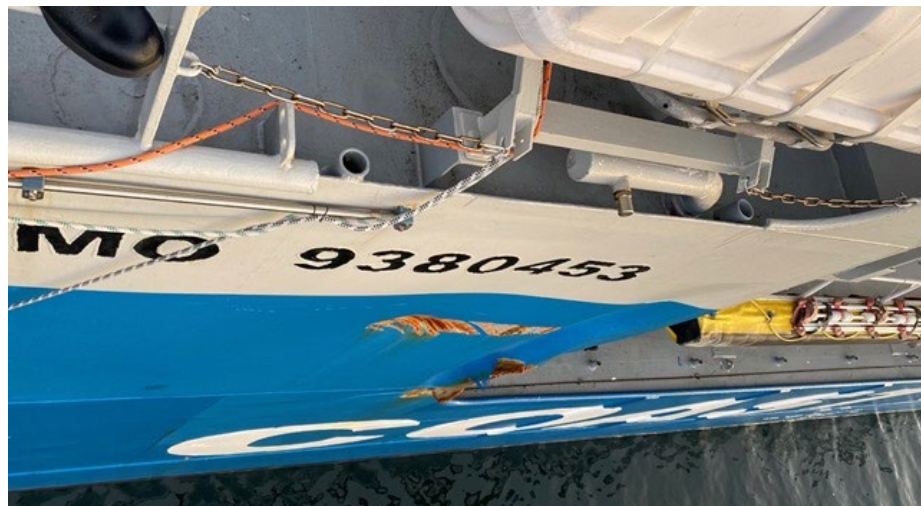
The Coast Guard vessels had to press their sterns into ALMIRANTE STORNI in order to keep the water jets targeted somewhat consistently. This caused damage to the fixed fenders on the sterns of the Coast Guard vessels. These were initially replaced with large loose fenders. However, the loose fenders could not be kept in place and were torn off. These fenders were replaced with large tractor tyres, which worked better. Aside from the problems with the fenders, there were also problems with visibility because of the large number of water jets. On one occasion, this resulted in the vessel KBV 002 lying alongside ALMIRANTE STORNI without this being detected and a minor collision between the two vessels occurred.

Figure 30. Damage to the port side of the vessel KBV 002. Image: Swedish Coast Guard.

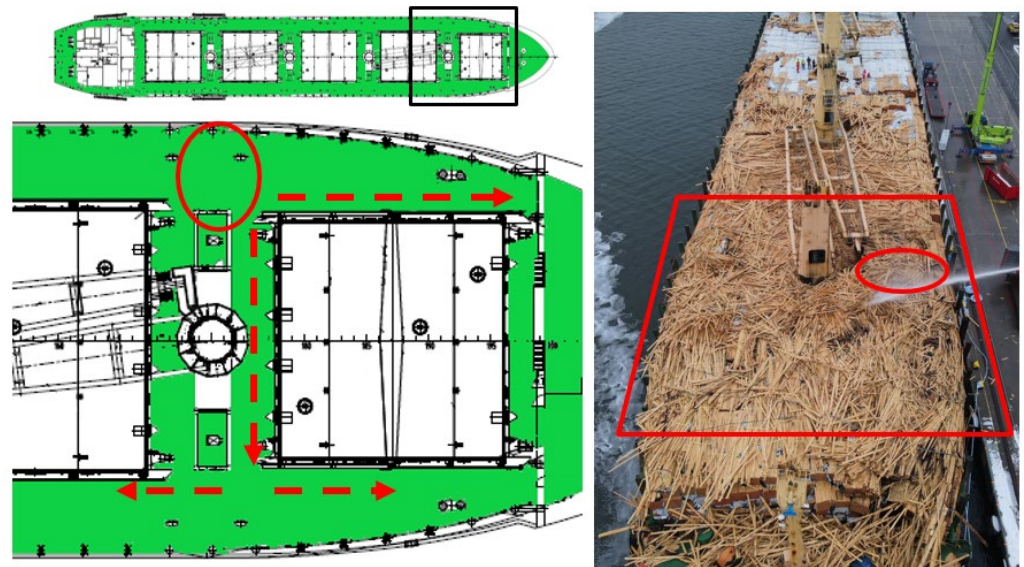
activated after the fire was discovered. All in all, this indicates that the fire did not start in the cargo hold and instead spread down into it.

Figure 31. The area within the circle is where the fire has burned longest. The fire has spread in the deck cargo in the area encompassed by the square. The dashed lines indicate the main direction in which the fire spread. Left image: Photograph courtesy of the owner of ALMIRANTE STORNI.

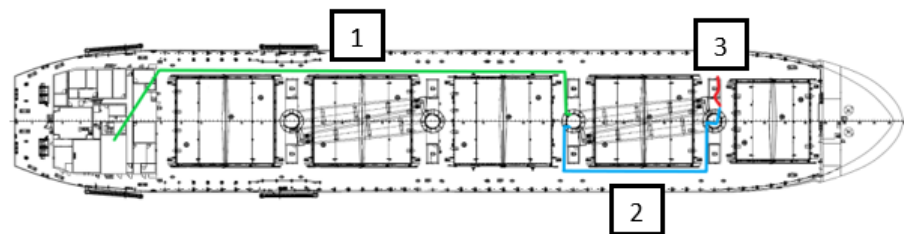
The electric cables were approximately 180 metres long from the power source in the engine room to the deckhouse by crane 1 and had various cross-sectional areas. The extension cable from the deckhouse was approximately 5 metres long (see Figure 32). The voltage in the vessel was 220 V phase-to-phase voltage with loads connected between phases. The circuit breaker for the electric cable (a miniature circuit breaker) was 16 amps and was located by crane 2. Rough calculations based on these values indicate that the impedance in the electric cables and the extension cable was so high that the current that arises in the event of an electric arc was lower than the miniature circuit breaker's threshold for tripping.

Figure 10. Lengths of the electric cables in the vessel and the extension cable. The electric cable marked with 1 had cross-sectional areas of 3x6 mm² and was approximately 120 metres, the electric cable marked with 2 was 3x2.5 mm² and approx. 60 metres, no. 3 was the extension cable and was 3x1.5 mm² and approx. 5 metres.
