Final report SHK 2023:11e

HUCKLEBERRY FINN – Crush incident
during loading operation in the Port of
Trelleborg, Sweden, 19 August 2022

File no. S-244/22

08 September 2023

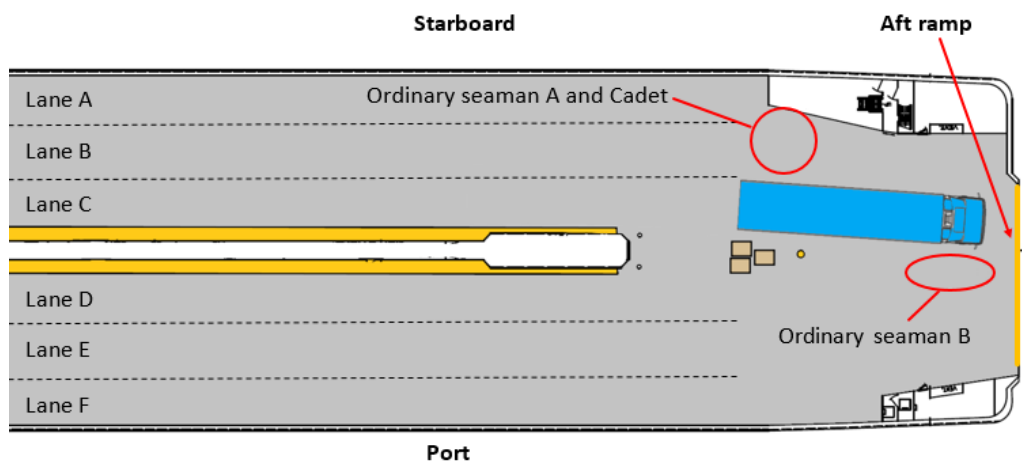
Figure 2. Sketch showing how the first semi-trailer truck on the starboard side was directed forward. The centre casing is marked in white and yellow.

Ordinary seaman B directed the semitrailer truck from its right side and moved between the centre casing and the aft ramp in the vessel's centreline. When the semitrailer truck was two to three metres from the aft ramp ordinary seaman B signalled with his whistle that the semitrailer truck was to stop because an object had become stuck under the trailer. Ordinary seaman A heard the stop signal and saw that the semitrailer truck stopped. The driver had the right side window open and also saw ordinary seaman B in the right wing mirror. Ordinary seaman B directed the driver to reverse in order to allow the ordinary seaman to remove the object. The driver was not paying any attention to the left side of the semitrailer truck but knew that there were two people there. Ordinary seaman A and the deck apprentice were standing on the left side of the semi-trailer truck, the semi-trailer truck was therefore blocking the view between them and ordinary seaman B (see Figure 3).

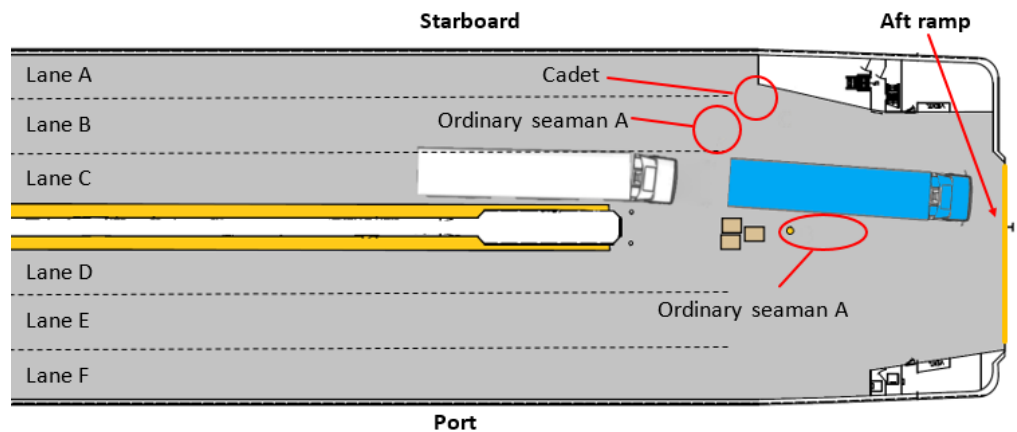
While the first semi-trailer truck was being driven on board another semi-trailer truck had been directed into the same lane. There was a sign in the windscreen of this semi-trailer truck to indicate that it was to be connected to the ship's electrical supply. The second semi-trailer truck rolled onto the car deck towards the first semi-trailer truck and ordinary seaman A directed it to park behind the first one.

Figure 3. Sketch showing how the first semi-trailer truck was stopped and another semi-trailer truck was directed towards the first by the ordinary seaman A. At that time ordinary seaman B was standing by the pillar in the centreline of the vessel.

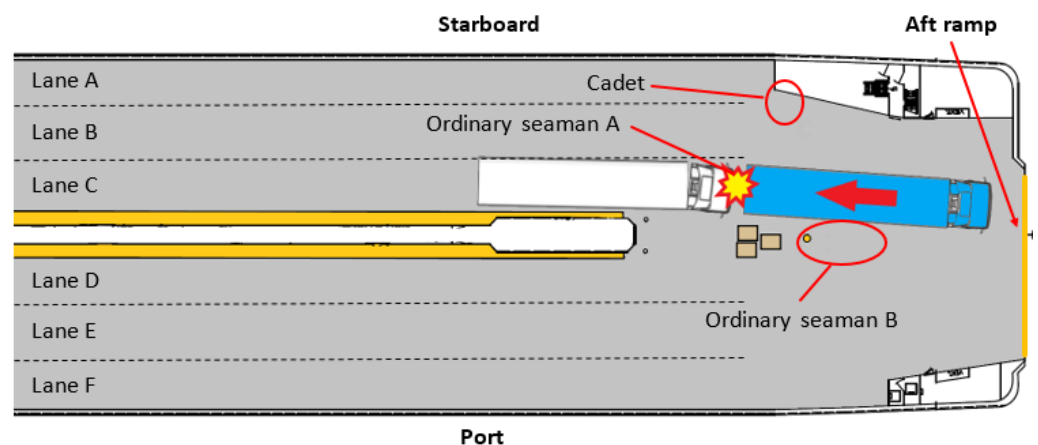
Ordinary seaman A walked in between the semi-trailer truck in order to get an electrical cable that was in the centre casing on the other side of the semi-trailer truck when the first semi-trailer truck began to reverse. Ordinary seaman A attempted to get back but was not able to make it all the way out and was crushed between the semitrailer trucks (see Figure 4).

Figure 4. Sketch showing how ordinary seaman A walked between the semi-trailer truck at the same time as the first semi-trailer truck reversed and crushed ordinary seaman A.

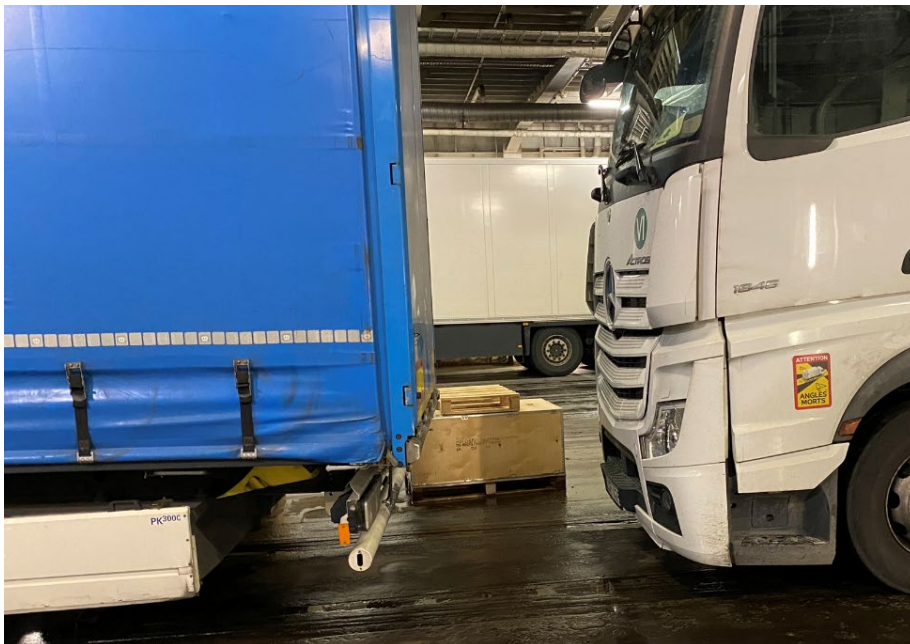
The driver of the first semi-trailer truck, which was reversing, felt resistance and understood that something had happened and therefore stopped. The driver of the second semi-trailer truck saw what was happening and began to reverse. When the pressure from the semi-

Figure 5. The semitrailer trucks immediately after the occurrence. Image: from the crew.

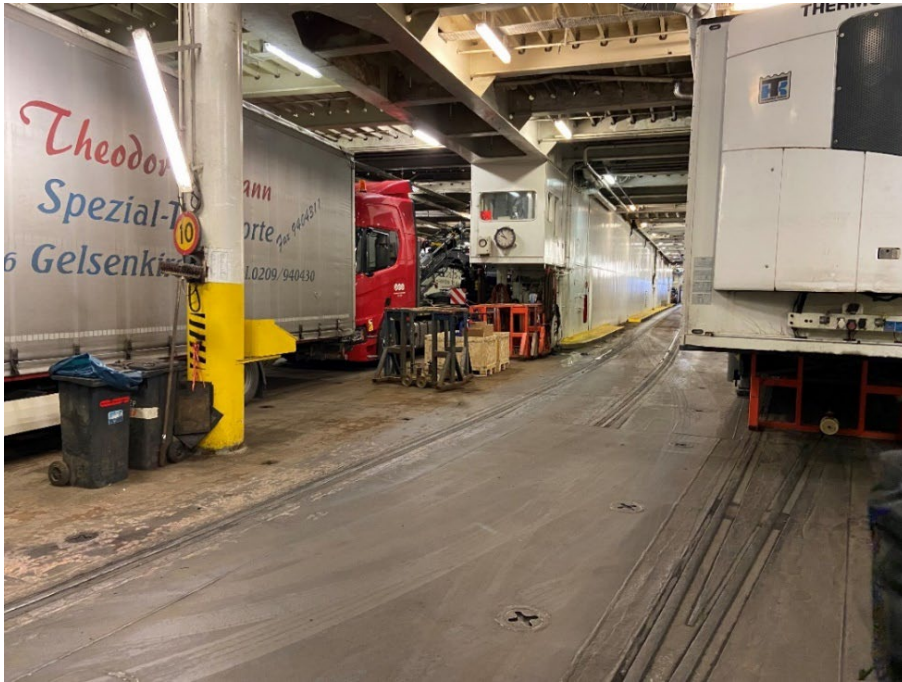
It was not possible to use the space between the centre casing and the column for cargo and it was therefore used to store a variety of stowage equipment and for engine supplies that were delivered to the vessel. There was also a desk and some waste bins by the pillar (see Figures 6 and 7).

Figure 6. The picture is taken from the stern facing forward, in towards the car deck, and shows the pillar in the centreline and the aft edge of the centre casing where the electrical cables were hung.

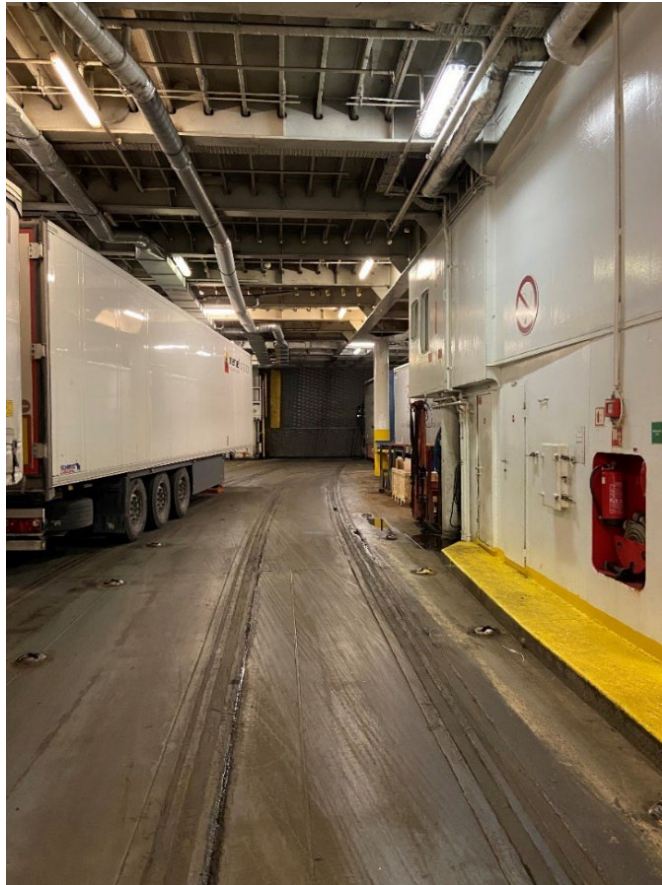
Figure 7. The picture is taken amidships and towards the aft ramp in lane C. The centre casing can be seen on the right of the picture and the pillar is just behind that in the centreline.

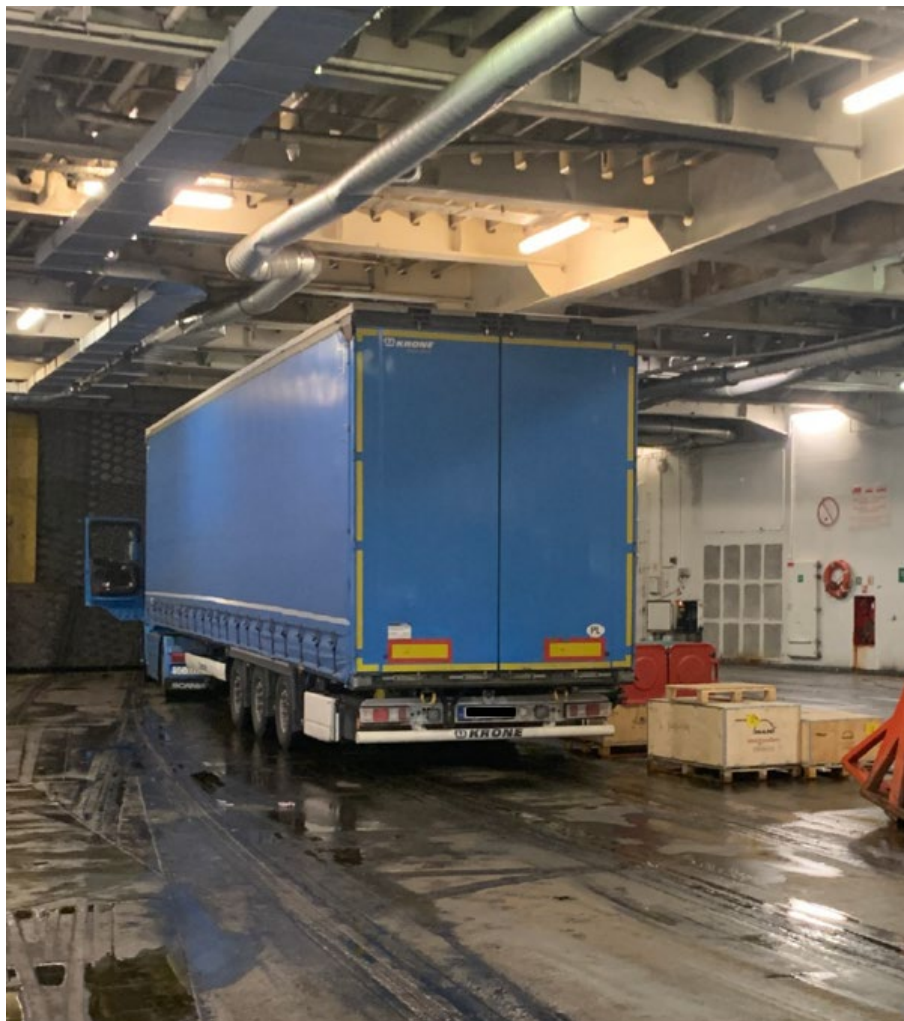
The first semi-trailer truck that was involved in the occurrence was a truck with a three-axle trailer that had a soft cover on the sides and solid doors at the rear. The second semi-trailer truck was a truck with a refrigerated trailer that needed an electrical supply during the crossing. Both semi-trailer trucks were 16.5 metres long.

Figure 8. The first semitrailer truck. The picture is after the accident once the other semitrailer truck had reversed away. Image: Swedish Police Authority.

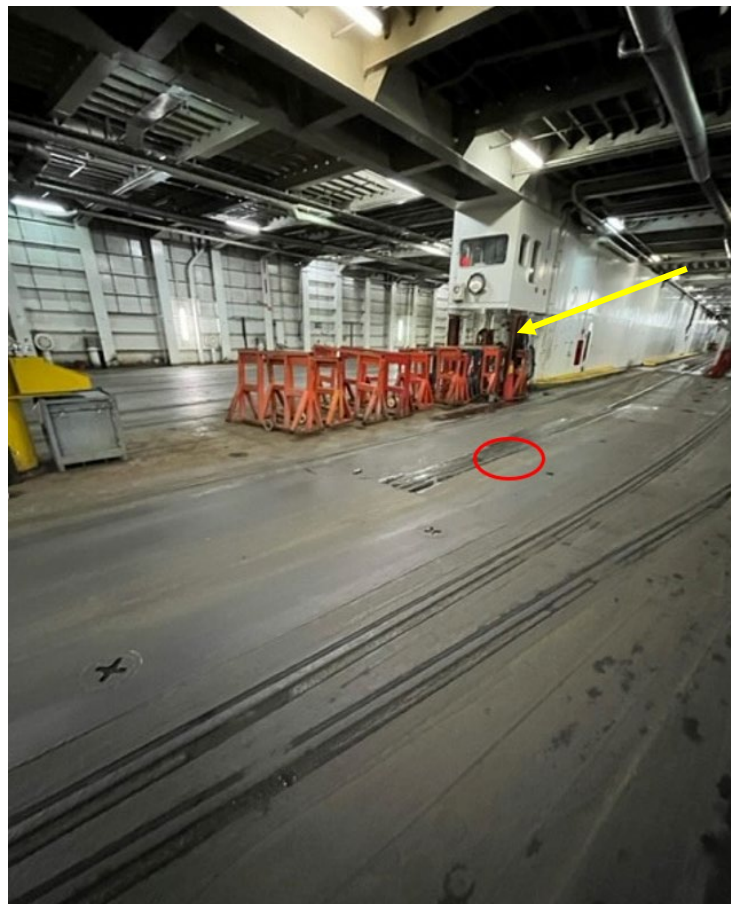
Both of the semitrailer trucks were therefore covering the entire space and c. 10 metres of the centre casing. The power supply cable that was supposed to be connected to the second semitrailer truck was attached to the aft part of the center casing. The shortest route by which to fetch the electrical cable was therefore to walk between the semitrailer trucks.

Figure 9. The red ring shows the approximate location where ordinary seaman A was crushed between the semitrailer trucks. The yellow arrow indicates where the electrical cables were stored. Markings inserted by SHK.
Image: The crew.
