Final report SHK 2023:08e

VIRGO – Grounding off Spitsbergen, Norway
on 14 June 2022

File no. S-131/22

20/06/2023

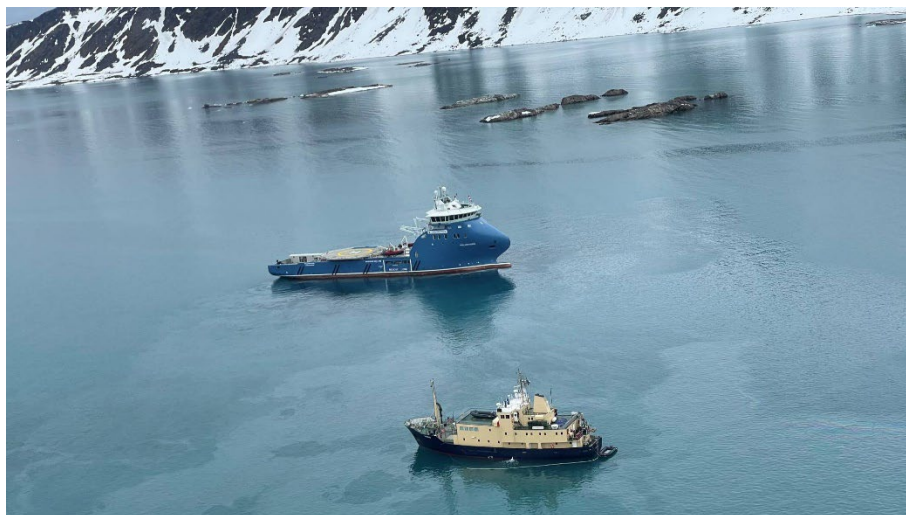
Figure 1. Overview of the vessel VIRGO (at the bottom of the picture) and POLARSYSSEL (upper part of the picture) following the grounding. The picture is published with the permission of the Governor of Svalbard.

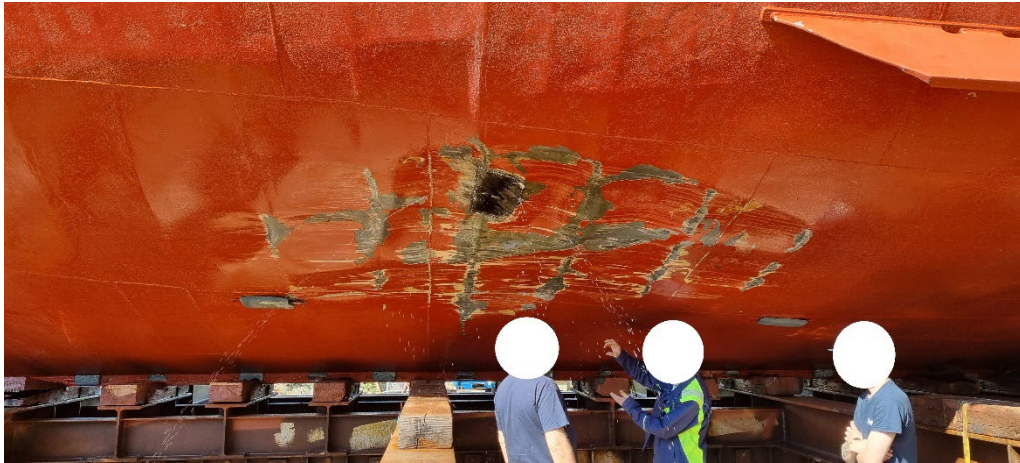
The vessel sustained structural damage during the grounding. The keel beam in the forepeak tank was indented and broken between frame numbers 56 and 60. In addition, a crack appeared in one of the starboard diesel tanks, where the frames in the same area were indented between frame numbers 44 and 51. The crack was 270 cm under the waterline and was 35 x 7 cm.

Figure 2. The picture shows the damage to the diesel tank. Photo: Rederi AB Virgo.

The Norwegian Coast Guard⁸ vessel KV ANDESNES arrived at the site at 21:30 hrs. The vessel brought divers who were tasked with performing a thorough inspection of the damage. After having inspected the damage, the divers made emergency repairs using margarine and wooden wedges in order to stop the oil spill and allow the vessel to return to Longyearbyen. The work to seal the hole in the fuel tank continued until around five o'clock the following morning. Once the work was complete, VIRGO departed for Longyearbyen, escorted by KV ANDESNES.

Underwater welding of the damage was conducted in Longyearbyen. The temporary repairs were approved by VIRGO's classification society RINA before the vessel was able to head to a shipyard on the Norwegian mainland for permanent repairs.

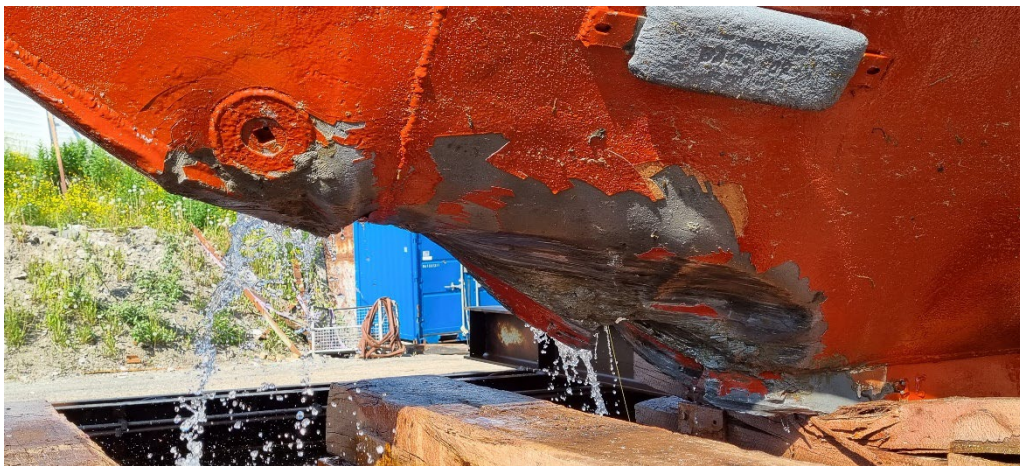
Figure 3. Picture of the forepeak tank. Photo: Rederi AB Virgo.

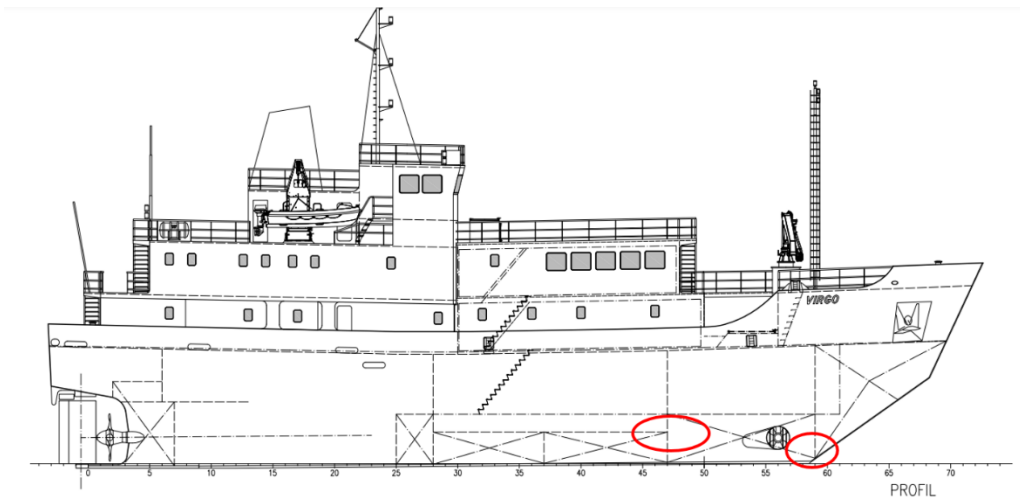
Figure 4. Drawing of the vessel with the damaged areas circled in red. Source: Rederi AB Virgo, markings added by SHK.

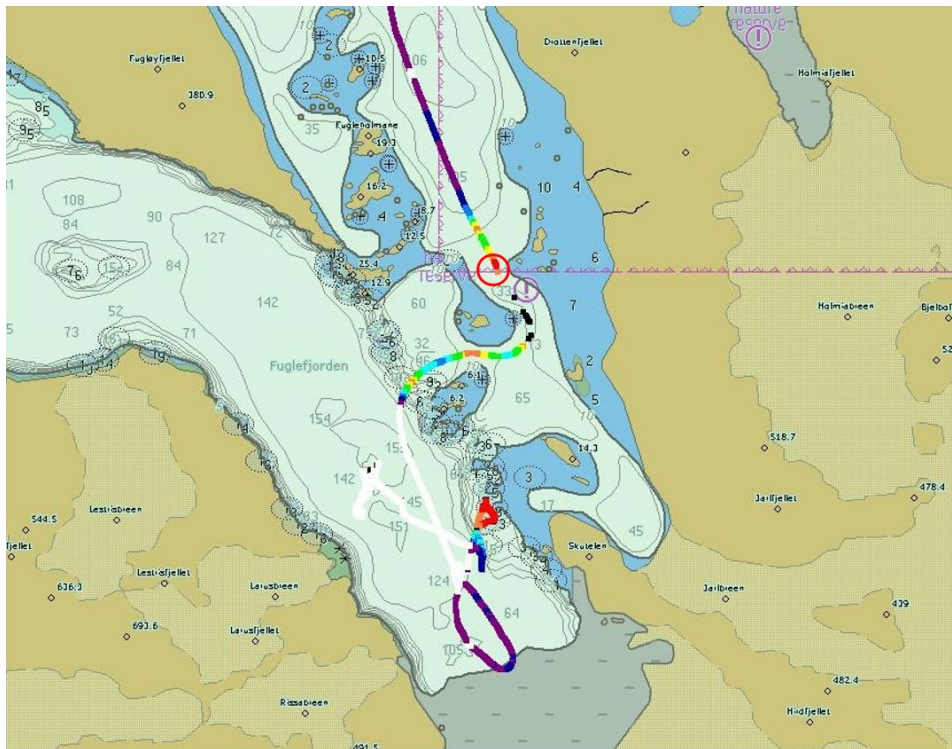
Figure 5. Chart from VIRGO's chart plotter, showing target trails from VIRGO. The red ring added by SHK shows the site of the grounding. © Kartverket.

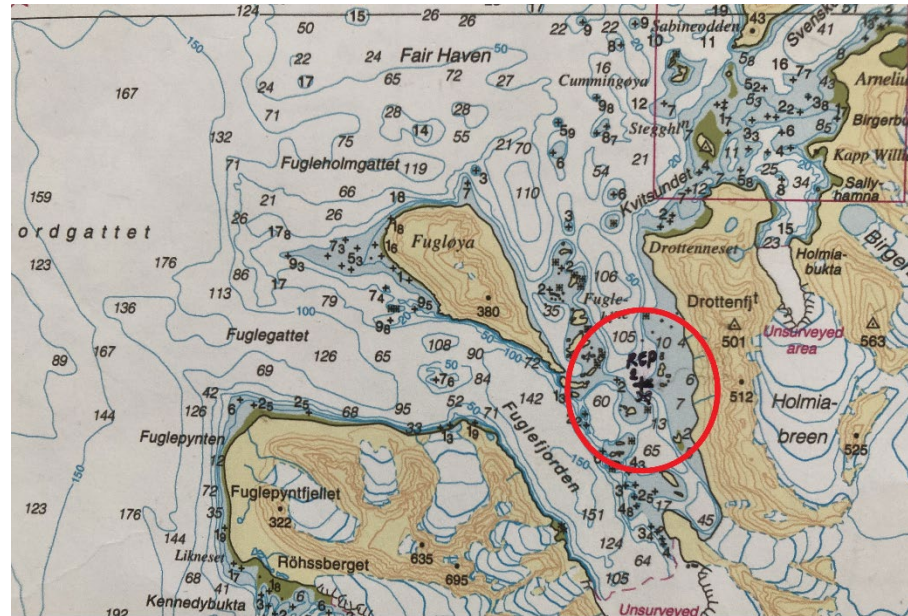
using hydrographic data by means of distance to known objects in the outline of the coast. The paper nautical chart, no. 521, that covers the area in question is on a scale of 1:100,000 (see Figure 7).

Figure 7. Picture of the paper nautical chart that covers Fuglefjorden. The position of the grounding has been circled in red by SHK. © Kartverket

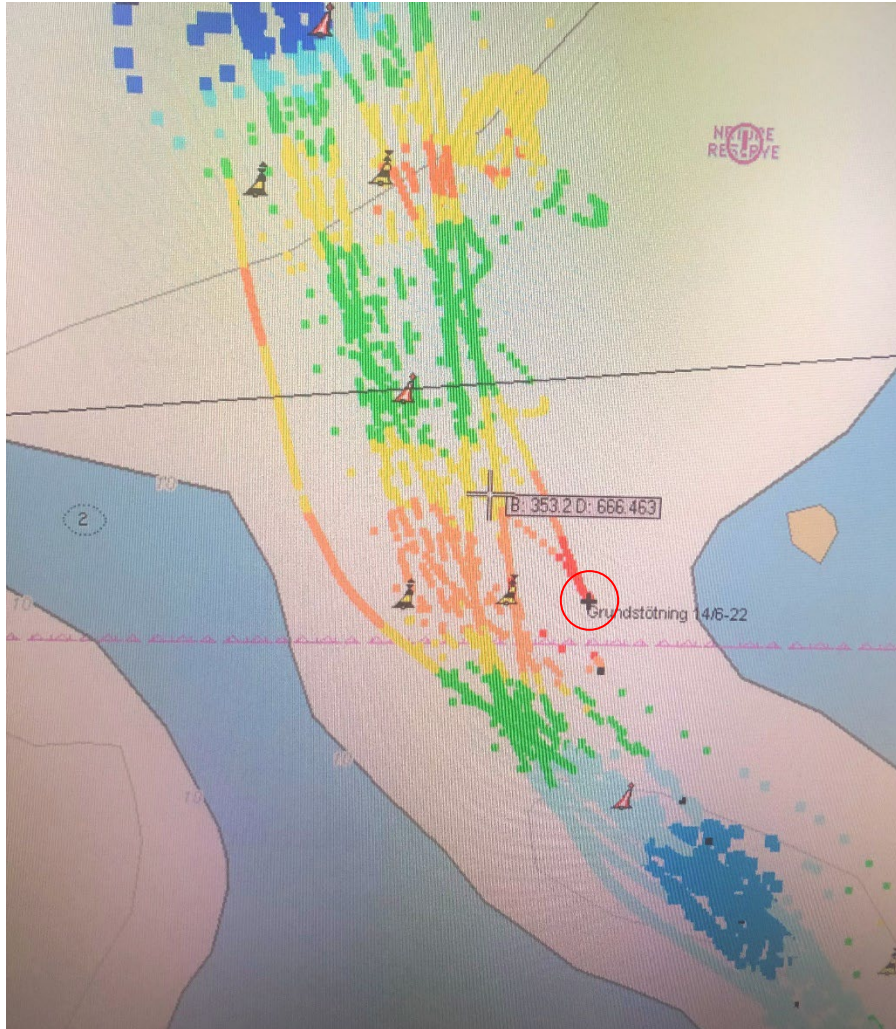
As mentioned in section 1.1, the vessel's own chart plotter contained a data bank with a large number of previous target trails from passages in the area of the grounding. The rock on which VIRGO ran aground was also registered from a previous passage where another vessel was proceeding at such a low speed that it came to a stop and reversed back into deeper water after the echo-sounder registered a sharp shallowing (see Figure 8).

Figure 8. Image from VIRGO's navigation system that shows the previous target trails and the location of the grounding, which is circled in red. The two target trails that lead to the site of the grounding are from another vessel that registered the rock on a previous occasion. The sea marks on the chart image are entered into the system manually and do not actually exist. The target trails from the occasion of the grounding are not included in the image.
