Final report RS 2016:04e

OSLO WAVE – collapsed loading crane in Bollstabruk, Sweden, 9 of June 2015

File no. S-86/15

03/06/2016

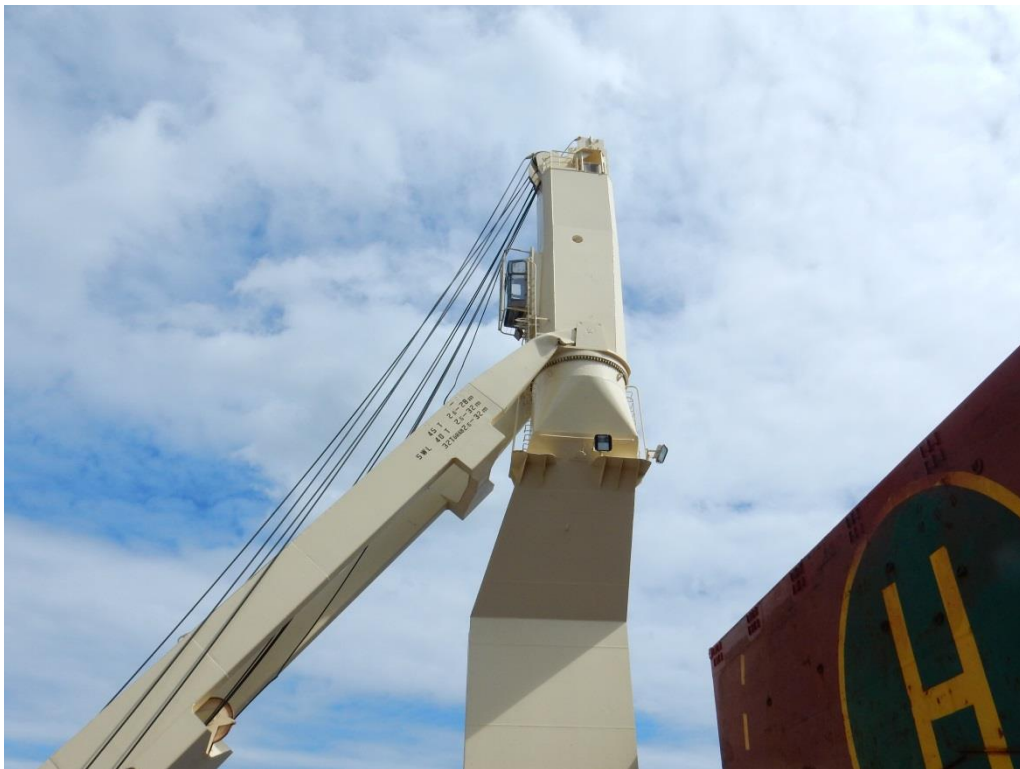
Figure 3. The ship's crane after the collapse.

The arm of ship crane no. 1 sustained damage to the mounting and external edge and to the drum's cable lock. The cable also developed a number of defects. Damage costs amounted to about 460 000€.

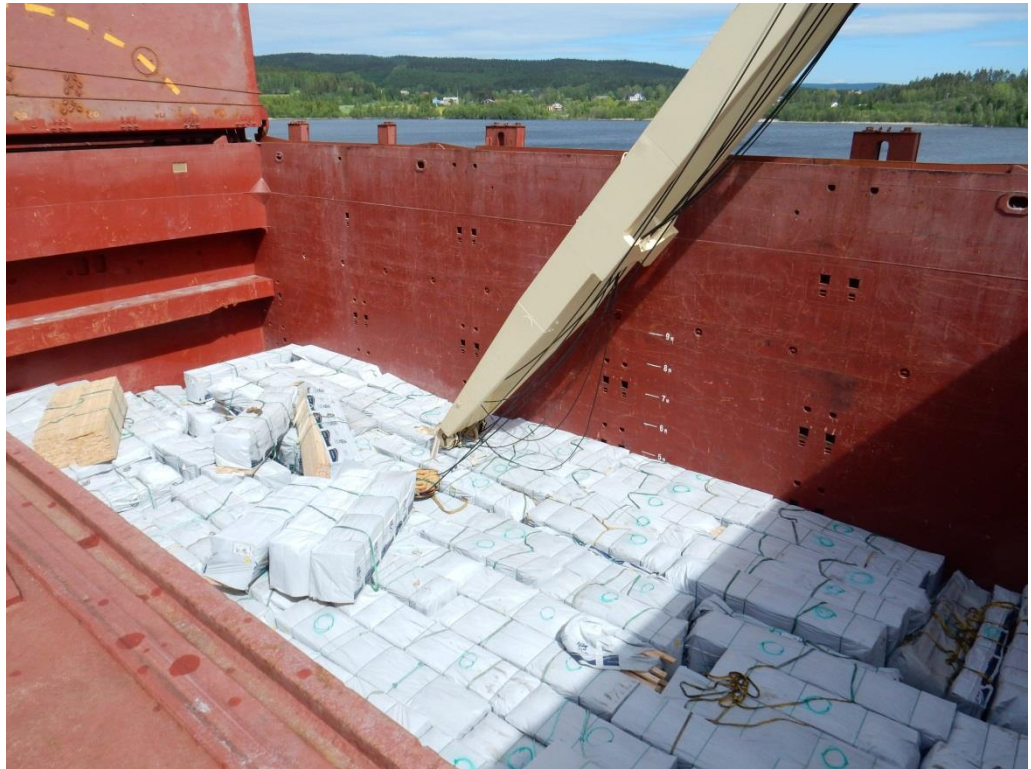
Figure 4. The crane arm after the collapse.

It has been established via the technical investigations that the crane collapsed due to the fact that the crane arm was manoeuvred below its lower limits, which resulted in insufficient cable on the winch drum to bear the weight of the crane arm together with the load in question. The cable locks on the drum thereby came loose and the crane arm collapsed.

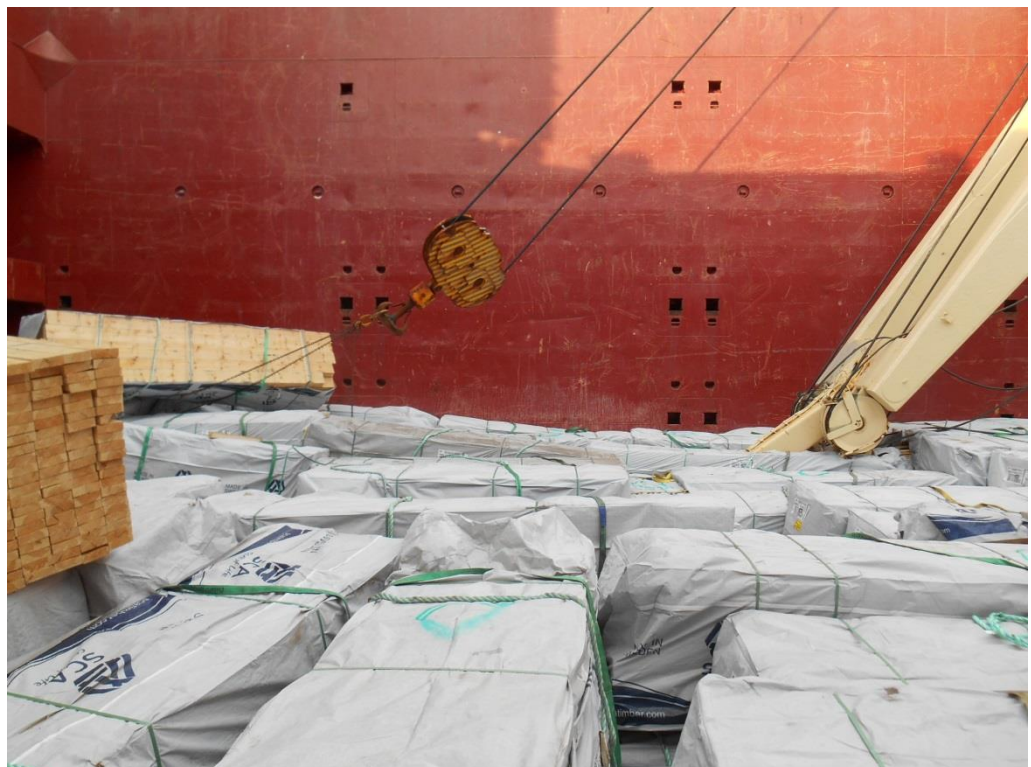
Figure 5. Top and block of the crane arm. Image: Bulkship Management

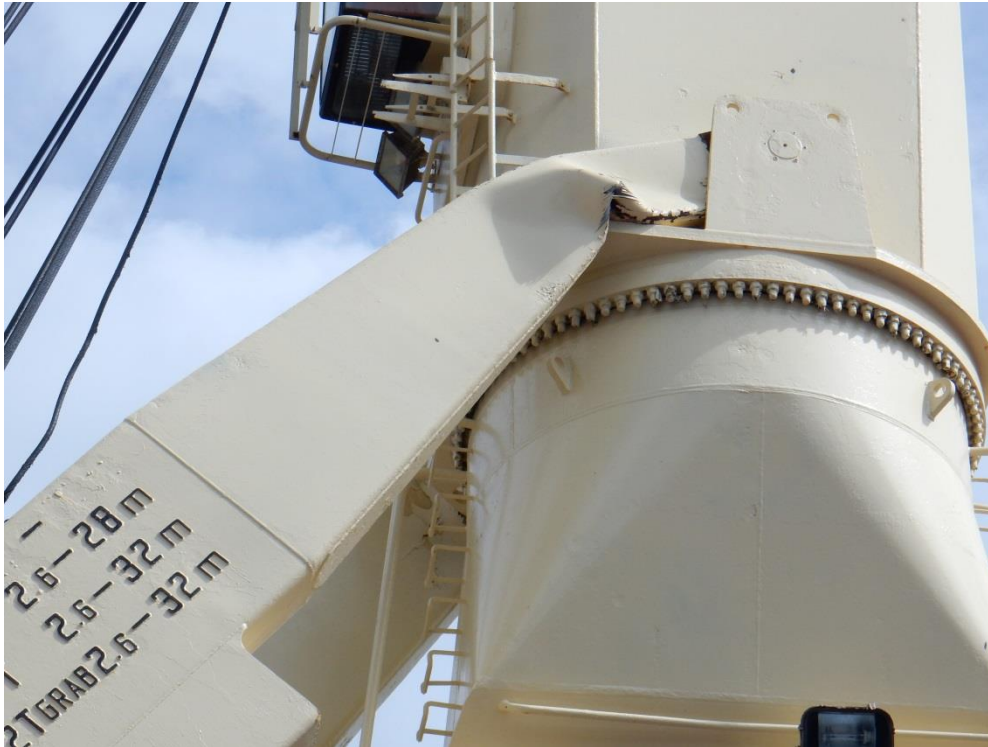
Figure 6. Mounting, crane arm.

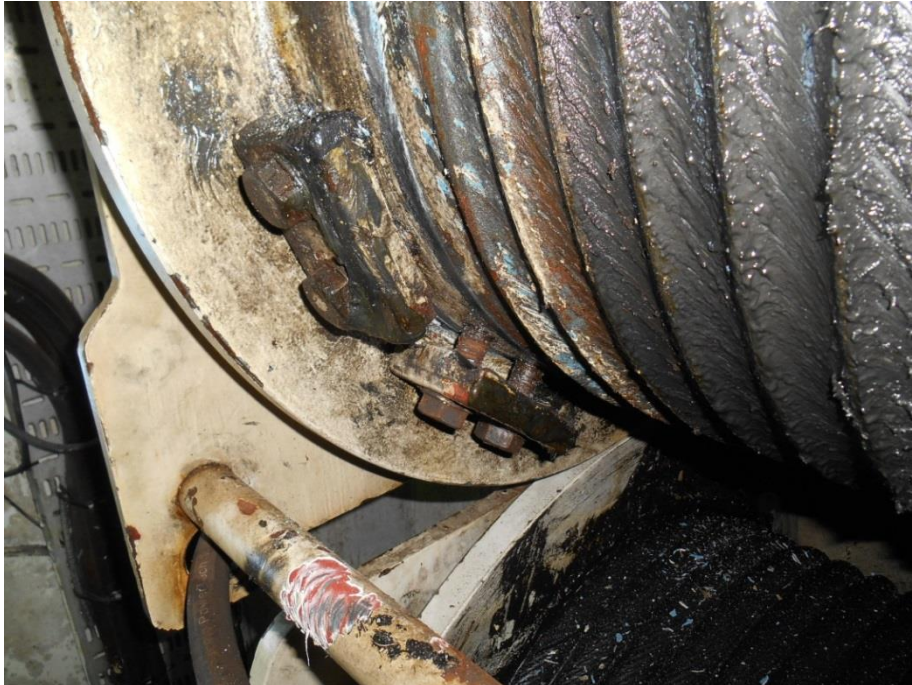
The technician then proceeded to perform checks and inspections on the collapsed crane, whose crane arm was still laying wrecked in the cargo hold. Witnesses to the incident, both on board and ashore, had explained that the crane arm had been operated at a more or less horizontal level, which the technician remarked on as the crane should never be able to reach horizontal level during cargo handling as this corresponds to the parking position. The position of the keyswitch (see figure 9) in the cabin was set to the middle position of 28 m for the crane arm's length/extension. He also saw that the cable that lowers the crane arm had been torn away from the cable lock of the winch drum (see figure 11).

Figure 11. Cable locks on the winch drums. Image: Bulkship Management

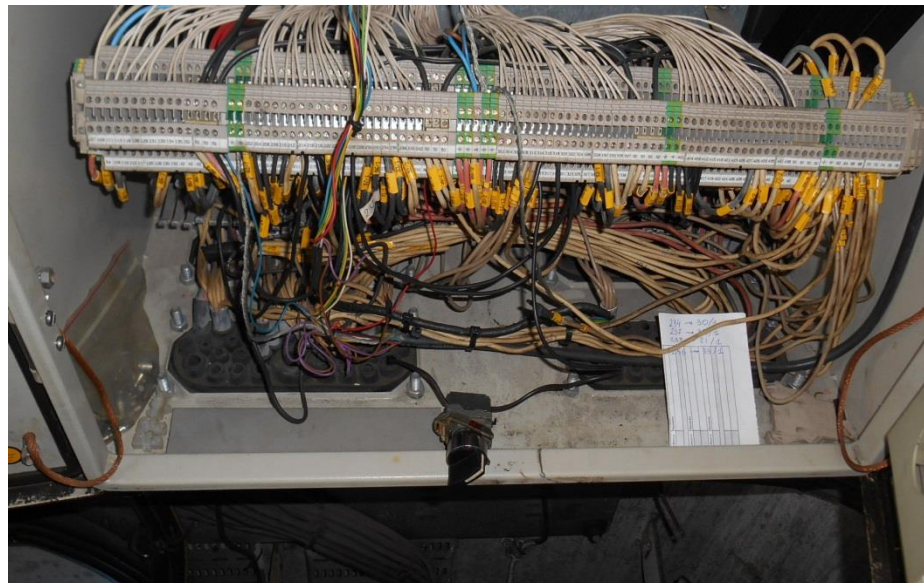
The technician then opened the control cabinet to check the control indicator lights and established that there were no indicators lit for limit switches GD3 and GD1, which should have been active at this point. In close proximity to this, there was also an extra 2-way switch (see figure 12), mounted on connected cables. The switch was placed about 5-6 cm inside the cabinet edge and in proximity to other cables in the cabinet.

When this switch was flipped over to the alternative position, the light indicators for the limit switches were activated correctly. After having tested the winch again, it was established that both limit switches for the crane arm were now correctly activated and would thereby have stopped the crane arm in the right position for both normal operation and parking position.

Figure 12. Extra 2-way switch connected. Image: MacGregor.

The activation of this extra 2-way switch functioned in such a way that all safety switches relating to the lower limit for the position of the crane arm were switched off. According to the technician, this switch has had a bypass function and enabled the limit switches for both the crane arm's lowest position and parking position to be bypassed. This means that the crane had been used for cargo handling within a range that entailed insufficient cable length on the winch drum. The weight of the crane arm itself, together with the load in question, was greater than what the cable lock alone has the capacity to hold. The cable was therefore torn away from the winch drum and

The collapse of the crane arm was caused by the fact that it was set up in such a way that it was possible to lower the arm to a point which was too low for cargo handling; such that there was insufficient cable remaining on the winch drum to hold the combined weight of the crane arm and cargo load. The reason it was possible for the crane arm to be lowered to this low point was that the low limit switches had been bypassed by means of an extra switch installed in the crane's control cabinet.
