Final report RS 2016:01e

BONDEN/ ASIAN BREEZE - collision in
the fairway off Malmö 16 March 2015

File no. S-37/15

22/03/2016

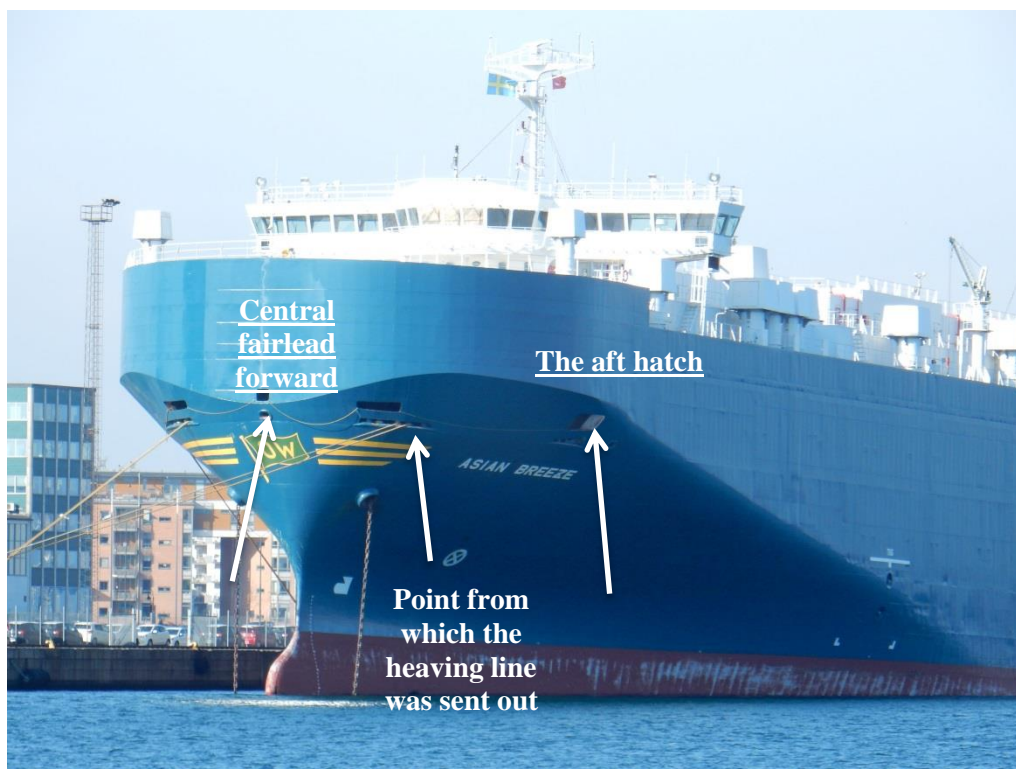
Figure 4. ASIAN BREEZE's forecastle.

The crew of ASIAN BREEZE attempted on two occasions to throw down their own messenger line without a sinker from the bow; i.e., from a position further forward than desired by the tugboat crew. The first attempt failed, and it was therefore agreed that BONDEN would instead go to ASIAN BREEZE's port side and make a fresh attempt from there. This time, the messenger line was successfully passed down to BONDEN, whose crew began preparing the connection. At this point, the car carrier had a speed of 2.5 knots.

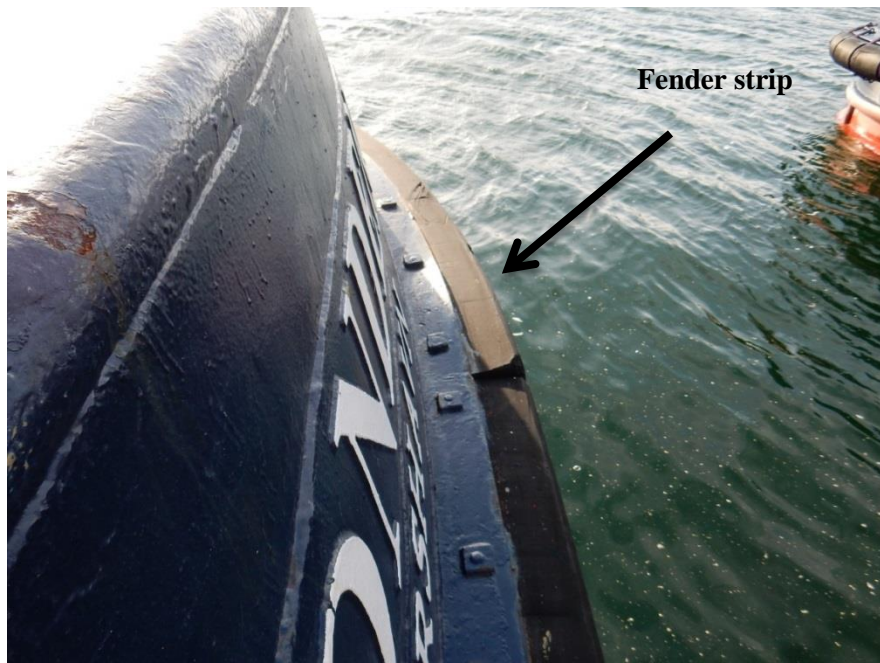
During the turn, however, the towline became stuck under BONDEN's own fender strip on the port side. This led the tugboat to perform an involuntary turn to port; see fig. 7. The master of BONDEN was thus forced to use the emergency release to quickly release the towline; see fig. 8.

Figure 7. BONDEN's fender strip.

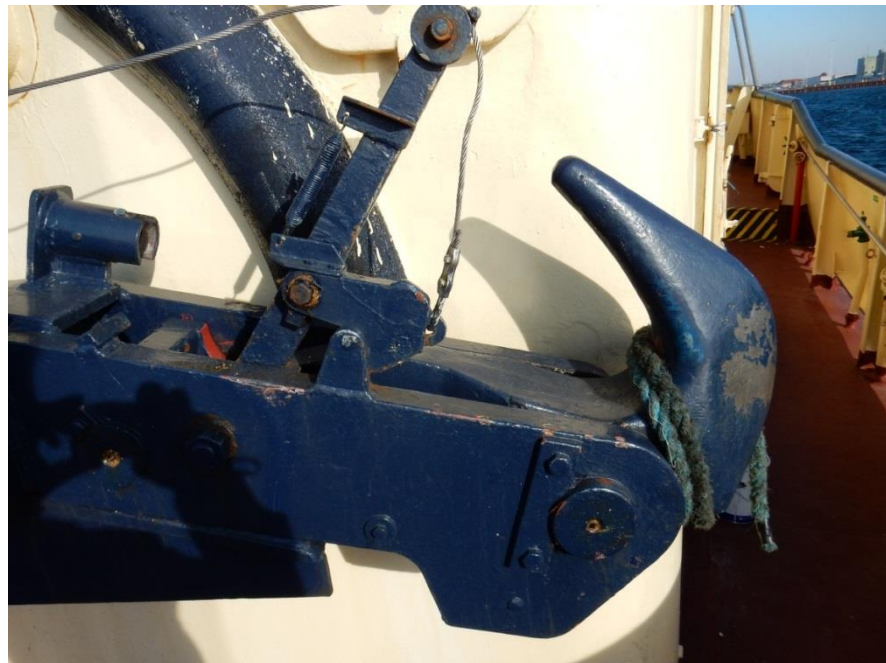
Figure 8. Hook with emergency release on board BONDEN.

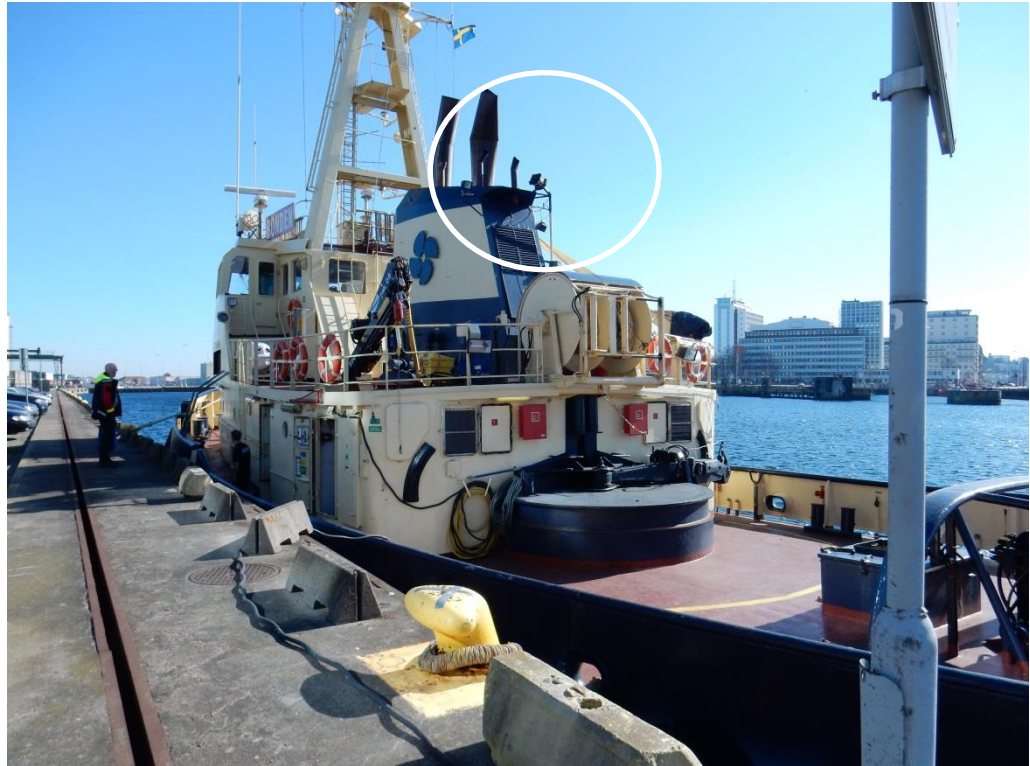
BONDEN received extensive damage to the propeller, propeller shaft and exhaust pipe, sheet metal damage to the aft hull and damage to a cord for a light. The damage was attended to in a visit to a shipyard.

Figure 9. BONDEN, damage to exhaust pipe and light.

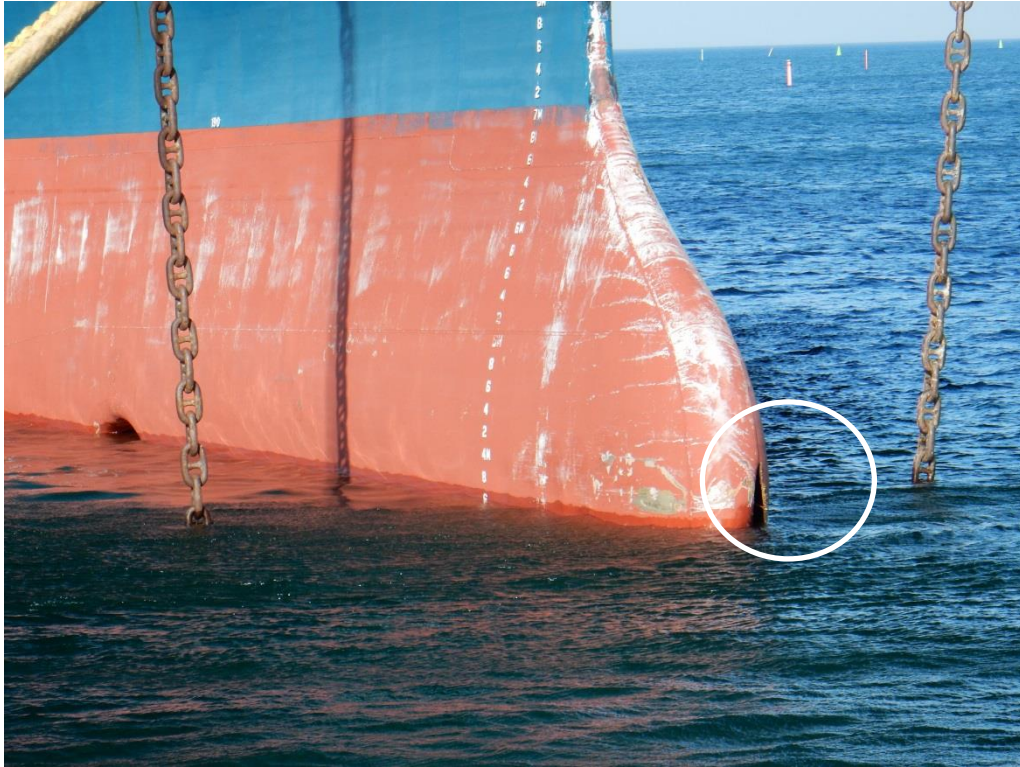
ASIAN BREEZE received a tear in its bulbous bow, close to the fore-peak, which is a ballast tank. The tank was empty at the time of the accident; see figure 10. The damage meant that the ship had to go to a shipyard for repairs later.

Figure 10. ASIAN BREEZE, tear to the bulbous bow.
