Interim report on the investigation of the collision between the split hopper barge *Karin Høj* and the general cargo ship *Scot Carrier*, resulting in the capsizing of *Karin Høj* and the deaths of its two crew, in the Bornholmsgat traffic separation scheme, Sweden on 13 December 2021

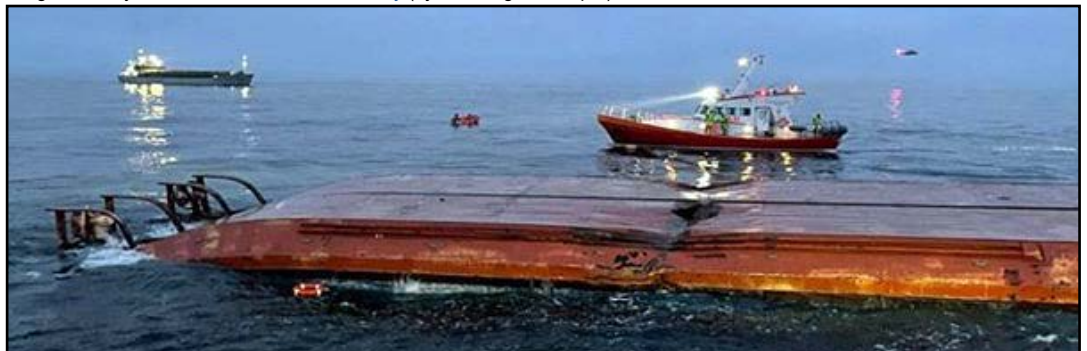
Capsized *Karin Høj* during search and rescue operations
