SERIOUS INCIDENT

Aircraft Type and Registration:	BAe ATP, SE-MAO	
No & Type of Engines:	2 Pratt and Whitney Canada PW126 turboprop engines	
Year of Manufacture:	1989 (Serial no: 2011)	
Date & Time (UTC):	22 May 2020 at 1258 hrs	
Location:	Birmingham Airport	
Type of Flight:	Commercial Air Transport (Cargo)	
Persons on Board:	Crew - 2	Passengers - None
Injuries:	Crew - None	Passengers - N/A
Nature of Damage:	None reported	
Commander's Licence:	Airline Transport Pilot's Licence	
Commander's Age:	57 years	
Commander's Flying Experience:	4,984 hours (of which 211 were on type) Last 90 days - 56 hours Last 28 days - 30 hours	
Information Source:	AAIB field investigation

Synopsis

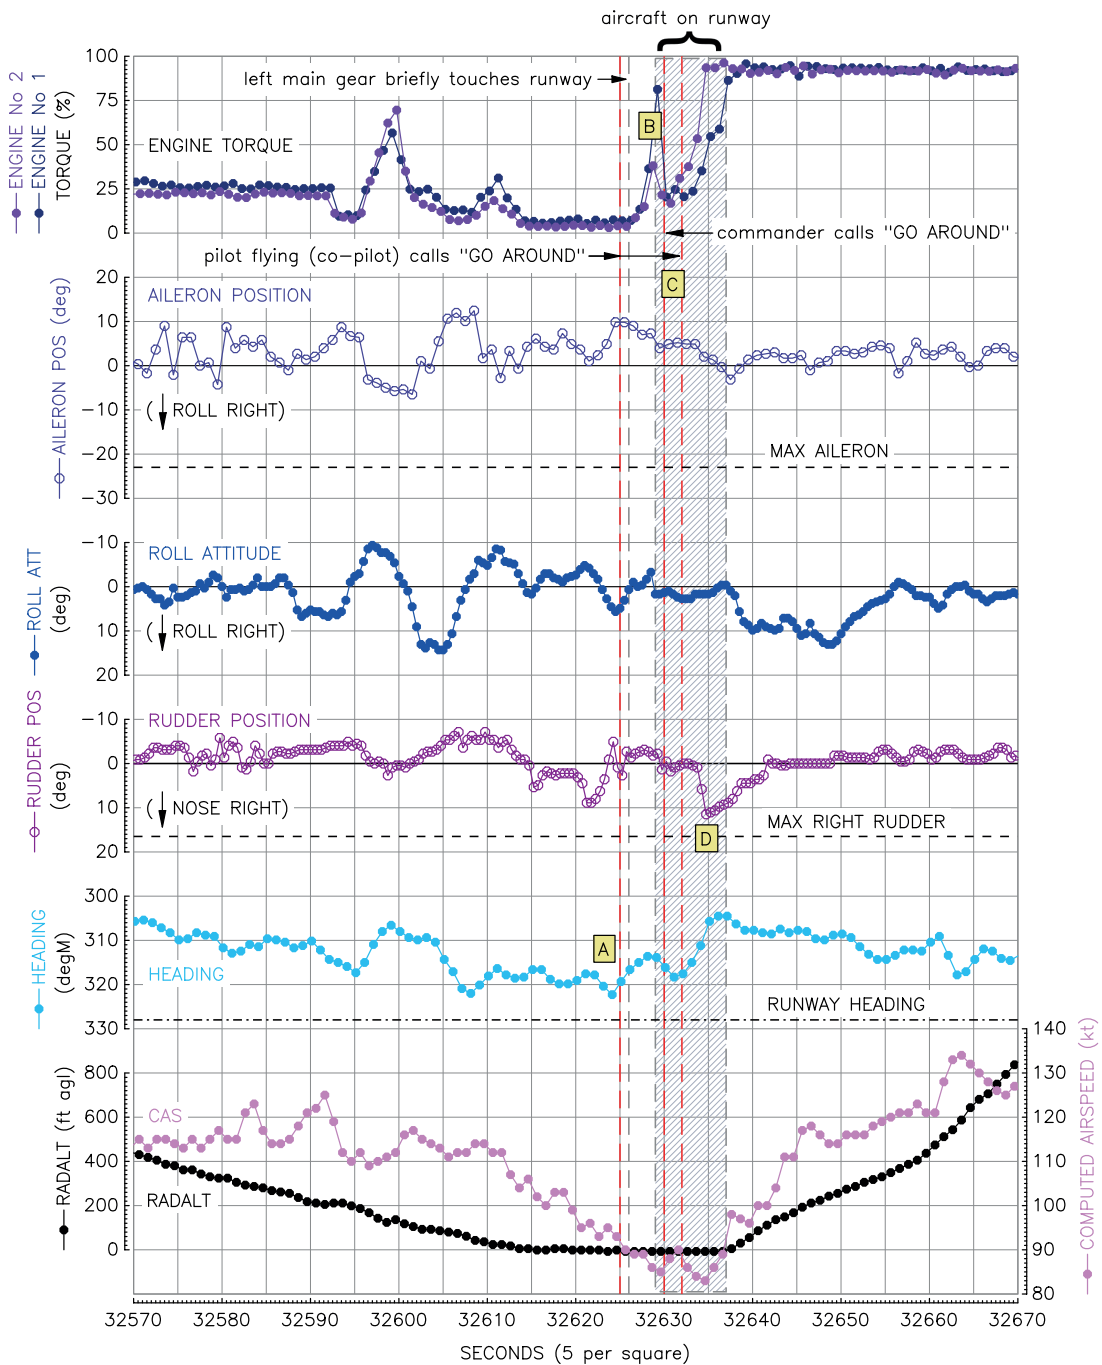
Figure 1 plots the flight data for the first approach and go-around. It starts with the aircraft on the descent passing through 400 ft agl, crabbed to the left by over 20° to the runway heading, and shows that during the approach varying amount of aileron and rudder inputs were used to keep the aircraft on the extended runway centreline. Key points from the data are labelled [A] through [D] and detailed as follows:

1. The co-pilot (PF) called "GO-AROUND" just as the aircraft was about to touch down briefly on the left main gear [A] (and Figure 2). The aircraft heading was about 8° to the left of the runway heading and increasing. The rudder deflection varied around zero and just under half left aileron was being used.
2. During the next three seconds the aircraft veered away from the runway heading while the commander was heard to say "LAND IT LAND IT LAND IT". The engine torques increased from idle to about 80% and then back to about 25% just as the aircraft touched down [B]. At touch down, the aircraft's heading was 15° left of the runway.

3. Shortly after touchdown, the commander called “GO-AROUND” which the co-pilot acknowledged [C] whilst advancing the power levers.
4. The aircraft remained on the ground for about eight seconds during which a small amount of right rudder and left aileron was initially used. The aircraft’s heading responded to the right rudder before veering away to the left. About 75% of full right rudder was then applied [D]. The aircraft’s heading was 24° left of the runway as the aircraft became airborne (Figure 3).

Flight data for the go-around

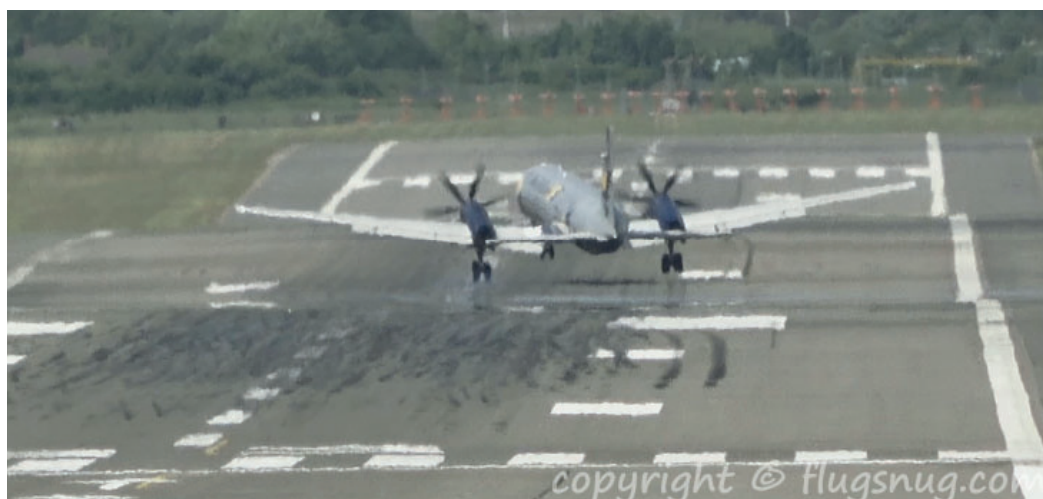
Figure 2

Image showing Point A from Figure 1 – touchdown on Runway 33

The co-pilot flared the aircraft and it briefly touched down although insufficient rudder had been applied to line the aircraft up with the runway. As a result of not pointing down the runway, the co-pilot decided to perform a go-around and called "GO-AROUND". The commander either did not hear him or did not hear him correctly and instead called for the co-pilot to land the aircraft. As a result, the co-pilot closed the thrust levers that he had begun to open, and the aircraft again touched down about 20° nose left of the runway direction. The co-pilot did not have full right rudder applied and as a result the aircraft diverged from the centre of the runway in the strong crosswind. The commander called for a go-around which the co-pilot acknowledged. Go-around power was selected, and the go-around performed as per the SOPs.

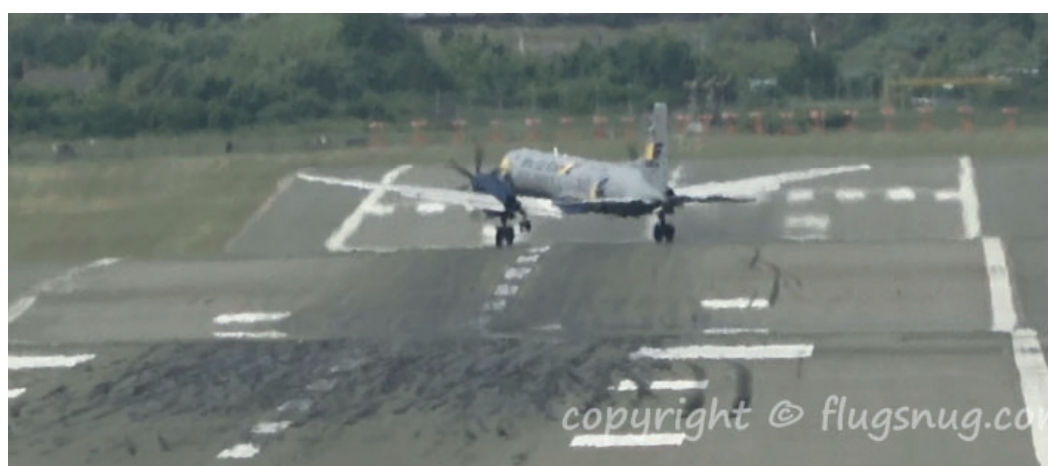
Figure 3

Image showing Point D from Figure 1 – power applied for the go-around

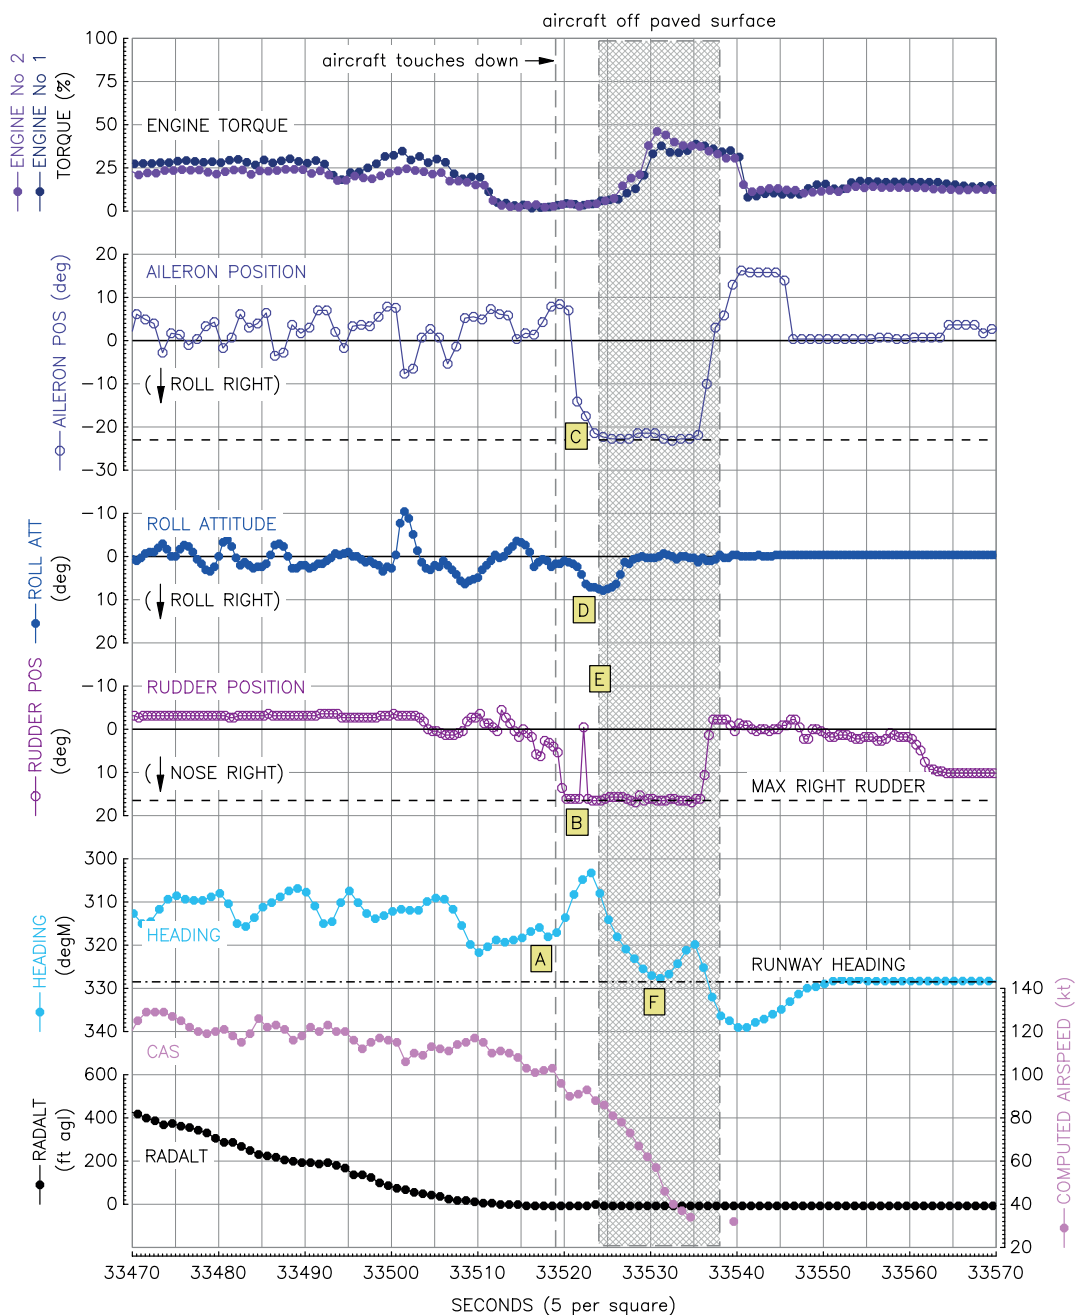
Figure 4
Flight data for the landing

Figure 4 plots the flight data for the landing. It starts with the aircraft on the descent passing through 400 ft agl, crabbed to the left by about 20° to the runway heading. A small amount of left rudder was used throughout the approach, with similar roll control to that of the first approach. During the last 15 seconds of the approach, the rudder became more active and moved to the right, reducing the crab angle to about 10° left of the runway heading. Key points from the data for the landing are labelled [A] through [F] and detailed as follows:

1. At touchdown, the aircraft heading was about 10° left of, and veering away from, the runway heading [A] (and Figure 5).
2. Full right rudder was immediately applied [B] and slowed the veering to the left, which peaked at 24° nose left.

3. Full right aileron was applied [C] causing the aircraft to bank 8° left wing up [D] and lift the left main gear off the runway (Figure 6).
4. About five seconds after touching down, the aircraft left the paved surface to the left [E] (and Figure 7) but in a right turn on the nose and right main gear.
5. Seven seconds after leaving the paved surface, the aircraft turned onto the runway heading [F], but on a parallel track to the left of the runway, before veering a little to the left again then back right, re-joining the runway another seven seconds later (Figure 8).

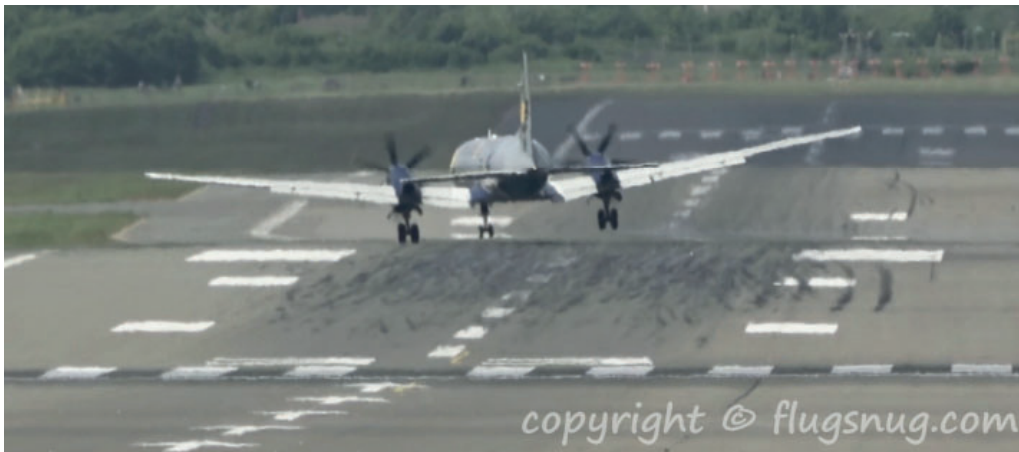
Figure 5

Image showing Point A from Figure 2 – touchdown on Runway 33

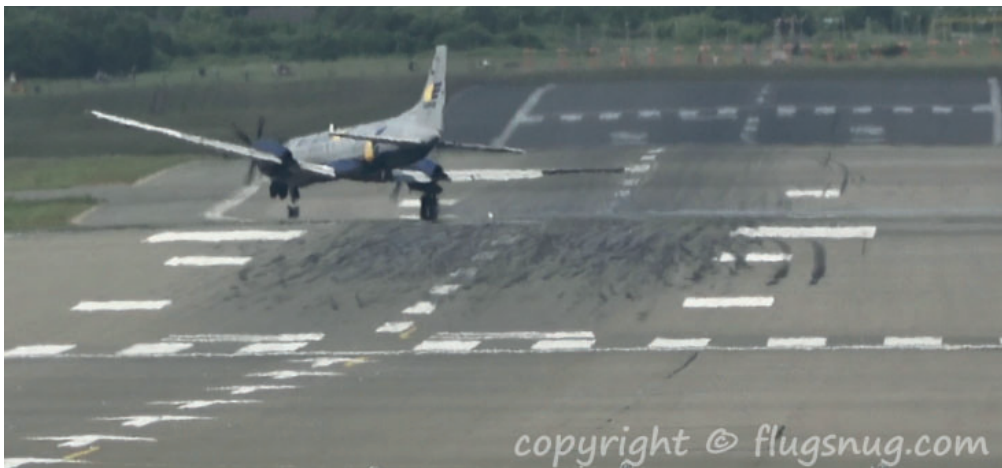
Figure 6

Image showing Point C from Figure 4 – full right aileron applied

The application of full right aileron was almost certainly the result of an inappropriate automatic process (motor programme). Moving the steering wheel right when wanting to steer a car right and moving the control wheel to place the right aileron to full deflection are the same movements. It is likely therefore that as the commander reached his maximum ability to consciously process the inputs coming in from his senses, he subconsciously reverted to a more familiar automatic process and attempted to 'steer the car'.

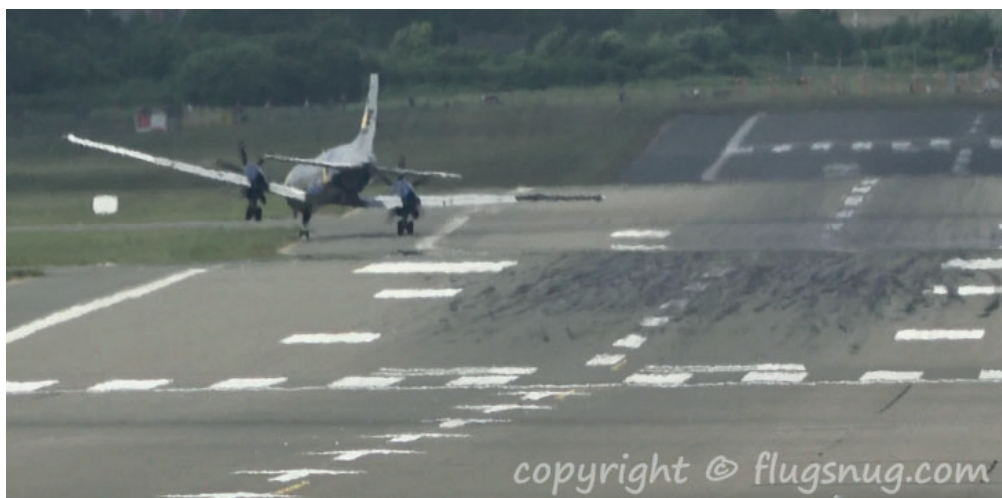
Figure 7

Image showing Point E from Figure 4 – SE-MAO leaves the paved surface

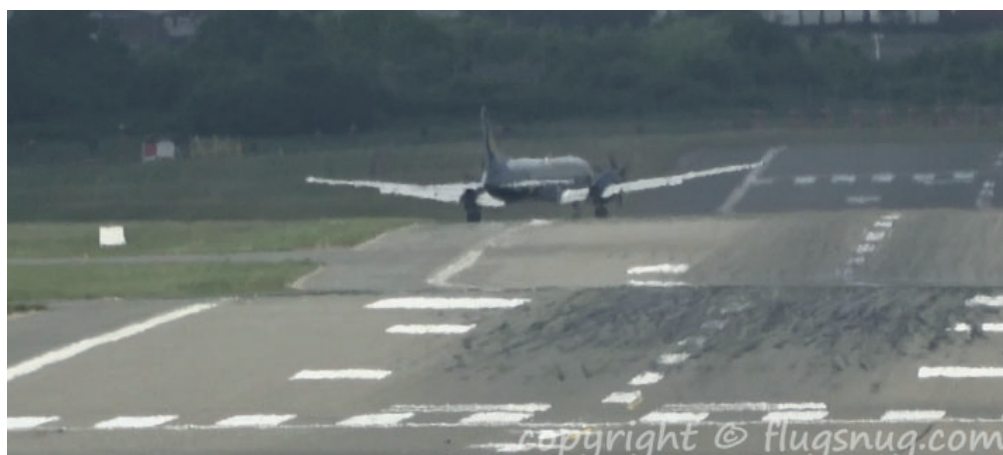
Figure 8

Image showing Point F from Figure 4 – SE-MAO returns to the paved surface

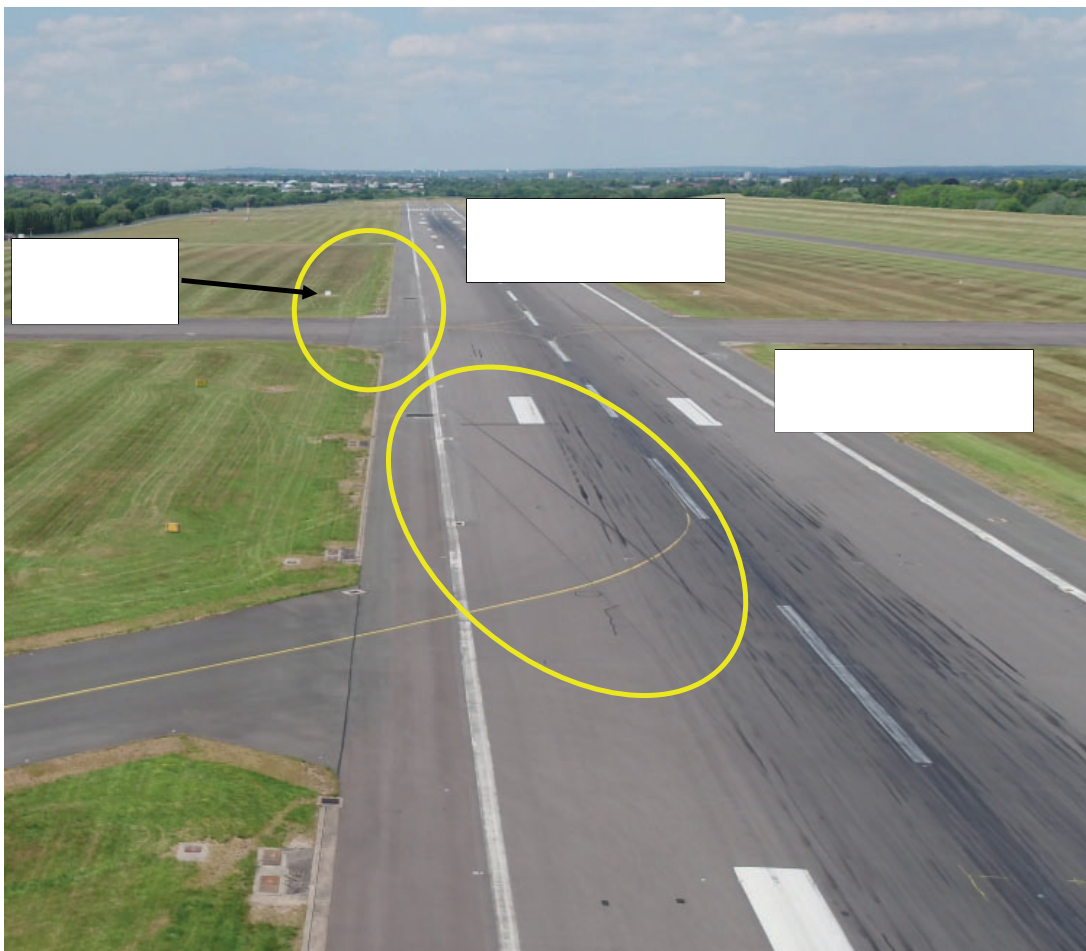
A team was deployed to survey the incident site. The nature of the terrain over which the aircraft travelled during the runway excursion was even and firm. The aircraft tyre marks on the airfield and the tracks in the grass were very clear and allowed accurate measurement. To determine the path of the excursion from the runway, GPS markers were sited at key points on the aircraft tyre tracks and an unmanned air system (UAS) used to compile an aerial survey of the section of airfield.

Using the images taken by the UAS it was possible to measure the distance from when the aircraft first left the paved runway surface until when the last wheel returned to the runway. The total distance was 450 m. Figure 11 shows the extent of the excursion, with the wheel tracks clearly visible in the grass.

UAS image of the runway and grass markings

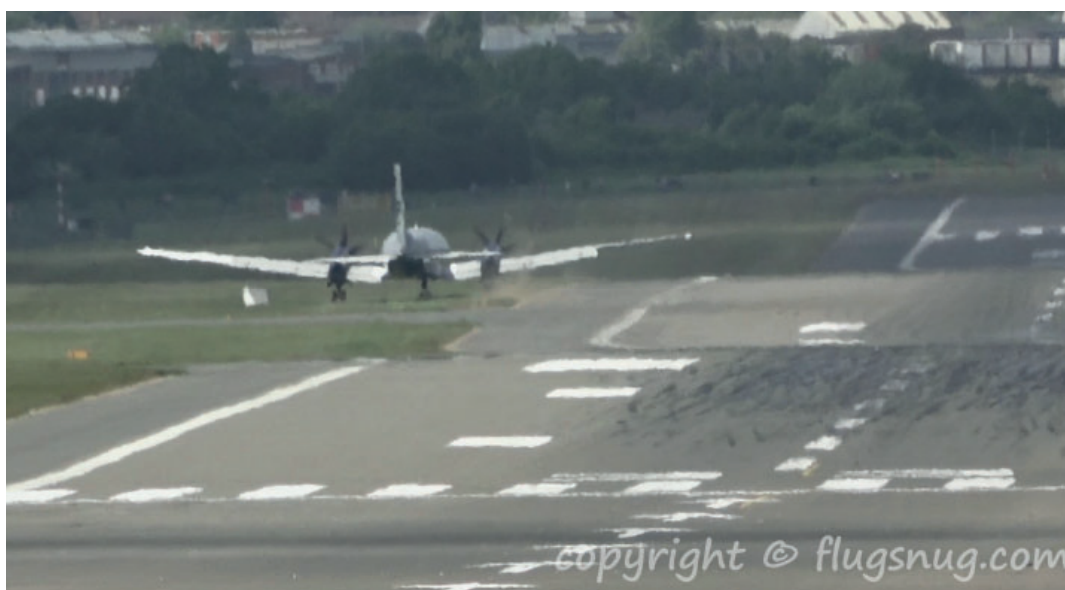
The airfield taxiway sign that passed under the left wing during the excursion was calculated to be just over 1 m below the lower surface of the wing. The sign was outside the diameter of the propeller, but it was above the lowest point of the rotational arc. Figure 12 shows the aircraft wing passing over the sign and Figure 13 shows an image of how close the sign was

to the wing. Whilst all signs on the airport are designed to be frangible, it is likely that had the propeller hit the sign some damage would have occurred to the aircraft.

Image of the aircraft wing passing over the taxiway sign

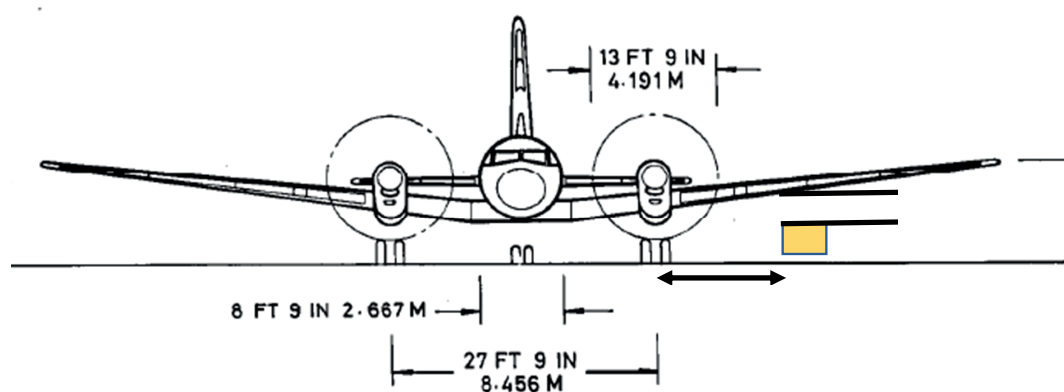
Figure 13

Distance of SE-MAO from taxiway sign represented by the yellow box
