DUTCH  
SAFETY BOARD

# Near miss between two aircraft during taxi

*The Hague, September 2021*

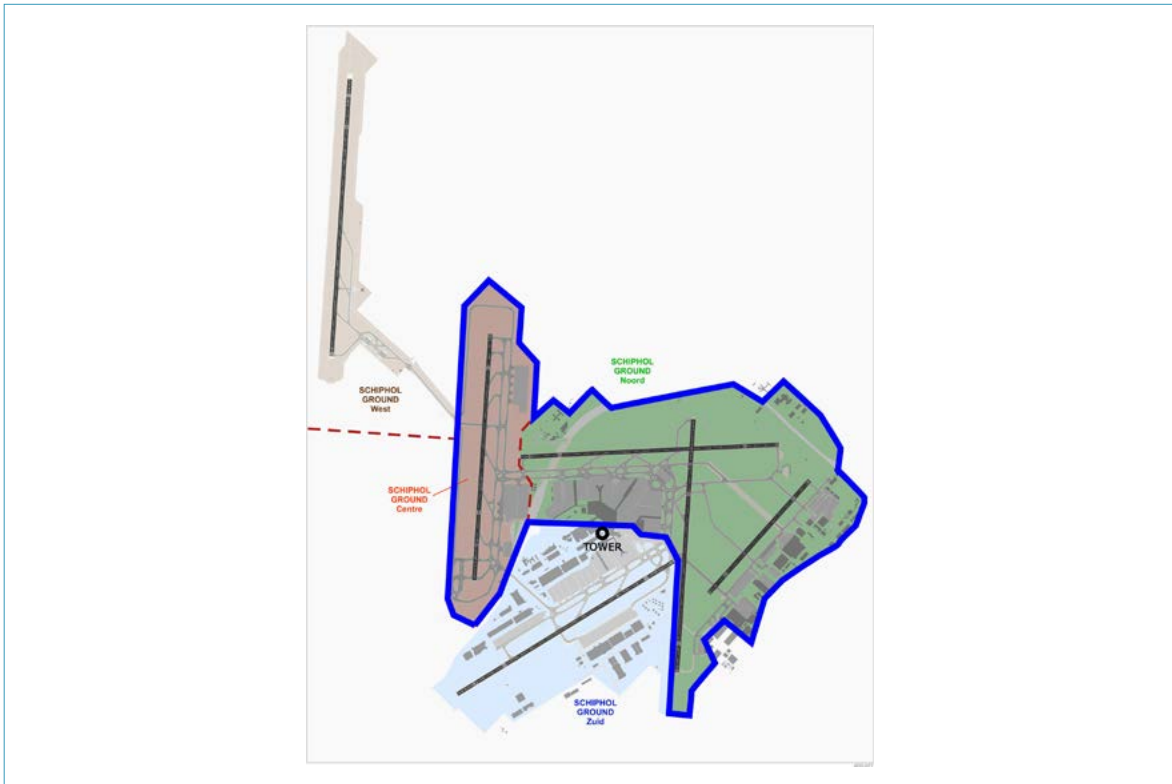
Figure 2: Areas of responsibility of Ground Control. (Source: Operations manual LVNL)

The ground controller was responsible for two ground areas, what is usual in the evening, meaning he had to control and monitor all taxiing aircraft and other traffic in the two areas. Because of the limitations due to the darkness, it was difficult for the ground controller to visually observe both aircraft. That was the reason he used the ground radar to serve as addition to the visual observation in order to check that the aircraft were moving according to the instructions and to establish the positions of the aircraft. Ground radar does not show the speed of taxiing aircraft.

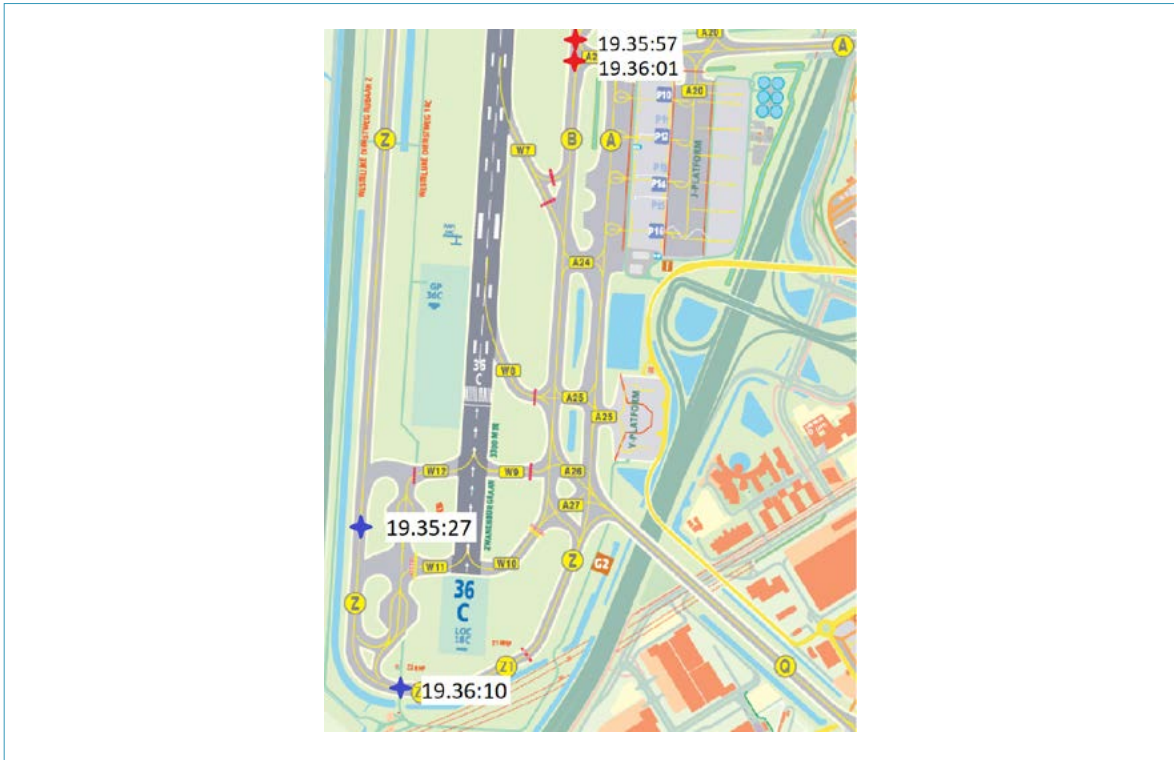
Both crew members were looking out for the other aircraft but did not see it. The first officer was simultaneously looking at the airport map for the correct route to the gate. When the aircraft arrived at A26 towards Q, the captain was the only person who was looking outside, the first officer was head down. Both did not see other aircraft after which the captain continued taxiing and steered to the left. Only when the crew of G-EZWY reported that they almost had a collision, they saw the other aircraft. The SE-DOY crew then apologized and admitted that it was their fault.

Figure 3: Time and position of both aircraft: blue G-EZWY, red SE-DOY. (Source: Amsterdam Airport Schiphol)

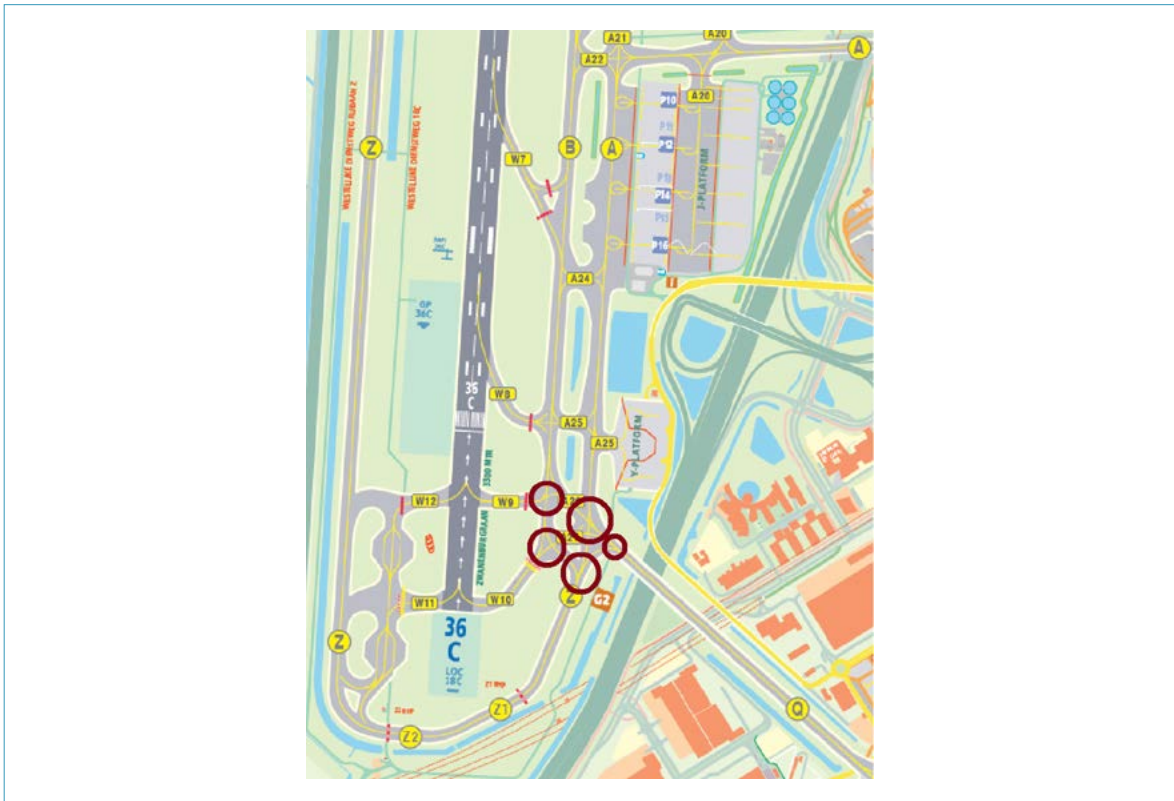
Figure 4: Map of the taxiways and the intersections east of runway 18C/36C. (Source: Amsterdam Airport Schiphol)

The combination of exits and taxiways has created many points where the taxiways A, B, Q and Z intersect, especially in the area east of the threshold of runway 36C (see Figure 4).

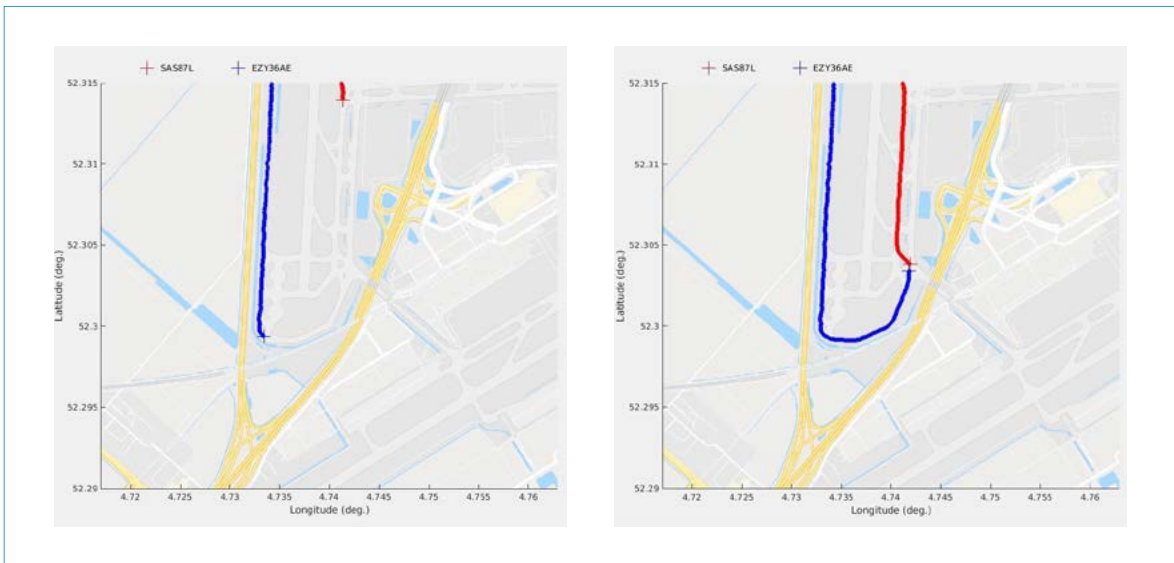
At the time of the instruction to give way to G-EZWY, SE-DOY was on taxiway B near A22 and G-EZWY was taxiing on taxiway Z2 (see Figure 5a). The instruction was given while the two aircraft were around 1,700 metres apart and some 90 seconds before they would meet. Because of the distance and the circumstances (darkness and ambient lighting) the crew of SE-DOY was unable to see the other aircraft at that moment. The crew had no technical aids at their disposal to detect other ground traffic, because the A320 is not equipped with such equipment.

At 19:37:30 hours the crew of G-EZWY informed SE-DOY that a near-collision had just happened (see Figure 5b). According to radar data, the shortest distance between the two aircraft's antennas that emit the radar signals was around 42 metres. However, in view of the inaccuracy of the radar system, the distance between these antennas and the wingtips and the location of the antennas on the fuselage, this distance does not represent the actual shortest distance between both aircraft. Referring to the statements from G-EZWY's crew the distance between their cockpit and SE-DOY's right wingtip was estimated between 5 and 10 metres. Although it was not possible to determine the exact distance between the two aircraft, it is clear that it was close and that a collision between the two aircraft was prevented only because the crew of G-EZWY made an effective emergency stop.

Figures 5a and 5b: positions of the aircraft at 19.36:01 and 19.37:30 hours respectively (Blue G-EZWY, red SE-DOY). (Source ATC the Netherlands)

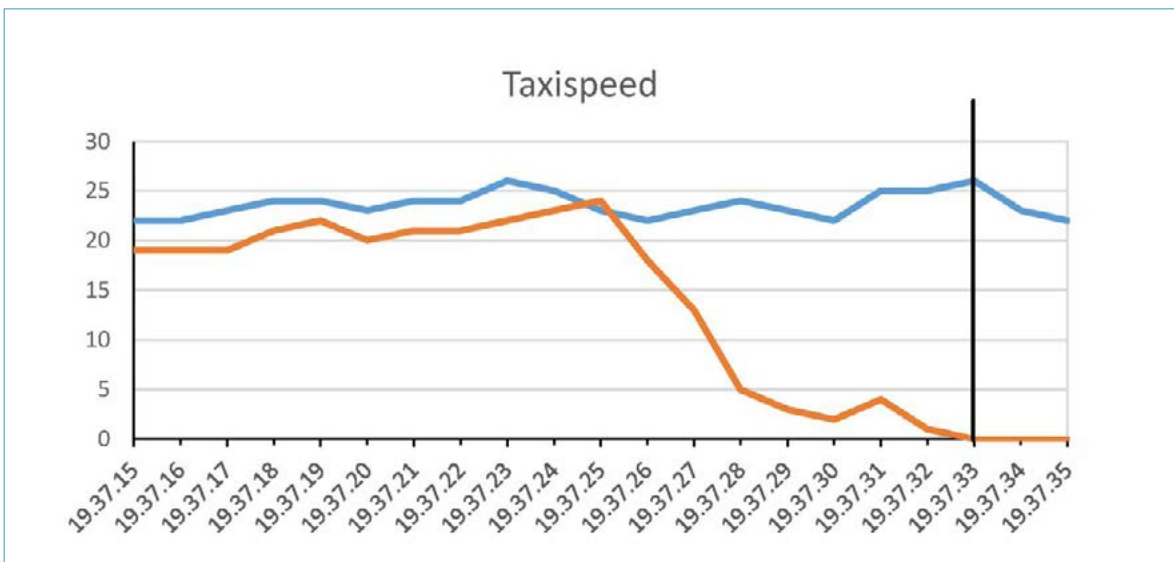
The taxi speed of both aircraft during the last 20 seconds before the incident was analysed using radar data. The taxi speed of both aircraft initially varied between 20-25 knots. This is considered to be a normal taxi speed. The taxi speed of SE-DOY remained unchanged throughout the period, indicating that the crew did not realise that they approached the location where they had to give way to the other aircraft. Around eight seconds before the occurrence, the taxi speed of G-EZWY decreased. This confirms the statement of the captain that he slowed down when he saw SE-DOY not reducing speed. G-EZWY came to a standstill around 19.37:33 hours<sup>3</sup> (see Figure 6).

Figure 6: Graph of the taxi speeds during 20 seconds. The black line depicts the moment of the near collision. (Source: ATC the Netherlands)

When approaching taxiway Q the crew of SE-DOY continued taxiing with the same speed and did not slow down. The crew of G-EZWY noticed this, slowed down and eventually made an emergency stop to prevent a collision.

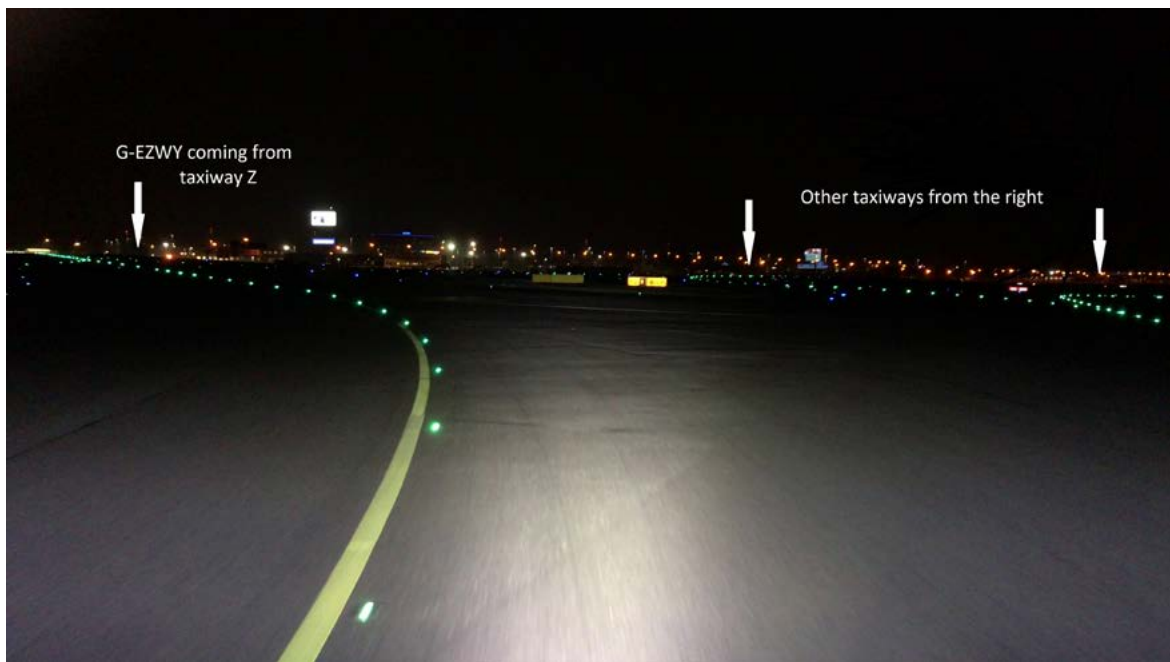
The ground controller instructed the crew of SE-DOY to give way to the other aircraft from the right when turning to taxiway Q. Figure 7 depicts the spot where SE-DOY made a left turn from taxiway B towards taxiway Q, as seen from the perspective of SE-DOY. On this location, several taxiways come together. Contrary to some other airports where only taxiways to follow are lighted, at Schiphol all taxiways in use are lighted, resulting in several green taxiway lights. The taxiway lights on the right are clearly visible. This may have given the crew the idea that the other plane was coming from that direction and focusing them to look in that direction. However, G-EZWY was coming from another taxiway, which is barely visible at this point. This all resulted in a confusing situation in the dark where G-EZWY came from another taxiway than the crew of SE-DOY might have expected.

Figure 7: Left turn towards taxiway Q where G-EZWY came from right, what is barely visible at this point.  
(Picture taken from a car, source: Amsterdam Airport Schiphol)

The crew of SE-DOY did not notice the other aircraft. This was influenced by the following facts: they did not recall the exact location as radioed by the ground controller, the lighting circumstances and the complexity of taxiways at the location. Other tasks they had to fulfill during taxi caused the crew to not actively search for G-EZWY.

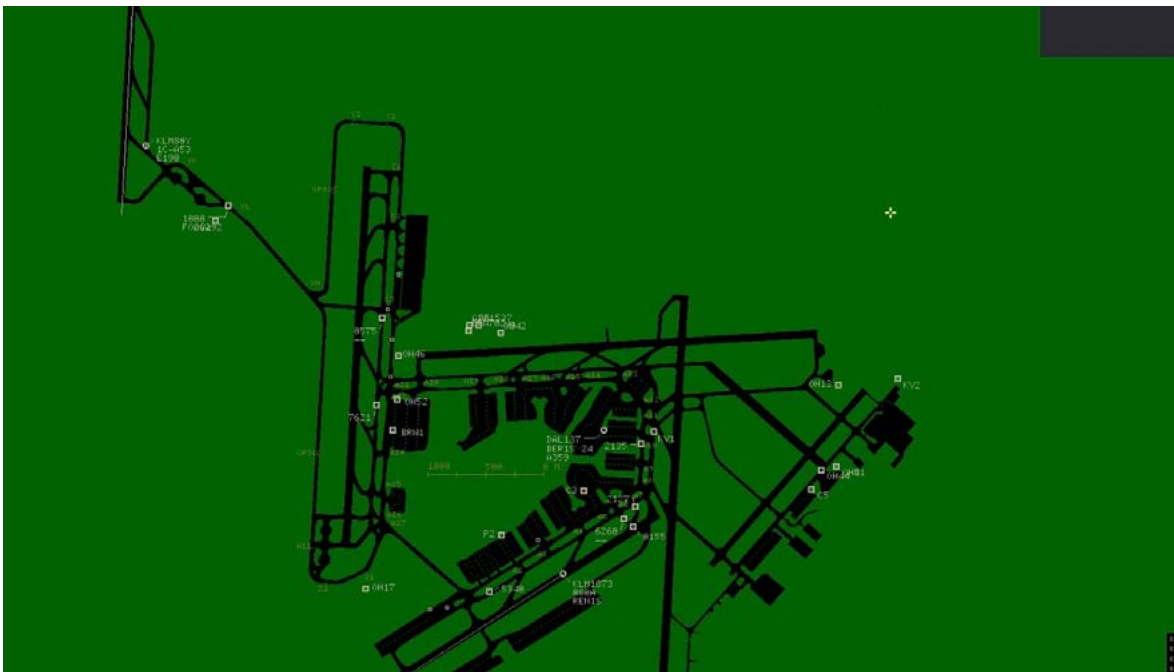
Figure 8: Picture of the ground radar screen of the whole airport. (source ATC The Netherlands)

Even if the controller had monitored both aircraft constantly on the ground radar, SE-DOY not slowing down was difficult to see on the ground radar screen and could only be noticed some seconds before the occurrence happened. It is very unlikely in such a situation that the controller would have been able to warn both aircraft in time. In similar cases where it is clear in advance that a possible conflict may arise, it is advisable to instruct one of the aircraft actively to stop and give way to the other aircraft.

Because the ground controller was unable to assess the situation properly due to the lighting conditions, properties of the ground radar and span of control, clear communication and checking whether the crew had understood the instructions, were essential. More active control and providing instructions when both aircraft approached each other, is essential under such circumstances.
