**Accident** to the BOEING - 737 - 800 - 8JP  
registered **SE-RPE**  
on 25 July 2021  
en route to Nice

**Turbulence en route, severe injury to a cabin crew member, emergency landing at destination**

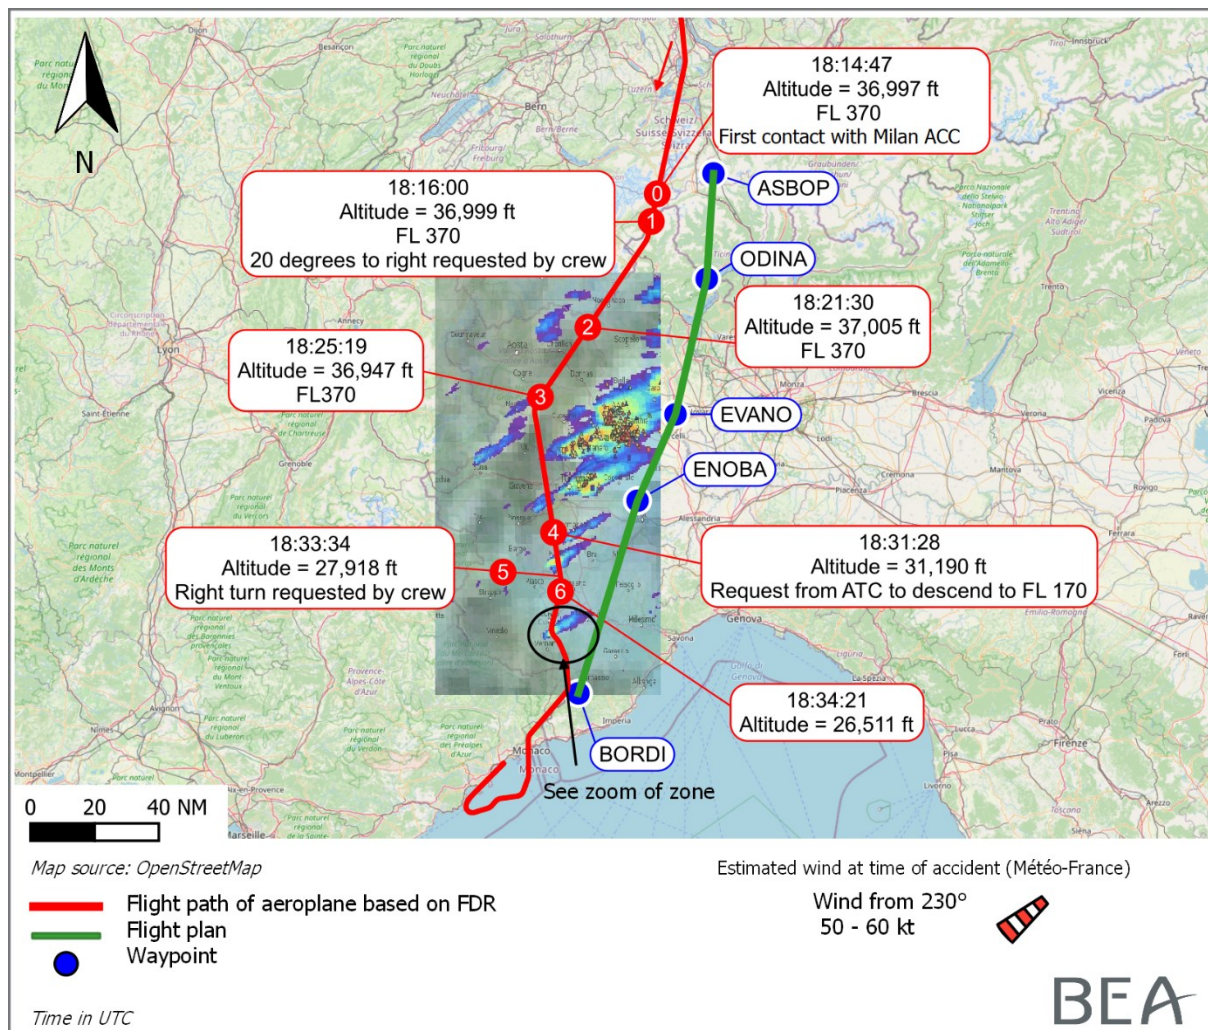
**Figure 1: path of the aircraft superimposed over the Météo-France radar image at 18:40<sup>8</sup>**

At 18:14:47, the crew contacted the Milan Area Control Centre (Milan ACC) and reported that they were on heading 195° in order to avoid storm cells (see Figure 1, point **0**). The aircraft was then at Flight Level 370 (FL 370).

At 18:16, the crew requested approval to carry out an avoidance manoeuvre by deviating 20° to the right (see Figure 1, point 1). The controller authorised the manoeuvre. Around five minutes later, the flight was transferred to another Milan ACC control sector. At this moment, the crew were discussing the large storm cells to their left.

Upon first contact with this sector at 18:26:09, the crew received approval to descend to FL 310 then to FL 270 and lastly to FL 170 with the controller requesting that they reach this level before BORDI (see Figure 1, point 4).

At 18:33:34, the crew requested “20° to the right to avoid” from the Milan ACC (see Figure 1, point 5). The controller approved the manoeuvre and asked the crew to stop their descent at FL 210.

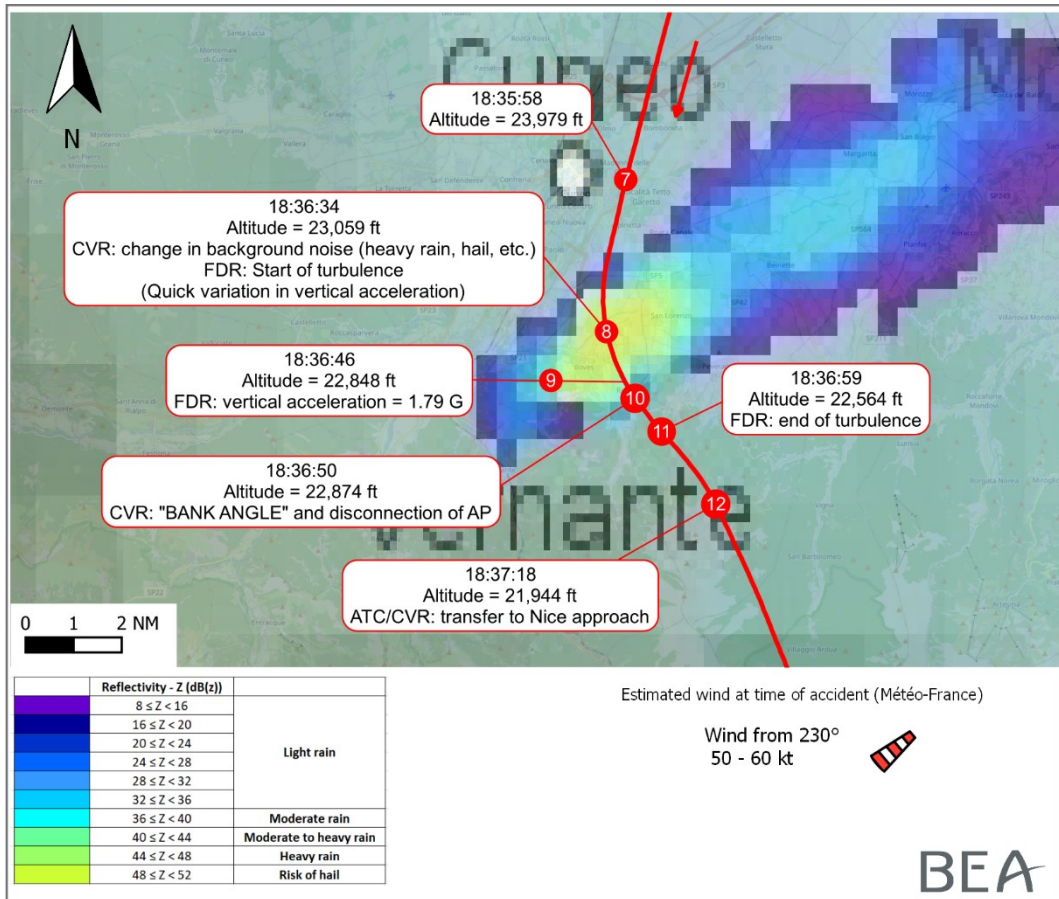
Figure 2: zoom in on the path at the time of the accident

At 18:34:21, the controller asked the crew over what distance they wanted to maintain this heading<sup>4</sup> (see Figure 2, point 6)<sup>5</sup>. The crew said that they needed to maintain it for a further 10 NM.

At 18:35:58, the crew notified the controller that they were able to head towards BORDI waypoint (see Figure 2, point 7). The controller authorised the manoeuvre and asked the crew to descend to FL 170 in order to be at this level on reaching BORDI waypoint. The crew read this back.

At the same time, the PF announced, “*Engine anti-ice on*”. One second later, there was a change in background noise (see Figure 2, point **8**), as if there was heavy precipitation pelting down on the cockpit windshields.

At 18:36:46 (see Figure 2, point **9**) the recorded vertical acceleration<sup>7</sup> reached + 1.79 g, decreased to 0.38 g in the following second, and then rose to + 1.52 g in the next two seconds.

At 18:36:50, the roll angle reached a maximum of 35.5°. The “BANK ANGLE” synthetic voice message was activated. The PF disconnected the autopilot (see Figure 2, point **10**). The vertical acceleration decreased to 0.27 g, then increased again to 1.67 g in the following two seconds. During this two-second phase, the speed decreased from 272 kt to 250 kt.

At 18:36:59, the turbulence stopped (see Figure 2, point **11**).

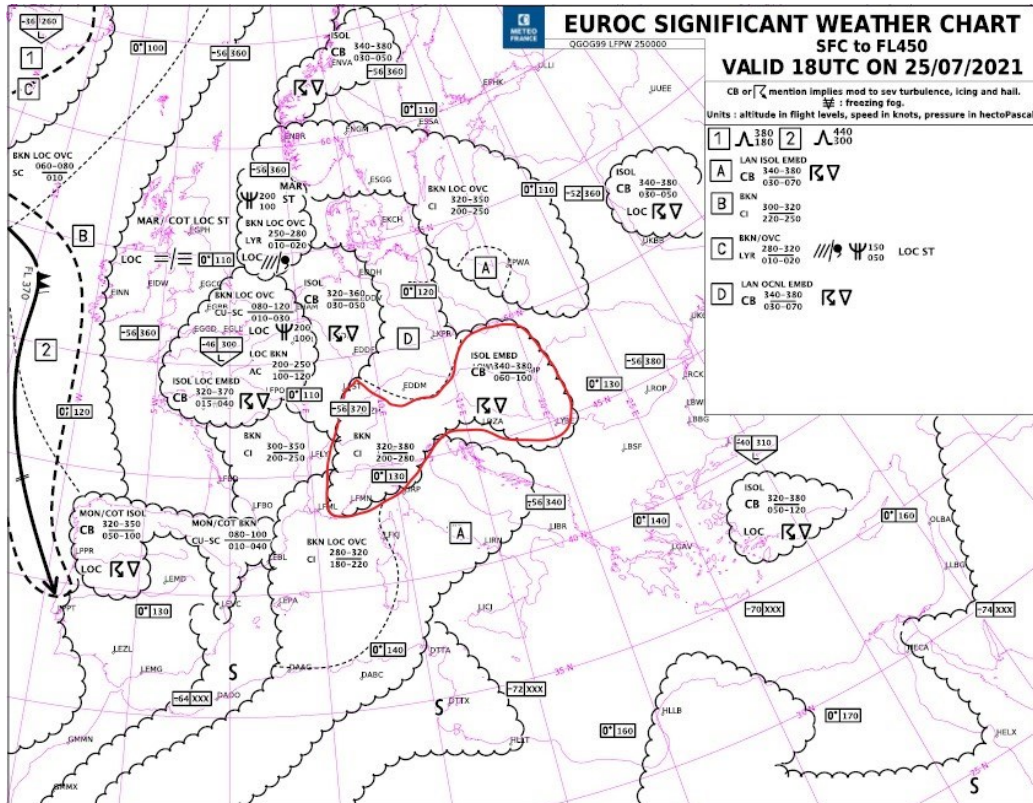
Figure 3: SIGWX chart valid at 18:00 (source: Météo-France)

The area circled in red on the SIGWX chart incorporates the accident site, and indicates:

- isolated CB, base FL 060 - FL 100, top FL 340 - FL 380;
- broken cirrus clouds, base FL 200 - FL 280, top FL 320 - FL 380;
- a 0° isotherm at FL 130.

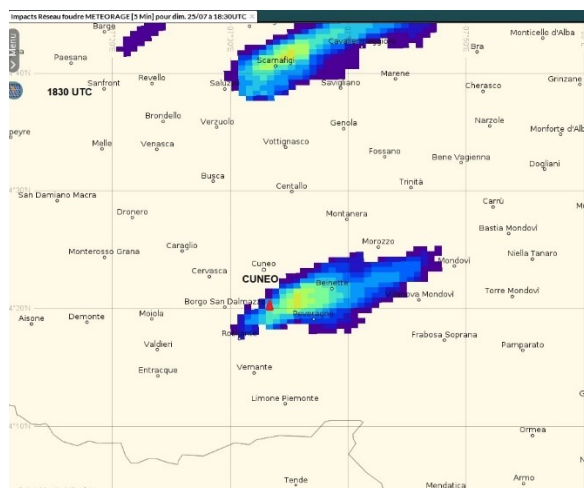
**Figure 4: situation at 18:30 (Source: Météo-France)**

An isolated convective cloud formed between 18:15 and 18:20 less than 10 km to the south of Cuneo (Italy), in the vicinity of the position indicated as the occurrence site. This almost-stationary convective cloud extended rapidly between 18:20 and 18:40, generating heavy showers with no thunderstorm activity, which made it difficult to decide whether it was a TCU with a long vertical extension or a CB; it dispersed as quickly as it had formed between 18:50 and 19:00.

The red triangle shows the position of the accident (each square measures 40 km x 40 km)

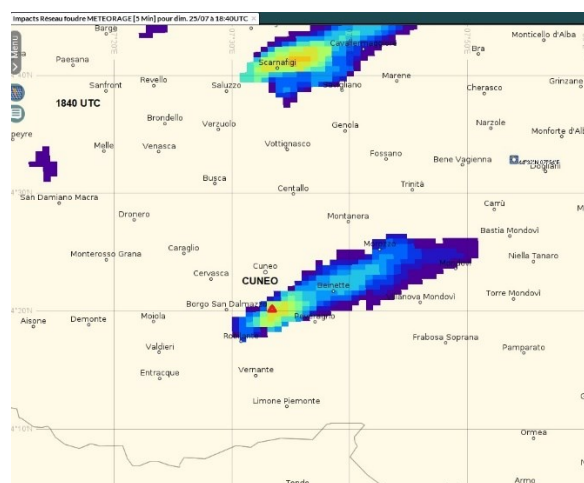
**Figure 5: situation at 18:40 (Source: Météo-France)**

The red triangle shows the position of the accident (each square measures 40 km x 40 km)

The area of strong convection slightly moved to the west, in the opposite direction to the southwesterly wind, and was located just below the accident site. The showers were moderate to heavy. No lightning strike was detected but this situation usually causes windshear and severe turbulence.

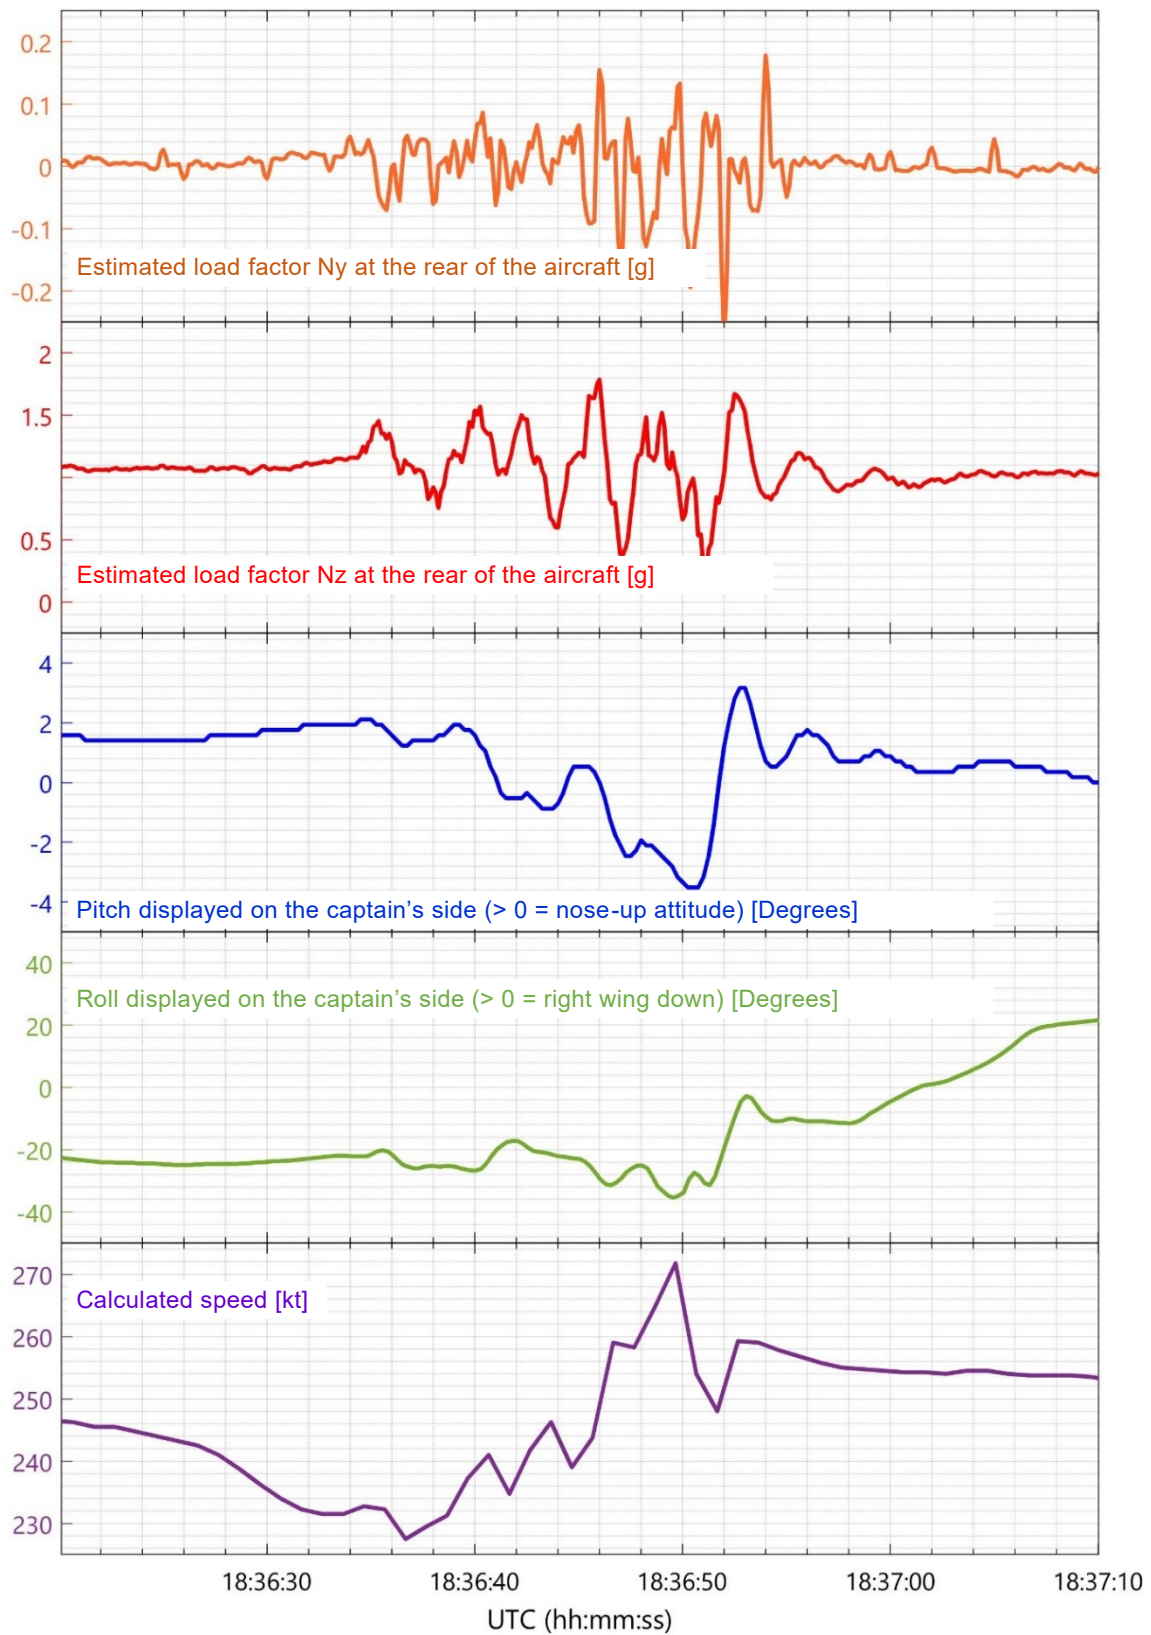
**Figure 7: graphs showing parameters recorded as the aircraft flew through the area of turbulence (source: BEA)**

From 18:36:34 onwards, the load factor values recorded presented major variations for 25 s. In the middle of this period, the variations in the vertical load factor reached high amplitudes for a duration of around seven seconds<sup>9</sup>. The load factors experienced at the cabin crew seat at the rear of the aircraft were estimated. These values are given in the table below (the extreme values reached may have been higher):
