AAR-21-05

# Runway Overrun During Landing

## Peninsula Aviation Services Inc. d.b.a. PenAir flight 3296

### Saab 2000, N686PA

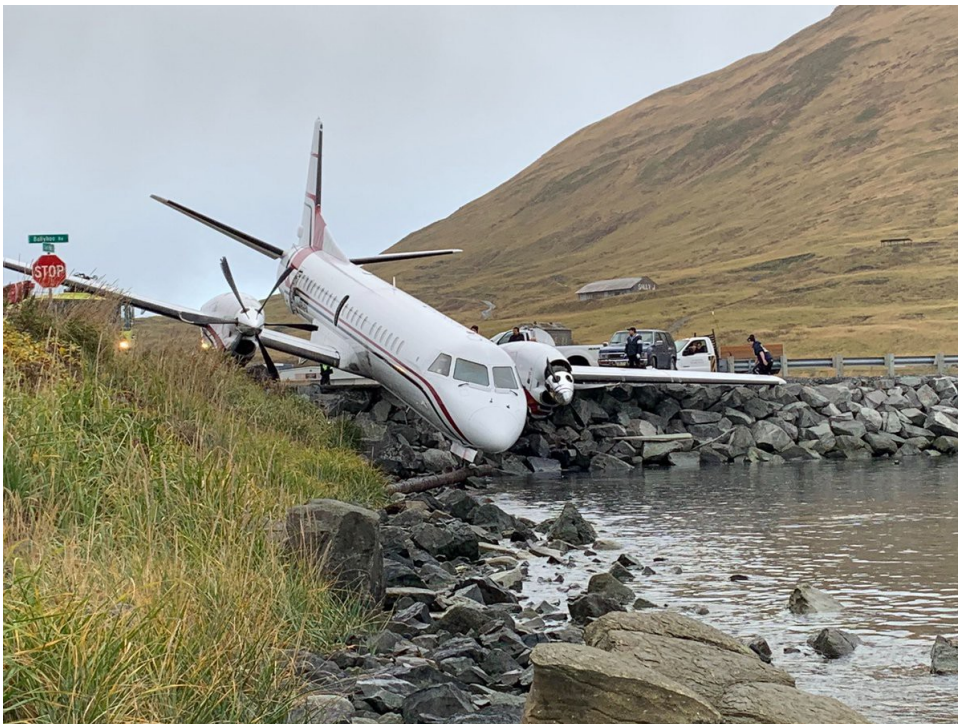
Video from two off-airport security cameras showed that the left engine shed propeller blade fragments and two propeller blades either before or as the airplane traveled across an off-airport road.<sup>20</sup> In addition, either the left wing or the left engine propeller struck a 7-ft vertical signal post. The left engine propeller then struck an 8-ft road sign mounted on a metal post, and the left engine shed propeller blade fragments and one propeller blade after contacting the road sign.<sup>21</sup> The security camera video also showed that the airplane overrun stopped at 1740:29. The airplane came to rest with its nose pitched downward, the nose gear in shallow water at the edge of Dutch Harbor, the left MLG embedded in rocks, and the right MLG on the shoulder of a road intersection, as shown in figure 2.

**Figure 2.** Airplane in its final resting location (Source: Unalaska Department of Public Safety).

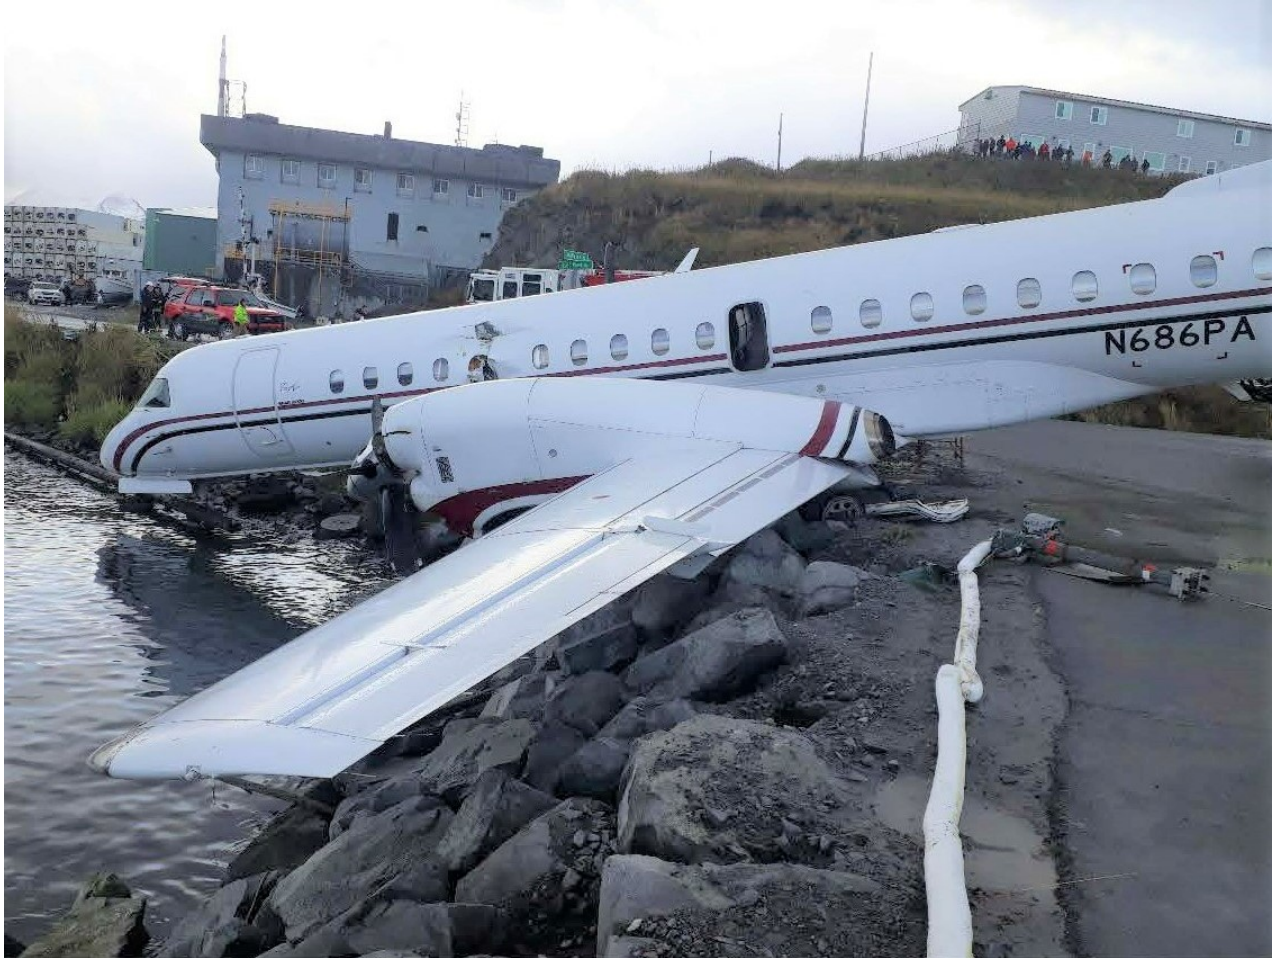
Figure 3 shows a hole and impact damage on the left side of the airplane located near the fifth passenger window on that side. Section 1.9.1 provides additional details about the damage to the airplane in this area.

**Figure 3.** Left side of accident airplane (Source: Unalaska Department of Public Safety).

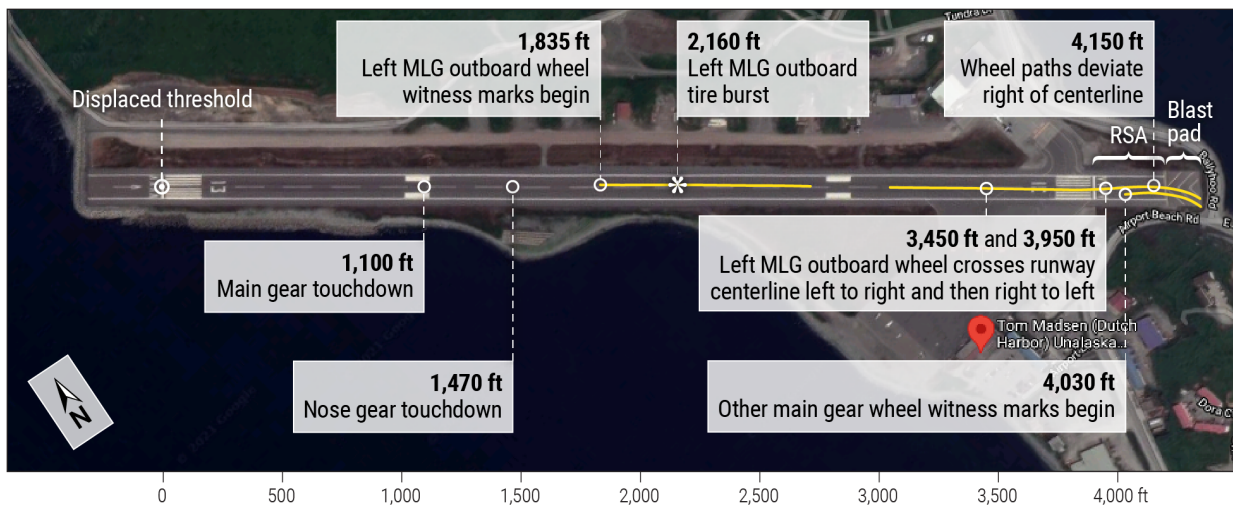
A postaccident GPS survey of runway 13 documented the witness marks associated with the accident airplane's ground track. Witness marks associated with the left MLG outboard tire began about 1,835 ft beyond the runway 13 displaced threshold.<sup>23</sup> The left MLG outboard tire path began on the left side of the runway centerline, crossed over to the right side of the centerline, returned to the left side, and crossed over again to the right side before the airplane overran the blast pad surface. The airplane was estimated to be about 2,160 ft beyond the runway 13 displaced threshold at the time of the tire burst captured on the passenger video. Witness marks associated with the left MLG inboard tire and the right MLG inboard and outboard tires began about 4,030 ft beyond the runway 13 displaced threshold and near the midpoint of the 300-ft RSA. Figure 4 shows the airplane's ground track from the time of the landing rollout to the blast pad departure, including the approximate location where the tire burst.

**Figure 4.** Airplane ground track overlaid on a Google Earth image.

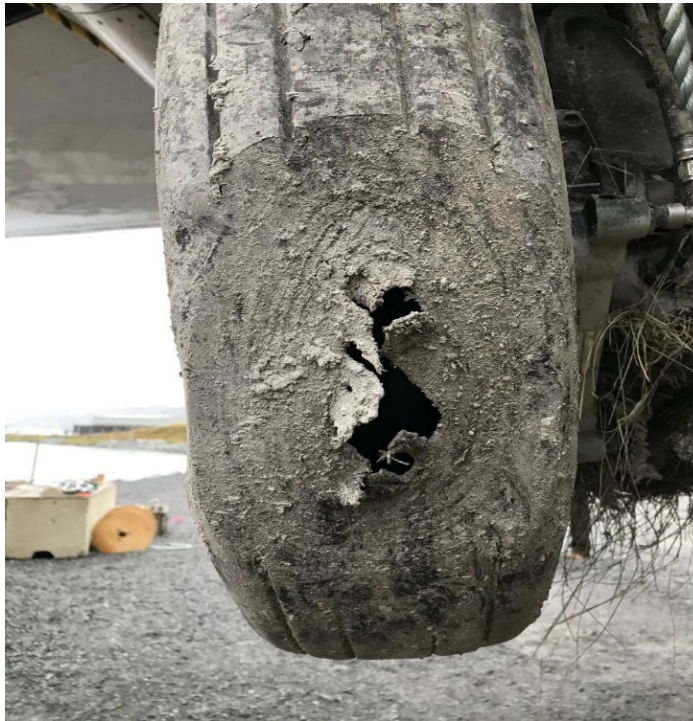
The left outboard tire was found deflated and had an oval-shaped worn area that corresponded with the area on the tire where the first officer documented the flat spot. The worn area measured about 11 inches in length and had a hole in the middle, as shown in figure 5. The left outboard tire also had another oval-shaped worn area that measured about 15 inches in length and had intact tread in the middle, as shown in figure 6. This worn area was about 180° from the flat spot area.

**Figure 5.** Worn area and hole in left outboard tire.

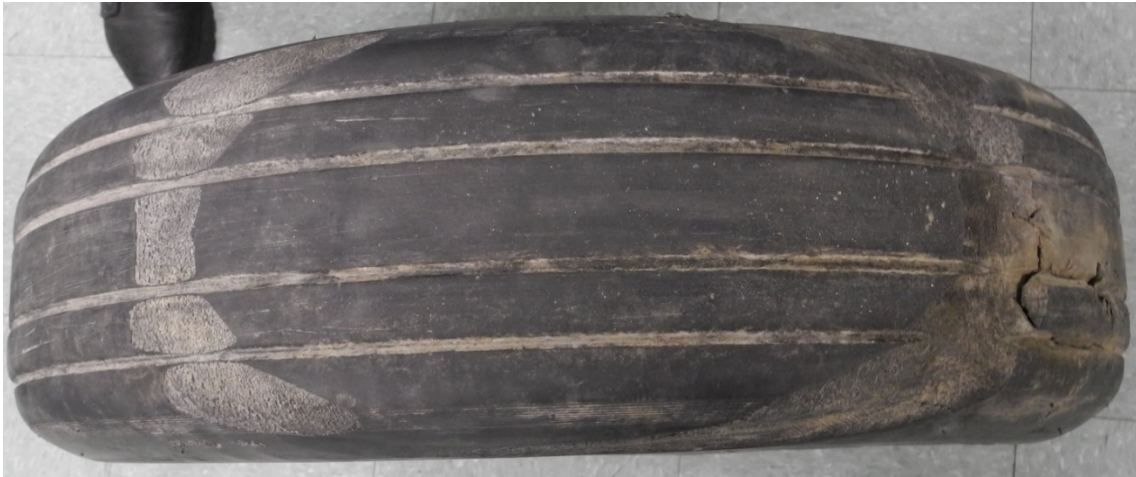
**Figure 6.** Additional worn area on the left outboard tire.

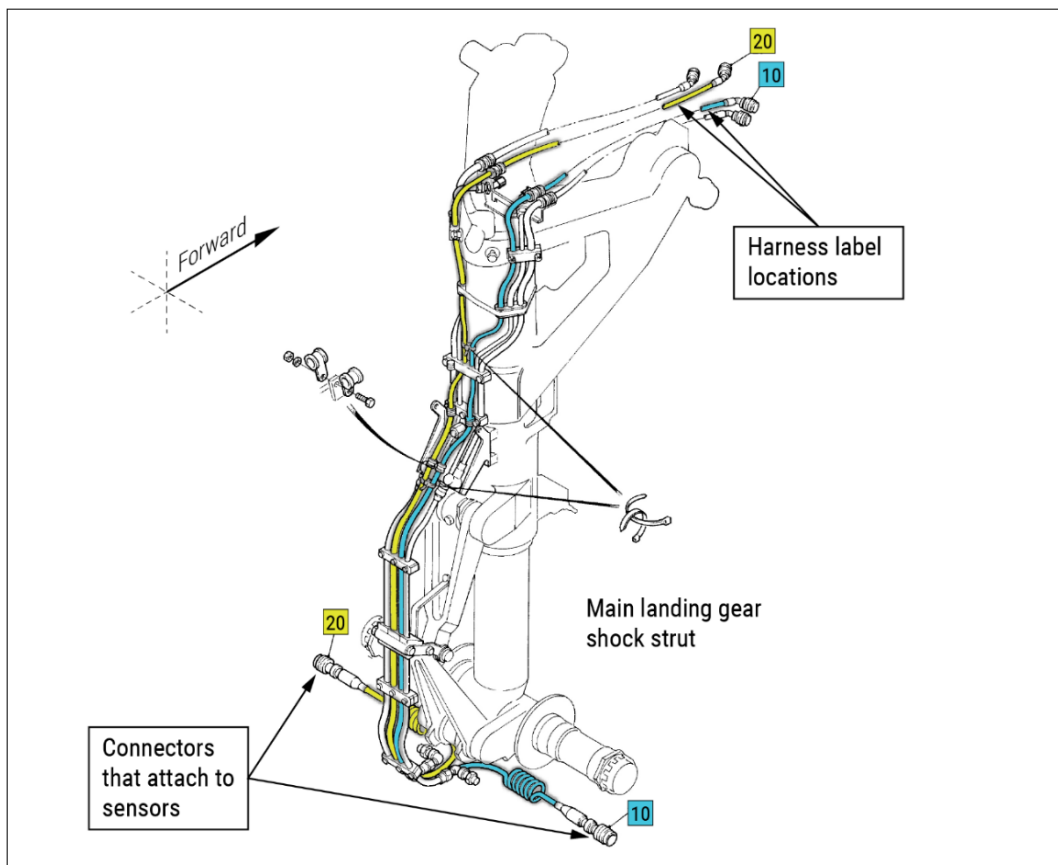
The wire harnesses have connectors at their top ends that attach to bulkhead fittings in each MLG wheel well. These connectors are keyed differently, so each connector can be attached to only one of the bulkhead fittings. The bottom ends of each wire harness are inserted through a hole in the base of each MLG shock strut, routed to the appropriate axle opening, and attached to the wheel speed transducers in the axles, as shown in figure 7. There is no distinguishing feature at the bottom ends of the harnesses to indicate which harness should be routed to the inboard wheel and which harness should be routed to the outboard wheel.

**Figure 7.** Routing for wheel speed transducer wire harnesses (Source: APPH).

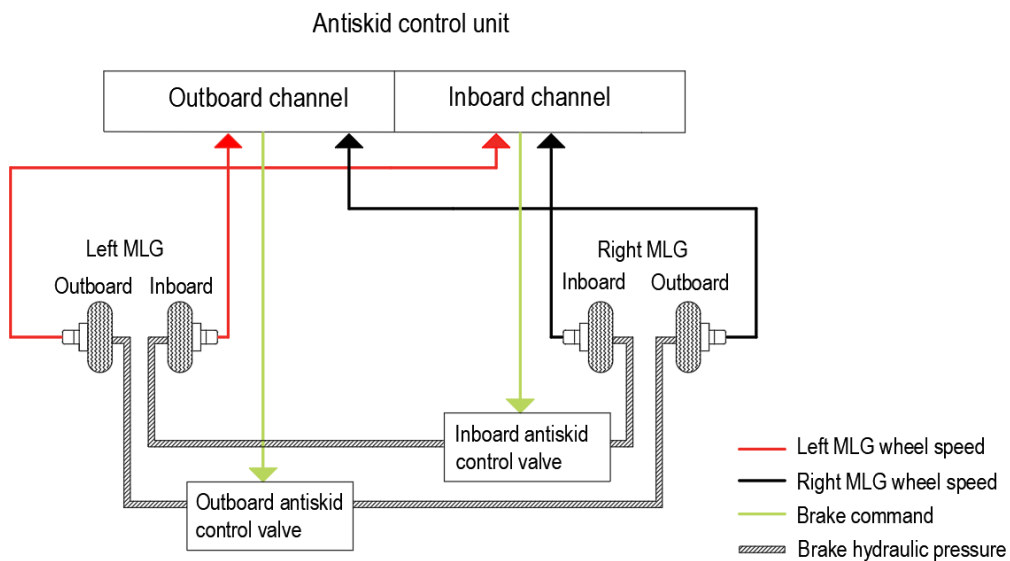
The incorrect wheel speed transducer wiring most likely occurred during the overhaul of the left MLG at the landing gear manufacturer's facility in January 2017, more than 2.5 years before the accident. This cross-wiring condition was not discovered until after the accident in part because the airplane was not in revenue service between the time of left MLG overhaul and PenAir's first revenue flight in June 2019. Also, the antiskid system does not generate a fault based on incorrect wiring. For a cross-wiring condition to potentially be detected, a significant skid event would have to occur for more than 2 seconds (based on the antiskid system's logic) and not be relieved. Saab's design of the wheel speed transducer wire harnesses did not consider that the harnesses could be incorrectly installed during maintenance and overhaul. In addition, three incidents that we investigated showed the potential for cross-wiring of antiskid system components in other airplane types.

The NTSB, Saab, and the accredited representative from the Swedish Accident Investigation Authority examined the recovered wheel speed transducer wire harnesses. During the examination, the participants noted that the left MLG wheel speed transducer wiring harnesses had been constructed differently. Specifically, the left outboard harness was constructed with one filler wire (a nonconducting wire with a fiberglass center used to fill space in the conduit and increase the strength), and the left inboard harness had two filler wires. As a result, the left outboard harness segment could be matched with a short wire segment (about 6.5 inches long) that had a label identifying the harness as 5/6 GA-P4. The short wire segment was also matched with the upper electrical connector with part number MS 27467T9B35P.<sup>39</sup> According to the installation instructions, this harness should have been routed to the left inboard wheel and not the left outboard wheel.<sup>40</sup> Thus, the examination showed that the left MLG wheel speed transducer wire harnesses were incorrectly installed. The examination also showed that the right MLG wire harnesses were correctly installed.<sup>41</sup>

Figure 8 shows the correct wiring for the left MLG wheel speed transducer. The crossed wiring of the left MLG wheel speed transducers, as described in the previous section, is shown in figure 9; the crossed wiring is shown in red.

**Figure 9.** Cross-wiring of left MLG wheel speed transducers.

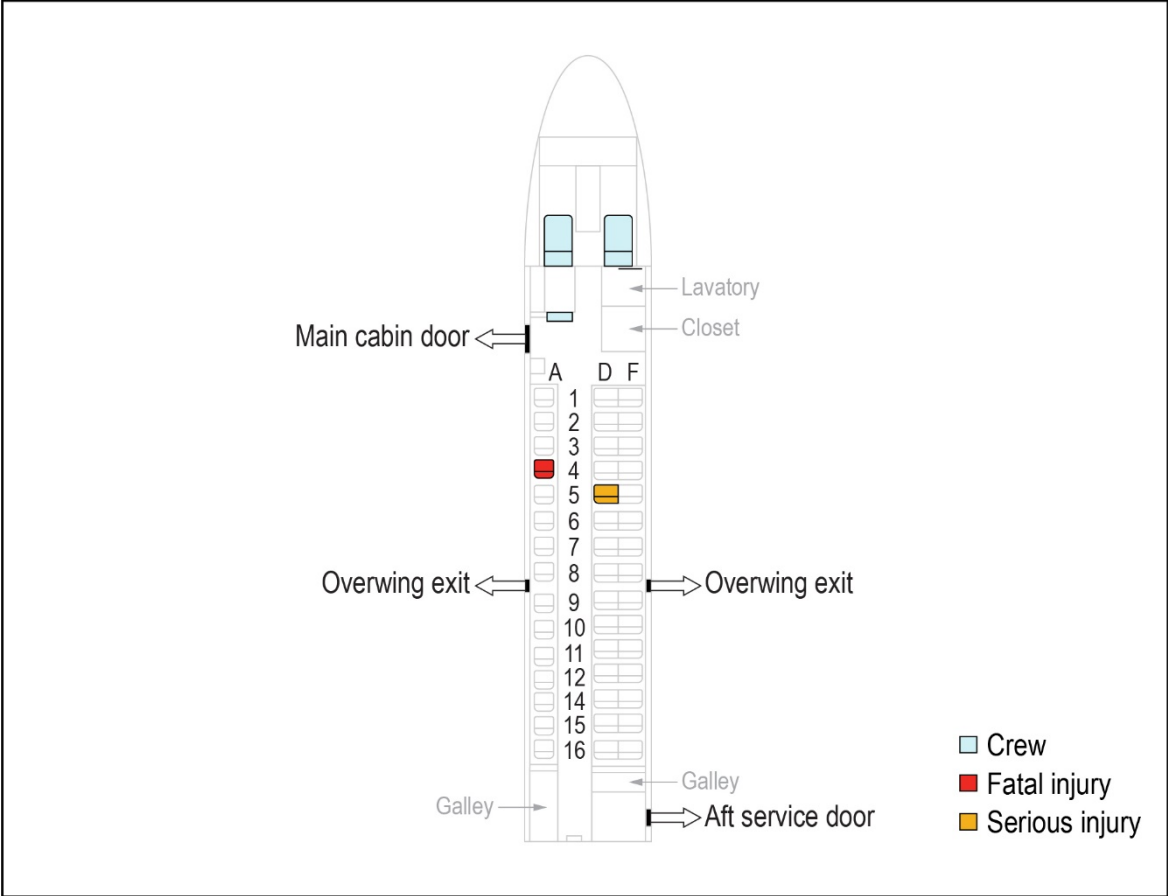
The accident airplane cabin was configured with a center aisle and 15 rows of passenger seats, numbered 1 through 12 and 14 to 16 (there was no row 13). A single seat on the left side of the cabin was designated A, and the two seats on the right side of the cabin were designated D (aisle) and F (window). The cabin had one aft-facing flight attendant jumpseat that was forward of the main cabin door on the left side of the airplane. In addition to the main cabin door, an aft service door was located on the right side of the airplane, and two overwing emergency window exits were located at row 9. Figure 10 shows the cabin configuration and the seating positions of the crew and the passengers who were fatally and seriously injured.

**Figure 10.** Airplane interior configuration and location of fatal and serious injuries.

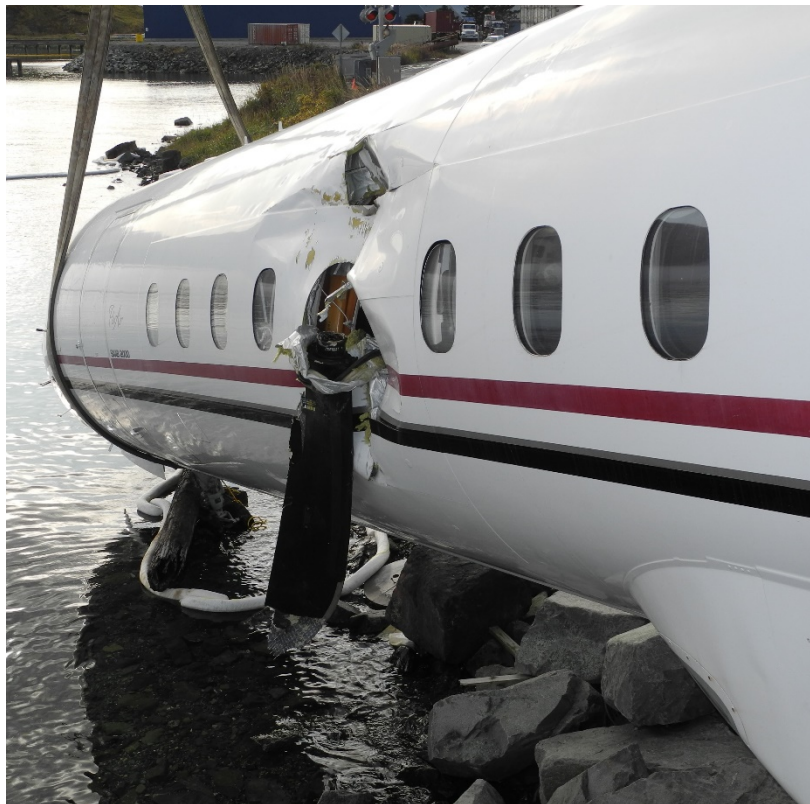
A left propeller blade impacted the left side of the cabin, as shown in figure 11, and damaged the cabin interior in the area between seats 3A and 6A, with extensive damage next to the seat 4A seatback and window. The overhead compartment in that area partially separated from its mounts and descended about 6 to 12 inches. The wall panel separated near seat 3A and was displaced aft and inboard. The wall panel and fuselage skin infringed about 10 inches into the seat 4A area at the lower seatback cushion. The 4A window fuselage frame was located on the cabin floor at row 2.

**Figure 11.** Impact area of left propeller blade.

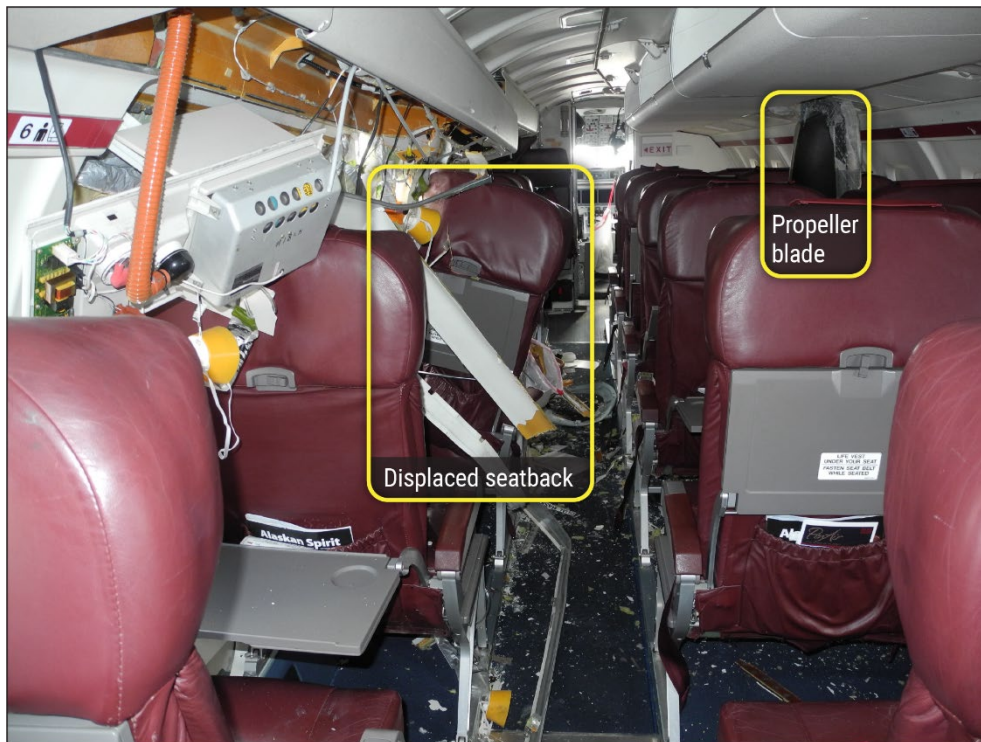
Seat 4A sustained substantial damage. The seatback was displaced inboard toward the center aisle, as shown in figure 12, and the seatback structure was fractured on the left side. The headrest cushion was partially torn away from the seatback, and the left side of the seatback (forward facing) had an 8-inch vertical cut through the foam and cover starting about 4 inches from the top of the seatback. The bottom seat cushion was askew. The right armrest was fractured at the forward mount and displaced inboard about 4 inches. The seat belt was not damaged and was functional. Another propeller blade had entered the left-side fuselage, traversed the cabin, and was in place vertically on the right side of the cabin in front of seat 4F, which can also be seen in figure 12. The blade was wedged between the overhead bin and the floor. There was no damage or scrape marks to the overhead bin, floor, or seats 4D and 4F except for a fracture and slight displacement of the inboard armrest of seat 4D. Seat 5D had a superficial x-shaped tear in the seat cushion.

**Figure 12.** Forward view of cabin from row 6.
