Final report RL 2021:08e

Incident at Gällivare airport on 10 September 2020 involving ES-ACD of the model RJ Series 900, operated by Regional Jet OÜ.

File no. L-78/20

9 September 2021

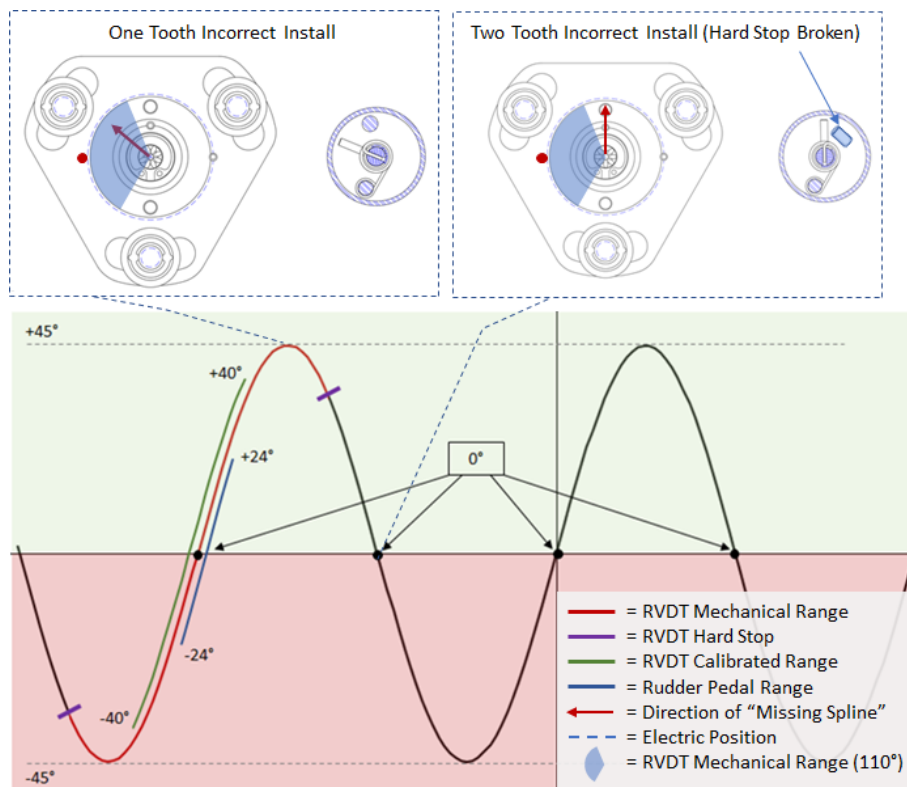
If the clockwise hard stop is broken the missing spline can be installed two teeth off (90 degrees) from the rig position. In this scenario the broken hard stop allows the shaft to rotate in to the next quadrant's electrical zero. In this position it is possible to rig the sensor and get an approved result with the aircraft's maintenance diagnostic computer. The polarity of the electrical output signal will be reversed, compared with the sensor output signal when the sensor is correctly installed (see Figure 6, Two Tooth Incorrect Install).

Figure 6. Electrical and mechanical characteristics if the missing spline on the sensor shaft is installed one or two teeth off from the rig position, clockwise seen from below the sensor.

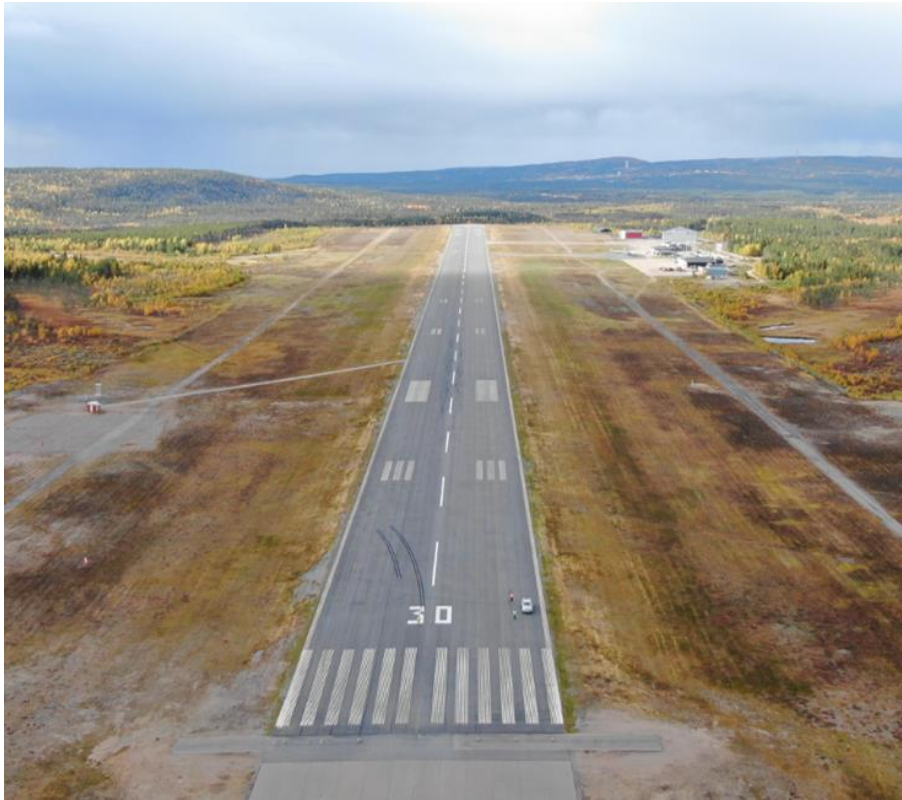
Figure 12. Photo taken over the runway and the airfield in the take-off direction. Tire tracks after the incident can be seen after the runway marking 30.

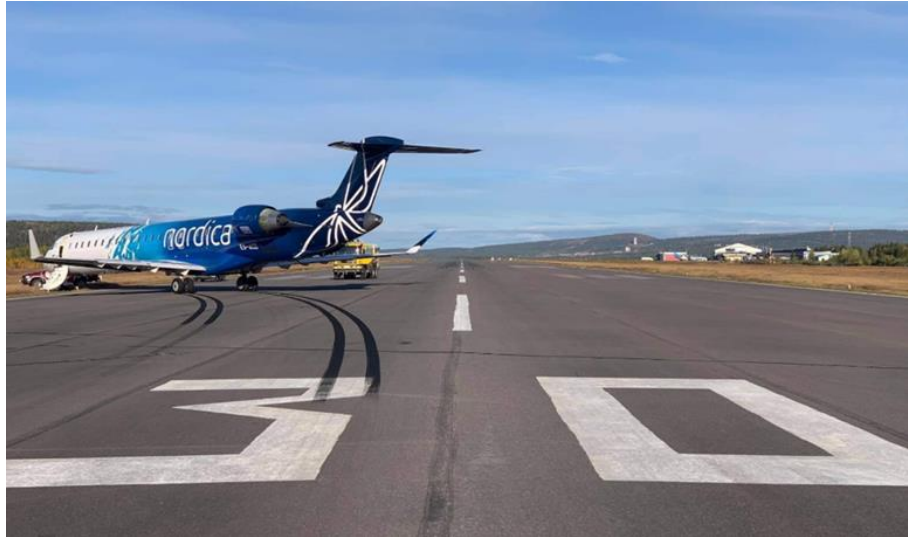
Figure 18. The aircraft's final position after the incident. After the runway marking 30, the black tire tracks are visible from the main wheels. Photo: The Rescue service Gällivare Airport.

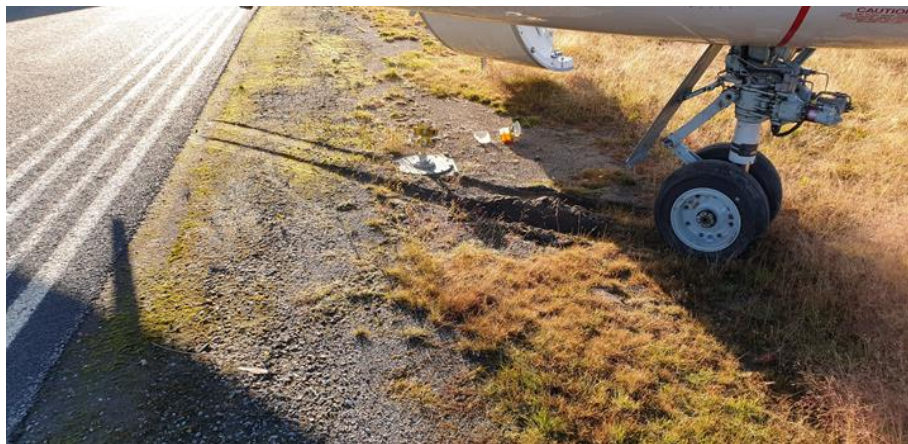
Figure 19. The aircraft came to a full stop with the nosewheel off the left side of the runway hard surface. Photo: The Rescue service Gällivare Airport.

The rim on one of the nose wheels was damaged.

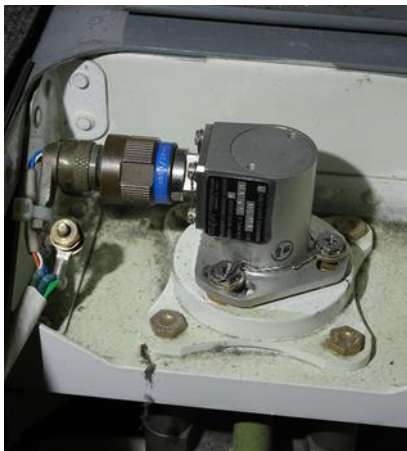
Figure 20. The sensor (RVDT) installed in the aircraft according to the installation description at the technical examination.

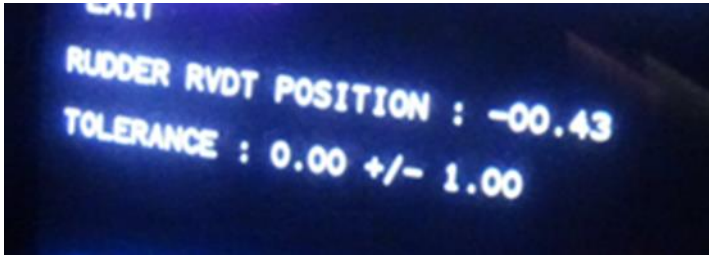
Figure 21. The page for sensor (RVDT) rigging, in the maintenance computer. -00.43 degrees with the rudder pedals in neutral position.

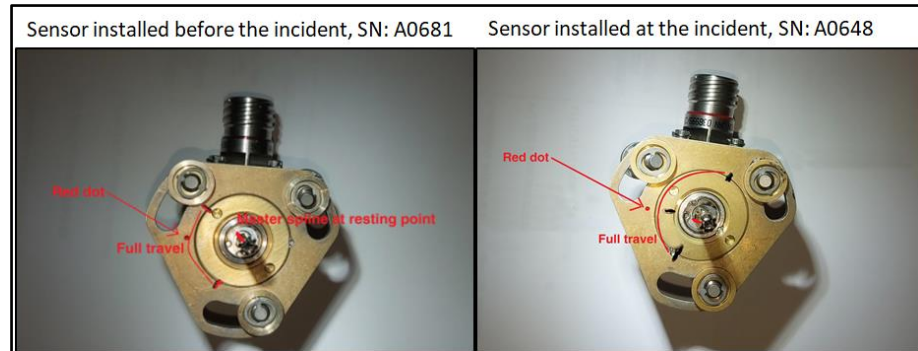
The sensor that was installed at the time of the incident, serial number A0648, had a larger range of motion than the sensor that had previously been installed, serial number A0681 (see Figure 22).

When the shaft was manually turned counter clockwise and clockwise on the sensor with serial number A0648, it felt as if there was an obstruction when it passed the red dot, where it sometimes also got stuck (see the picture to the right in Figure 22).

Figure 22. Pictures of the sensors (RVDT) that were compared. Left picture: The range of motion is marked with a red line, the flex shaft with missing spline is spring-loaded against the mechanical stop, +55 degrees (clockwise seen from this view). Right picture: The range of motion, marked with a red line, is longer compared to the left picture. The missing spline on the flex shaft is stuck at the red dot.

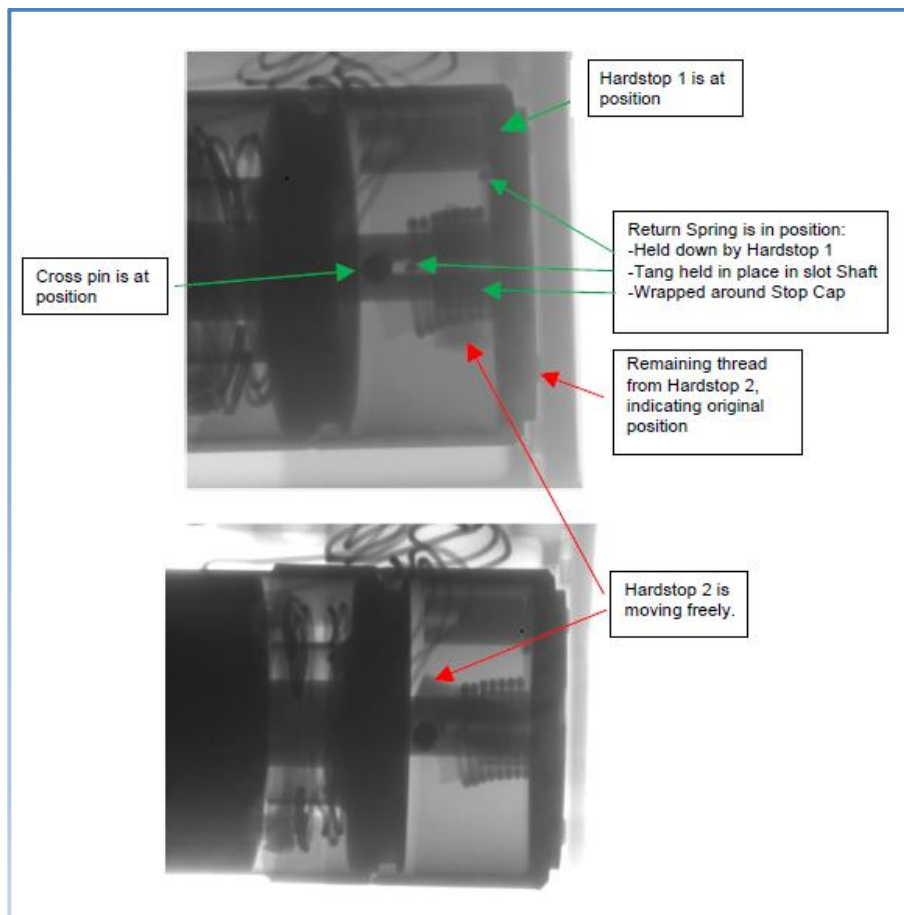
The sensor was X-rayed and it was found that the unit had internal damage. The mechanical stop number two had dislodged from its original position (see Figure 24).

Figure 24. X-ray's from the examination. The lower image with a darker contrast.

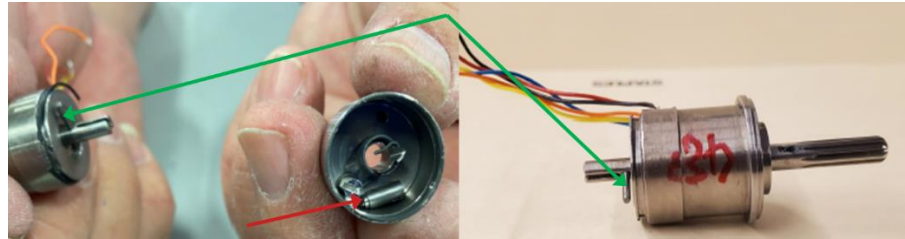
Figure 25. The sensor after disassembly. The green arrows show the cross pin on the shaft. The red arrow shows the hard stop that is loose in the stop cap assembly.

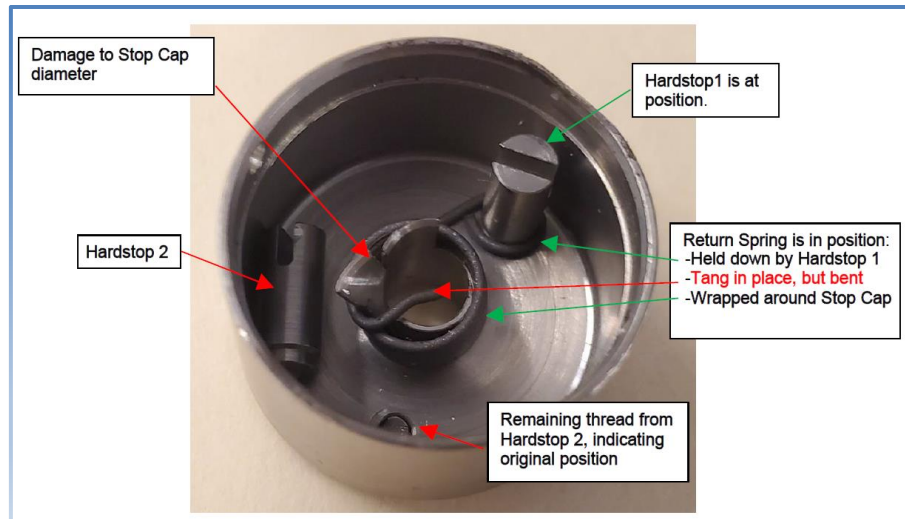
The following damage could be found in the stop cap, which was dismantled from the sensor unit. Mechanical stop number two had been broken off, the end of the return spring was bent and the stop cap was damaged at the end of the return spring (see Figures 26 and 27).

Figure 26. Close-up of the disassembled stop cap assembly.

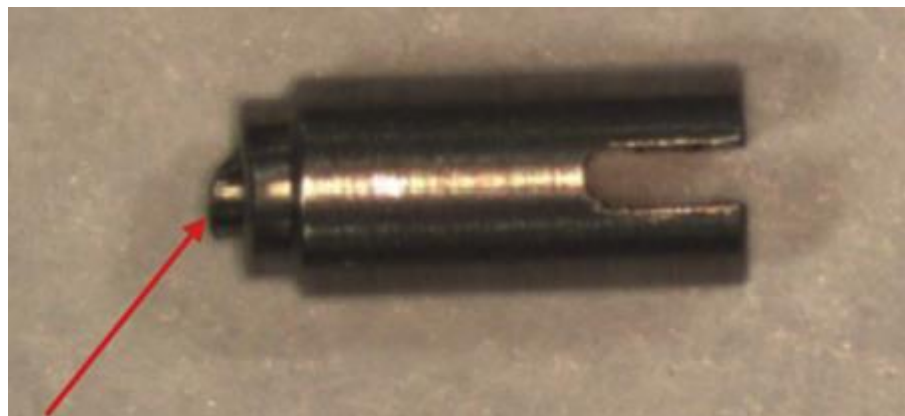
Figure 27. Hard stop that had been broken off and was loose in the stop cap assembly. The red arrow shows the fracture location.

The force that is required to break the hard stop is 15.9 lbf (pound-force) according to Woodward MPC Inc.

The examination showed that the deviation of the output signal is due to the mechanical stop number two had been detached from its original position. Due to the fact that the mechanical stop had been broken off, the sensor shaft could rotate outside the intended working range.
