## *Final report RS 2022:02e*

NATALY – fatal workplace accident on  
25 March 2021 off Landsort,  
Stockholm County

File no. S-62/21

2022-03-02

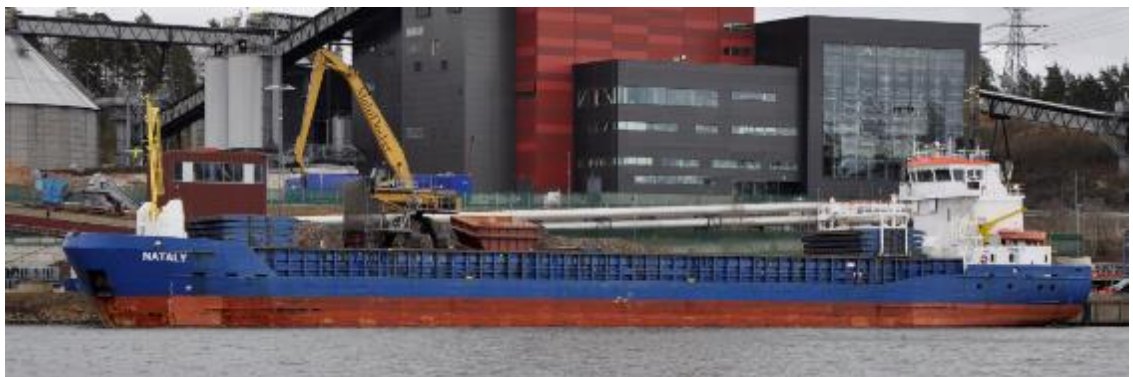
Fig. 1. NATALY moored at Igelstaverket after the occurrence.

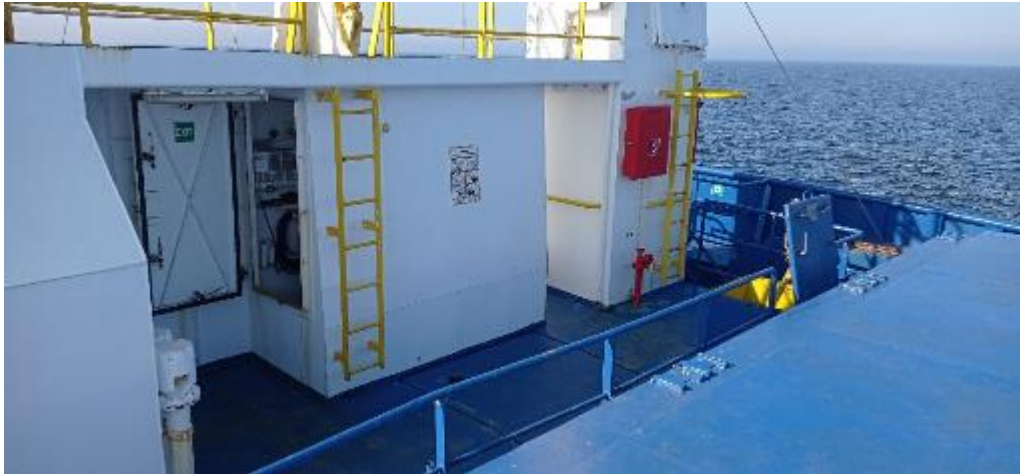
The cargo hold was reached using ladders in tube-like shafts, one on the forward end of the cargo hold (see Fig. 2) and one on the aft end. The shafts were reached through a hatch that must be kept closed at sea if it is not established to be risk free. At the bottom of the shafts there was an opening in the form of a door hole from the passageway out into the cargo hold. There was no door in the opening, and to prevent the cargo in the form of bulk products streaming into the shaft, there were timber boards that were mounted in tracks on the side of the door hole (see Fig. 3 and 4). The wooden boards thus acted as an unsealed separation between the shaft and the cargo hold. Consequently, from the perspective of ventilation, the shaft must be regarded as part of the cargo hold.

Fig. 2. The picture is aimed obliquely forward to starboard from the cargo hatch. The hatch for the forward shaft is open and can be seen on the right in the picture. Image: the shipowner.

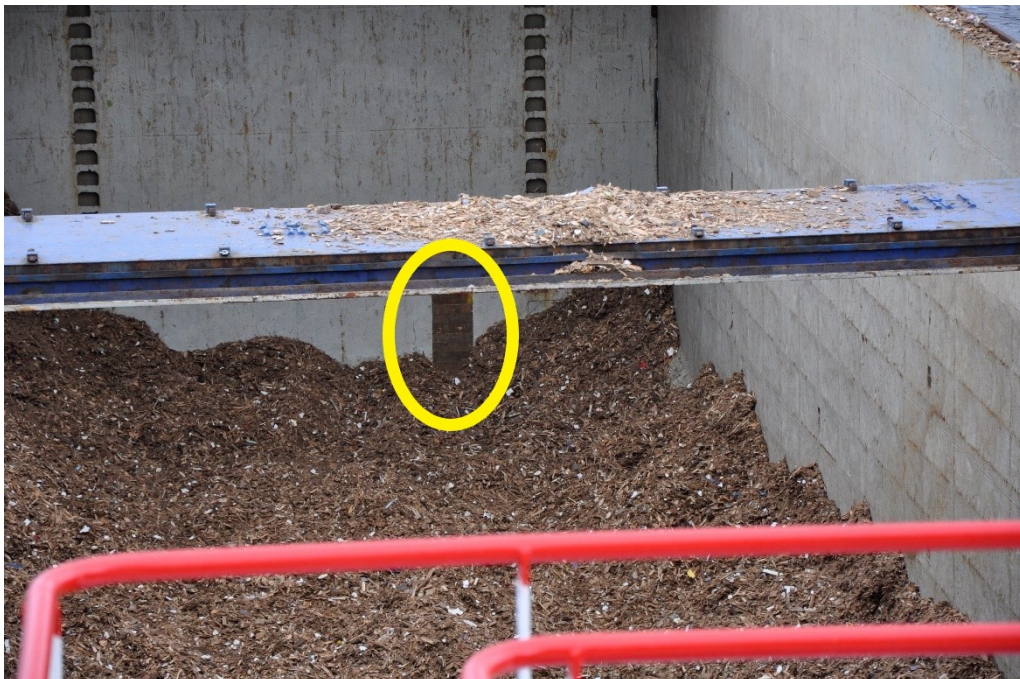
Fig. 3. The picture, which is aimed forward from the aft side of the cargo hold, shows the cargo hold after a large part of the cargo has been unloaded. The exit (marked yellow) from the forward shaft out into the cargo hold is seen in the middle of the picture. The wooden boards that are intended to prevent the cargo from getting into the shaft are still mounted in the tracks in the door hole. The inside of the door hole is seen in Fig. 4.

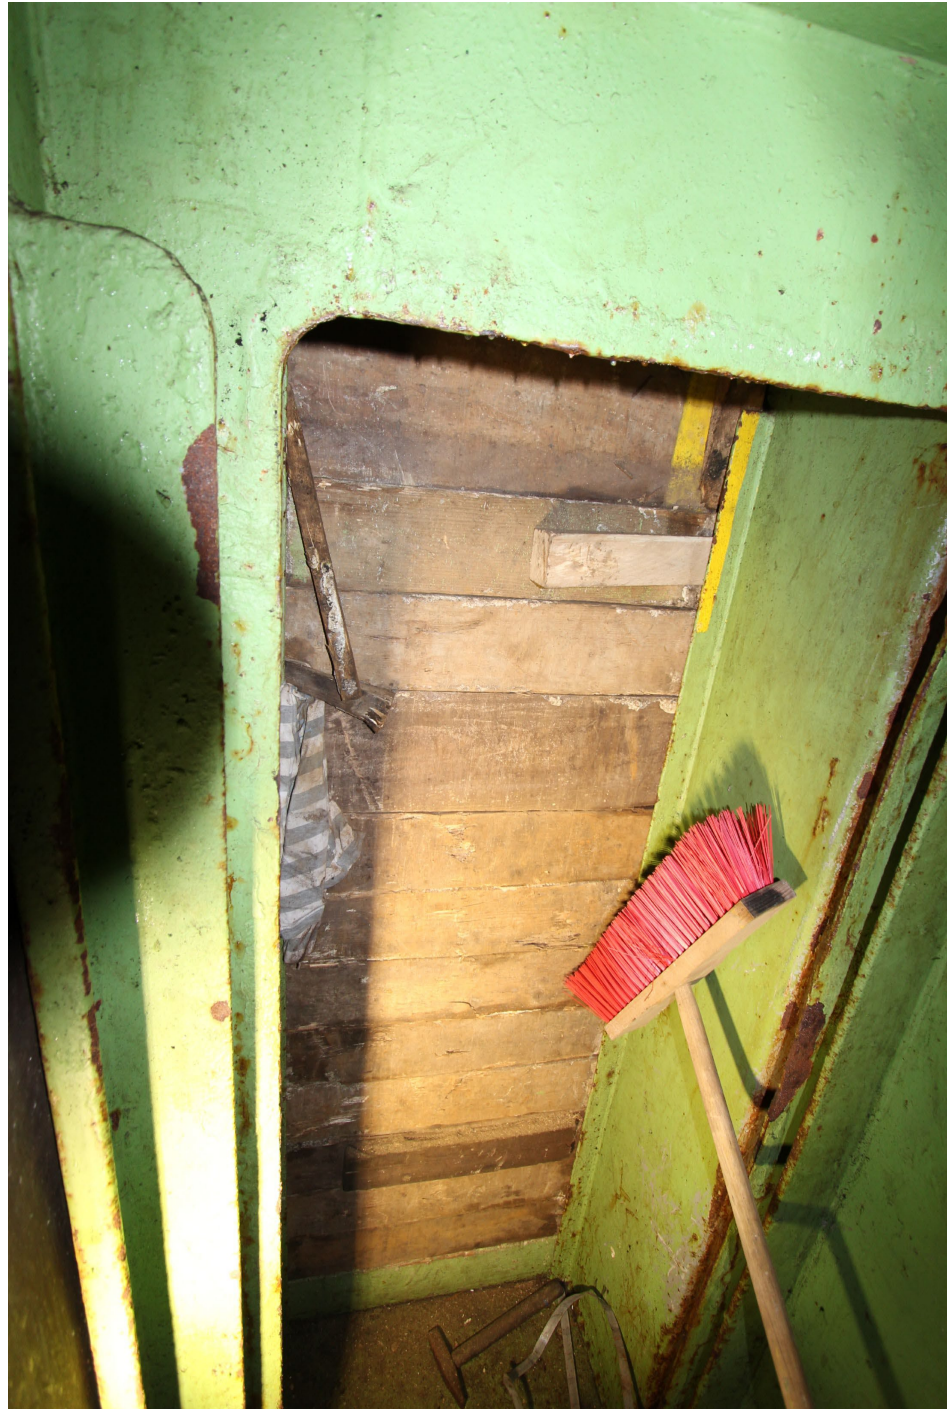
Fig. 4. The temporarily built wall in the door hole from the cargo hold shaft in to the cargo hold. The picture is taken at the bottom of the shaft and shows the inside of the door hole that is shown in Fig. 3. Image: Swedish Police Authority.

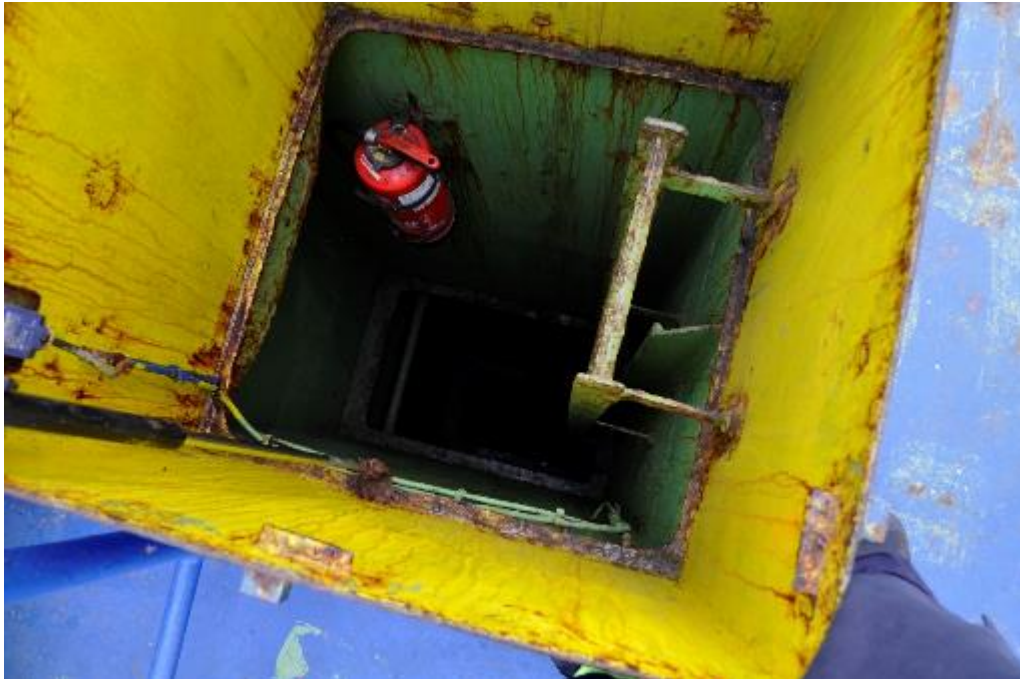
The hatches for the shafts were square with the dimensions 75 x 75 cm. The ladders took up 19 cm, and the usable space between the ladder and the opposite bulkhead was thus 56 cm (see Fig. 5). There was also a fire extinguisher and some shelves in the shaft, which further reduced the available space. The depth of the shaft was 7.8 m. Being stored at the bottom of the passageways was some equipment, which was used when cleaning and sweeping the cargo hold, along with the wooden boards for the door hole (See Fig. 6). According to certain information from witnesses, there was also a light available if needed.

Fig. 5. The forward shaft viewed from above.

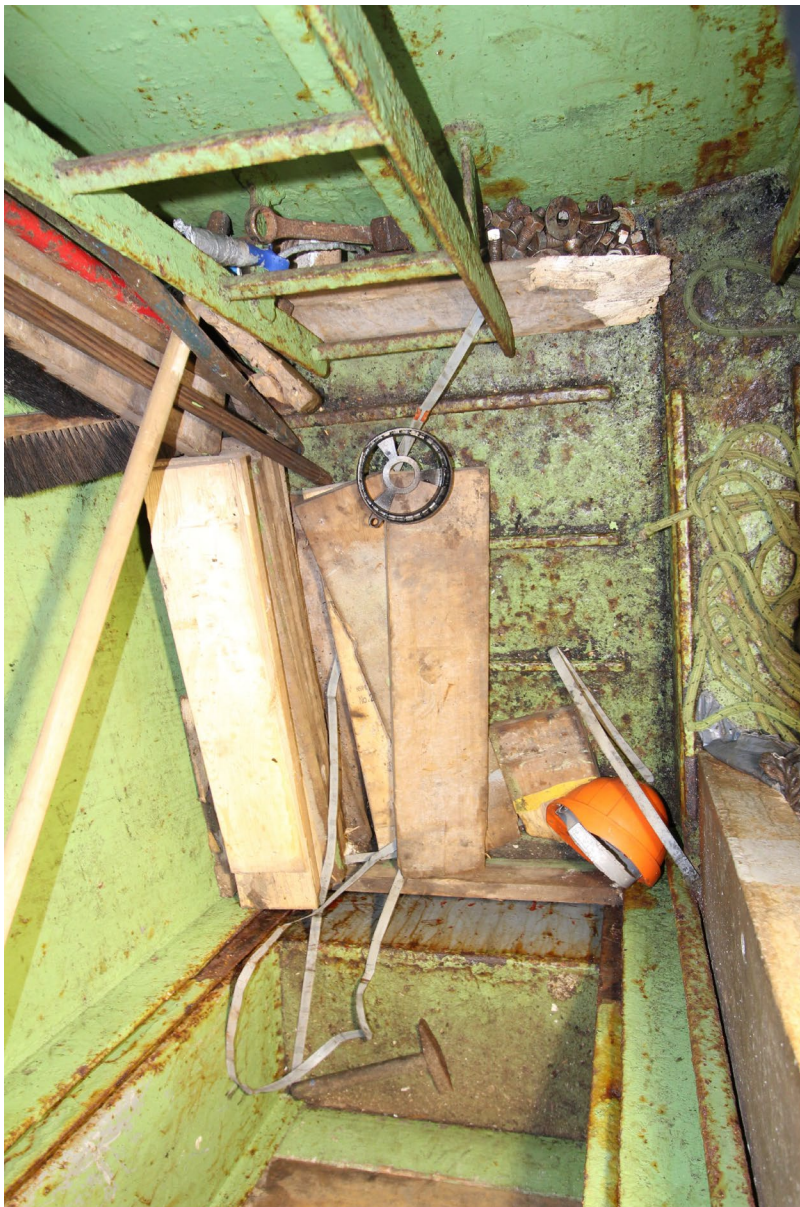
In summary, the conclusion is that the result of the post mortem suggests that the deceased was subjected to severe hypoxia and that the cause of death is suffocation.

Fig. 6. The bottom of the cargo hold shaft, seen from above. It was here that the victim was found. Image: Swedish Police Authority
