Final report RS 2022:07e

Very serious marine casualty involving a lifeboat in Frihamnen harbour, Stockholm den 12 April 2021

File no. S-76/21

2022-07-13

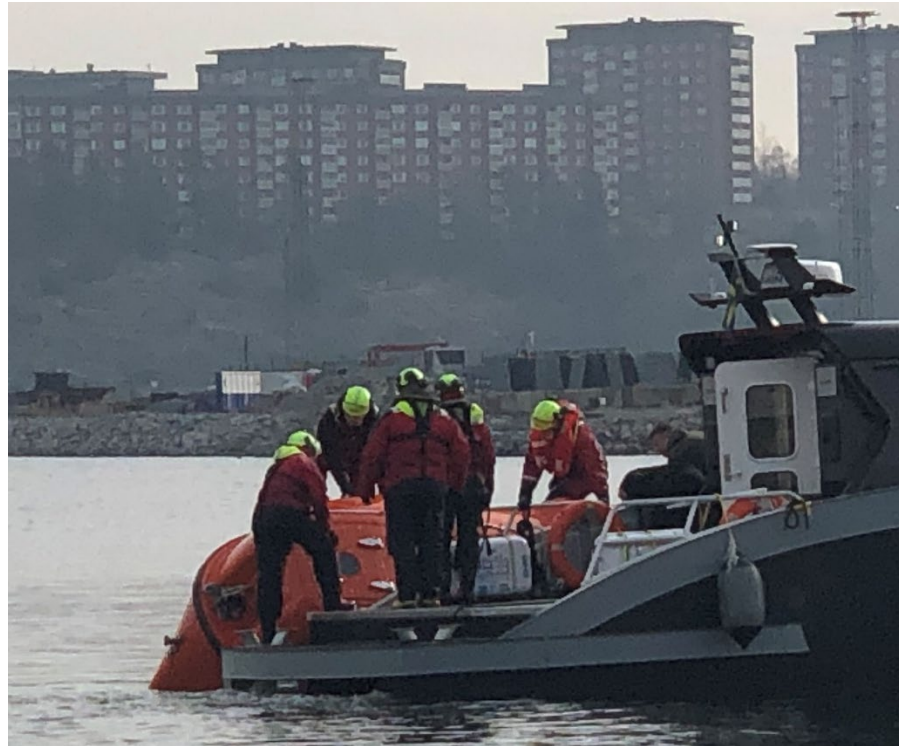
The accident was caused by the lifeboat's stability properties, which meant that small changes in centre of gravity gave rise to large angles of heel. When those on board moved around in the lifeboat in order to allow the helmsman to be changed, the centre of gravity moved upwards. This led to the boat heeling heavily, taking on water through an open side hatch and heeled over. At system level, the accident was caused by insufficient stability requirements for small, enclosed lifeboats with side openings near the gunwale.

The person who was sitting in the side hatch had to throw himself out into the sea and the instructor who was standing outside in the stern fell into the water. The person who was sitting closest to the stern hatch decided to dive out through it and his inflatable life jacket inflated immediately afterwards. Others scrambled out onto the boat's superstructure through the starboard side hatch and the hatch in the bow. Aside from the three people who ended up in the water, the others were able to cling to the lifeboat, which was now lying with a heavy list to port and half filled with water.

Figure 2. At the time of the accident. Image: Safetygruppen & Navigationsgruppen Sverige AB.

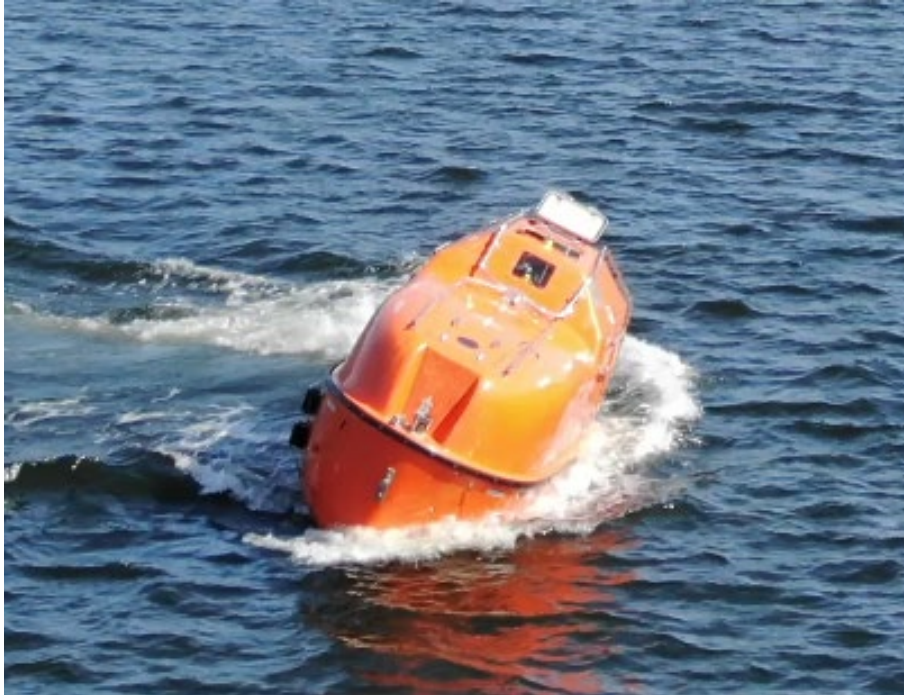
Figure 10. Picture from manoeuvring tests. Four people, including a helmsman, were on board. A sharp starboard turn was performed at a speed of 6 knots.

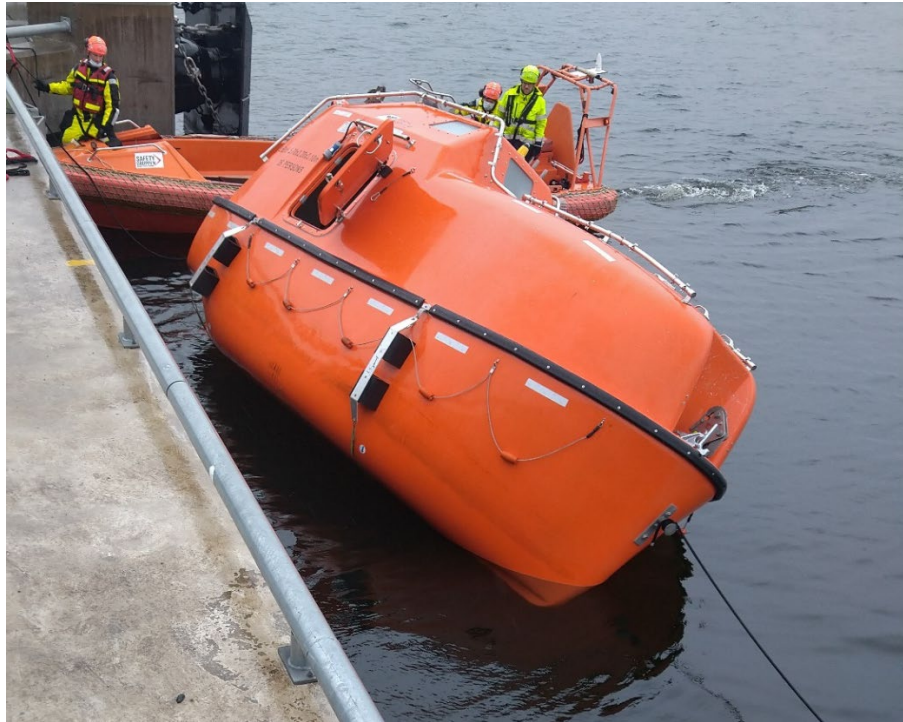
A maximum list of 40 degrees and a freeboard of 110 millimetres were measured during the test.

It was established that even very small movements by the two people on board affected the size of the list.

Figure 11. The list during the load test.

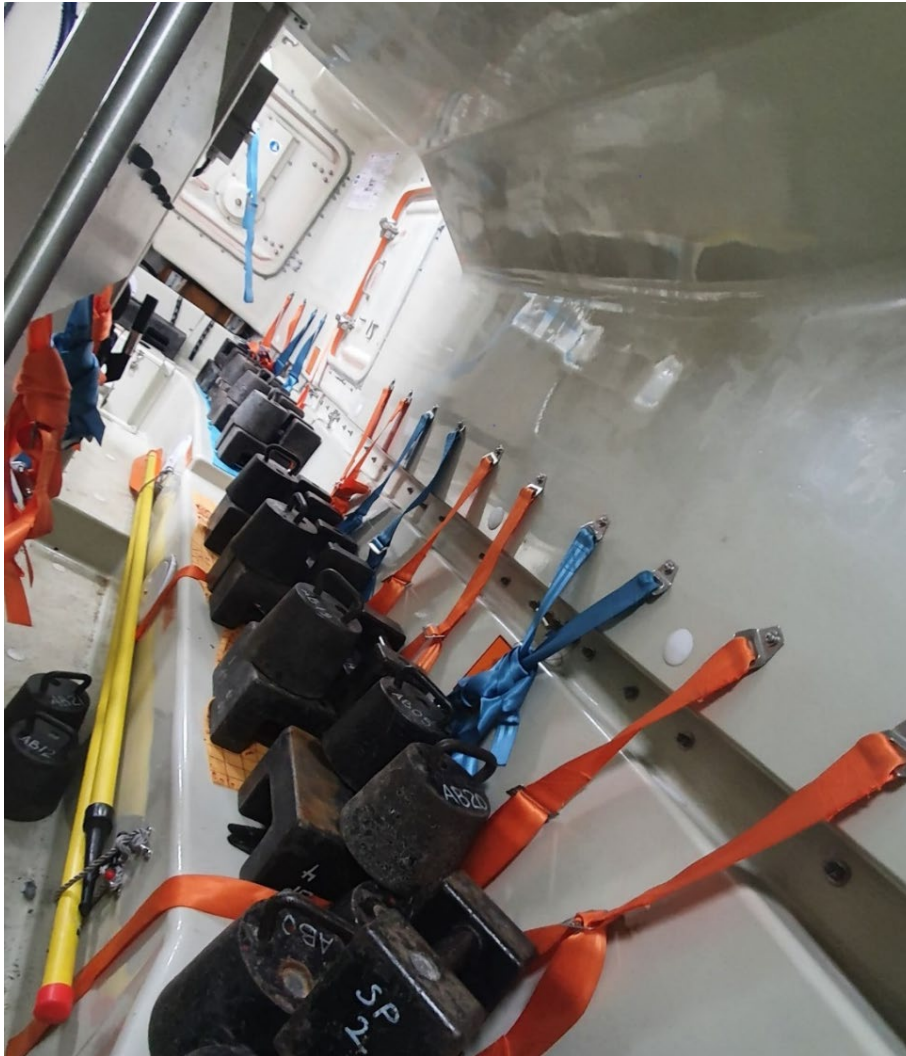
Figure 13. Picture from inside the lifeboat during the load test.

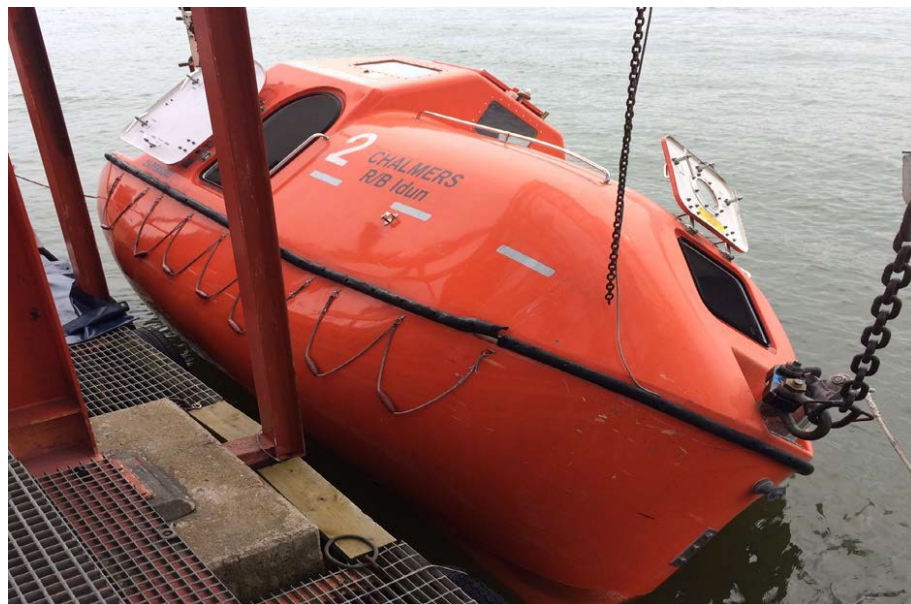
Figure 15. One of the three lifeboats that were tested by Chalmers University of Technology. The lifeboat in the picture is of another make than the one in question. Image from Chalmers Technical University, Report SK-17/219.

In 2017, an occurrence took place at a training facility at Chalmers University of Technology that involved a lifeboat of a similar type demonstrating unstable tendencies while in use. As a consequence of this occurrence, and within the scope of a diploma thesis⁹, load tests and stability calculations were performed on three different lifeboats. The load test was conducted using weights equivalent to half of the permitted number of passengers on one side, i.e. in accordance with the requirements in the LSA Code. According to the report, the tests

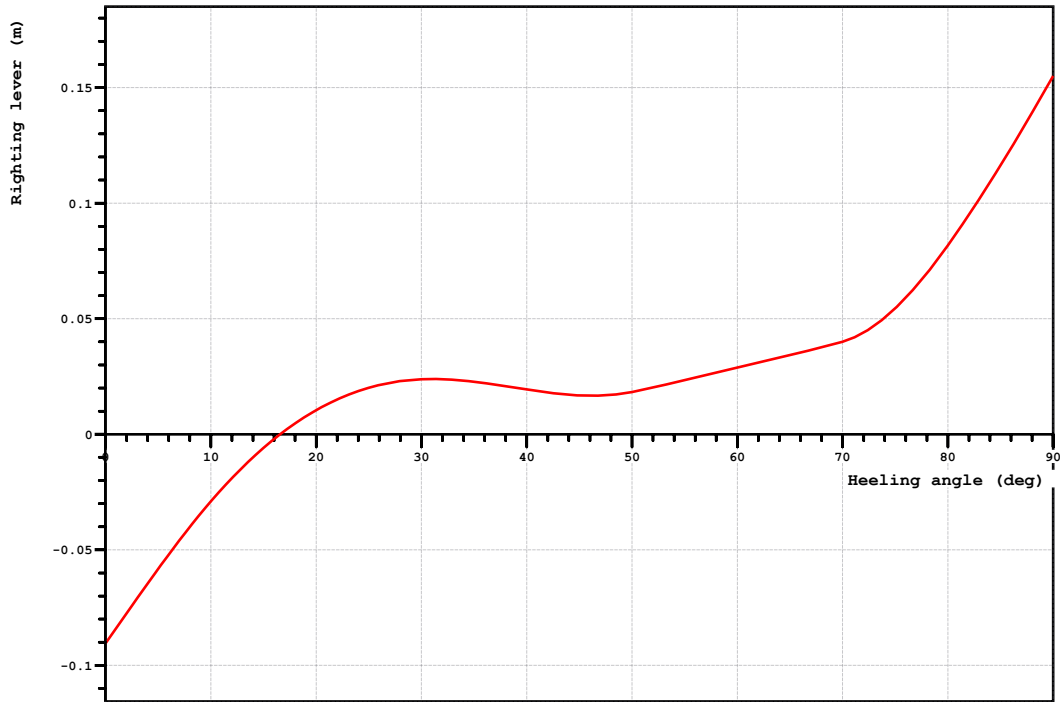
GZ CURVE

The investigation indicates that the stability properties deteriorate the fewer people are loaded in the lifeboat. The worst stability calculated was under loading condition LK5, with extreme lists and a high risk of the lifeboat to heel over or water coming in through the side openings. A risk of large angles of heel was also calculated under loading condition LK7.
