Final report RL 2015:11e

**Accident in Kungsängen on 14 July 2014
involving helicopter SE-JKJ of the model
MD 600N, operated by a private individual**

File no. L-0088/14

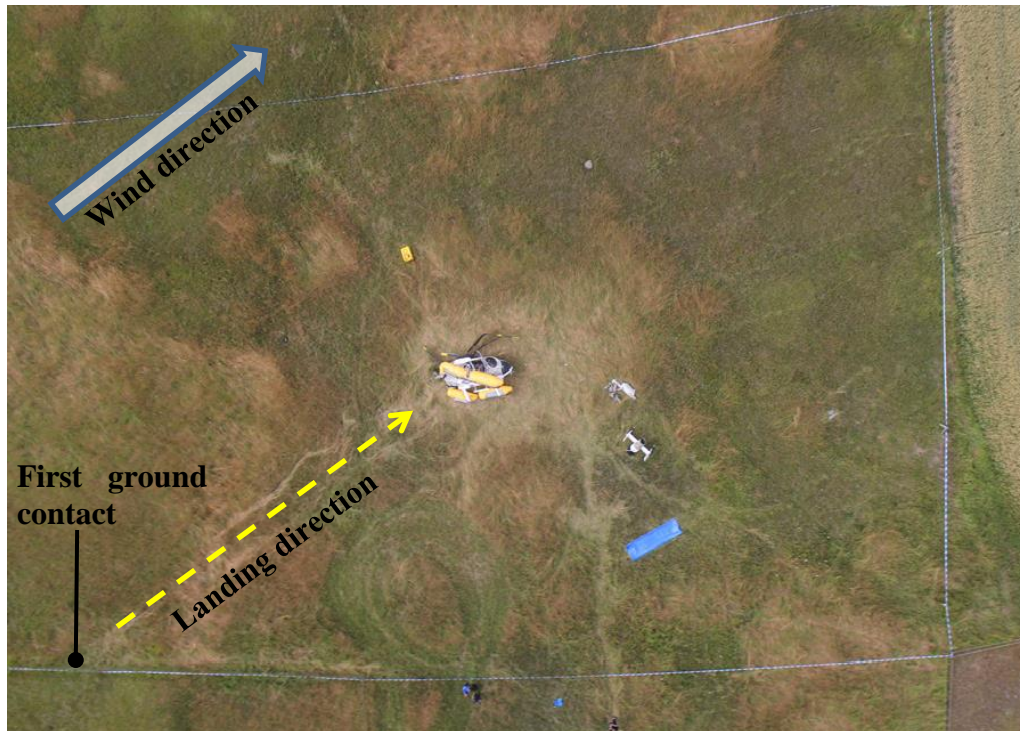
The accident site is situated in a meadow with cultivated pasture surrounded by a forest, in a sparsely populated area. The meadow is enclosed with sheep fencing. The tail boom's lower guard hit the upper part of the fencing and cracked a post before the tail boom hit the ground and broke.

Figure 9. Accident site. Photo: Air Unit.

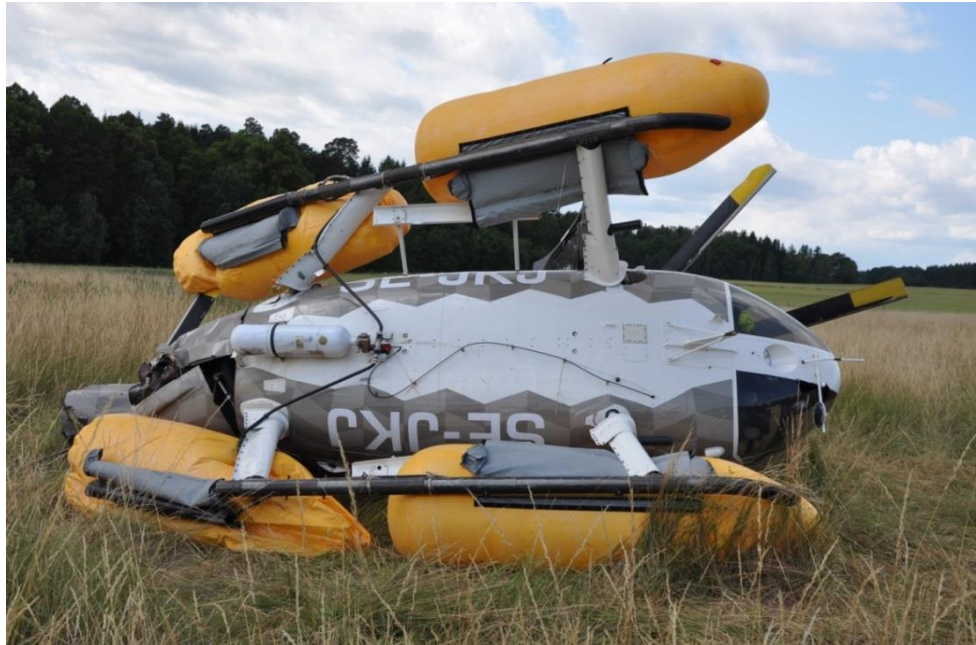
It can be noted that unauthorised persons had moved the tail boom and other large parts before the commission could secure the accident site.

Figure 10. The helicopter.

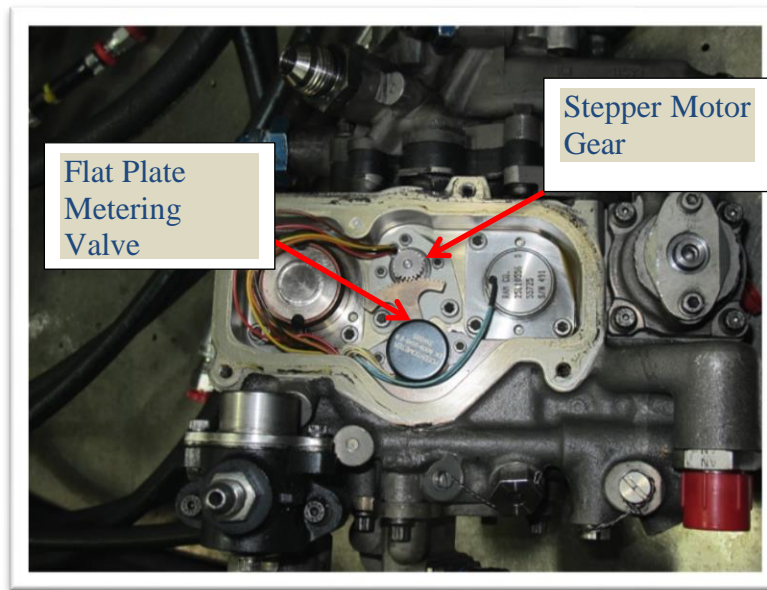
Figure 11. Shows that the position of the HMU metering valve is fully open.

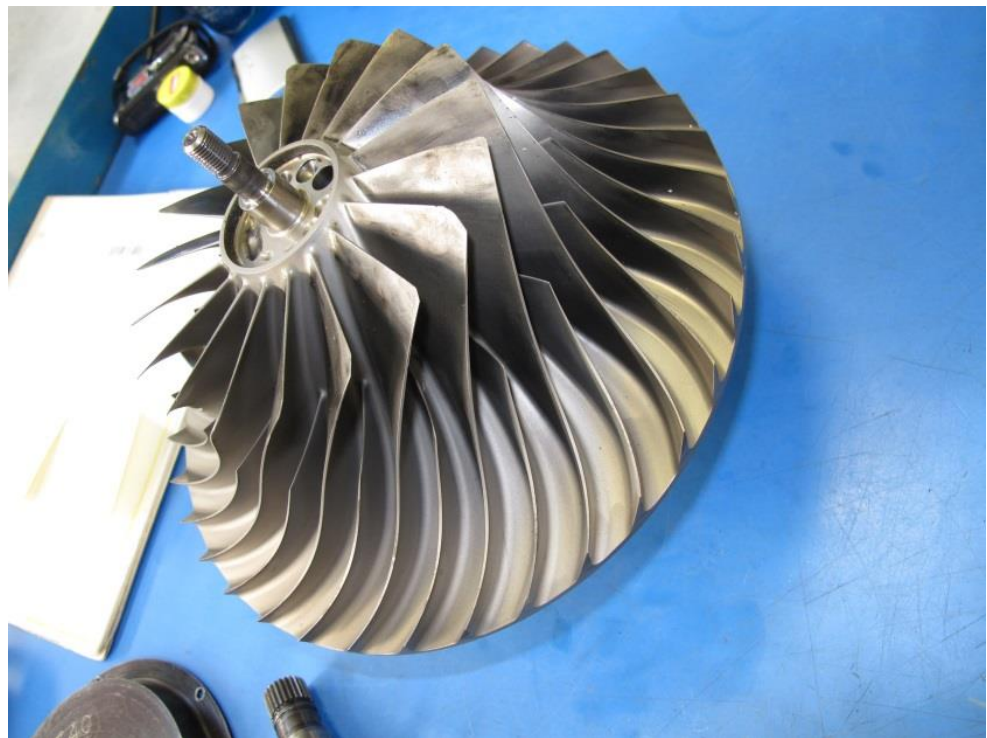
Figure 12. Radial compressor in good condition.

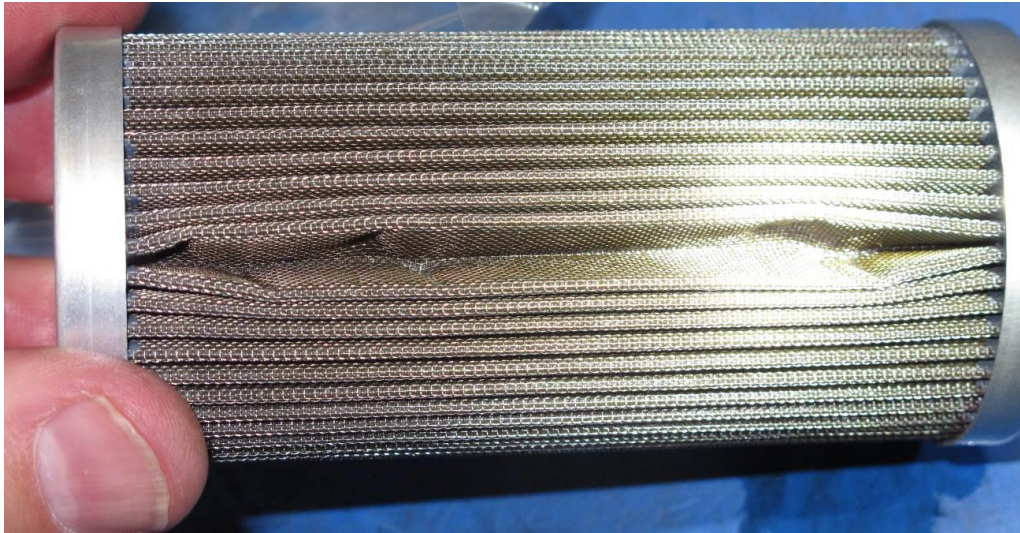
Figure 13. Fuel filter with limited quantities of foreign objects.

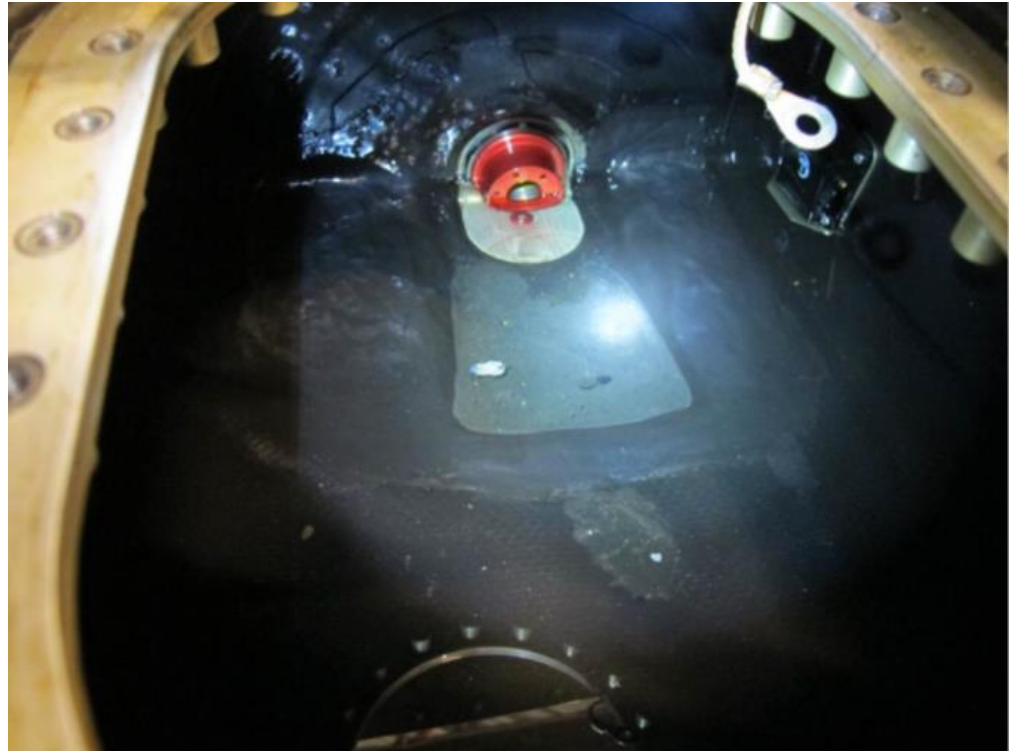
Figure 14. Fuel tank with remaining fuel and water.

The helicopter's fuel tank contained a certain quantity of water and other contaminants despite the fuel tank having been emptied and cleaned during maintenance work only around six weeks prior to the incident. The various fuel samples submitted contained mould spores and microorganisms. None of the contaminants found were however deemed to have affected the engine's operation.

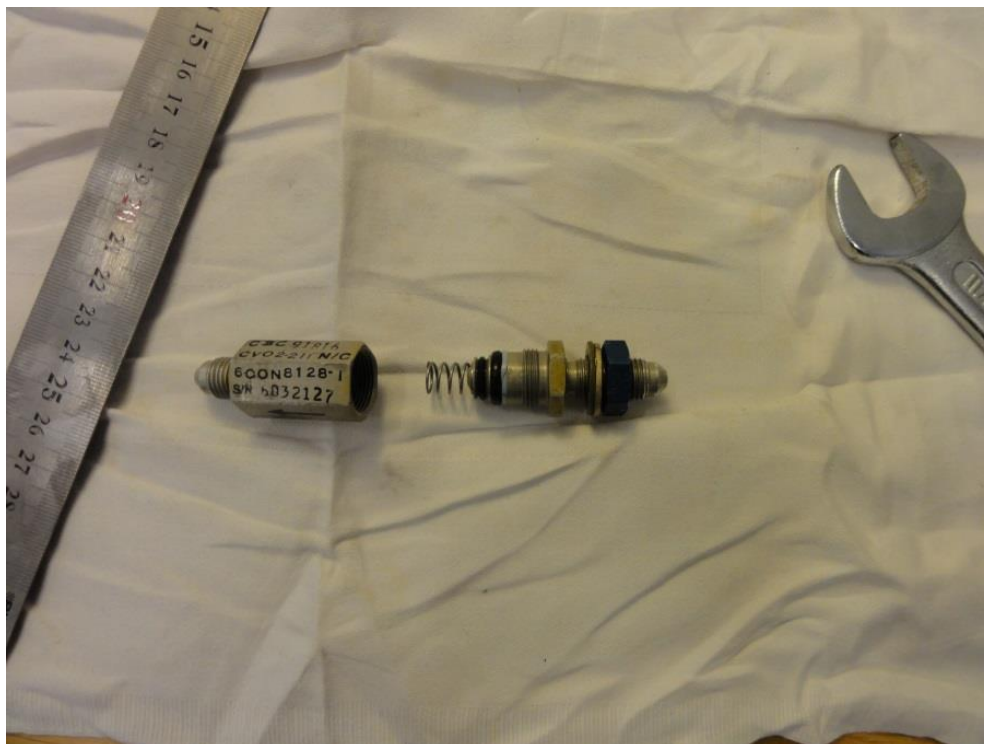
This transfer system consists of an ejector or jet pump, fuel lines and a check valve. During functional checks, the check valve was found to be clogged, which resulted in it yielding a severely restricted flow to the transfer system. A simple cleaning of the check valve provided a considerably higher flow.

Figure 15. Check valve.

The accident was caused by the check valve in the fuel transfer system having reduced function due to contaminants, which meant that the remaining fuel could not be utilised and the engine therefore stopped due to fuel exhaustion.
