Final Report RL 2017:05e

**Serious incident at Vilhelmina Airport,
Västerbotten County, on 6 April 2016
involving the aeroplane SE-LLO of model
BAe ATP, operated by NextJet AB.**

Reference no. L-35/16

5 April 2017

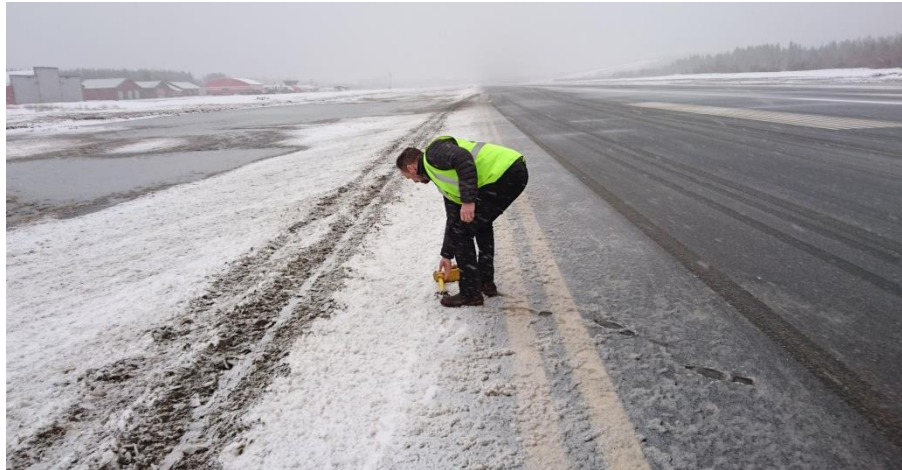
The wheels were at most 2.5 metres outside of the edge of the asphalt. Roughly 500 metres from the touchdown zone, the aeroplane's wheels hit one of the runway edge lights, which came loose from its fitting and was thrown to the side. The crew reported to the tower via radio that they "were almost off the runway there".

Figure 2. Tracks of the aeroplane outside of the runway and the runway edge light that was run over. (The photo is taken opposite to the landing direction.) Photo: Vilhelmina Airport.

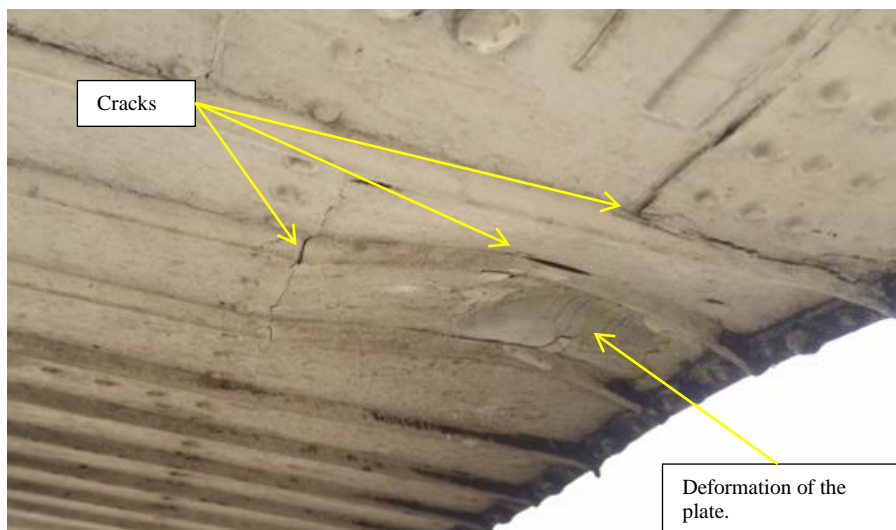
The damage to the aeroplane that was discovered was localised to the trailing edge of the inner part of the right wing flap. The damage consisted of cracks and a deformation of the flap plate measuring roughly 290 x 180 mm. The underside of the plate was indented by approximately 25 mm and a bulge of some 8 mm was detected on the top side (see Figure 4).

Figure 4. The underside of the damaged wing flap. Photo: NextJet AB.

The damaged flap was not found to be in a repairable state; it was removed from the wing and a new flap unit mounted. The damage established could not be investigated by SHK as the part was destroyed after the flap was replaced. It is therefore not possible to determine with any certainty just how deep into the aircraft's structure these cracks went, or if some of the cracks stopped at the paint layer.

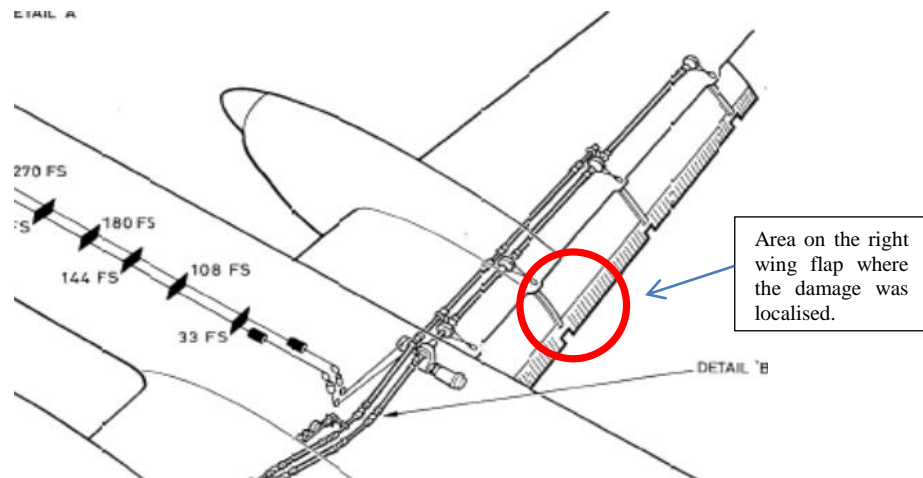
The damage was localised to an area on the inner part of the wing flap that is located behind the right engine nacelle and above the right main landing gear (see Figure 5).

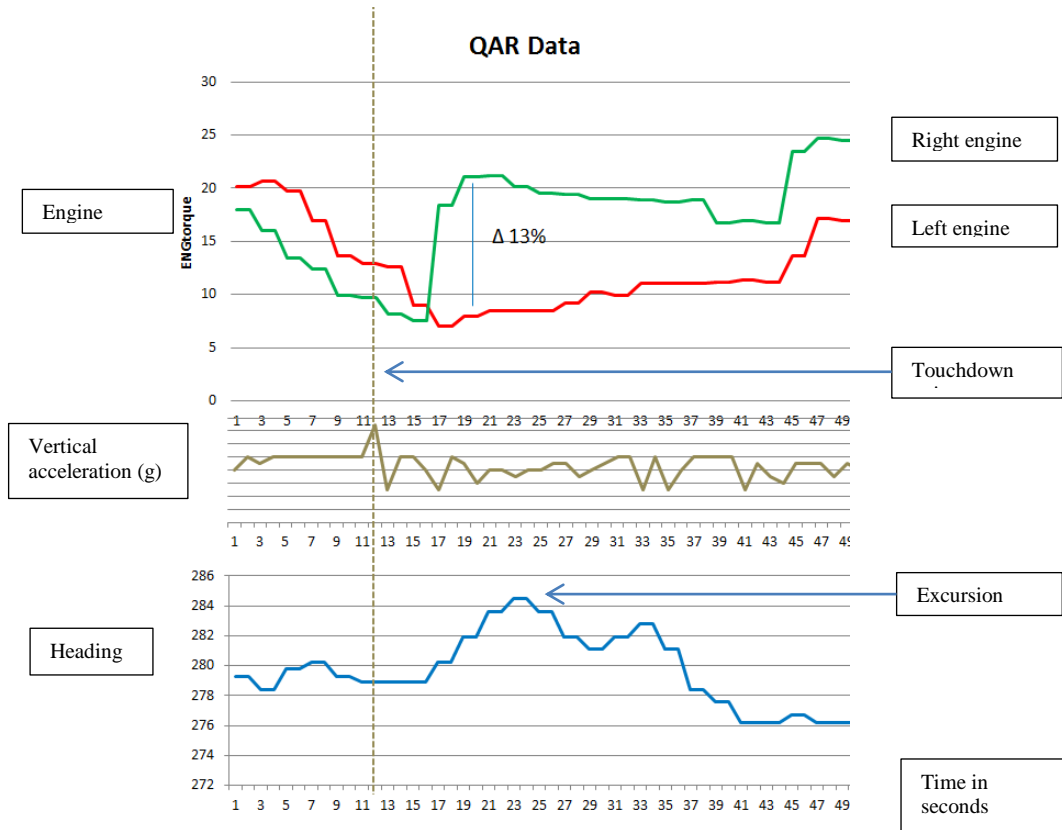
The parameters that SHK chose to look at in more detail have been compiled in the graphic in Figure 10. It can be established that reverse thrust was applied approx. 5 seconds after touchdown but that the power was asymmetrical, with the right engine producing more thrust. The difference (Δ) in engine power was 13 % at approx. 8 seconds after touchdown. At this time, a change in heading of some 5° to the right is observed, meaning the aeroplane yawed towards the right runway edge.

At the same time as the aircraft was yawing towards the right runway edge – beginning essentially at the same time the yaw began – sharp displacements of opposite rudder were recorded. Brakes, throttle position and nose-wheel steering are not in the list of recorded parameters.

Figure 10. Graphic showing certain parameters from the FDR.

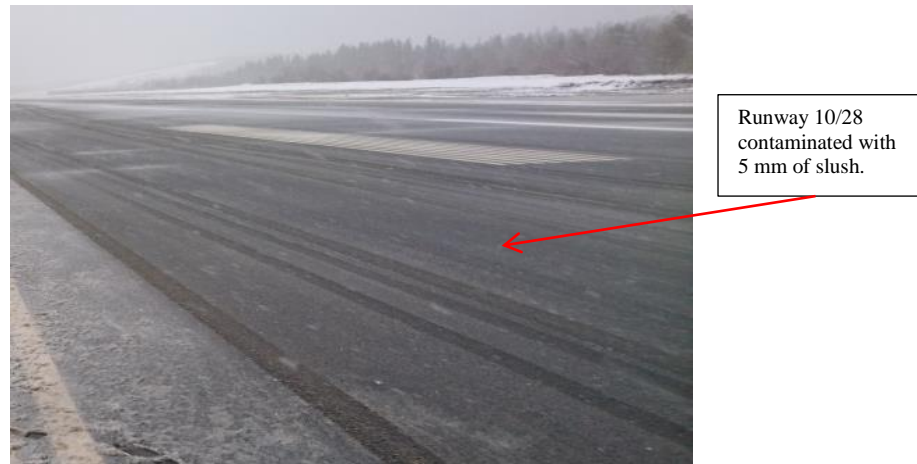
At the time of landing, the runway was covered with 5 mm of slush (see Figure 12). The performance data used at the time of the incident show that the crew had not made any corrections for the contaminated runway; they based their calculations solely on the reported friction coefficients. Contact with the operator and performance data provider has revealed that this was consistent with the data used in the operator's manuals.

Figure 12. Runway 10/28 soon after the incident. Photo: Vilhelmina Airport

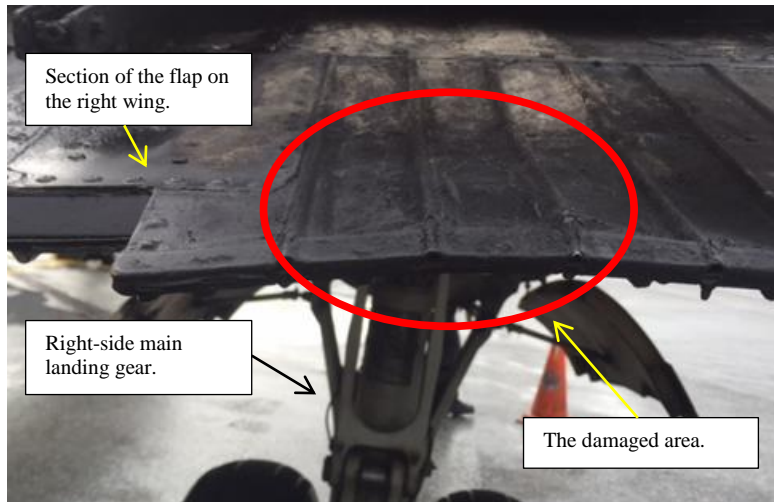
SHK considers it remarkable that the damage to the aeroplane was not identified on this occasion. The deformations were visible both on the underside and the top-side of the flap section in the area behind the right engine nacelle (see Figure 13). The cracks that had arisen in the structure of the flap were clearly visible, without the need for any methods other than a visual inspection.

Figure 13. Upper side of the right wing flap. Photo: NextJet AB.
