Final Report RS 2017:05e

ASKÖ – Grounding at Hässelby holme,
Stockholm County, Sweden, on 9 December
2016

File no. S-205/16

15 November 2017

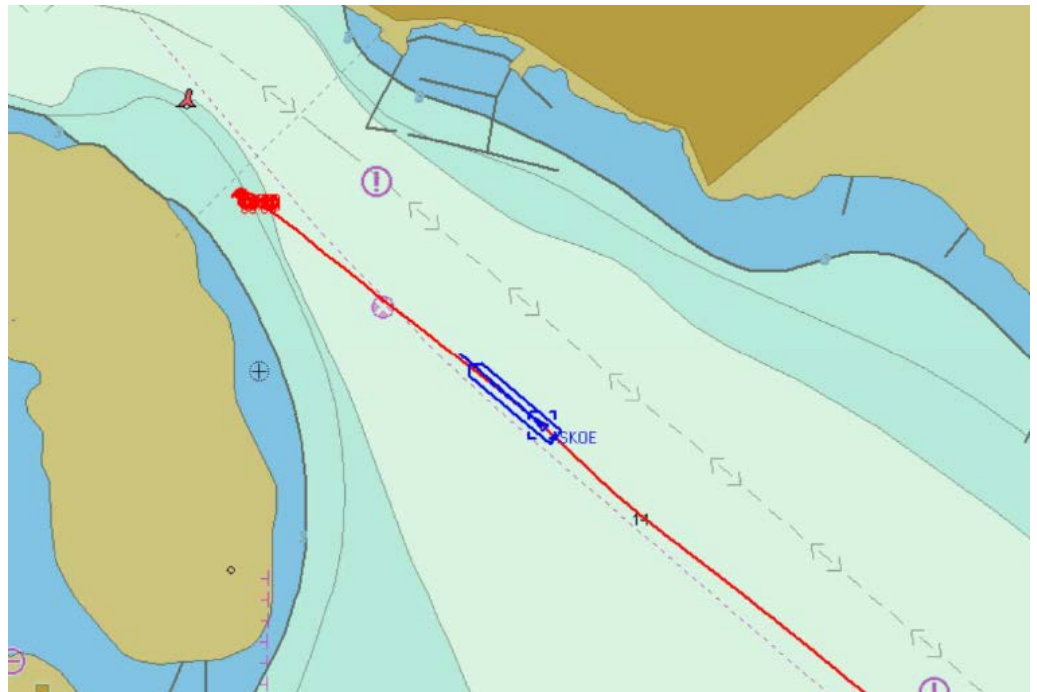
buoy. He was not able to turn, but stopped the engine before the vessel ran aground at about 04.50.

Figure 3. ASKÖ's AIS track at 04.48.

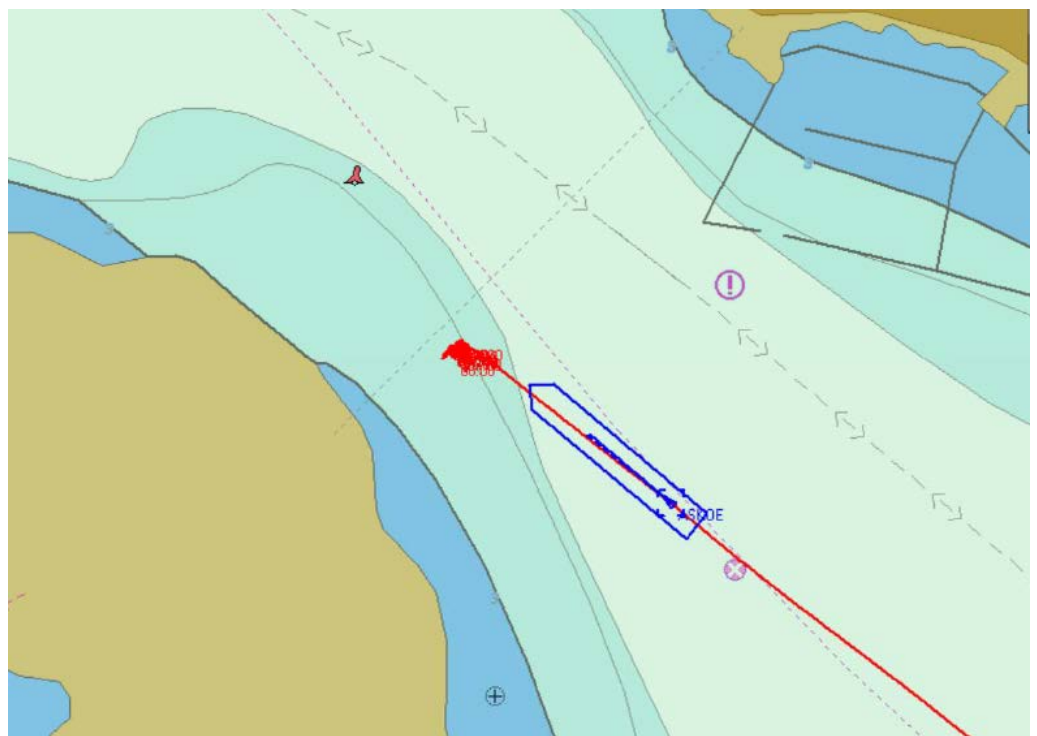
Figure 4. ASKÖ's AIS track at 04.49.

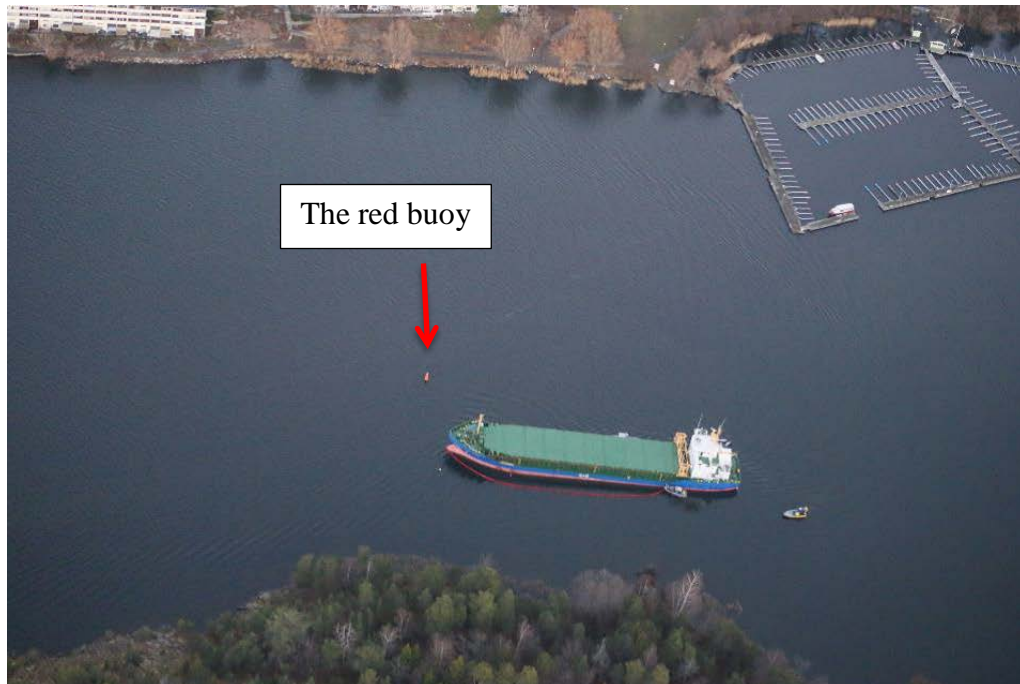
Figure 5. ASKÖ aground at Hässelby holme. Image: The Swedish Coast Guard.

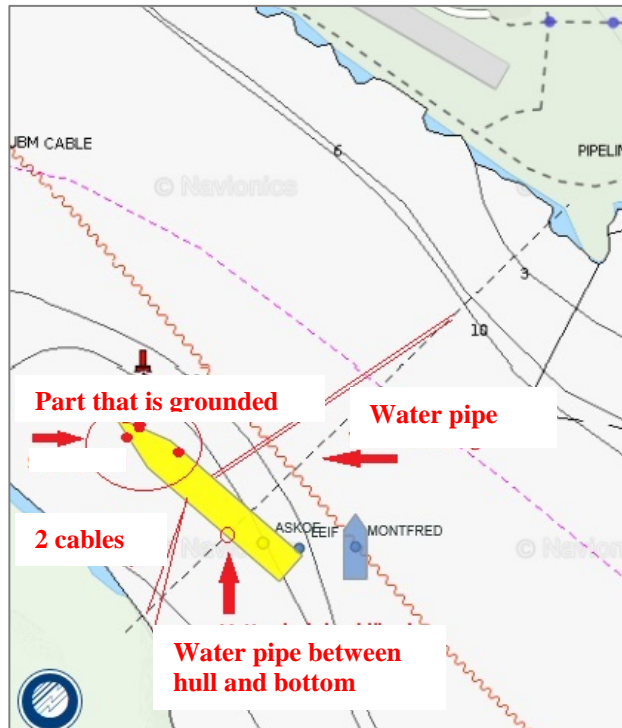
a water pipe that belonged to Stockholm Vatten⁸ (see Figure 6). More information can be found in section 1.5.

Figure 6. ASKÖ's position after the grounding. Image: The Swedish Coast Guard.

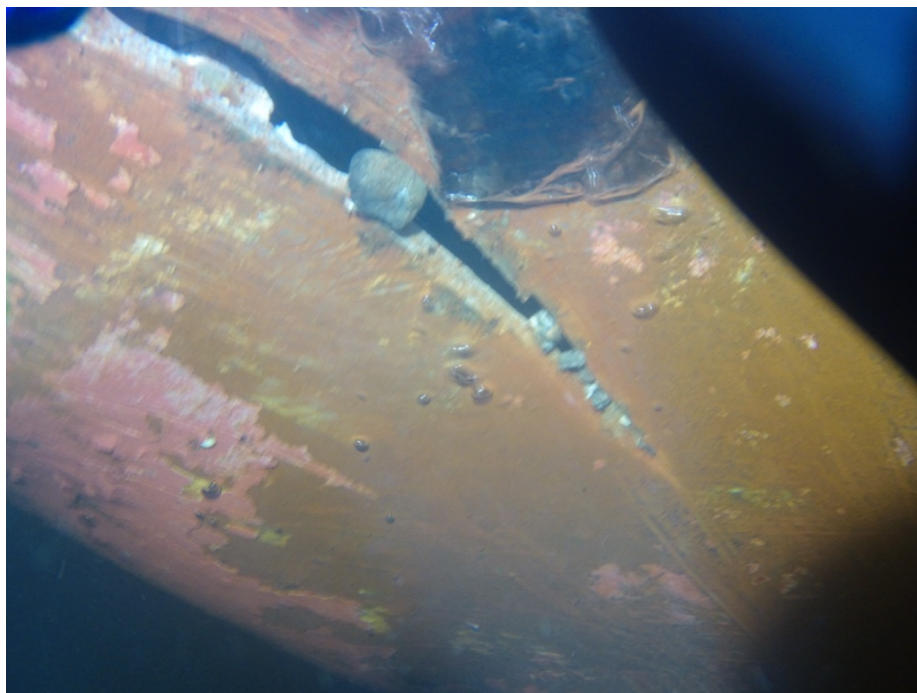
- Forepeak between frames 121 and 113: several large indentations and holes.
- Bow thruster room from frames 113 to 110: cracks and holes.
- Deep tank from frames 110 to 104: several large indentations and holes.
- Double bottom 1 port from frames 104 to 88: several large indentations and holes.
- Double bottom 1 starboard from frames 104 to 88: several large indentations and holes.
- Double bottom 2 port from frames 88 to 70: several large indentations and holes.

Figure 7. Dive image from examination of the underside of ASKÖ. Image: Hartmann Reederei.

Hull damage had to be repaired and a total of 19 tonnes of steel had to be replaced while at the yard in Poland between 14 December 2016 and 9 January 2017.

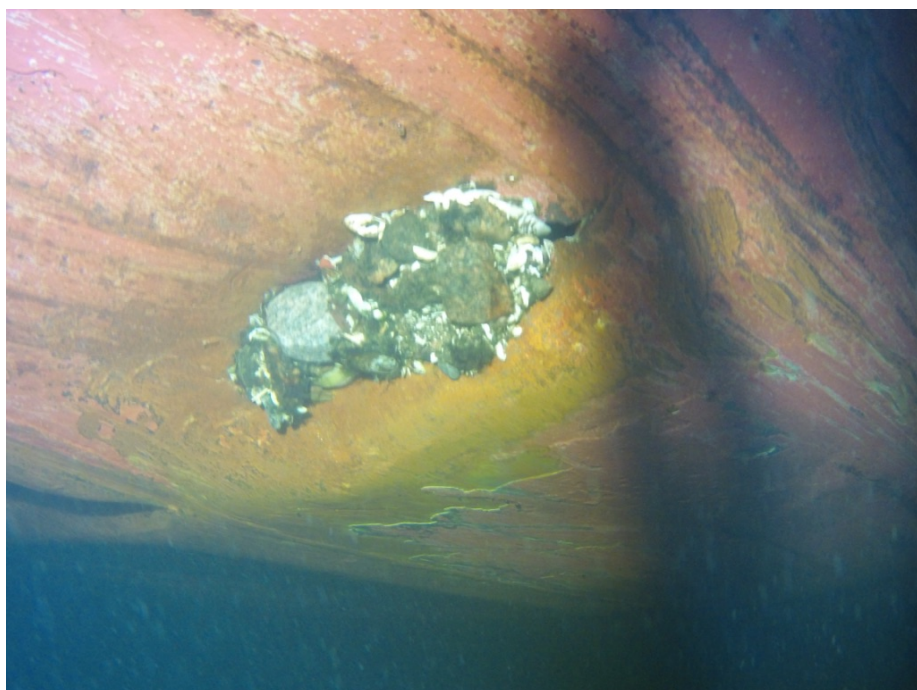
Figure 8. Dive image from examination of the underside of ASKÖ. Image: Hartmann Reederei.

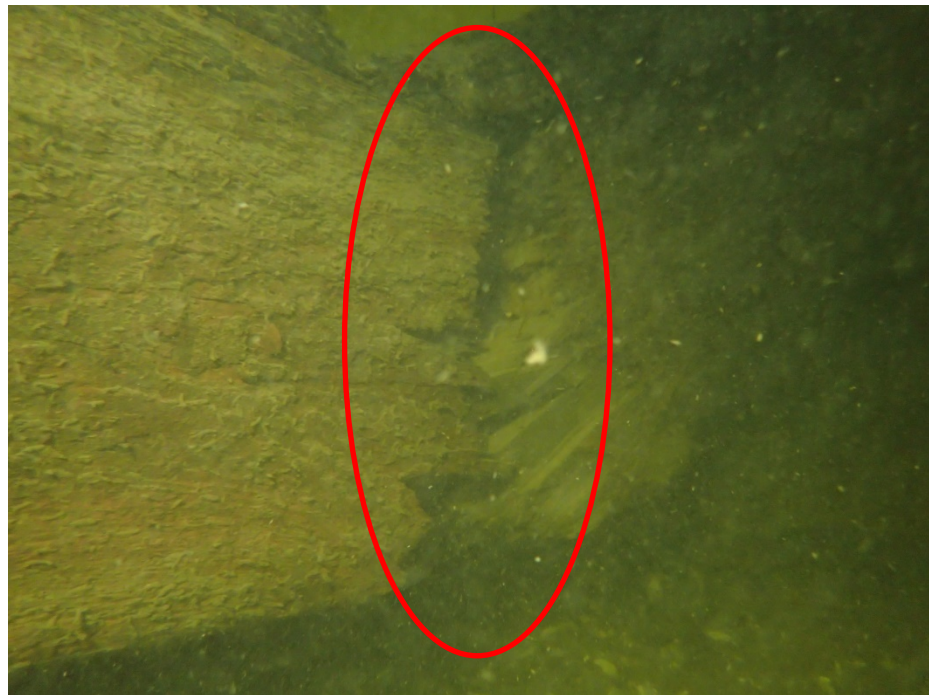
The grounding caused damage to a number of crossbars in the supporting structure (see Figure 10). Three of the wooden beams on which the water pipe was resting were split when the pipe “sprang down” due to the weight of the vessel. According to a dive inspection conducted subsequently by Stockholm Vatten, the water pipe has then sprung back up and become partly free hanging in the water. Some superficial damage also occurred to the water pipe itself and to its protective insulation (see Figure 11).

Figure 10. One of the three broken crossbars in the supporting structure. Image: Stockholm Vatten.

Once Stockholm Vatten had conducted its own dive inspections, it was possible to establish that the pipe itself was intact, but that the pipe's insulation and parts of its supporting structure had been damaged and needed to be repaired. The assessment from Stockholm Vatten was that it was pure luck that the water pipe was not damaged more extensively, which could have resulted in major consequences for the water supply in large parts of the capital city area.

Stockholm Vatten will need to carry out repairs to both the water pipe and the supporting structure. As these repairs require some extensive underwater work in the form of pile driving, a decision and approval from the county administrative board is required according to Stockholm Vatten before the repairs can begin.

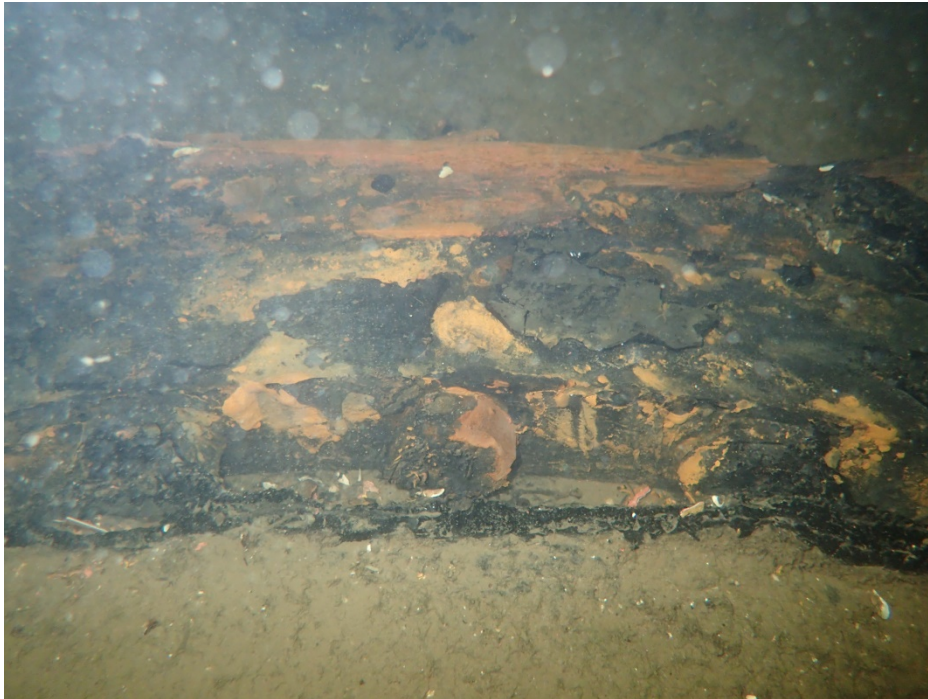
Figure 11. The water pipe's bolted flange at a joint and surrounding crush damage in the pipe. Image: Stockholm Vatten.

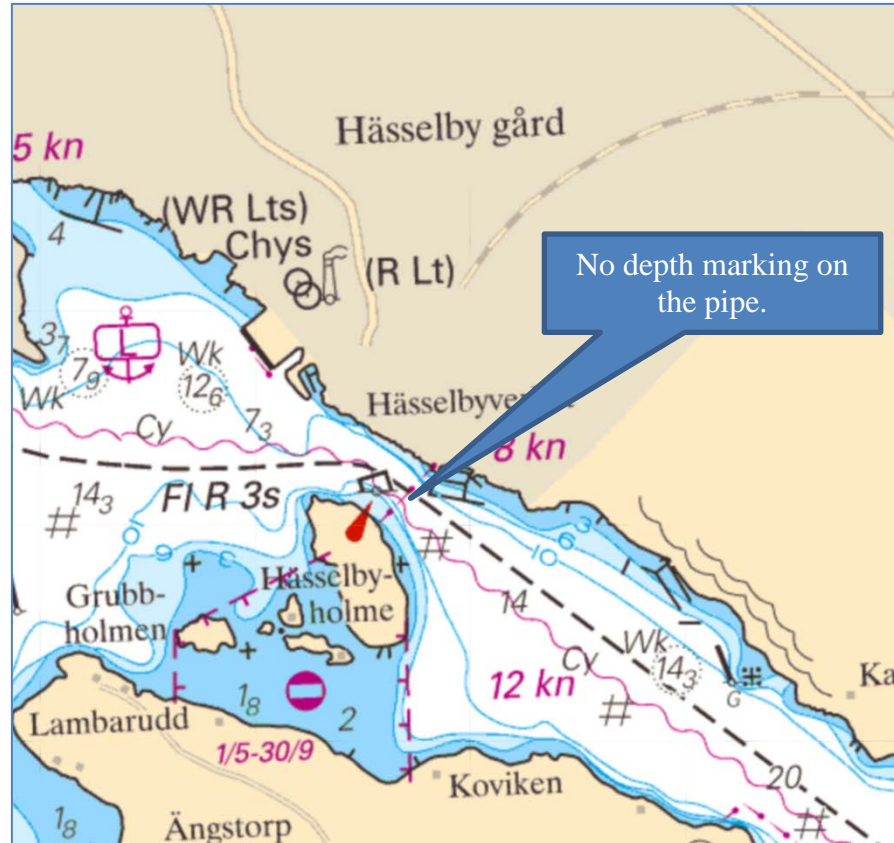
According to the Maritime Administration's chart services, the water pipe in question was marked on applicable charts; however, there was no information about the depth of the pipe (approximately 6.5 metres) (see Figure 12). The solid blue lines on the chart along each shore in the fairway represent a depth contour of 10 metres. Accordingly, the chart indicates that the fairway in question has a water depth to the lake-bed of at least ten metres.

Figure 12. Hässelby holme and the marking of the water pipe. Image: The Swedish Maritime Administration's no. 10-01518 chart services.

As a result of ASKÖ's grounding and following dialogue with Stockholm Vatten concerning the deficient marking of the water pipe on the charts in question, the Maritime Administration requested raw data from the hydrographic survey in 2012. At the analysis of the raw material, one could find a trace of the current water pipeline. The Maritime Administration has therefore adjusted the charts with correct depth information for the fairway.

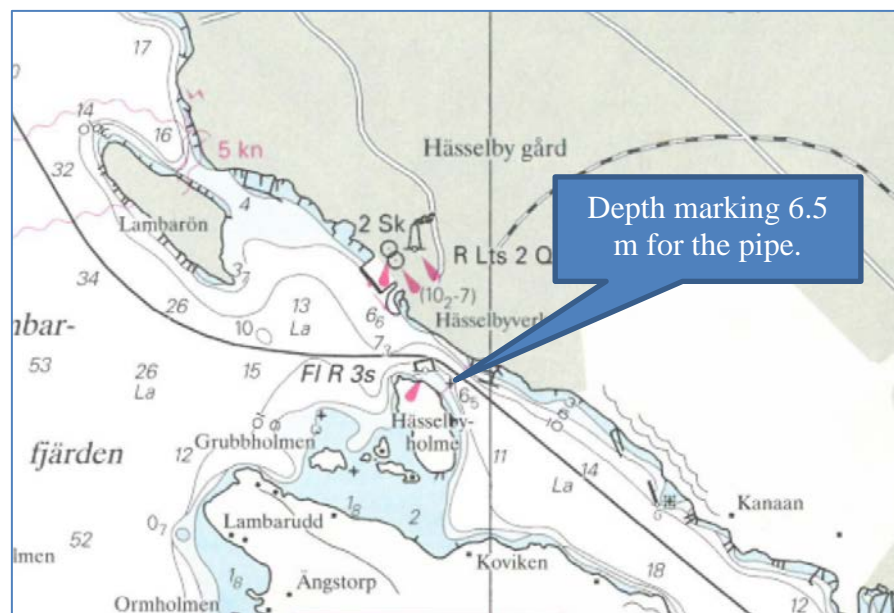
The water pipe was also marked on older charts (1994). However, there it was stated that the water pipe was at a depth of 6.5 metres (see Figure 13).

Figure 13. Hässelby holme with marking of the water pipe and a depth indication of 6.5 metres. Image: The Swedish Maritime Administration's chart from 1994. The Swedish Maritime Administration no. 10-01518 chart services.

According to the Maritime Administration, the depth of the water pipe was reported on the chart for this area for the first time in 1954. Following a hydrographic survey in 1988, the chart was given a marking in the form of a submerged rock with a depth indication of 6.5 metres. A further hydrographic survey of the area, commissioned by the Swedish Transport Administration, was conducted in 2012. No water pipe was reported in the data from this survey that was supplied to the Maritime Administration. Consequently, the Maritime Administration chose to remove the depth indication of 6.5 metres, but let the mark of the pipe remain

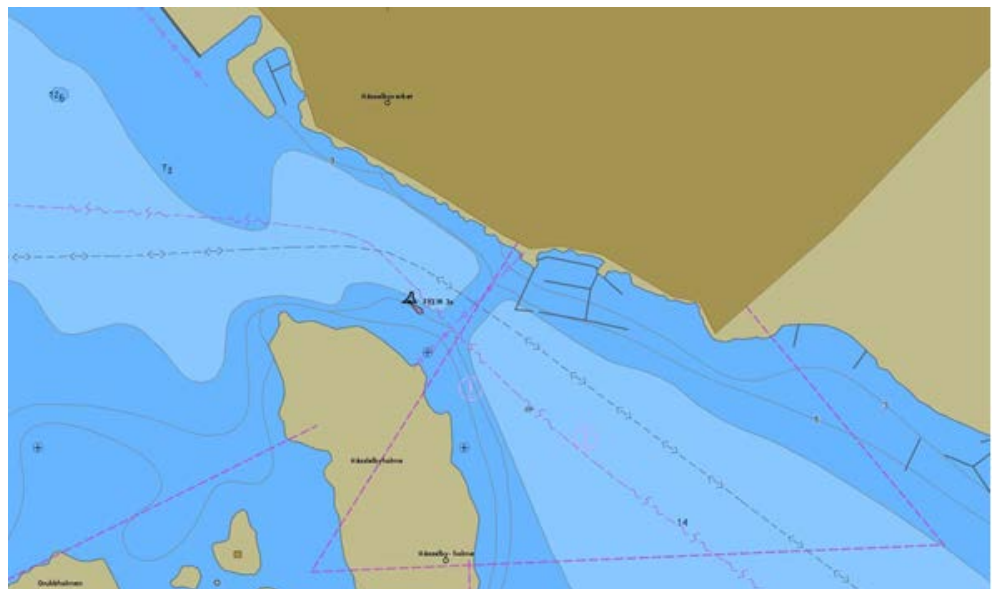
Figure 18. New chart image. Image: The Swedish Maritime Administration.

In order to clarify that the depth of the current location at the water-pipe is less than 10 meters, the Maritime Administration has adjusted the chart by adjusting the depth curves to a depth of 6 to 10 meters (see Figure 18). In addition, the Swedish Maritime Administration has updated valid procedures with additional checks and identification of objects for incoming externally hydrographic surveys. At the Maritime Administration's own hydrographic surveys it is already a routine to always carry out the identification of objects as described in the chart. In addition, the Swedish Maritime Administration has been given the task of Stockholm Vatten and Avlopp to thoroughly hydrographic survey this and all other water pipelines with the same construction in their possession. This will ensure correct depth in the Swedish Maritime Administration's databases and products.
