Final report RL 2020:06e

Accident at Vuoggatjålme, Norrbotten County, on 10 August 2019 involving the helicopter SE-JOA of the model Bell 206L-1, operated by Arctic Air AB.

File no. L-110/19

16 June 2020

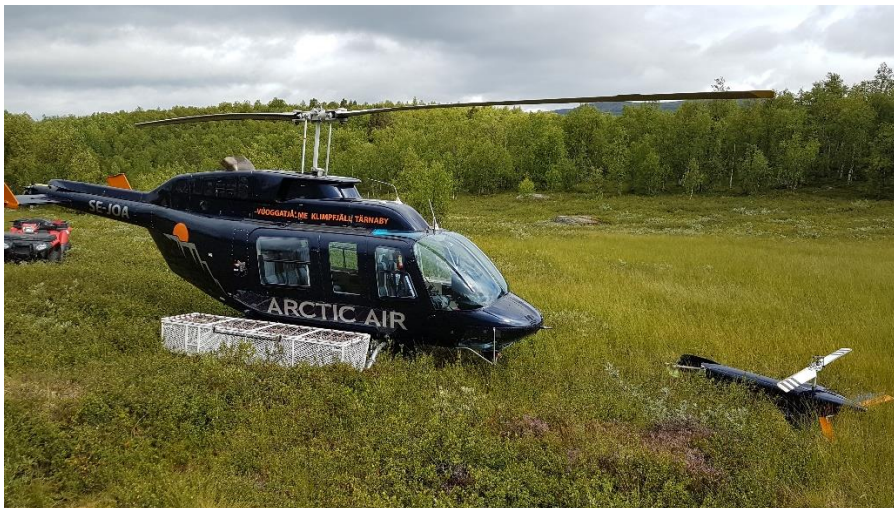
Figure 8. The site of the emergency landing, with the cut-off tail boom in front of the helicopter. Photo. The pilot.

The damage sustained on the helicopter was slightly limited. Following the occurrence, the helicopter was standing on its skids and a part of the tail boom with the tail rotor was lying a little way in front of the helicopter. There were indications that contact had been made with the mire on the mirror and the pitot tube that are mounted at the front of the nose. The main rotor blades had clear signs of having been in contact with the tail boom.

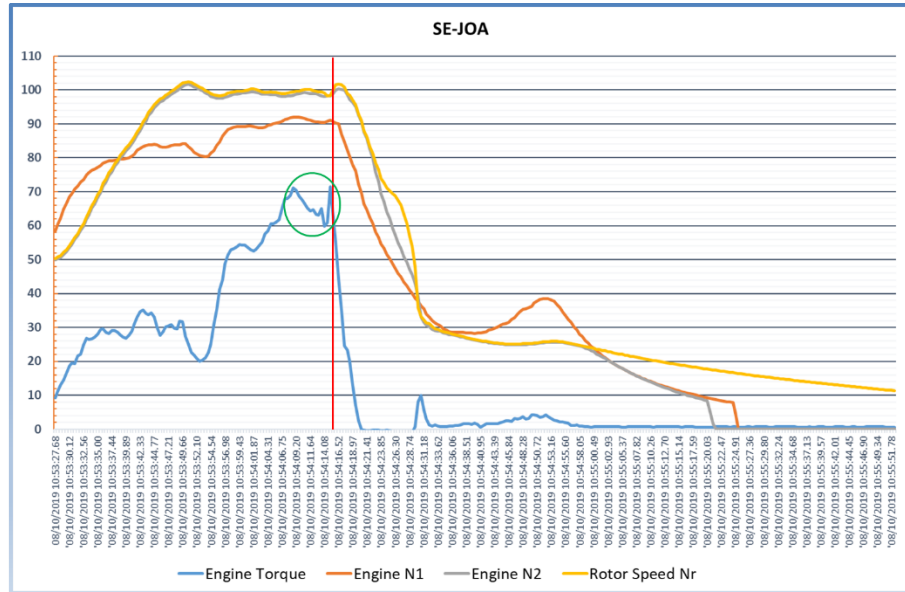
In the seconds preceding the loss of power, the engine data show that the engine torque (TRQ) has been at 71 % before dropping to around 60 %, only to then return to 71 % once more. The final increase from 60 % to 71 % occurs in a second (see Figure 9).

A sharp drop in the parameters gas generator rpm (N1), free turbine rpm (N2), the engine torque (TRQ), the turbine outlet temperature (TOT) and the main rotor rpm could be seen in the first second after the start of the loss of power. The engine torque was the parameter that dropped the fastest, followed by the turbine outlet temperature (see Figure 9). The caution that was activated first was low main rotor rpm (NR) because the rpm fell below 90 %, which occurred around 12 seconds after the first engine problems.

Figure 9. The engine data in the memory unit. The red line indicates the moment power was lost. The green circle marks the time of the fluctuations in the engine’s torque, just before the loss of power.

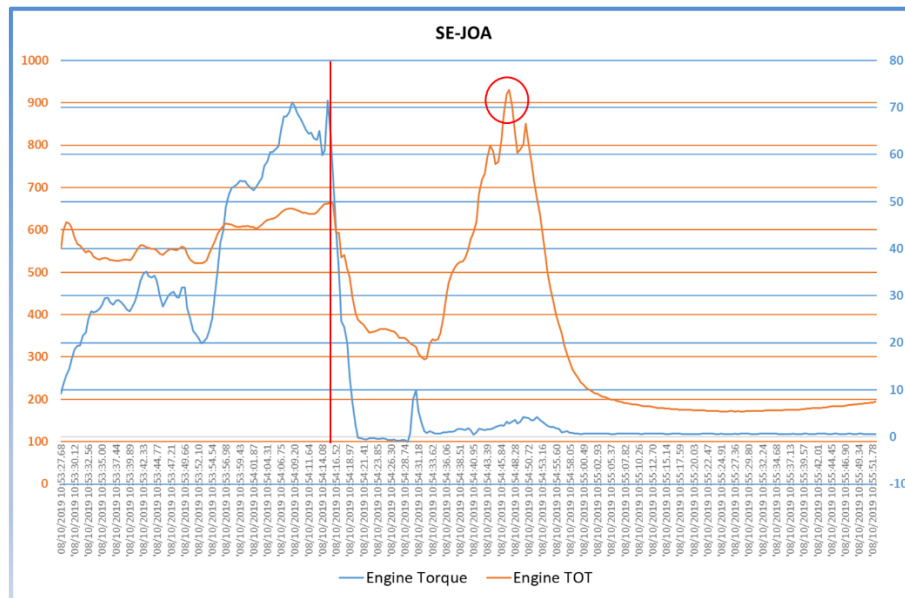
Around seventeen seconds after the start of the loss of power, a distinct increase in turbine outlet temperature is seen, with a peak value of 929 degrees Celsius, before then falling again (see Figure 10). The engine’s gas generator rpm (N1) also increases somewhat over the same period.

Figure 10. The engine data in the memory unit. The red line indicates the moment power was lost. The red circle marks the temperature peak in the turbine outlet temperature TOT.
