Final report RL 2019:03e

Accident at Falköping Airport on 26 July 2018 involving glider D-4033 of the model SZD-9 bis 1 E Bocian, operated by a private individual.

File no. L-92/18

13/02/2019

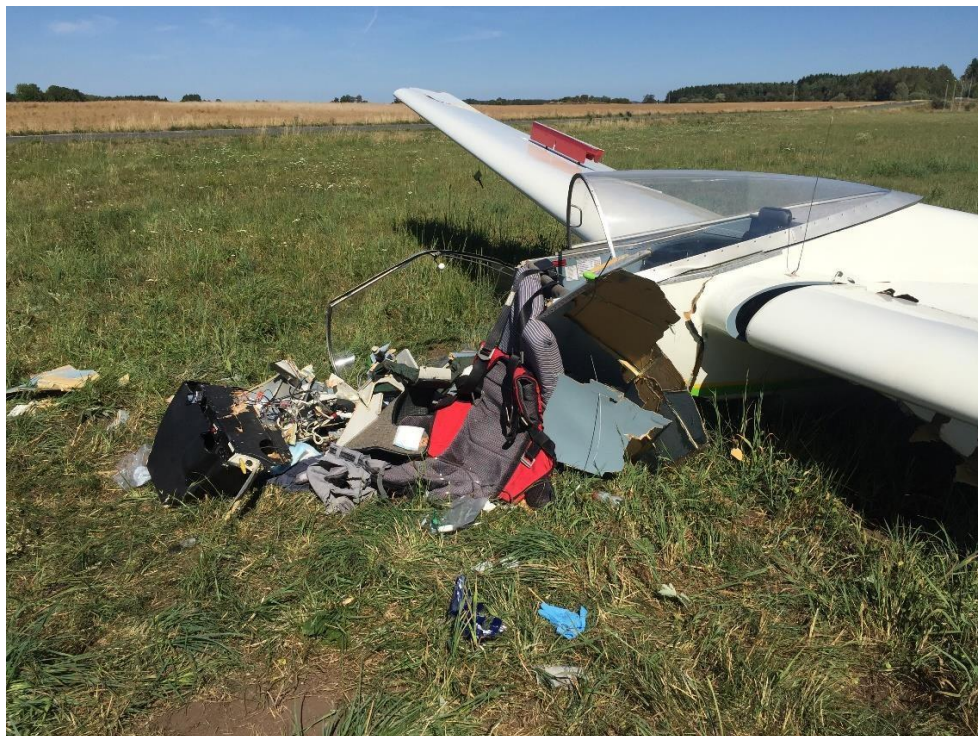
Across the normal point of touchdown, the altitude was 50 metres. A turn onto the base leg was initiated at 40 metres altitude, after which the glider rapidly lost altitude and hit the ground (see figure 1).

Two witnesses, both experienced glider pilot instructors, have stated that the nose was raised just as the aircraft entered the turn onto the base leg and that the aircraft then went into a spin⁵.

Figure 1. The front cockpit was severely demolished upon impact. Photo: Henrik Svensson.

The aircraft model was constructed in the 1950s and is made from pinewood and birch veneer. When the aircraft was built, there were no set requirements on crashworthiness. The cockpit is comprised of thin plywood, which gives no suitable protection for the pilots in the event of an accident.
