The Islamic Republic of Iran
Civil Aviation Organization
Aircraft Accident Investigation Board

Preliminary Report #2

Issue date: January 21, 2020

State File Number: A981018URPSR
Type of Occurrence: Accident
Date of Occurrence: Jan. 08. 2020
Place of Occurrence: Near Imam Khomeini INTL Airport/ the I.R of Iran
Aircraft Model: B737-800
Registration: UR-PSR

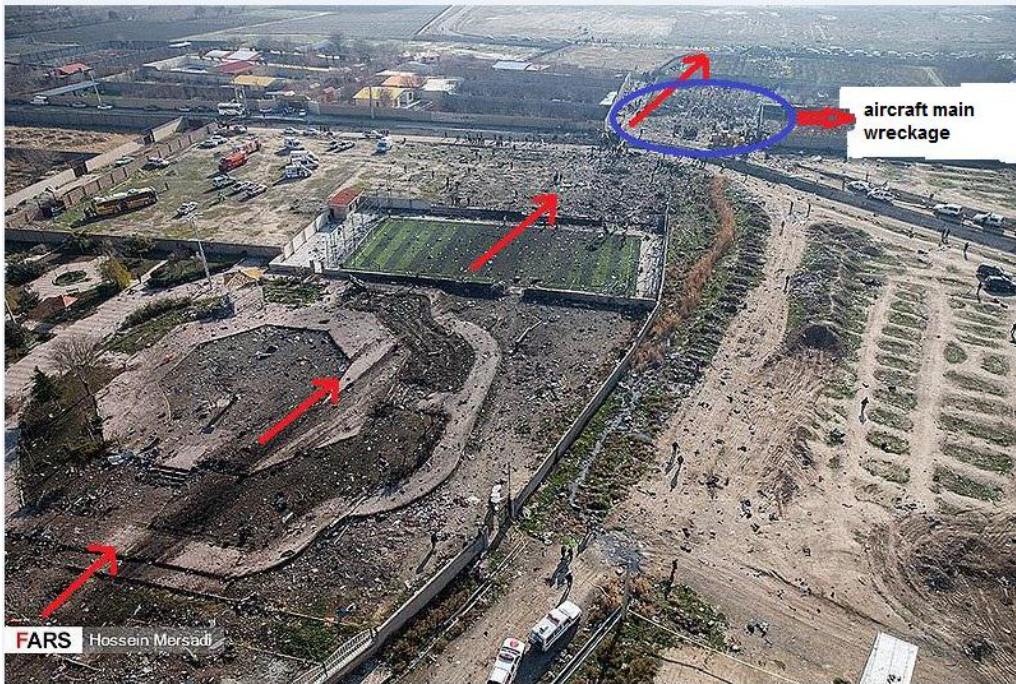
The aircraft lost her altitude and passed by a residential area; ultimately, the aircraft's initial impact point was with a barrier in a recreational park. The aircraft fuselage, subsequently, impacted the ground, disintegrating completely after passing a football pitch, which in turn damaged the surrounding agricultural farms and gardens. Following the initial impact, other impacts were observed along the track at the accident site, wrecking the fuselage and spreading across the entire track.
