Final report RJ 2022:02e

**Derailment involving a freight train
between Kummelby and Häggvik,
Stockholm County, on 11 February
2021**

File no. J-05/21

2022-06-02

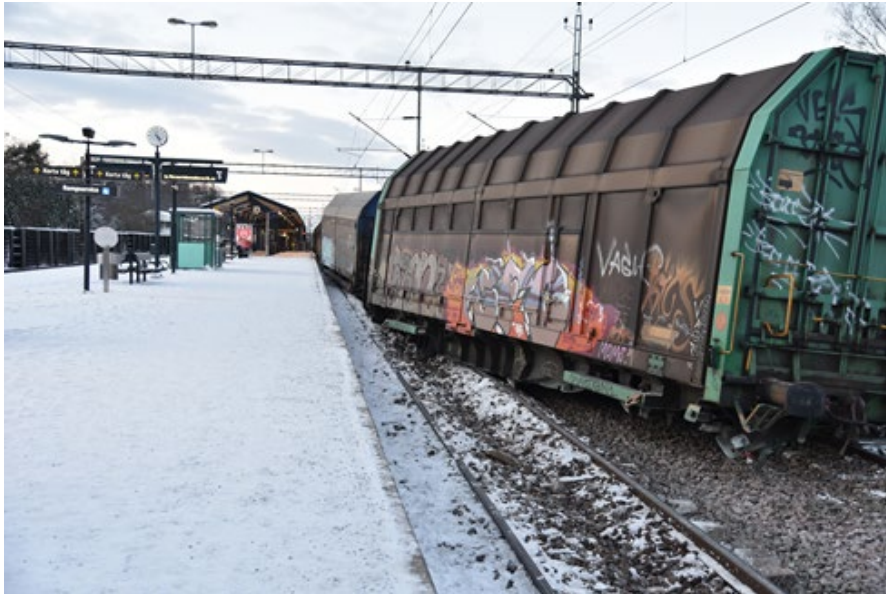
Figure 3. The train stationary following the derailment at Häggvik commuter station with the last wagon shifted sideways.

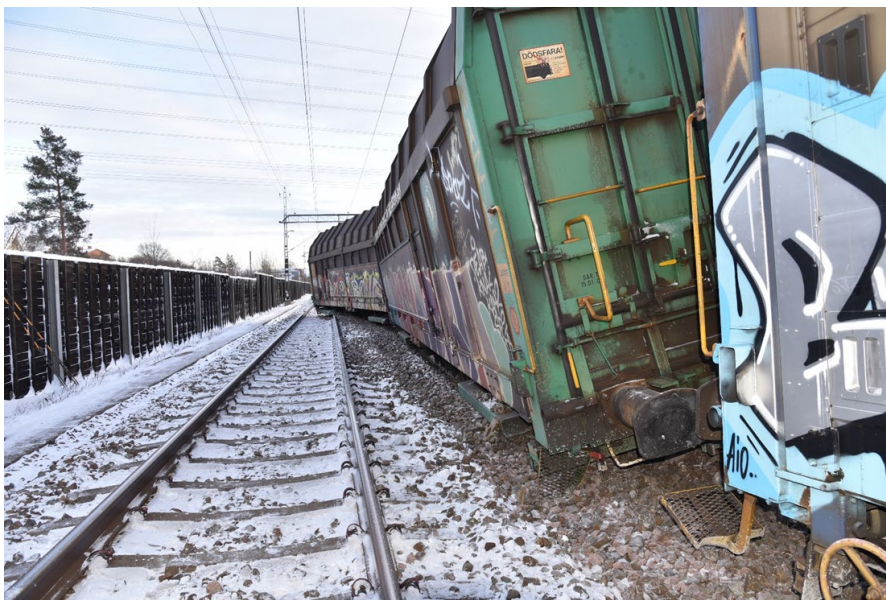
Figure 4. The last wagon came to a stop shifted sideways, with the rear portion in the adjacent track. The photographer is standing with their back facing in the train's direction of travel.

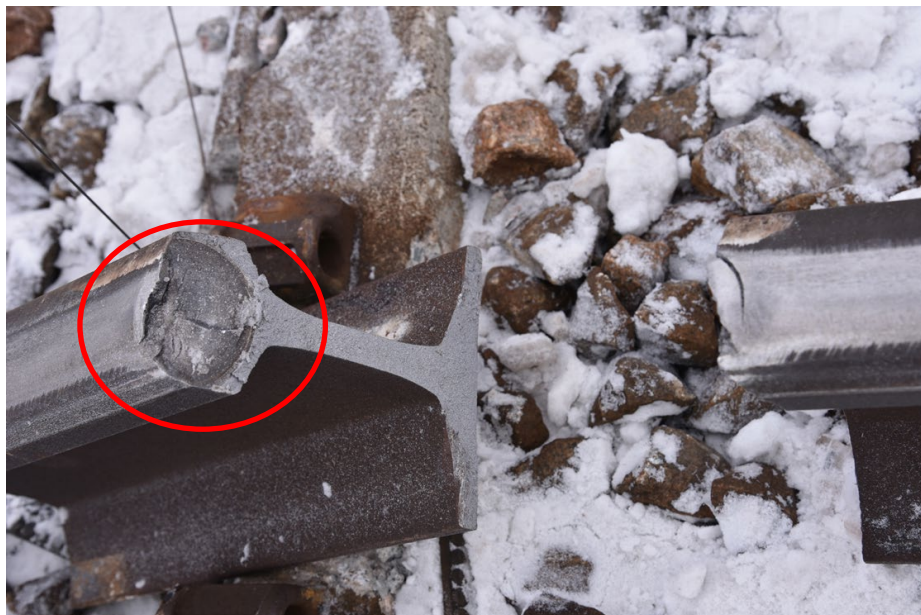
SHK identified signs of preceding crack formation in the majority of the rail head at the fracture surface that comes first in the direction of travel (see Figure 6).

Figure 6. Signs of preceding crack formation in the rail head at the fracture surface that comes first in the direction of travel.

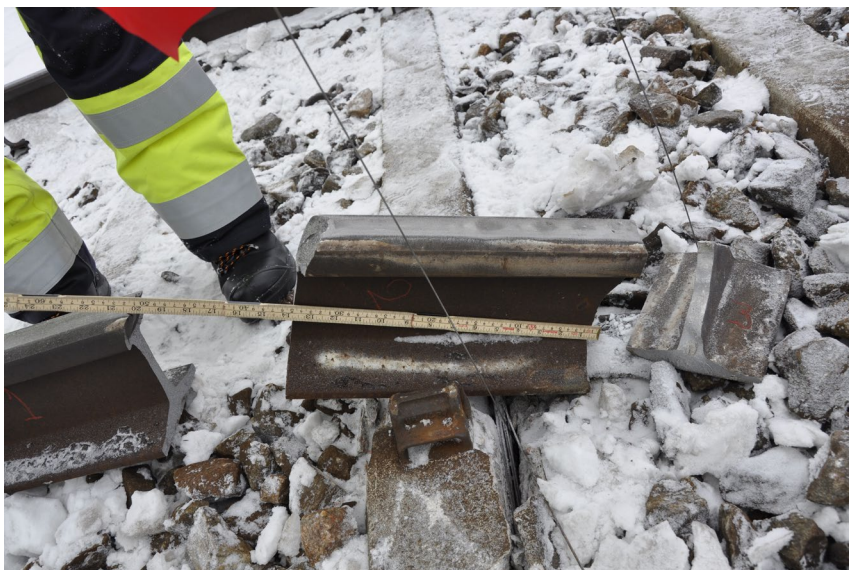
Figure 7. White spray paint on one of the pieces of broken rail.

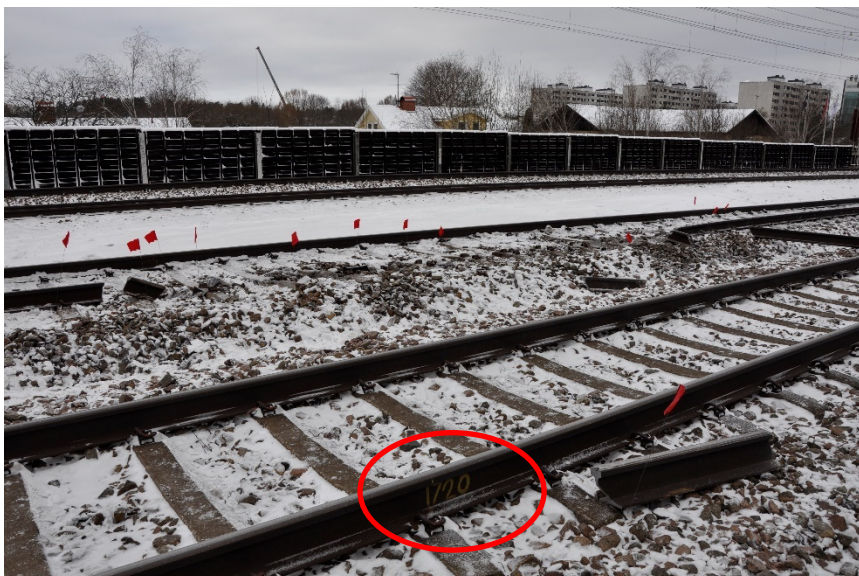
Figure 8. Adjacent rail marked with 720 in yellow paint. Corresponding marking was also found on one of the broken pieces of rail (see Figure 16).

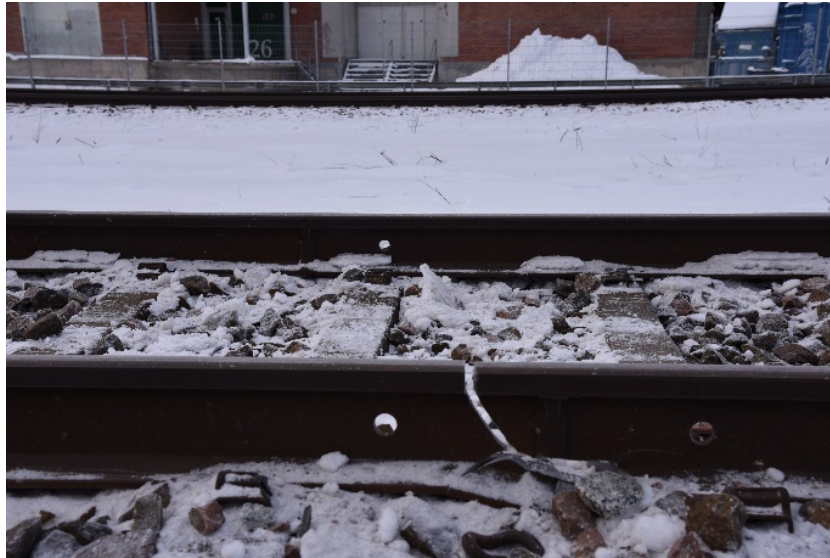
Figure 9. Smaller break in the rail between the large break and Häggvik.

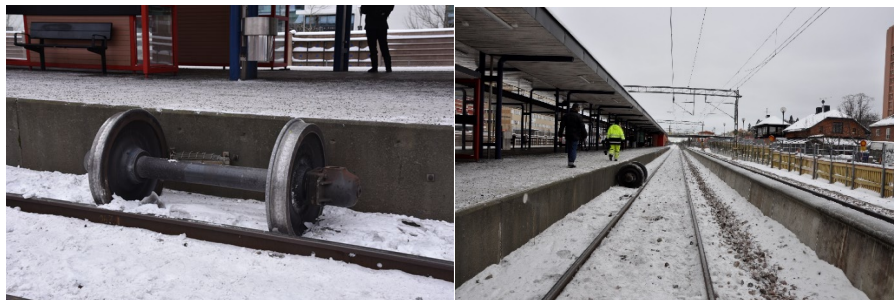
Figure 10. The final axle from the last freight wagon was found lying alongside the edge of the platform at Sollentuna commuter station, 600 metres after the broken rail.

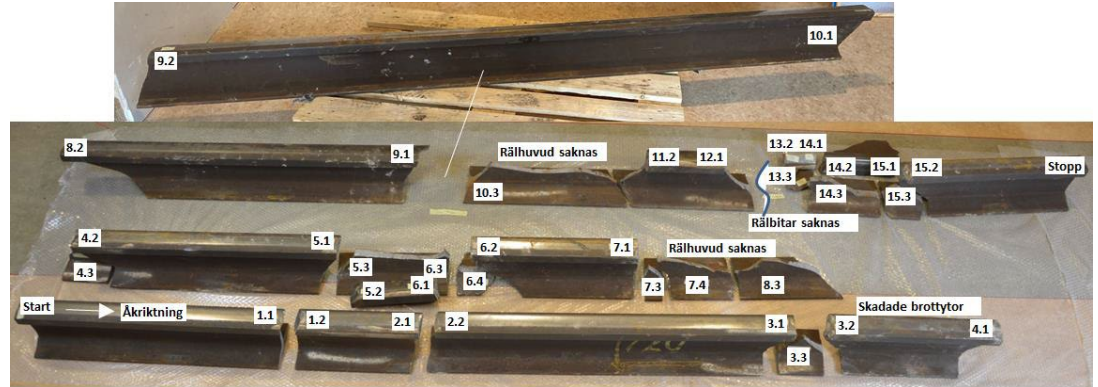
The 9 m rail has fractured in to several pieces (see figure 16). The fractured rail pieces do not show any global deformation. The fractured rail pieces show no or very little local deformation in the vicinity of the fracture surfaces. A small amount of the fractured rail is missing. The numbers 720 in yellow paint was identified on one of the rail pieces. White spray paint was identified on several of the pieces. The visual examination shows no welded joints or areas with repair welds on the rail pieces.

Figure 16. Sequential lineup of the fractured rail pieces. The fracture surfaces are numbered.

Three more fracture surfaces shows distinct but smaller vertical fatigue cracks, 5.1, 10.1 and 11.2 in Figure 16. All the four fracture surfaces with fatigue cracks are positioned in between two sleepers.

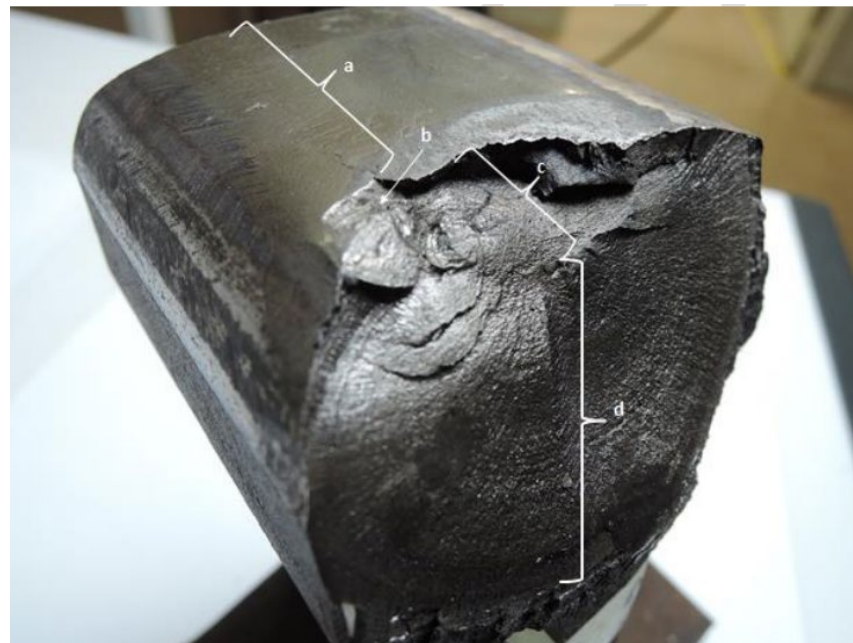
The first fracture, in relation to the direction of the freight train, is numbered 1.1/1.2 in Figure 16 and shows a fracture surface with an elliptical crack that has propagated vertically through almost the entire rail head. The visual examination shows that the vertical crack has its initiation at a crack, parallel to the rail head surface, a few millimeters below the surface. The parallel crack is actually a number of parallel cracks in different levels below the surface that originate from surface fatigue cracks.

Figure 17. Fracture surface 1.2 showing the surface fatigue cracks (a), spalling (b), parallel crack (c) and vertical crack (d).

Fracture 1.1/1.2 (see Figure 16 och 17) is the primary fracture and the reason for the following failure of the rail. At the crack surface a number of parallel cracks has initiated the vertical crack that caused the first overload fracture. The critical crack length is 44 mm.

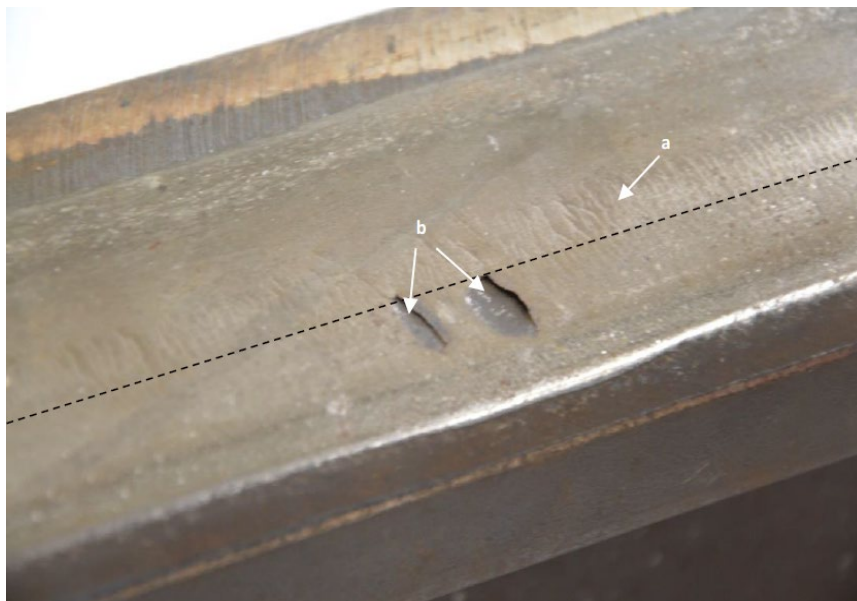
The running surface on all examined rail pieces shows clear signs of surface fatigue. See example in Figure 18 where surface cracks have propagated parallel to the next surface crack resulting in spalling.

Figure 18. The running surface shows surface fatigue cracks (a) spalling (b) resulting from rolling contact fatigue. The position is located between fracture surface 11.2 and 12.1. The dashed line shows the position of the axial rail cut.

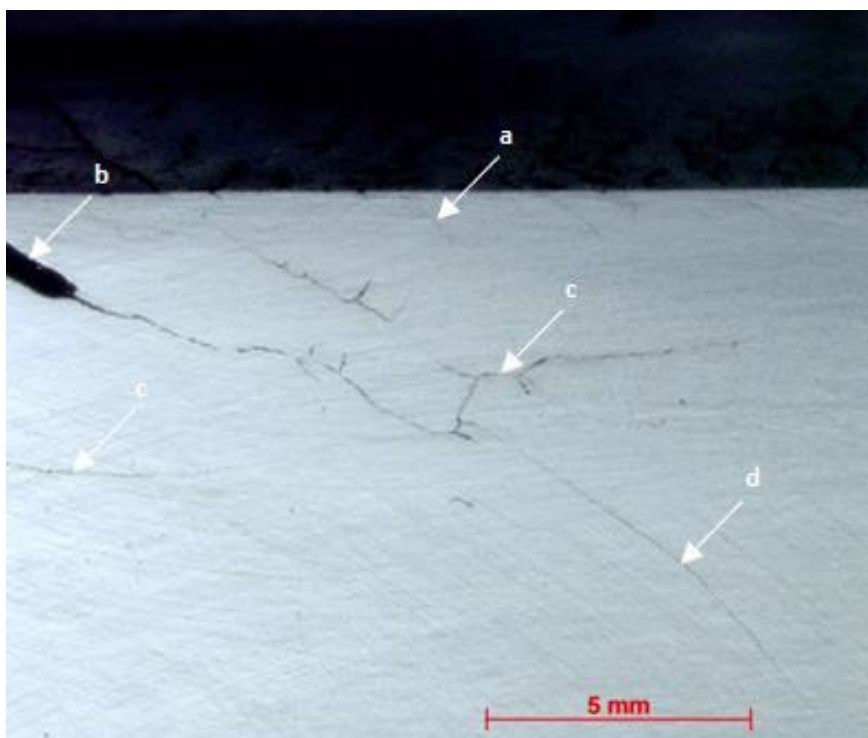
Figure 19 shows an axial cut along the rail head, between fracture surface 11.2 and 12.1, with surface fatigue cracks, spalls, parallel cracks and an early stage of a vertical crack.

Figure 19. The image shows an axial cut along the rail head, between fracture surface 11.2 and 12.1, with surface fatigue cracks (a), spalls (b), parallel cracks (c) and an early stage of a vertical crack (d).

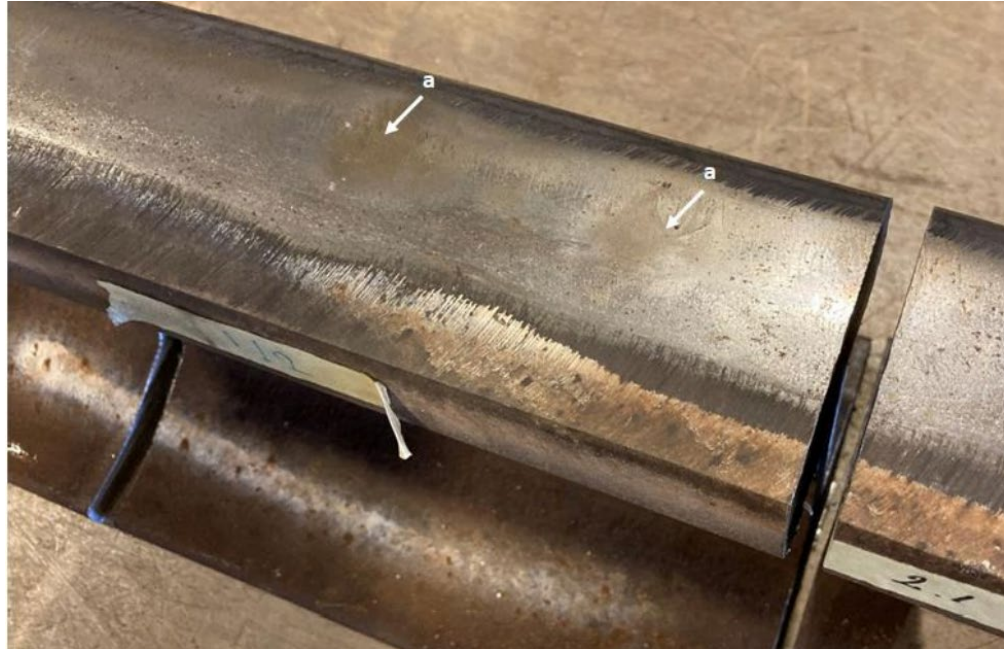
Figure 20 shows dark spots on the running surface which indicate that parallel cracks have propagated below the surface. The dark spots are visible with some regularity but not on all rail running surfaces. There is no notable depression in the surface which would indicate friction or impact damage.

Figure 20. The running surface shows dark spots with surface cracking (a).

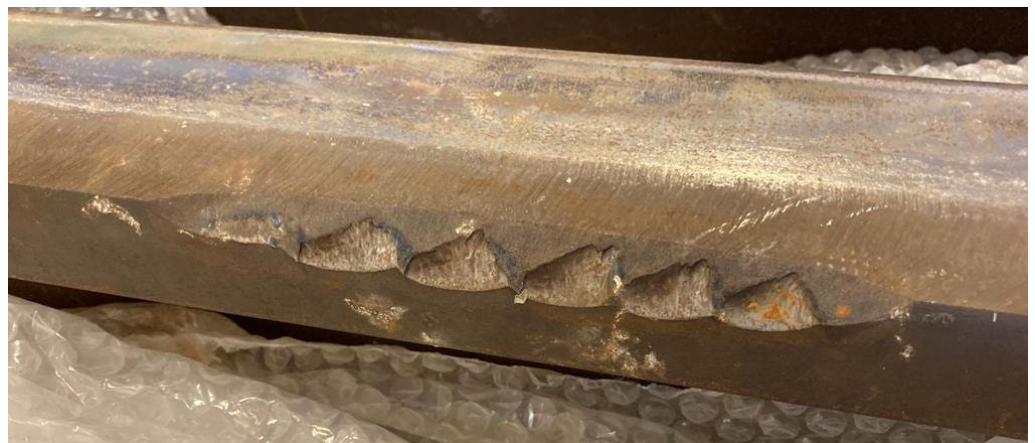
Figure 21 shows distinct mechanical damage on the edge of the running surface between crack surface 8.2 and 9.1. Further mechanical damage can be seen on the running surface between fracture surface 4.2 and 5.1 with axial and slightly angled indents

Figure 21. Mechanical damage between fracture surface 8.2 and 9.1.

The mechanical damage that is visible on the running surface is assessed not to have affected the rail break.

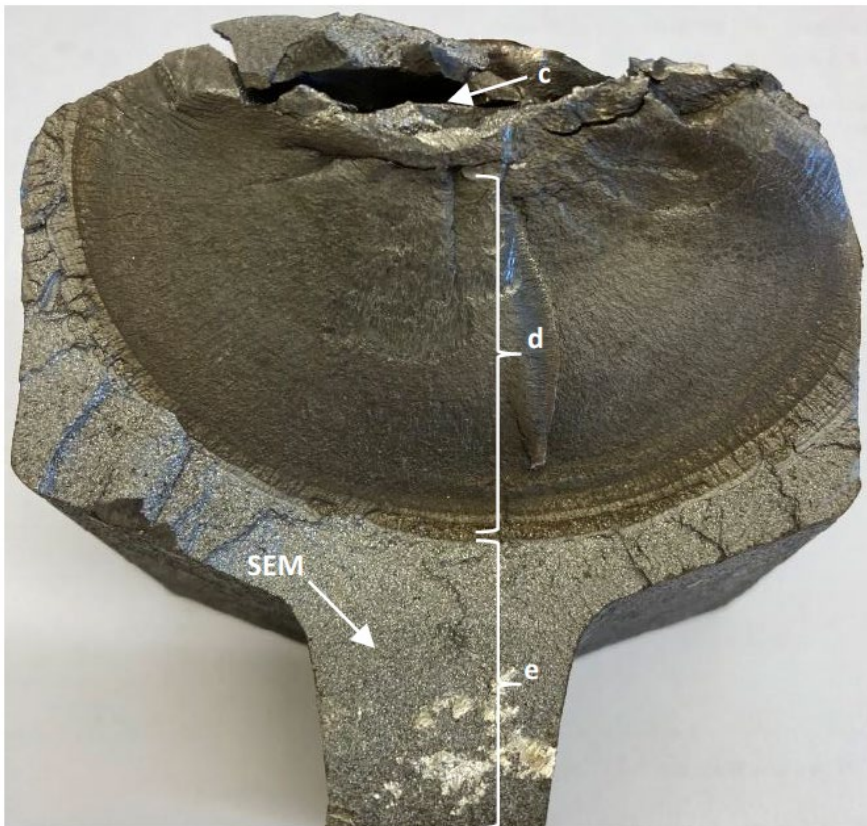
Figure 22 shows the fracture surface 1.1 where the vertical crack has almost propagated through the entire rail head.

Figure 22. Fracture surface 1.1 with parallel crack (c), vertical crack (d) and overload zone (e) and the area investigated with scanning electron microscope (SEM).

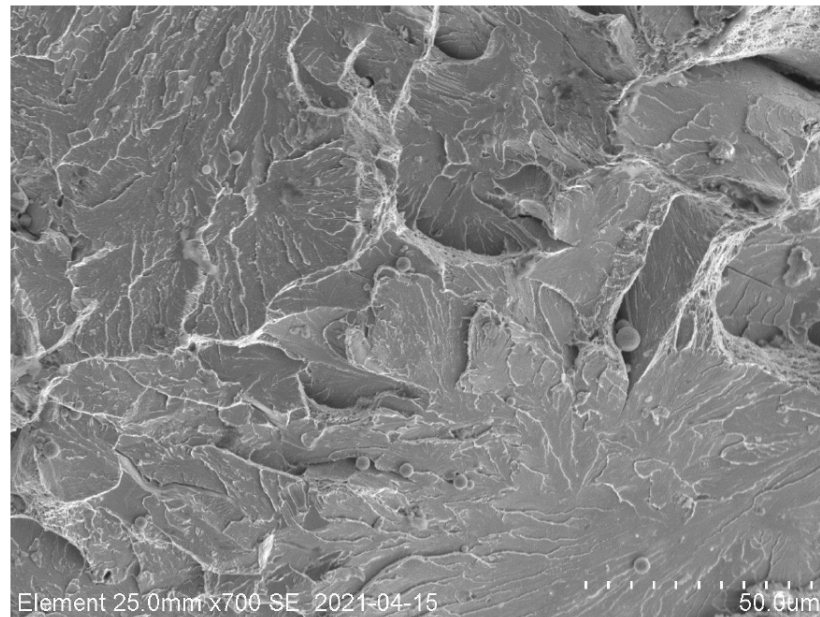
Figure 14 shows the overload zone using a scanning electron microscope at 700x magnification. The overload zone shows a distinct brittle fracture character with transcrystalline cleavage fracture and river pattern.

Figure 23. The fracture surface examined with a scanning electron microscope at 700x magnification. The overload zone shows a distinct brittle fracture character.

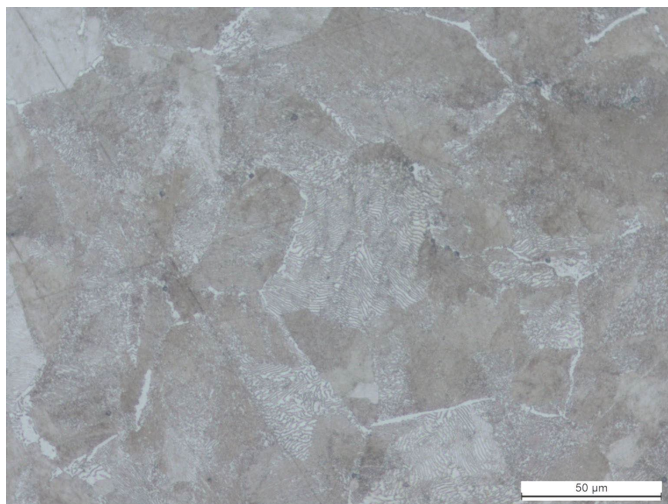
A microstructural examination was performed on a polished and etched micro sample that was extracted close to the fracture surface 1.1. The examination shows a microstructure with relatively small grains, pearlite structure and ferrite in the grain boundaries, see Figure 24. The overall grain size is relatively small whit the grains in the core slightly larger than the grains close to the surface. The grains close to the running surface have a deformed elongated shape which indicates plastic deformation due to contact with the train wheel.

Figure 24. The rail head microstructure, below the running surface, at 500x magnification.

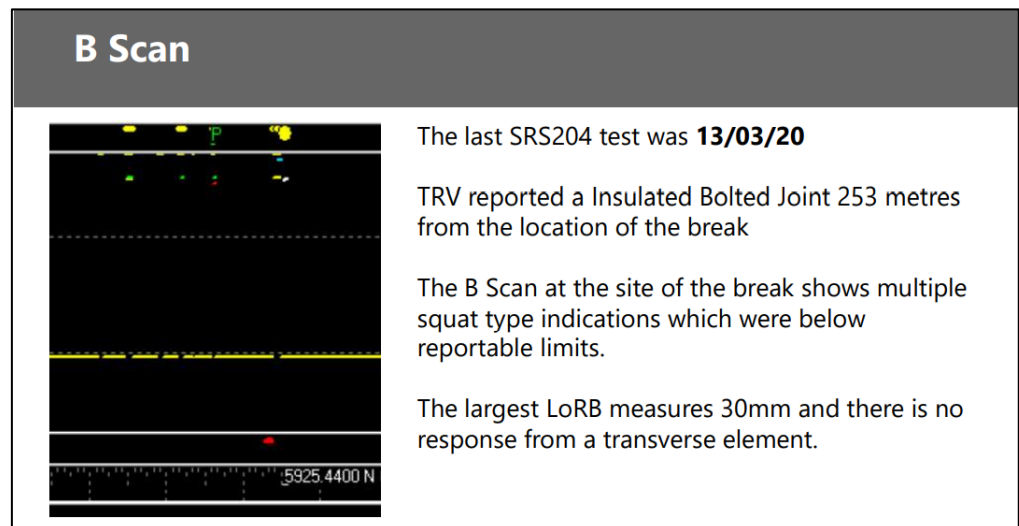
reported to the Transport Administration. Sperry Rail’s data contains measurement train indications of ‘squat type’ defects under the limit for reporting to the Swedish Transport Administration at kilometre 12+712 metres (see Figure 35). The indications showed a 30 mm longitudinal crack but no transverse crack. The limit for reporting to the Swedish Transport Administration was 100 mm longitudinal indications or indications with a depth of 10 mm.

Figure 35. Sperry Rail’s data shows that there were indications of minor defects that did not reach the limit for reporting to the Swedish Transport Administration at kilometre 12+712 metres. Source: Sperry Rail.
