Final report *SHK 2023:10e*

**Unanticipated yaw – Accident near
Härnösand, Västernorrland County on
26 June 2022 involving the helicopter
SE-JER of the model Bell 206B.**

File no. L-58/22

25 August 2023

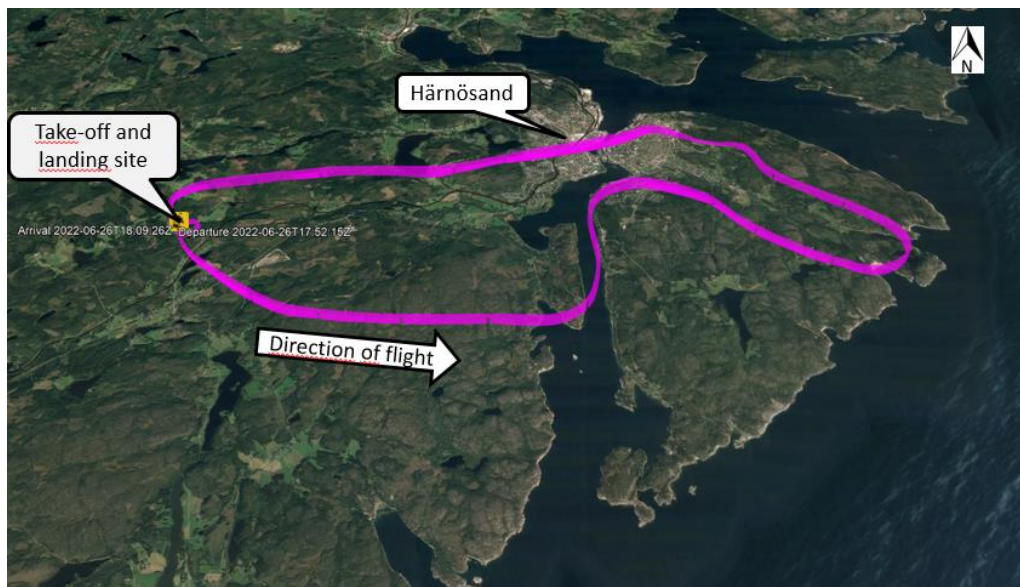
The flight was performed locally, including over the town of Härnösand (see Figure 1). After flying for just over 15 minutes, an approach to the take-off and landing site was made from the north.

Figure 1. Image with flight data that shows the entire flight. Markings inserted by SHK. Map image: Google Earth. © Lantmäteriet File no. R61749_190001.

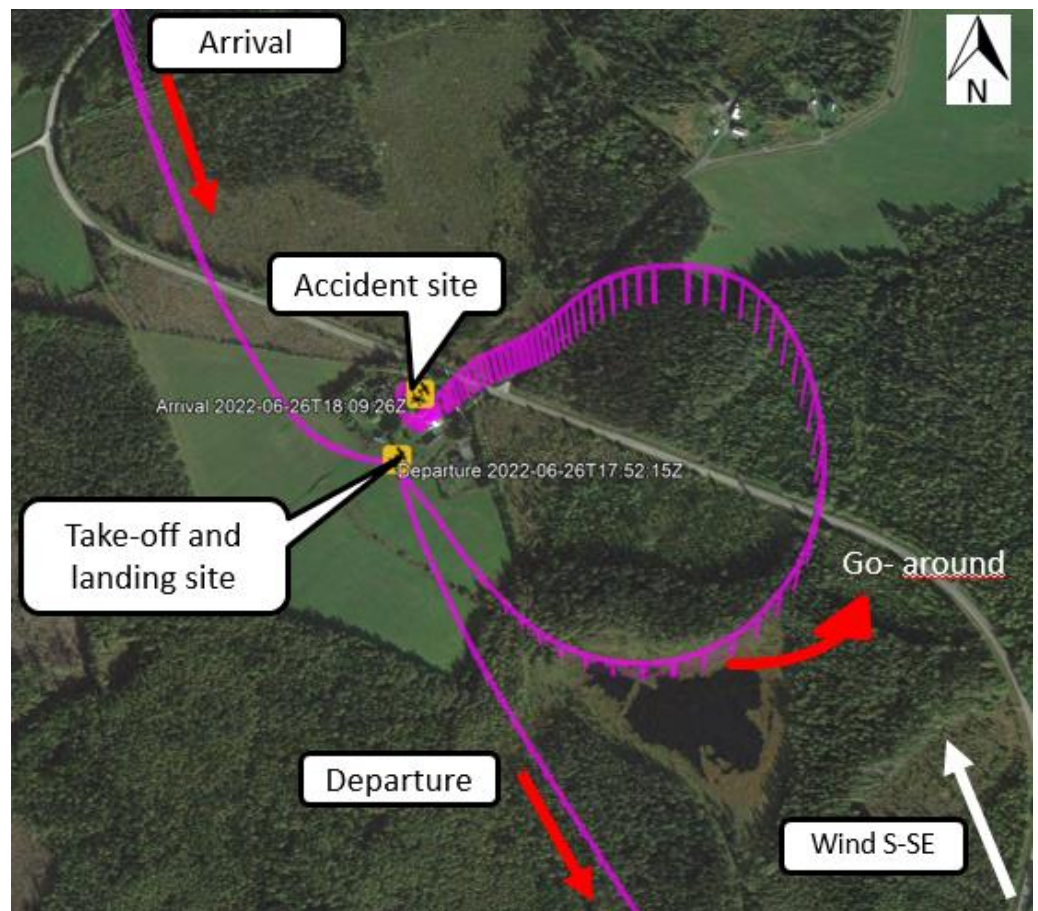
The pilot made an attempt to land in an east-north-easterly direction on the cultivated field. Due to an indication that the engine's torque was too high, the pilot was not able to manoeuvre the helicopter in yaw to the desired heading. Consequently, the pilot performed a go-around by turning left in order to land in a different direction on a plot at a nearby house. This was a site the pilot had used before. The plot was confined and a small tree had been removed to increase obstacle clearance.

Figure 2 shows the outbound direction at take-off, the approach direction, the take-off and landing site in the cultivated field, the go-around with a left turn and the accident site.

Figure 2. Image with flight data that, among other things, shows the area of the take-off and landing site, the go-around and the final approach towards the accident site. Markings inserted by SHK. Map image: Google Earth. © Lantmäteriet File no. R6174919_0001.

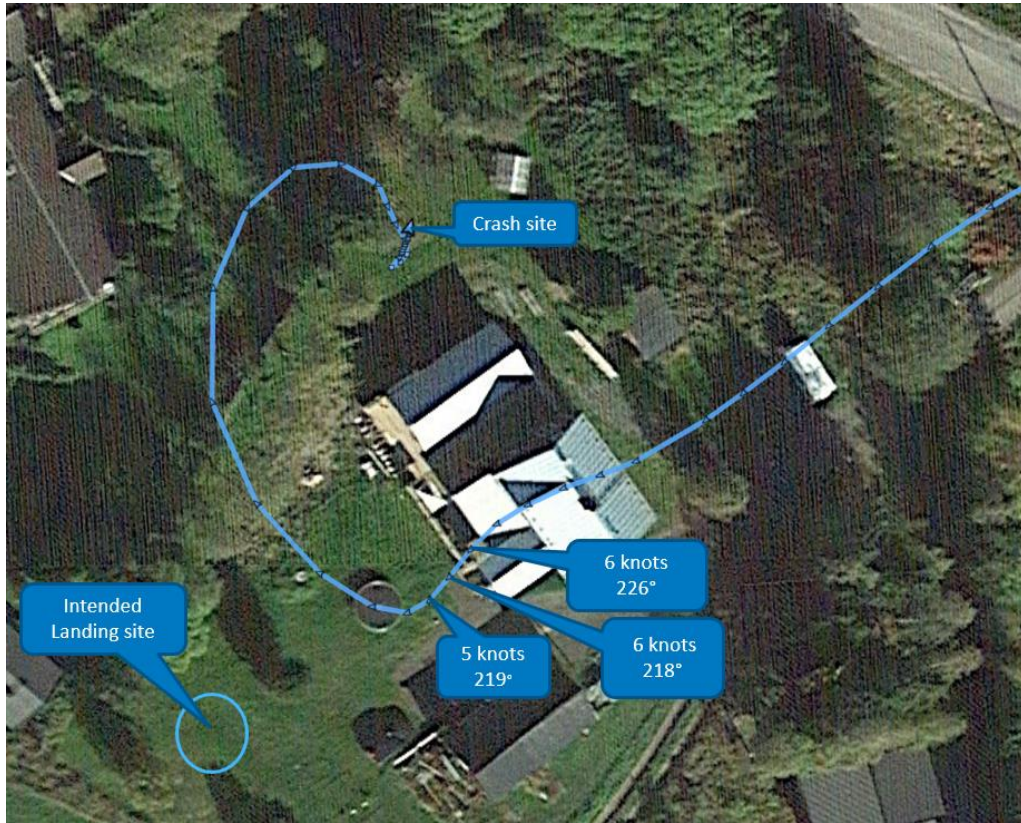
A final approach was made on a south-westerly heading in order to make a steep descent towards the new landing site. At the end of the final approach, the helicopter passed over a residential building in which there were a number of people. The helicopter’s ground speed at that time was approximately 5 knots and decreasing, both the track and heading was around 220° and the height above the ground was approximately 30 metres (see Figure 3).

Figure 3. Image with flight data that shows the flightpath during the final approach. The ground speed and track in the last three seconds before the helicopter began to yaw to the right are marked, as is the intended landing site on the house plot and the site of the accident. Please note that the satellite image from Google Earth does not show the actual conditions at the time of the accident. Markings inserted by SHK. Map image: Google Earth. © Lantmäteriet File no. R6174919_0001.

Shortly after this, the helicopter began to yaw to the right. The pilot gradually increased left pedal displacement but felt that this was not sufficient to counteract the yaw.

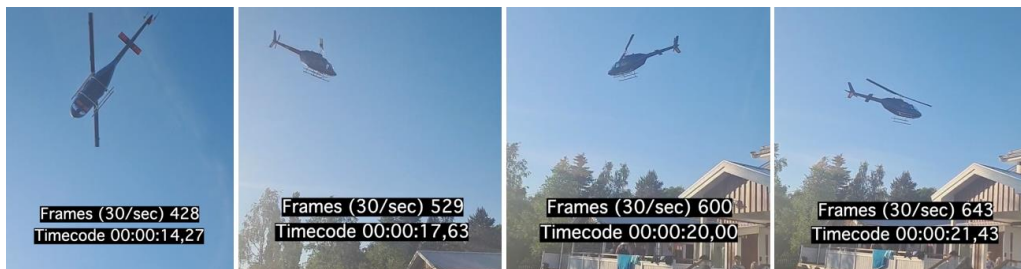
To manage the yaw, the pilot lowered the collective and pushed the cyclic forward, but the yaw continued and developed into an uncontrolled rotation to the right (see Figure 4).

Figure 4. Series of images showing the helicopter in the uncontrolled rotation to the right. Markings by SHK that show frame rate and time code. Photo: Private.

The low speed of the helicopter, together with the prevailing wind conditions, has likely led to the tail rotor's effectiveness being initially affected by main rotor disk vortex interference. This resulted in an unanticipated yaw to the right. The helicopter then received the wind from the tail which increased the yaw rate. Once the yaw developed into a rotation, the tail rotor was struck by the airstream from the side, further reducing its effectiveness. The pilot's action to reduce engine power caused the rotation to cease, but simultaneously caused the helicopter to descend towards the ground since the rotor RPM decreased.

The pilot had insufficient knowledge about the phenomenon of unanticipated yaw and which flight conditions entail a risk of this. Consequently, the pilot was probably not able to identify the initial signs that the helicopter was entering an unanticipated yaw and to take sufficient action in time to prevent the sequence of events from developing.

Increased knowledge among pilots about unanticipated yaw and which flight conditions lead to this phenomenon is considered to be able to reduce the risk of similar accidents. Actions should therefore be taken by EASA and the Swedish Transport Agency to, in an appropriate way inform pilots and other concerned parties such as training organizations.

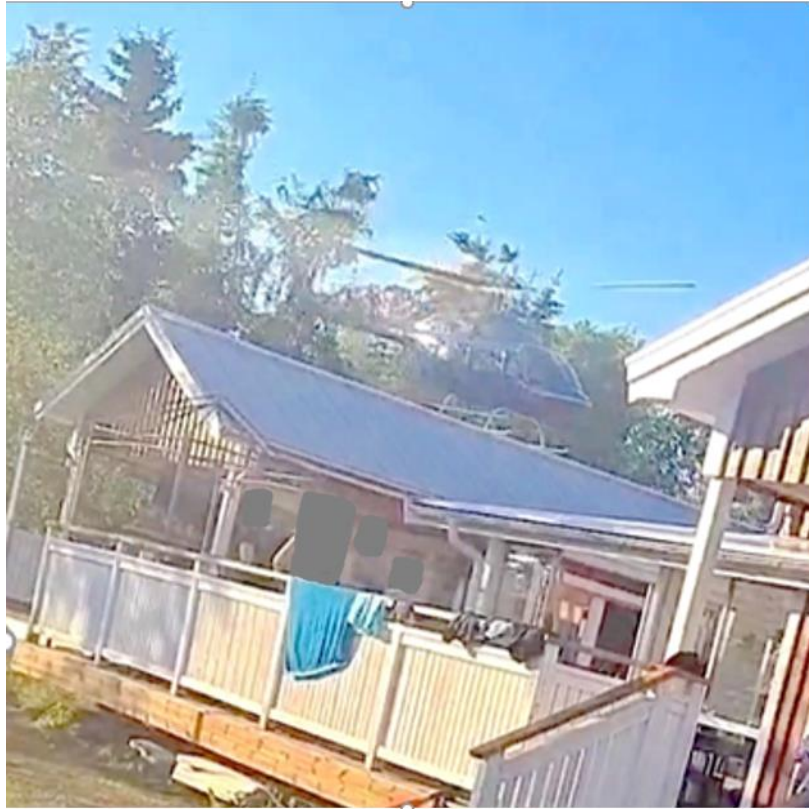
The pilot turned the throttle handle to idle in order to reduce the rotation. The rotation stopped, but the reduction in engine power simultaneously caused the helicopter to descend towards the ground. The helicopter collided with a number of trees and hit the ground hard (see Figure 5).

Figure 5. Position of the helicopter immediately prior to the impact. Photo: Private.

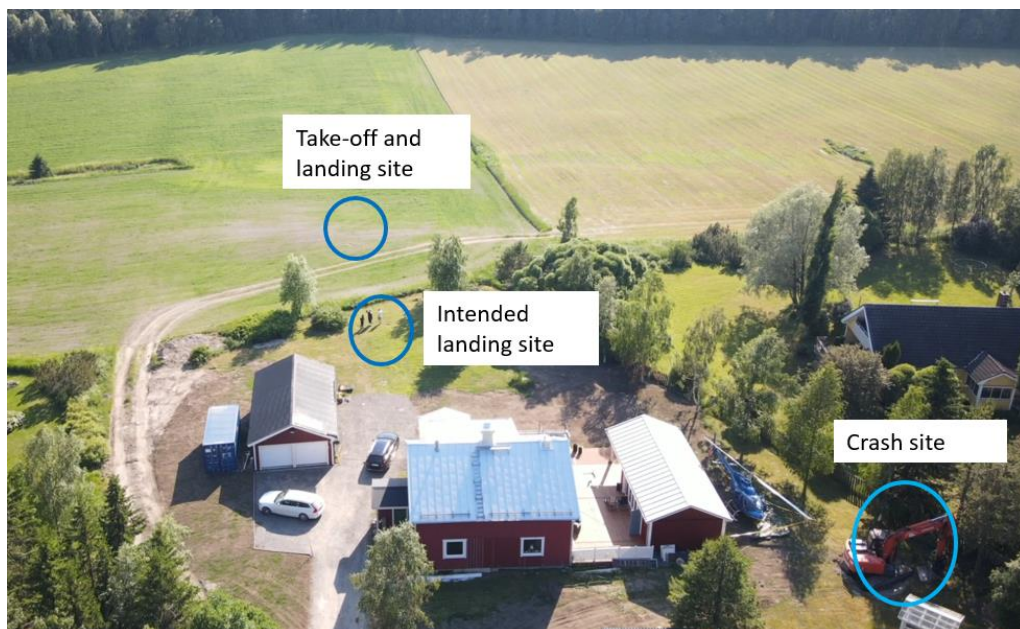
The helicopter hit the ground vertically by a group of trees in a garden. The crash site was about 10 metres from the closest residential building and just over 70 metres north of the take-off site (see Figure 8).

Figure 8. Picture of the accident area seen from the direction of the final approach. The take-off site in the field, the intended landing site on the house plot and the crash site are marked.

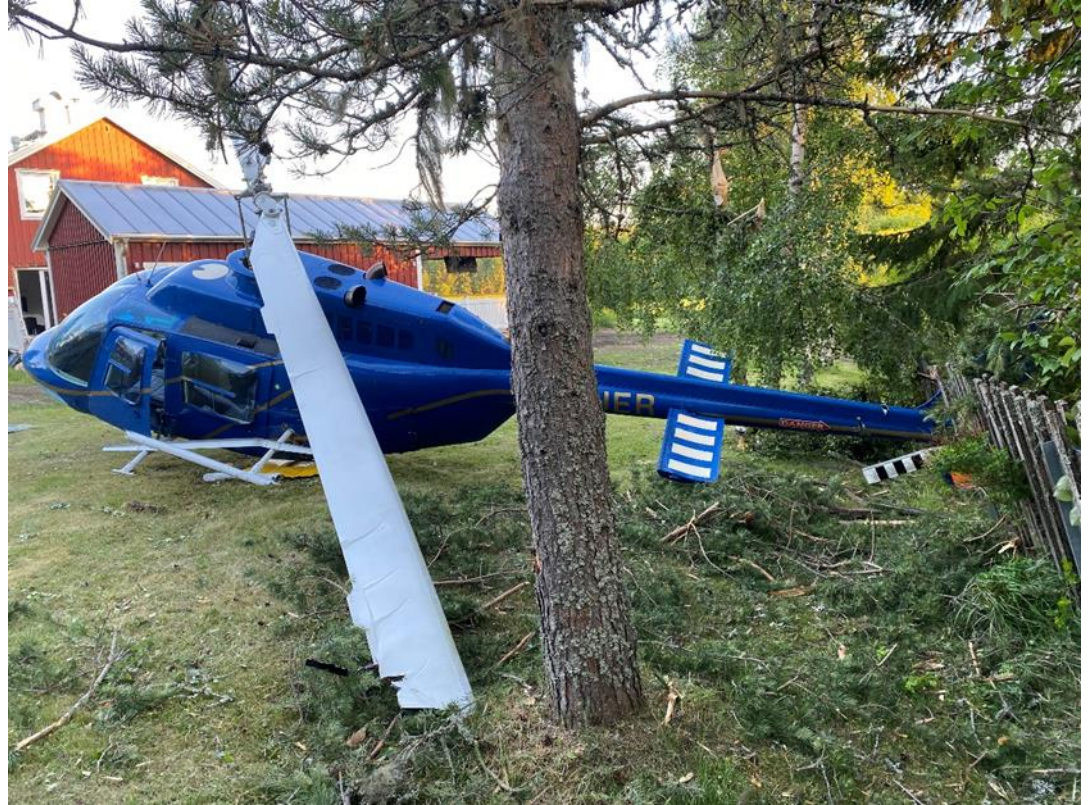
Parts of trunks and branches from birch and pine trees were cut off by the rotor blades. The aft portion of the tail boom had hit a fence that formed the boundary of the house plot and that of a nearby residential building (see Figure 9).

Figure 9. The helicopter at the crash site. Photo: Medelpads Rescue Service Association.

The left landing skid was broken and had ruptured the fuel tank. The aft portion of the tail boom suffered damage that was caused, among other things, by the tail rotor blades and the collision.

The outer part of one of the main rotor blades was broken off during the collision with the trees. It was found 185 metres from the accident site.

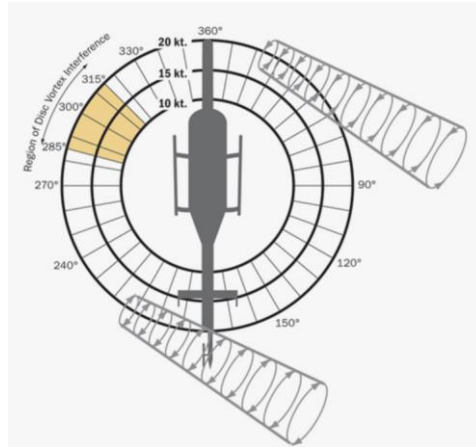
- With the wind from the left front, 285° to 315°, relative to the helicopter, the downward airflow and tip vortices from the main rotor can be blown into the tail rotor and cause so-called Main Rotor Disc Vortex Interference, which reduces the effectiveness of the tail rotor and an unexpected yaw can occur (see Figure 10).

Figure 10. Region of Main rotor disc vortex interference. Source: FAA.

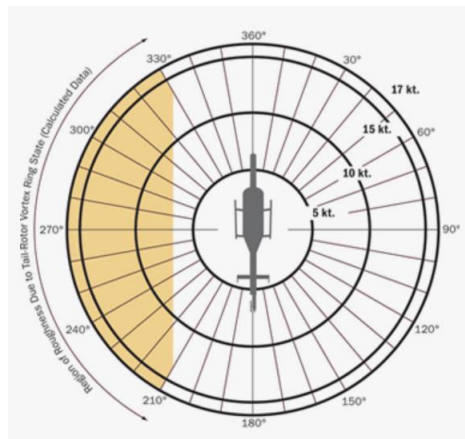
- With wind from the side, 210° to 330°, the airflow through the tail rotor can be pushed back and cause recirculation of the air through the tail rotor, known as Tail rotor vortex ring state, which reduces the effectiveness of the tail (see Figure 11).

Figure 11. Region of tail rotor vortex ring state. Source: FAA.

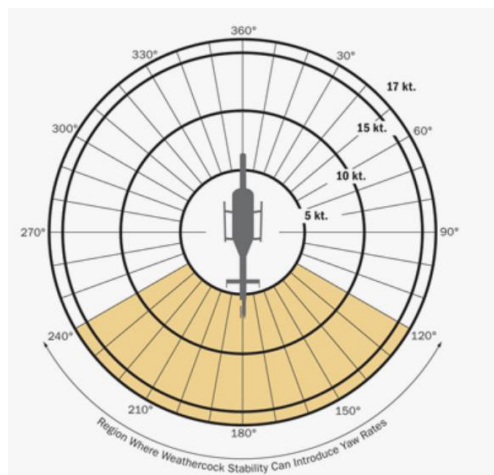
- With wind from the tail region, 120° to 240, the helicopter's tail section and tail fin acts as a weathercock and tries to turn the helicopter into the wind (weathercock stability) (see Figure 12). An unanticipated yaw or increase of yaw rate can then occur.

Figure 12. Weathercock stability. Source: FAA.
