Rapport RS 2007:01

General cargo ships MARINA-S and TINTO Collision on 25 April 2006 in the Baltic Sea

**MARINA-S and TINTO
Collision on 25 April 2006**

The report has been issued on 15 March 2007

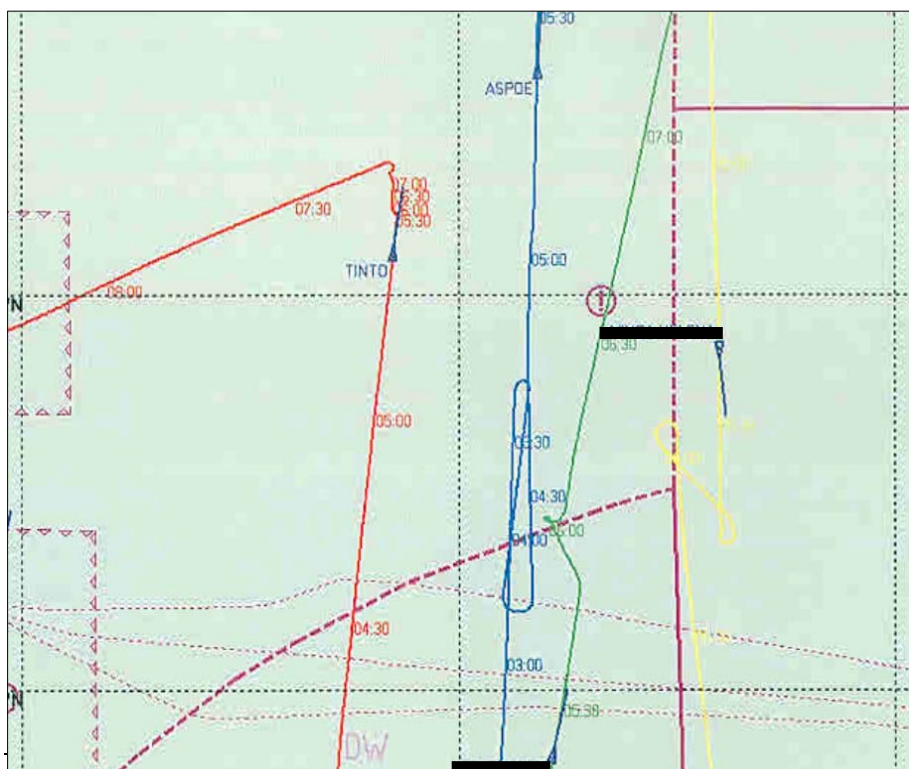
TINTO was fitted with AIS. TINTO's movements are indicated by the track history (the red line) in the extract below. The track of the overtaking ship ASPOE is shown in blue. Times indicated are local time. According to the AIS information, TINTO's course and speed remained unchanged until the moment of the collision.

Screen dump from the Swedish Maritime Administration's AIS recordings.

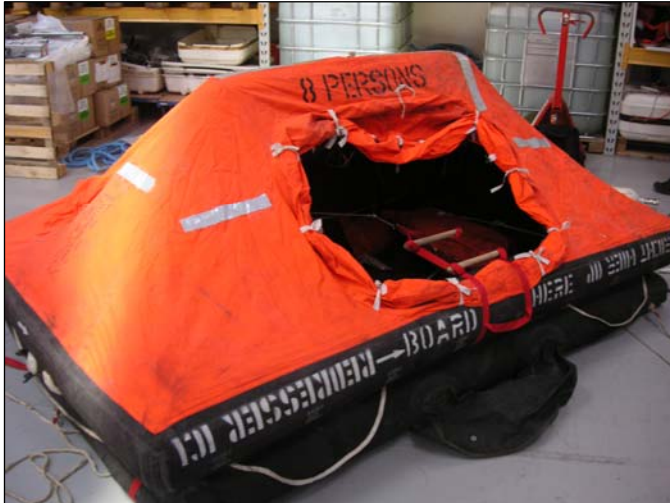
When the Swedish Coastguard recovered the raft it was noted that the raft was full of seawater. The raft itself was inflated and the rings were hard. The supporters to the roof were not inflated.

Picture of the raft - taken during a test of the inflation system at Raffel & Co in Denmark.

According to the technician at Raffels, which is certified to perform reinspection on this type of raft, the roof should have inflated automatically.

At the test, the raft was inflated by means of pressure air and all functions were as normal. The lower ring inflated first, then the upper ring and finally the roof. There were minor damages to the outside of the raft, most probably due to handling of the raft when it was recovered. The raft maintained the pressure after it had been inflated.

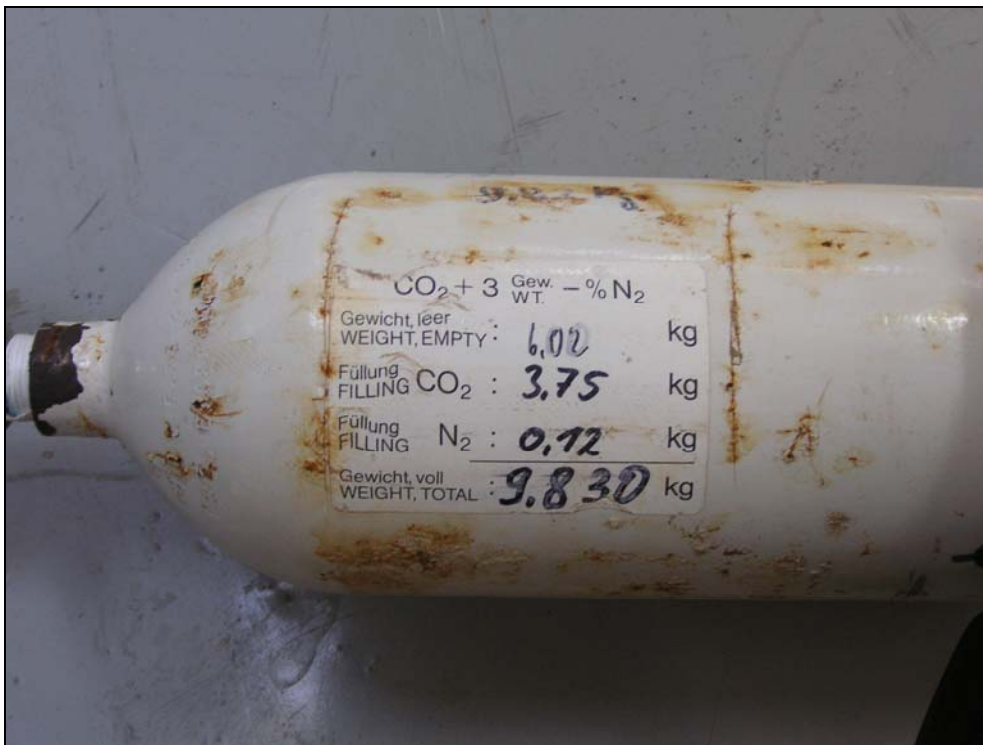
Liferaft Service Record attached to the raft.

According to the record shown above, the raft had been reinspected on September 2001, October 2002, January 2004, February 2005 and January 2006. At the last reinspection of the raft in 2006, a gas inflation test had been carried out.

The raft's CO₂ bottle was according to its markings manufactured in 1990 and was pressure tested in October 2002. According to the marking and the re-inspection certificate, the gas mix was 3750, gr. of CO₂ and 120 gr. of N₂.

The test performed after the accident did not show any damage or defects in the inflation system. It has, however, not been possible to rule out that the malfunction could have been caused by defects in the CO² supply system at the time of the bottle was activated.
