Final report RL 2018:08e

**Accident in Älvsbyn, Norrbotten County,
on 26 September 2017 involving the
helicopter SE-JVI of the model
MDHI 369D, operated by First European
Aviation Company (FEAC).**

File no. L-114/17

20 August 2018

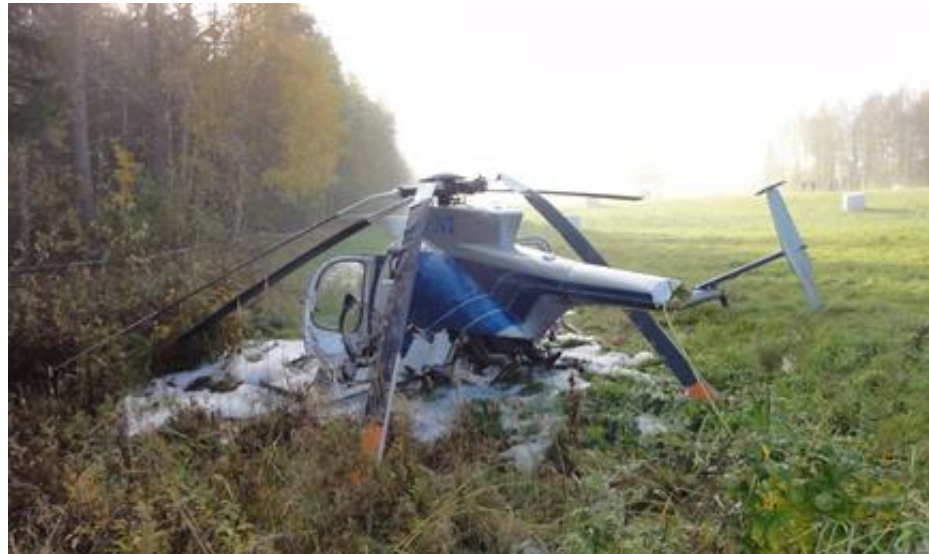
Hull loss. The aircraft sustained substantial structural damage, including to the skids and rotor system.

Figure 2. The helicopter, seen from the approximate track upon impact.

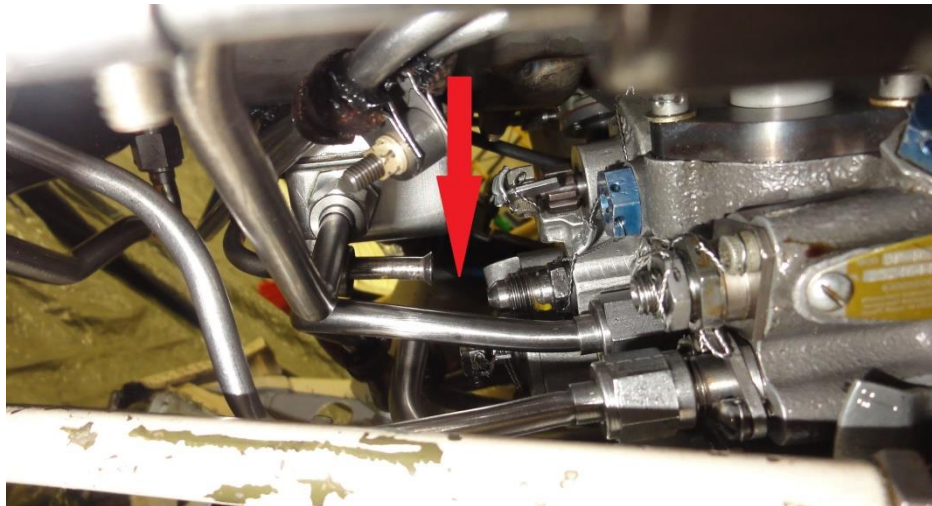
The cause of the engine failure was that the pipe nut backed off and the pipe came loose resulting in a loss of engine power. The nut could back off due to the methods of securing the engine fittings with prescribed torque and the visual slippage inspections before flight was flawed.

In SHK's examination of the engine following the accident, it was discovered that the pipe that supplies reference pressure (reference pipe) from the engine compressor to the free turbine regulator and the fuel control unit had come loose from its fitting (see figure 9). The threads of the pipe nut and the fitting were intact, which indicates that these had come apart prior to impact. The investigation noted that another pipe nut in the same pipe system was also loose, but it had not been completely dislodged. The last known maintenance on the fuel control unit, when the connection unit (Filter Assembly) was fitted, was carried out on 29 September 2015 according to the identification plate on the fuel control unit. The safety wire on the connection unit was sealed with the marking H S P.

Figure 9. The image shows the fuel control unit fitting that had come loose.

In the examination of the helicopter, SHK discovered that the pipe that supplies reference pressure from the engine compressor to the free turbine regulator and the FCU had come loose from its fitting. The threads of both the pipe nut and the fitting were intact, which indicates that the pipe had loosened prior to impact.

- Evaluate whether the construction of the Rolls-Royce engine RR 250-C20 and other models using the same type of B-nut, without any other safety measures than the tightening torque and the prescribed nut checks, provides sufficiently secure protection against engine failure in single-engine configurations. *(RL 2018:08 R1)*
- Investigate whether there is a need to inform concerned sections of the industry that there may be deviating fittings (Filter Assembly) in circulation in international flight operations. *(RL 2018:08 R2)*

- Evaluate whether the construction of the Rolls-Royce engine RR 250-C20 and other models using the same type of B-nut without any other safety measures than the tightening torque and the prescribed nut checks in accordance with EASA AD 2004-0009R3, provides sufficiently secure protection against engine failure in single-engine configurations. *(RL 2018:08 R3)*

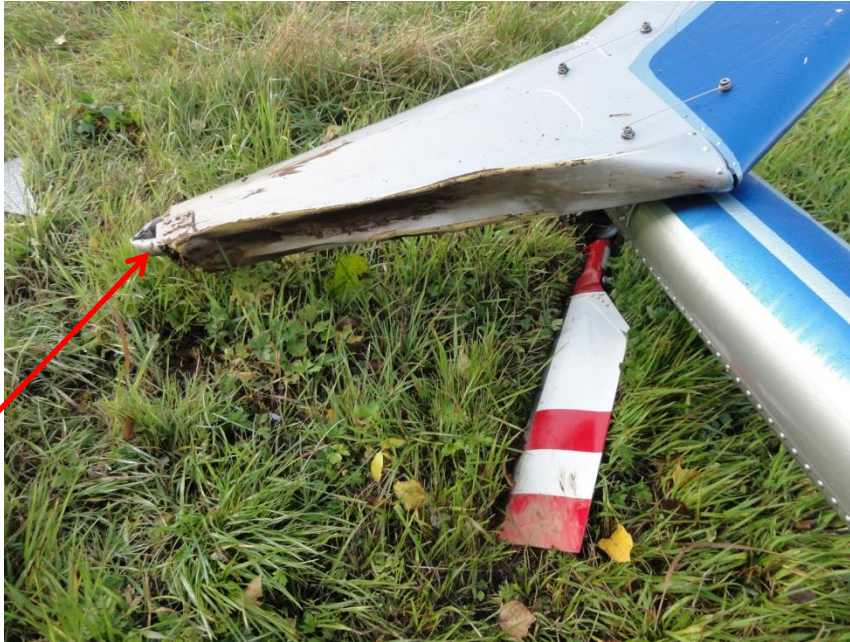
The examination of the accident site showed that, when it collided with the ground, the helicopter had a high vertical speed and hit the ground tail rotor guard first (see figure 17), followed by the landing gear, which collapsed in the collision.

Figure 17. Ground contact with tail rotor guard and fin.

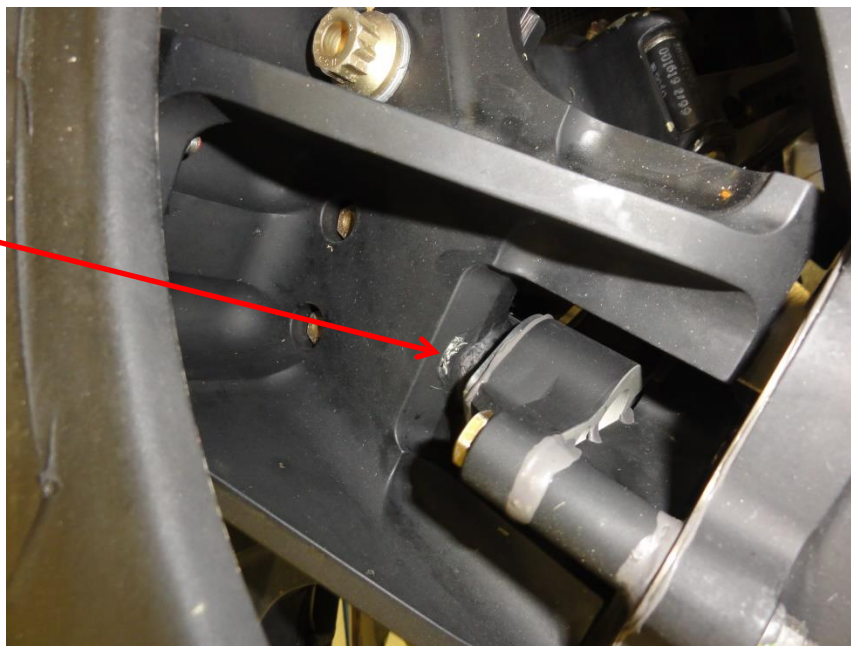
The damages to the helicopter, ground and nearby trees indicate that the helicopter had a descent angle of approximately 70 degrees, close to zero forward speed and very low rpm in the main rotor and tail rotor, combined with an exceptionally large coning angle¹⁵ of the rotor disk at some point during the sequence (see figure 18).

Figure 18. Damages to the main rotor hub following a high coning angle.

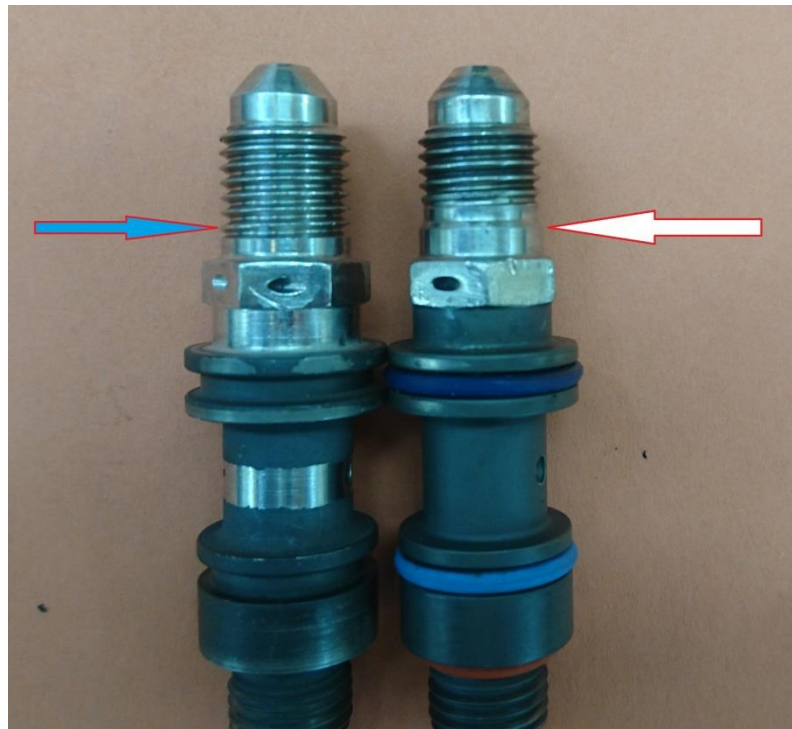
The connection unit for the reference pressure sent by the compressor to the fuel control unit (Filter Assembly) differed somewhat from other connection units; for one, there were around two fewer rotations on the thread (see figure 19). In addition, according to the engineering drawing from the manufacturer of the fuel control unit, the article number should be engraved on the connection unit. This number was missing.

Figure 19. The inspected connection unit to the right and a reference connection unit to the left.

In SHK's opinion, there are two possible causes which individually or in combination may have entailed the pipe loosening from the assembly. One is that the threads on the connection unit (Filter Assembly) were not consistent with the fuel control unit manufacturer's specifications, and the second is that the pipe nut was not mounted correctly.

With regard to the way in which the connection unit in question deviated from the specifications, SHK's tests and checks have shown differences in the force required to loosen a pipe nut which has been tightened to the correct torque. As a result of the differences, the material stress in the unit may have been too low even if the correct tightening torque was applied. This would mean that the unit would have a

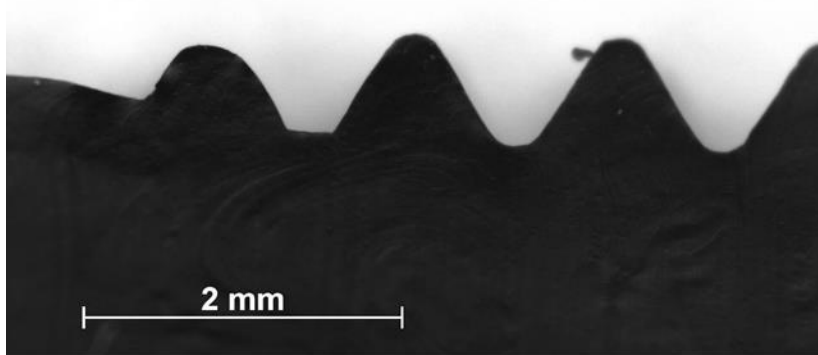
As is clear from figures 20 and 21, the thread geometry is different.

Figure 20. Cast of the mounted FA shown in figure 19. The white area represents the thread.

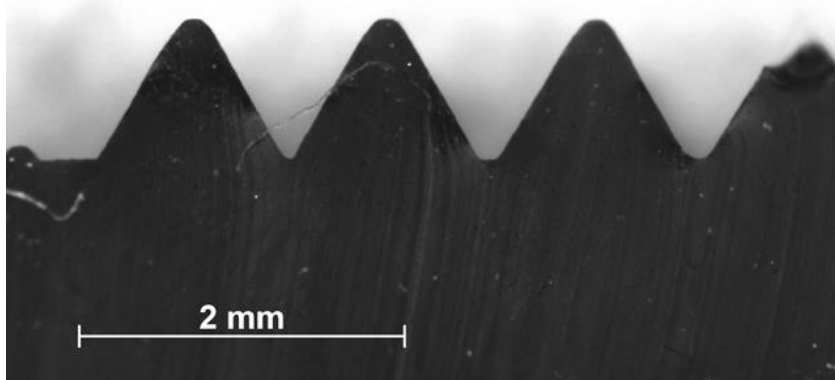
Figure 21. Cast of the reference FA shown in figure 19. The white area represents the thread.

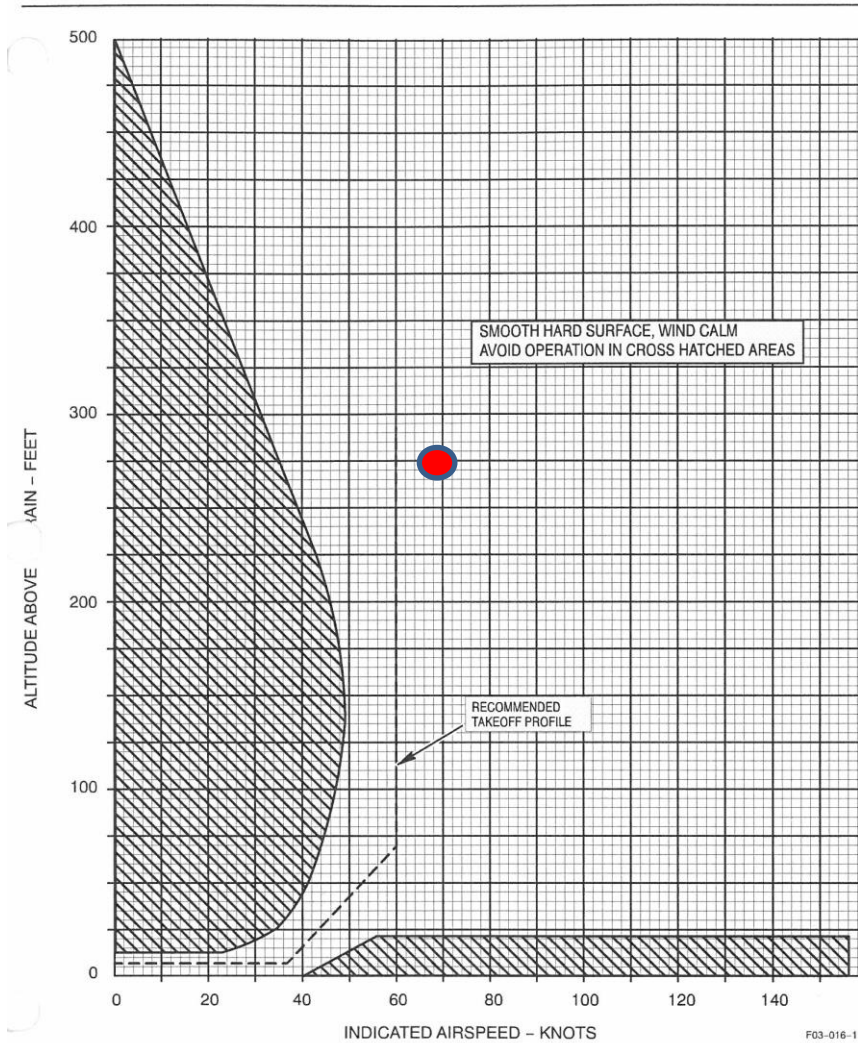
A heavily loaded helicopter means a higher rate of descent and thereby a shorter glide distance than for a helicopter of the same type with a light load. A more heavily loaded helicopter also entails a higher air-flow which drives the main rotor, thus affording a better opportunity to regulate the rotor rpm. The combinations of altitudes and speeds whereby the type certificate-holder states that there are conditions for performing a safe autorotation landing are illustrated by the different areas in figure 23. It is not prohibited to fly within the two marked areas, but this should be avoided where possible.

Figure 23. Height Velocity Diagram. The red dot marks the approximate speed and altitude at which the engine fault occurred. The marked areas represent speed and altitude combinations at which a successful autorotation landing is difficult to perform.
