# In-flight loss of propeller involving Saab 340B, VH-NRX

18.5 km SW of Sydney Airport, NSW | 17 March 2017

**ATSB Transport Safety Report**  
Aviation Occurrence Investigation  
AO-2017-032  
Final – 10 October 2018

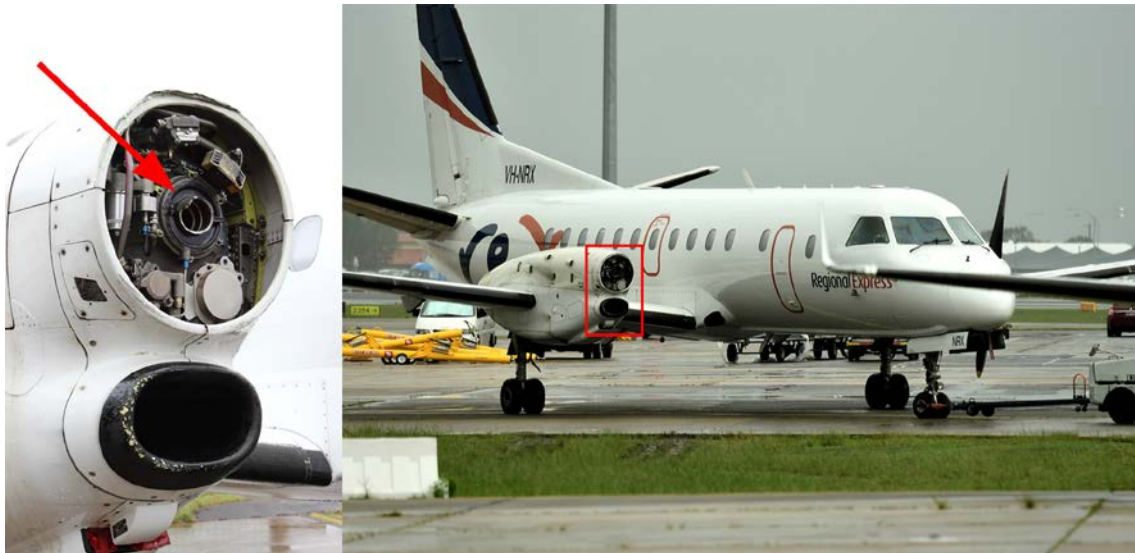
**Figure 1: The aircraft, VH-NRX, at Sydney Airport after the incident showing the point of separation of the propeller in close-up**

An inspection of the aircraft by the ATSB at Sydney Airport identified that the propeller shaft had fractured, leading to the separation of the propeller.

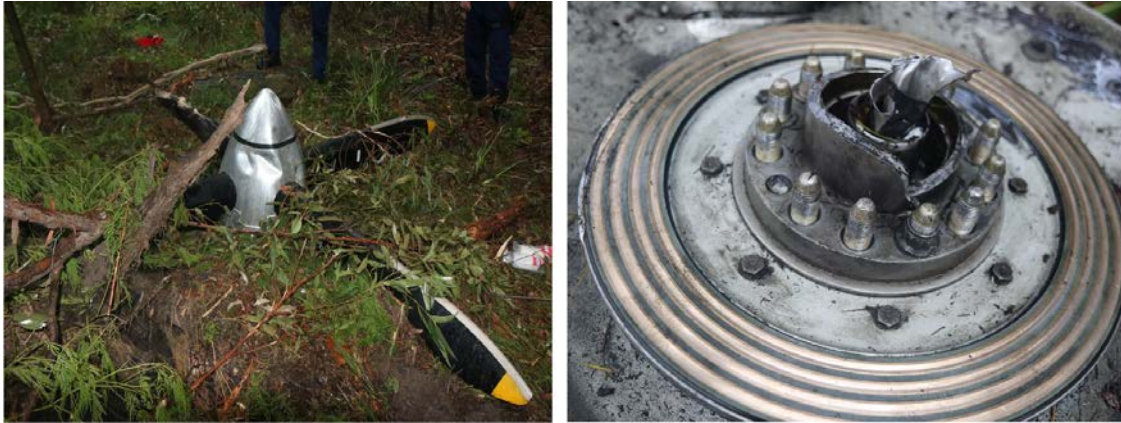
**Figure 2: The separated propeller from VH-NRX**

On 21 March 2017, the NSW Police Aviation Support Branch (PoIAir) located the propeller in an area under dense forest about 10 NM south-west of Sydney Airport. The propeller was found with the flange section of propeller shaft secured to the propeller assembly and a fracture through the propeller shaft (Figure 2).

The image on the left shows the propeller as found in bushland by PoAir about 10 NM south-west of Sydney airport. The image on the right shows the propeller flange still attached to the rear of the propeller. Note that the attachment nuts were in the process of being removed by ATSB investigators onsite, in order to release the flange. Source: ATSB

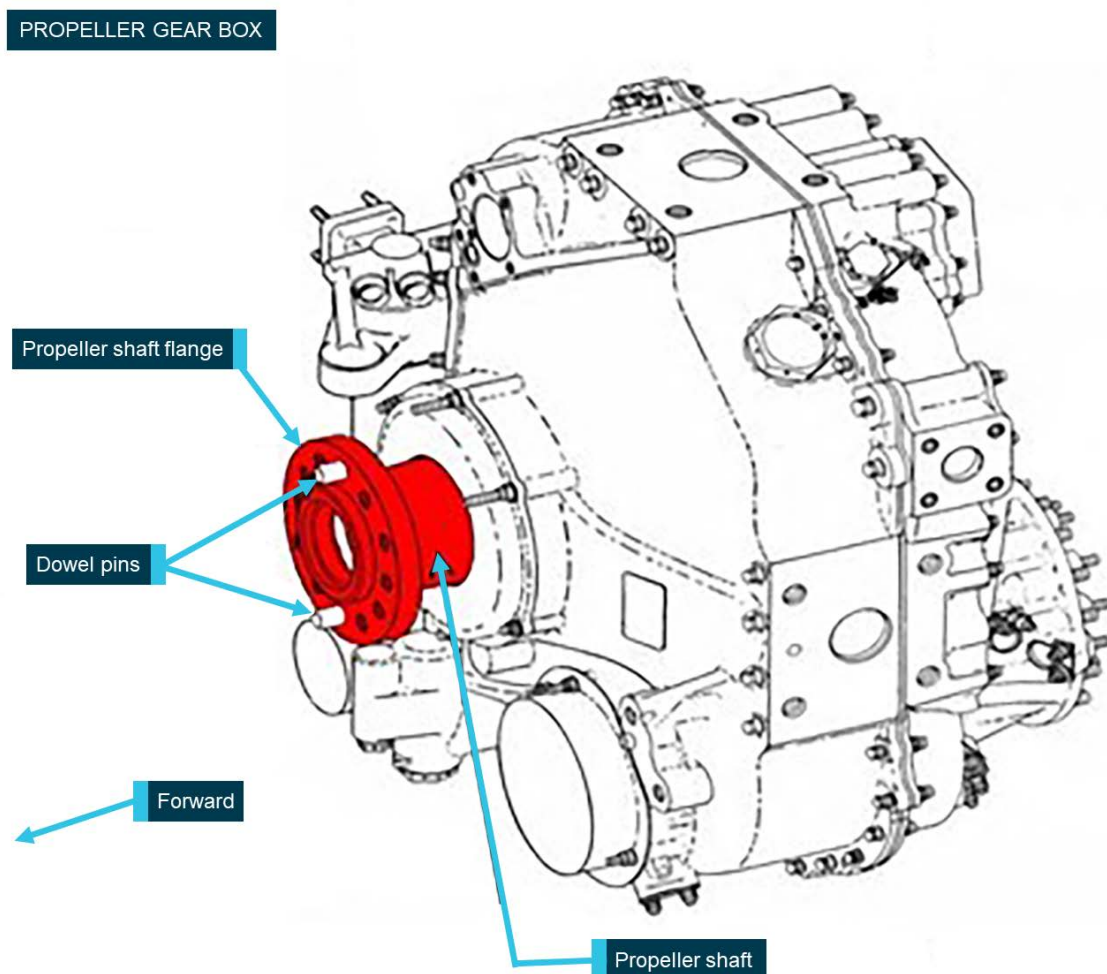
**Figure 3: Propeller gearbox schematic highlighting the recovered section of the propeller shaft**

The propeller separated due to cracking between the propeller main shaft and the flanged region (Figure 3) on the right side PGB.

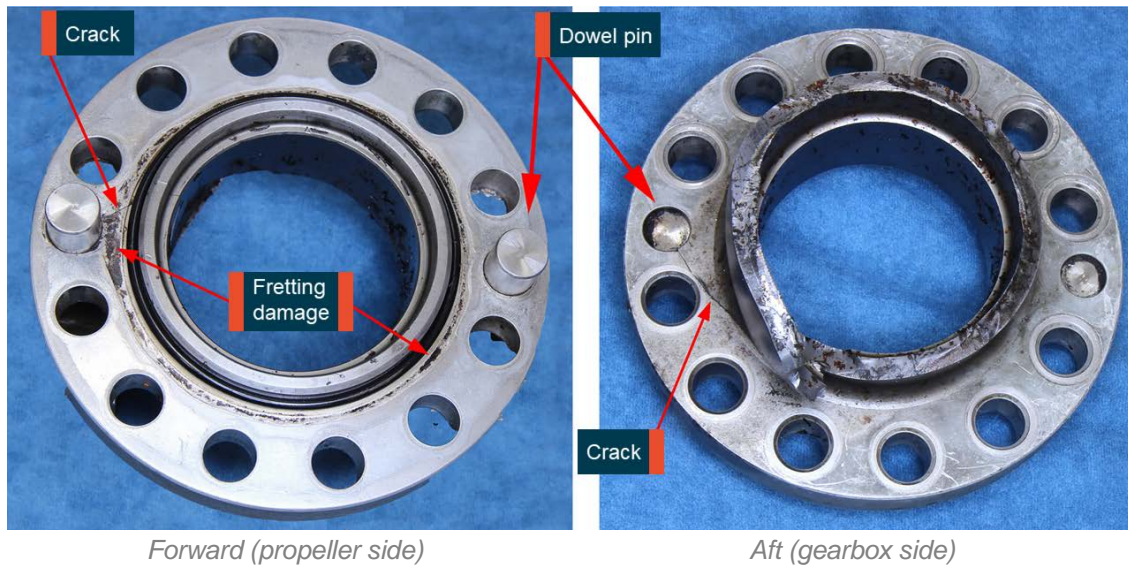
**Figure 4: Separated shaft section in their as-received condition**

Image shows that cracking was observed near one of the dowel pins and the fretting discolouration observed on the propeller side of the flange. Source: ATSB

Examination of the propeller flange section of the fractured shaft revealed cracking emanating from one of the dowel pin holes (Figure 4). The cracking had progressed through the flange thickness, transitioning into the shaft portion at an angle indicative of torsional loading, and ultimately resulted in shaft separation. The shaft fracture had deformed in a radial direction, which exposed some of the fracture face, and evidence of beachmarks typical of fatigue (cyclic) cracking were observed (Figure 5).

Local fretting damage and corrosion was observed around the forward flange surface circumference with the more severe damage observed directly inboard of the dowel pin hole at the

crack location. Remaining flange thickness in the more heavily fretted region measured 0.684 inch (17.37 mm), which was 0.03 mm below the minimum manual limit requirement of 0.685 inch (17.40 mm). An oily dark residue was present around the retention lip feature of the dowel pin hole.

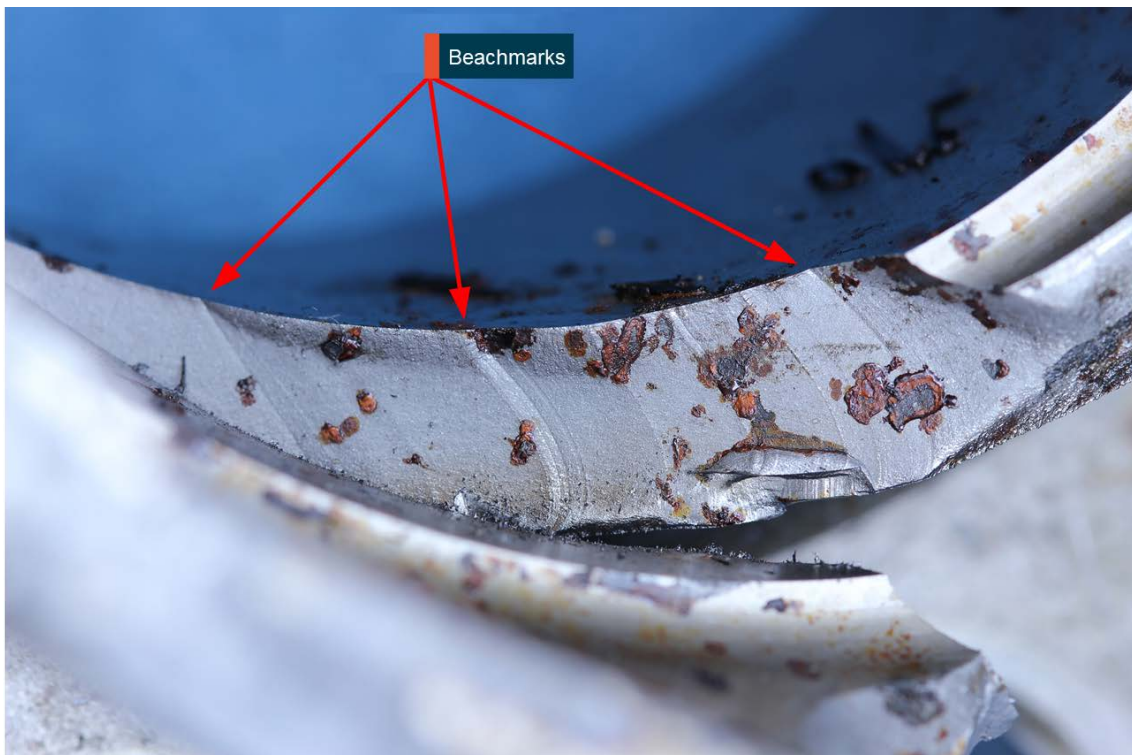
**Figure 5: Section of the exposed propeller shaft showing beachmarks**

Image shows the beachmarks on the fracture surface, which was indicative of a fatigue failure mechanism. Source: ATSB

The shaft failed as a result of a fatigue crack propagation that initiated at a dowel pin hole. The crack then propagated into the shaft in a torsional manner, before failing in overstress.

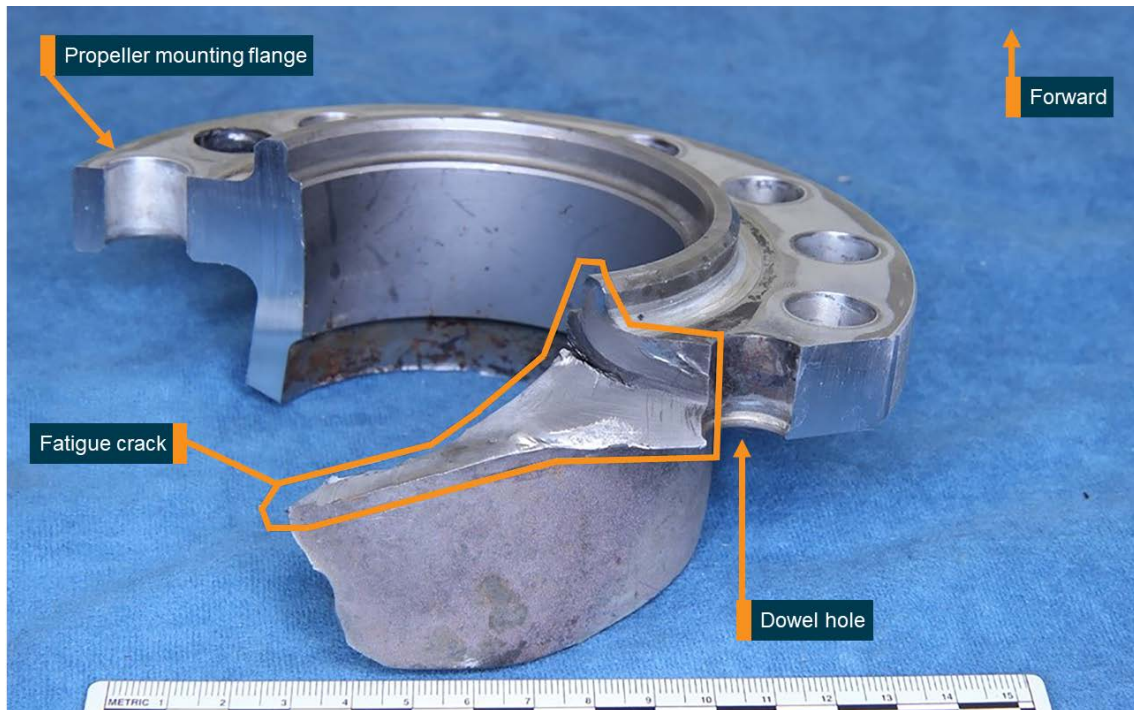
**Figure 6: Section of the propeller shaft showing the fatigue crack progressing into the shaft**

Following the initial visual examination, the sample was sectioned through the dowel pin holes in order to expose the fracture surface (Figure 6). Once opened, a discoloured initial fracture region consistent with fatigue was observed towards the forward flange face along with some discoloration of the dowel pin itself. The fatigue fracture itself had completely progressed through the flange thickness.

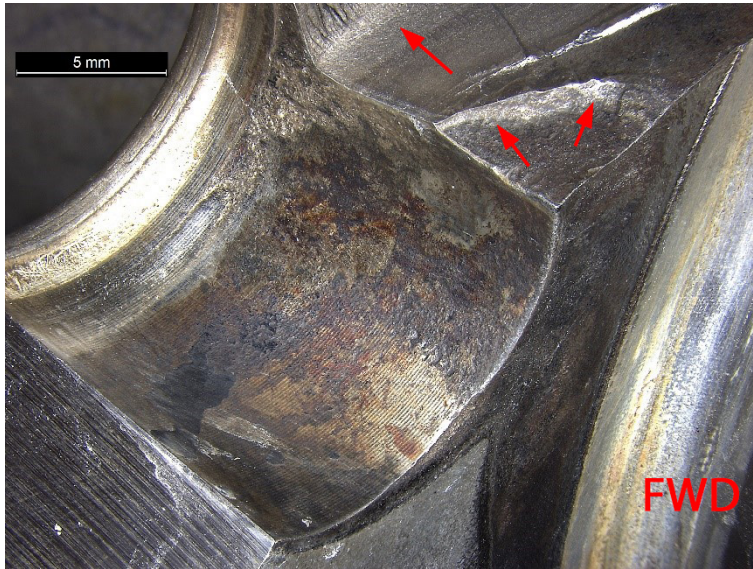
**Figure 7: Corrosion observed within the bore of the dowel pin hole**

The dowel pin bore was corroded in parts (shown in Figure 7), and corrosion pitting was found near the fracture. Cadmium (Cd) plating, normally present on the forward flange face, dowel pin hole surfaces and exposed propeller shaft, was missing within the dowel pin hole, with the exception of several streaks near the aft end of the hole.

Image show corrosion in bore, along with crack originating at the forward corner of the dowel pin hole (arrowed) Source: ATSB

Due to the corroded condition of the initial fracture surface, a definitive root cause for crack initiation could not be established, although corrosion within the dowel pin hole was believed to be a strong contributor to crack initiation. Analysis by General Electric indicated that the initiation of fatigue cracking of the flange may be associated with a combination of factors that include:

In September 2017, GE made changes to the maintenance manual, including the introduction of fluorescent penetrant inspection of the dowel pin areas, a clarification of the inspection criteria for corrosion, and the addition of photographs of the dowel pin area condition.

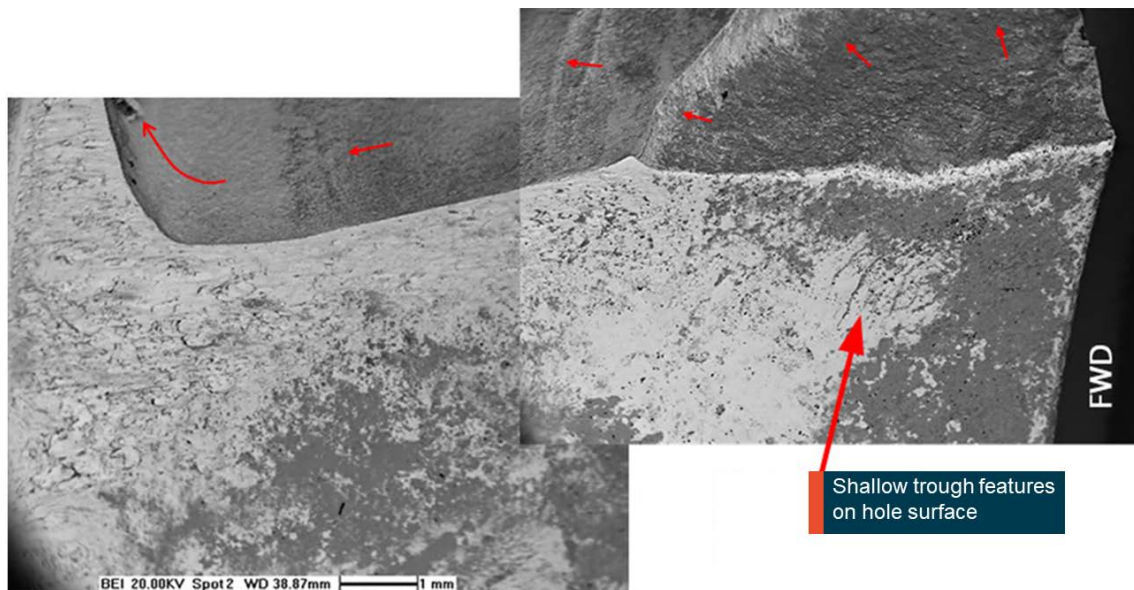
**Figure 8: Scanning electron microscope image of the internal surface of the dowel pin hole and initial fracture surface**

Following the visual examinations and preliminary sectioning at the ATSB facilities, the fractured components were returned to the engine manufacturer for additional analysis and testing. Examination in a scanning electron microscope confirmed the presence of corrosion product immediately below the initial fracture region along with shallow, trough-shaped features (Figure 8). Corrosion pitting was observed along the edge of the initial fracture leading to a rounded appearance. Spectral imaging (energy dispersive x-ray analysis) of the dowel pin hole and fretted region on the propeller shaft flange forward face also confirmed the absence of original cadmium (Cd) plating. The corrosion product consisted of iron (Fe), oxygen (O) (consistent with a steel corrosion product) sulphur (S) and residual cadmium (Cd).

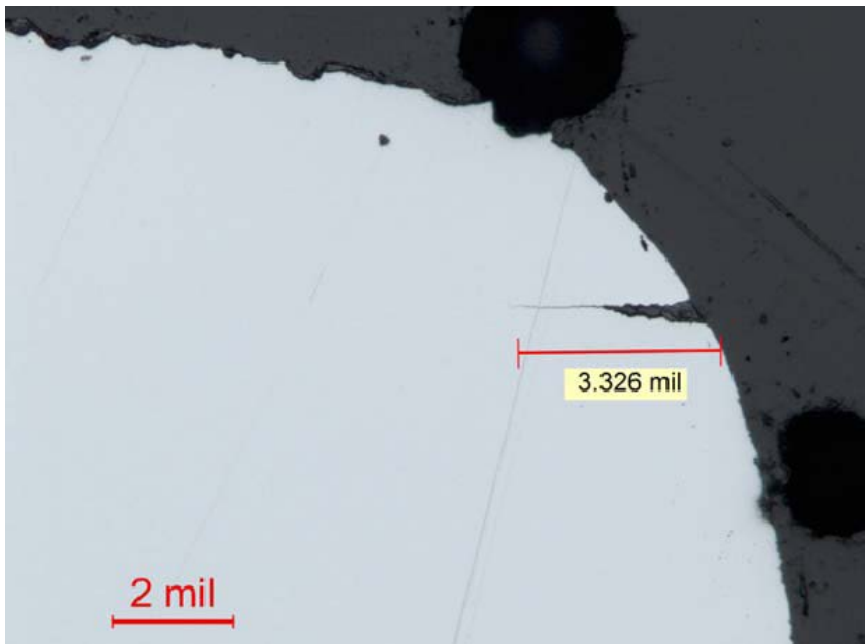
**Figure 9: Metallographic cross section adjacent to the fracture surface showing secondary cracking**

microstructure was tempered martensite, consistent with the material type in the correctly processed condition. However, the metallographic sections showed significant general surface corrosion, pitting corrosion and secondary cracking in the area adjacent to the primary fracture surface. Many of the shallow secondary cracks identified during a step polishing examination were filled with corrosion product (Figure 9). The presence of multiple shallow crack features supported crack initiation towards the forward dowel pin hole area.

The micrograph shows the secondary cracking extending from the dowel pin hole in the region adjacent to the primary fracture surface. Also, note the corroded initial fracture surface at the top of the image, and the rounded fracture edge. Note that 2 mil is approximately equal to 50 µm. The crack length in the image is approximately 84 µm in length. Source: GE

The presence of that significant secondary corrosion did, however, support either an initially slower moving crack or a crack that had arrested for some unquantifiable period allowing the corrosion to occur. The remaining, less damaged portion of the fracture surface was consistent with lower alternating stress, high cycle fatigue (HCF) mechanisms, ultimately leading to shaft separation.
