## *Final report RL 2017:10e*

**Serious incident after take-off from Gothenburg/Landvetter Airport on 7 November 2016 involving SE-DSV an aeroplane of the model AVRO-RJ 100, operated by Braathens Regional Aviation AB.**

File no. L-112/16

7 December 2017

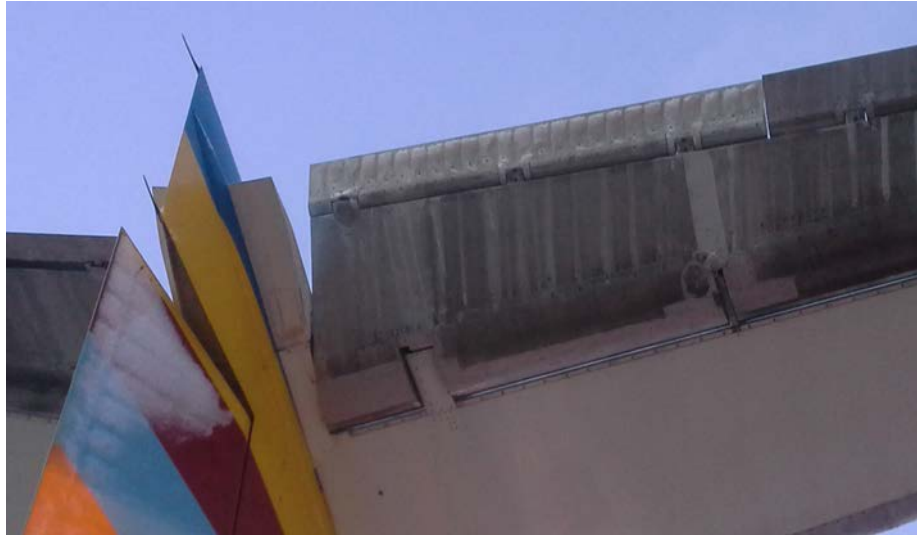
The operator's engineer inspected the aeroplane in order to find the source of the vibrations. The inspection revealed extensive ice contamination on the primary and secondary flight control surfaces, mainly on the elevators, rudder, ailerons and flaps. The ice-covered surfaces were documented with pictures (see Figures 3–5).

Figure 3. The rudder and right elevator after the incident. (Photo Aviator).

As previously described the aeroplane returned with remaining contamination in the form of ice on several of the critical surfaces of the aircraft, mainly on elevators, rudder, ailerons and flaps. Contamination was also found on the underside of several flight control surfaces.

In this case, the ice contamination on the aircraft was relatively extensive. Based on the above, SHK concludes that the vibrations were caused by the unbalance in the elevator system that arose because of the ice contamination.

The ice was removed and further maintenance, such as service of the rain repellent system and the replacement of SD cards in QAR, were performed with references to AMM. The engineer also performed an external inspection to find other sources of vibration, such as loose or missing panels, without finding any. The latter measures were performed without reference to AMM. The aircraft was approved for continued operation after a performed testflight and by issuing a certificate of release to service in the aircraft technical log.

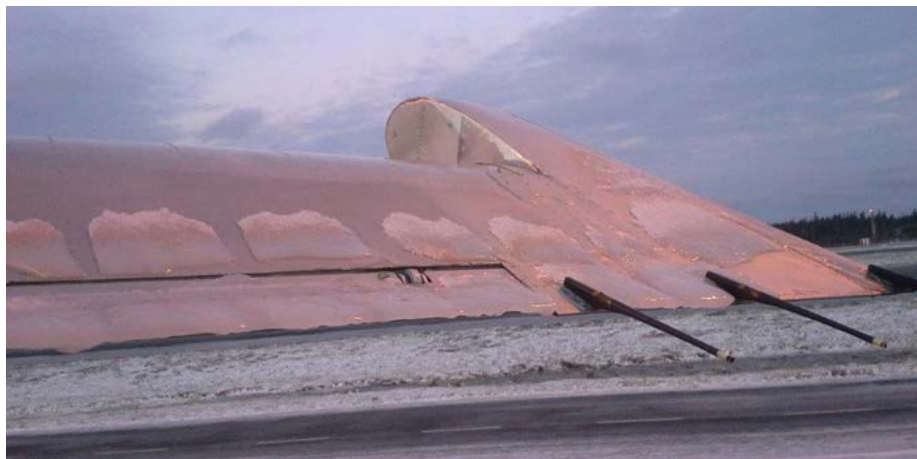
Figure 4. The right aileron after the incident. (Photo BRA).

As shown, residual ice was found on the undersides of ailerons and elevators after the event. It can be noted that none of the people involved noticed this. Neither the engineer nor the commander detected the ice contamination on these surfaces. Consequently, these surfaces were not covered by the de-icing order. The commander has stated that if he had discovered the ice, he would have specifically mentioned it.

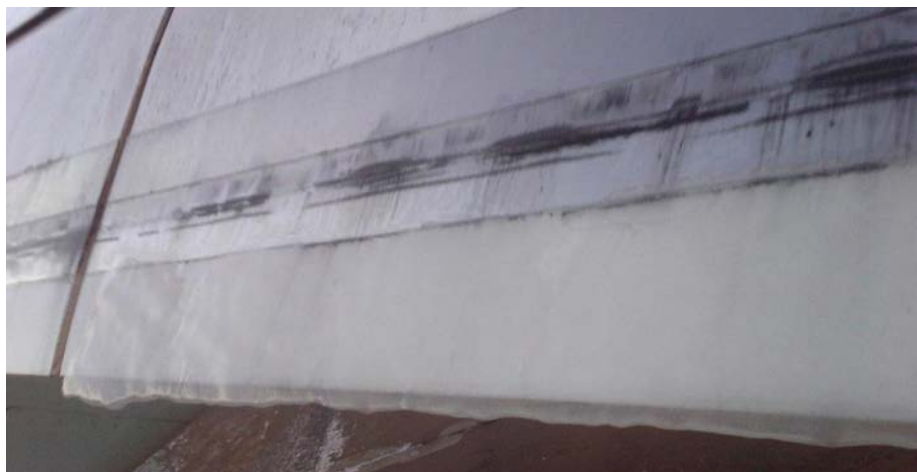
Figure 5. The left flap after the incident. (Photo BRA).

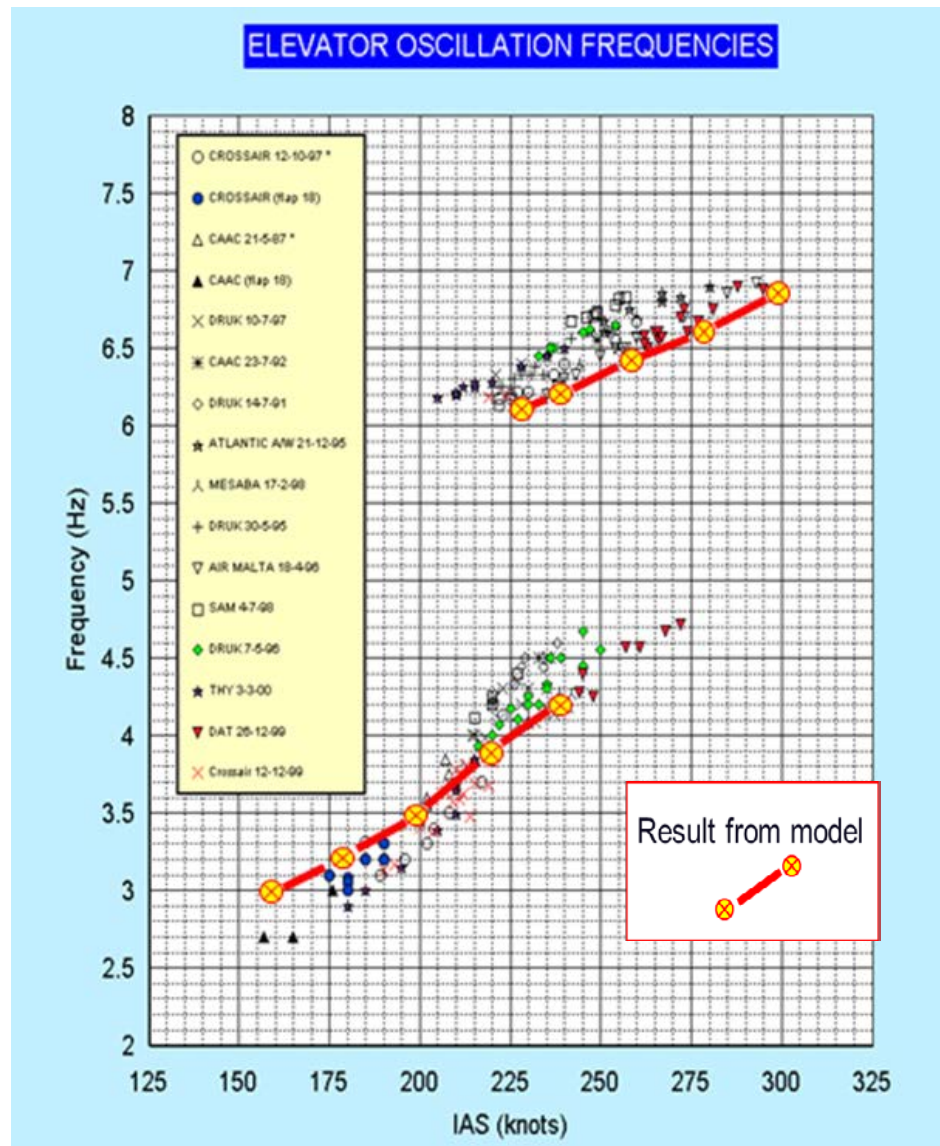
Figure 10. Elevator oscillation frequencies. Picture by BAE Systems.

Consequently, it appears from the available reports and data that the most likely cause of the vibrations is an unbalance in the elevator control system interacting with aerodynamic forces and the structural vibrations modes of the entire aeroplane to give a flutter instability with limited amplitude, a so-called “limit-cycle oscillation” (LCO).

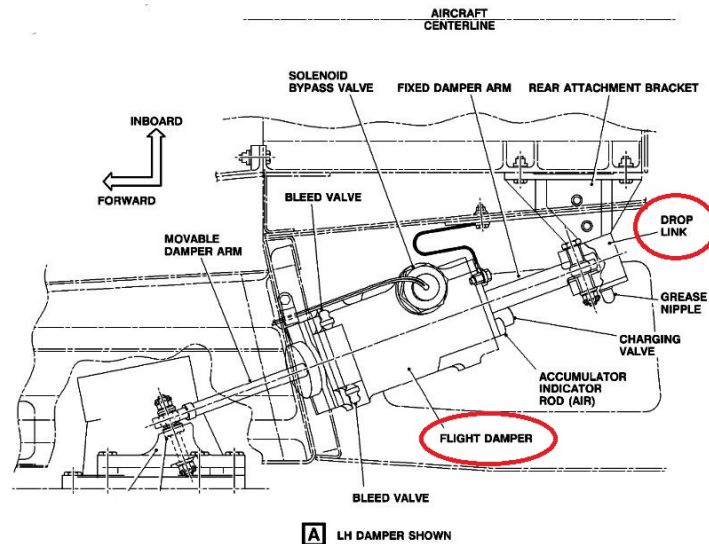
During these final inspections in Cologne, damages were found on one flight damper and one drop link, (see figure 12). According to the engineer that performed the inspection, it is uncommon to find a play larger than limit on the drop links.

Figure 12. Flight damper and drop link.
