STATENS HAVERIKOMMISSION (SHK)
BOARD OF ACCIDENT INVESTIGATION

Report S 1992:5e

**Maritime Accident on 5th November 1991
10 nautical miles east of Teesport,
England, U.K.**

Board of Accident Investigation (SHK) has investigated a maritime accident which occurred on 5th November 1991 outside Teesport, England, U.K. with a ro-ro vessel, MS Stora Korsnäs Link I.

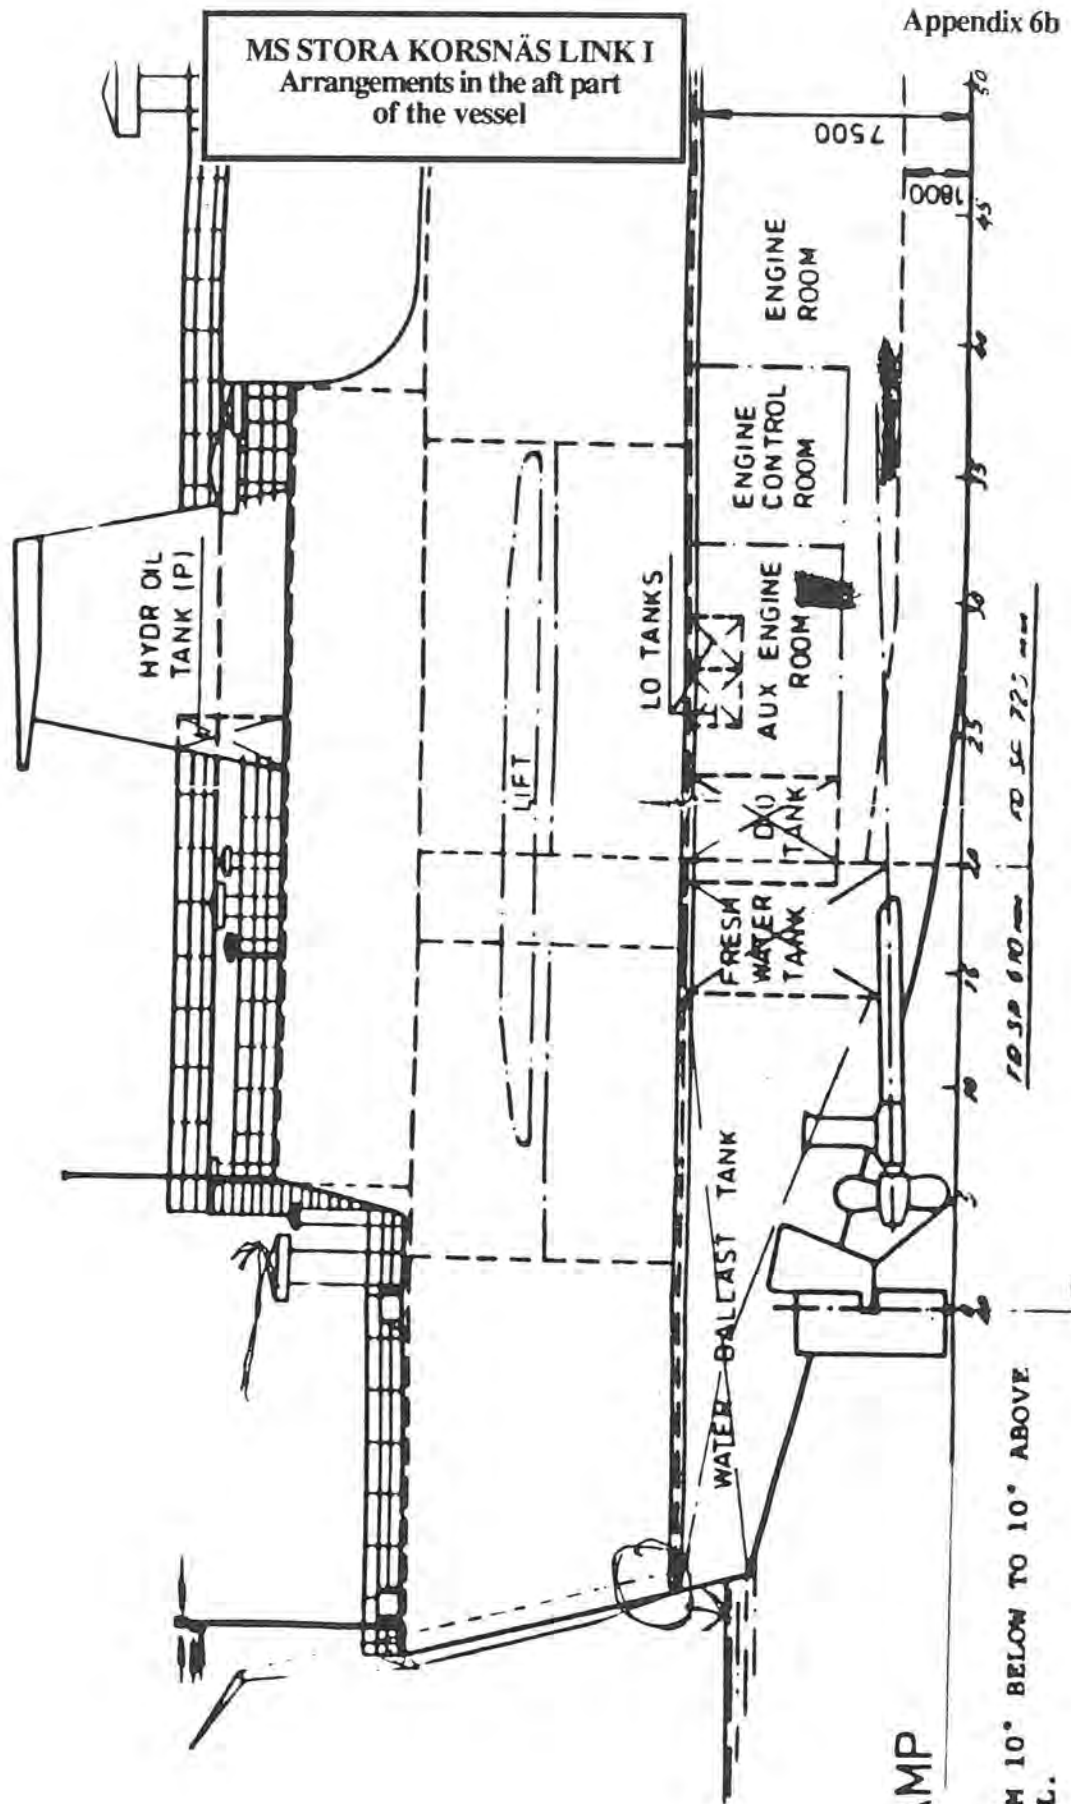
MS STORA KORSNÄS LINK I
Arrangements in the aft part
of the vessel

- On the starboard side below the waterline at frame 30 a 3ft x 4 ft hole was created. The bulkhead between the auxiliary engine room and the main engine room was bent heavily forward and the steel door was missing. A rupture of 7ft by 1ft had formed between frames 35 and 40, with outward-bent edges.

The complete destruction in the auxiliary engine room, the 3ft x 4ft hole in the starboard side at frame 30, the heavily distorted bulkhead towards the engine room, the blown away door and the 7ft x 1 ft rupture between frames 35 and 40 in the engine room indicate on the other hand that a violent explosion had taken place in that region. The combined area of the holes in the side shell below the waterline would permit rapid water flooding of the vessel, and its subsequent turning over and foundering.

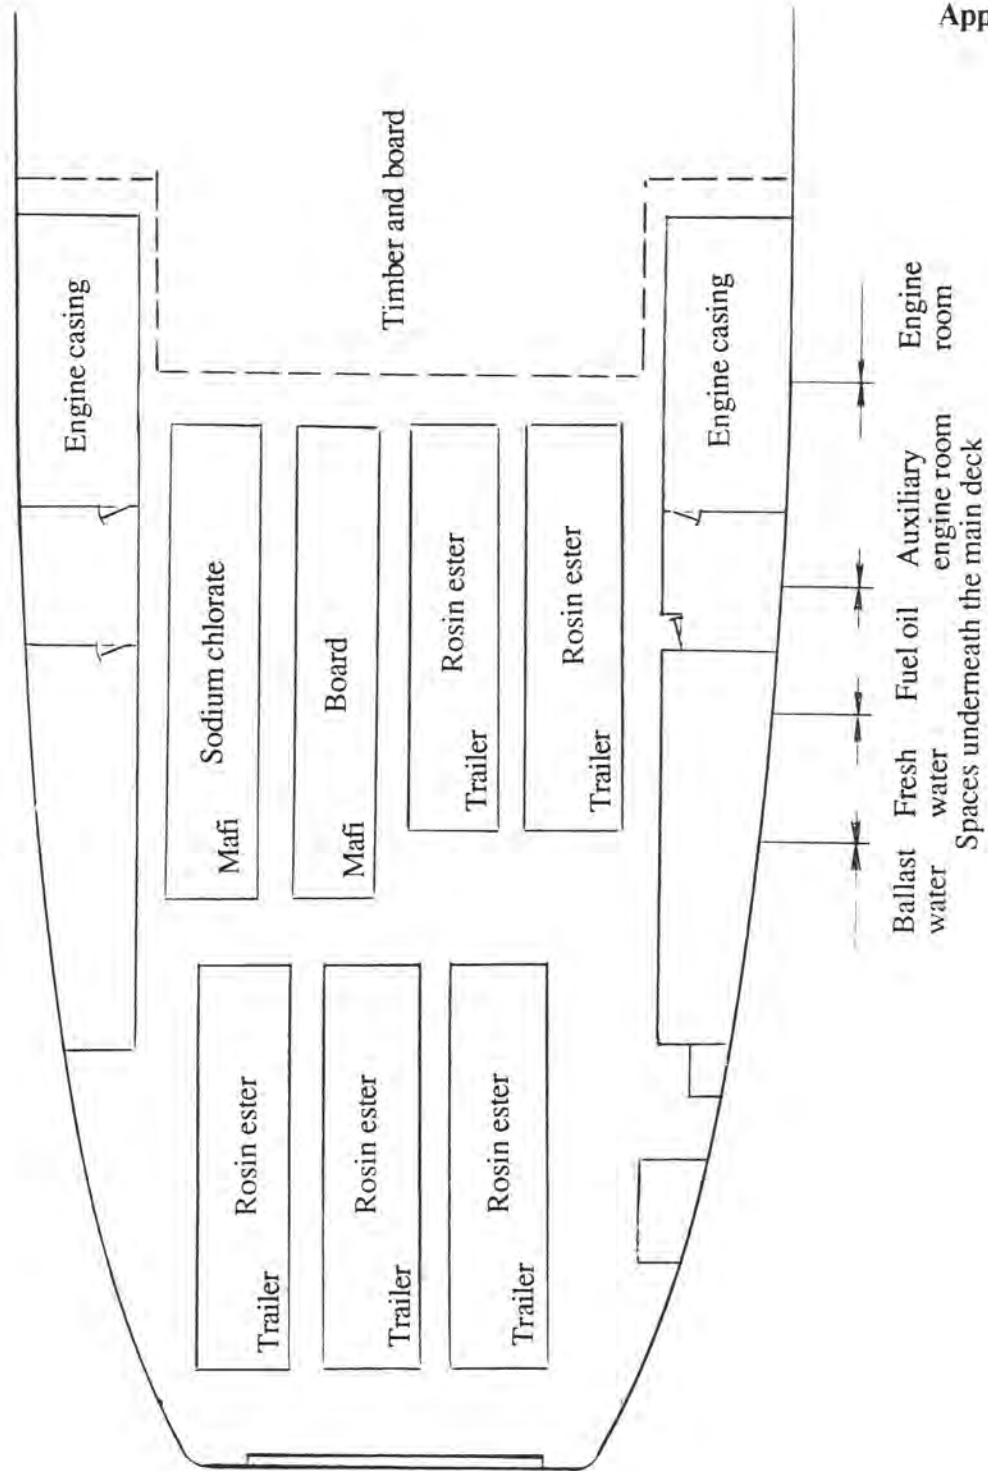
MS STORA KORSNÄS LINK I
Likely stowage of sodium chlorate
and rosin ester cargoes

The fire on board eventually involved the cargo on the aft part of the main deck where the containers with sodium chlorate and tall oil rosin ester were stowed. The heat caused the rosin ester to melt and flow onto the deck. During the melting phase the temperature in the rosin ester may locally be rather constant at 135°C as the available heat is used for melting the ester. The heat required to melt the entire cargo of rosin ester is about 10 GJ which corresponds to the burning of about 500 kgs of pulp. The volume of the molten rosin ester was about 140 m³.

It is likely that the first explosion ruptured the garage deck and the main deck in the area of the storage of the chlorate and rosin ester cargoes, and blew out the stern ramp. It is also likely that chlorate (both solid and molten) and rosin ester was ejected, and mixed, through the holes in the garage deck and the main deck and caused the ensuing explosions. During each of these later explosions the burning surface was probably larger than during the first one (due to more efficient mixing and spreading mechanisms). Explosions in gases are not considered capable of creating sufficient pressure to rupture hull plating below the waterline.
