Final report RL 2021:06e

**Accident at Linköping/Saab Airport,
Östergötland County on 26 September
2020 involving SE-CXN, an aeroplane of
the model Cessna-180D, operated by a
private individual.**

File no. L-83/20

10 June 2021

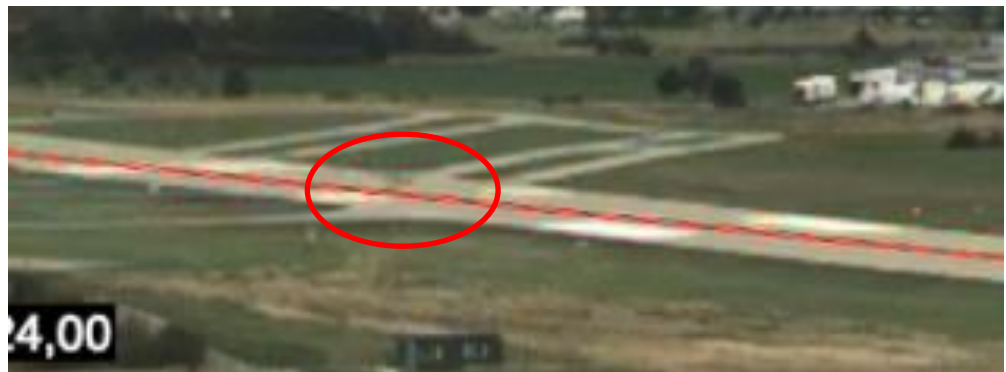
Figure 11. The aeroplane's estimated initial touch-down point. The centre line and circle have been added by SHK. Source: Sundsvall RTC.

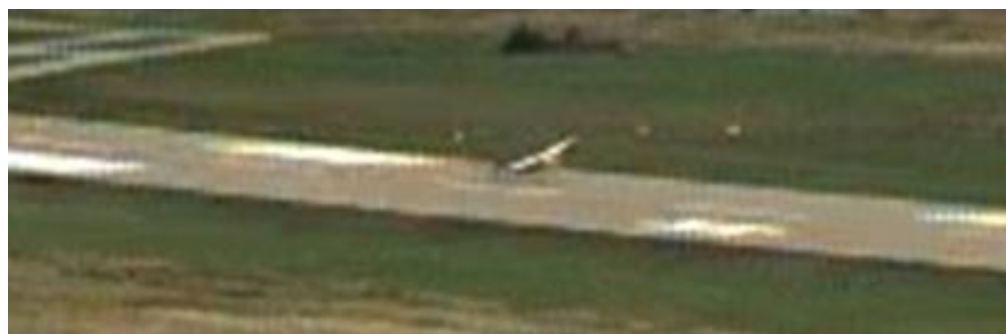
Figure 12. The left wing is raised and the ground loop sequence begins. Source: Sundsvall RTC.

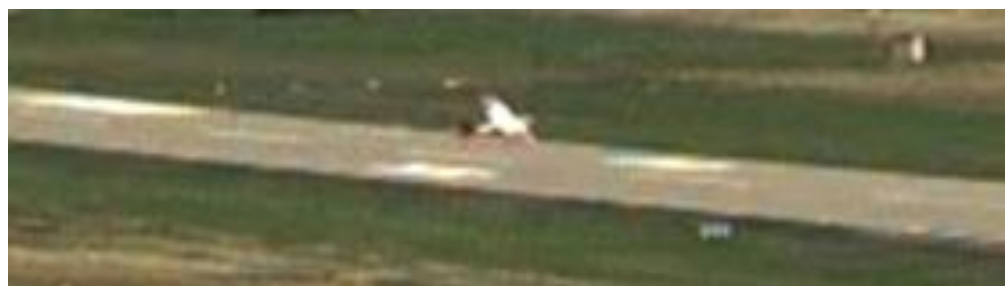
Figure 13. The aeroplane leaves the paved surface. Source: Sundsvall RTC.

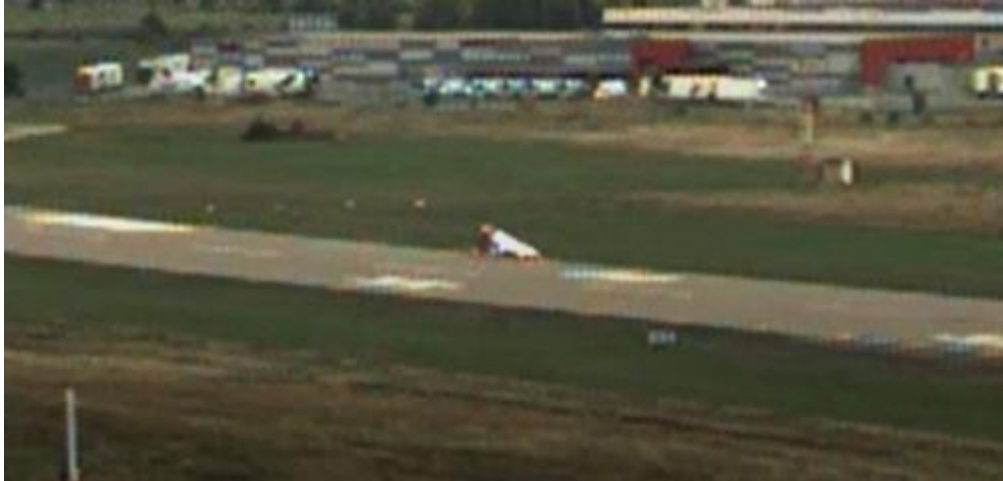
Figure 14. The aeroplane comes to a stop with the main wheels outside of the paved surface and the right wing is in contact with the ground. Source: Sundsvall RTC.

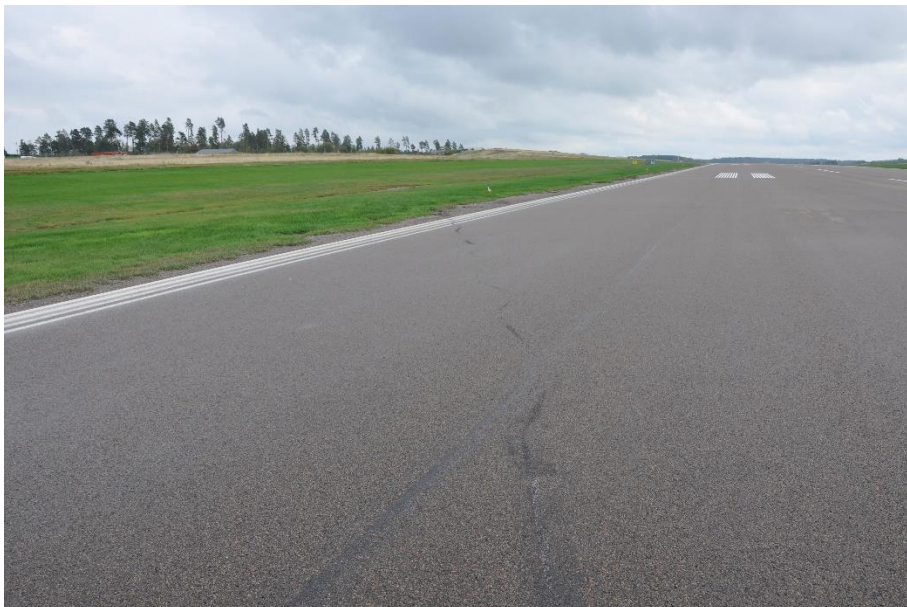
On the runway there were clear marks of tyre and metal that ended with tracks in the grass (see Figures 15, 16 and 17). The marks were of a rubber and metallic nature and were a total of 50 metres long.

Figure 15. Clear white marks of metal and marks of rubber up to the excursion point.

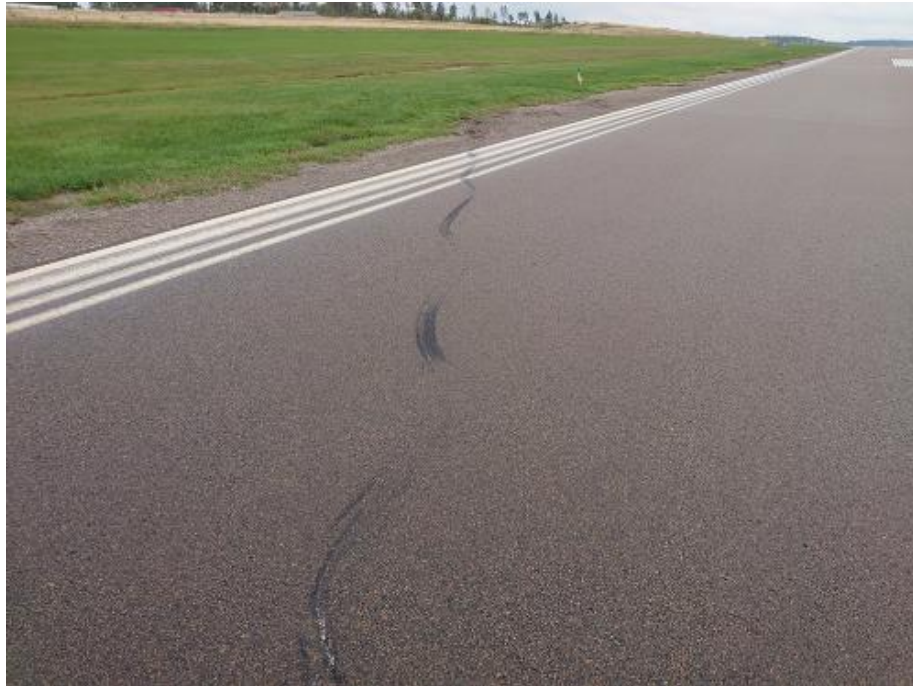
Figure 16. Marks on the runway from rubber and metal.

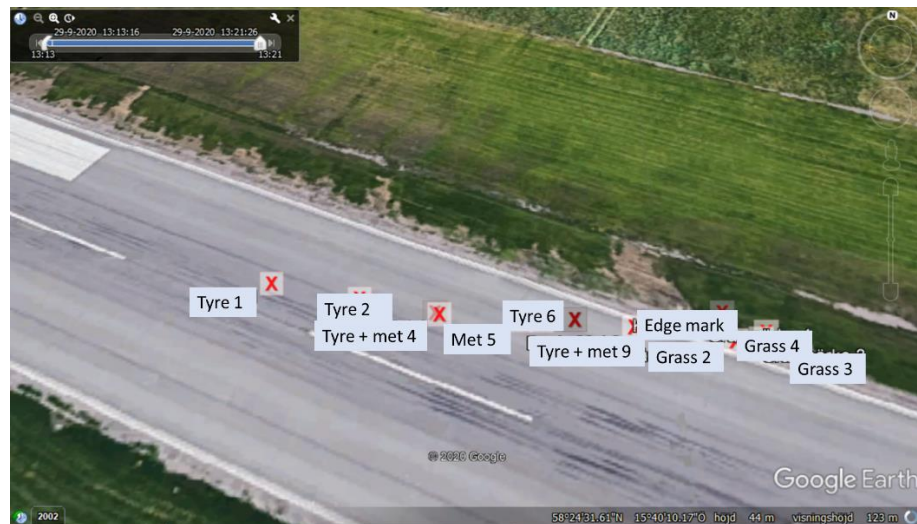
Figure 17. Marks on the runway from the first mark to the final position north of the runway (tyre and metal). SHK's measurements overlaid on a picture of the runway from Google Earth.

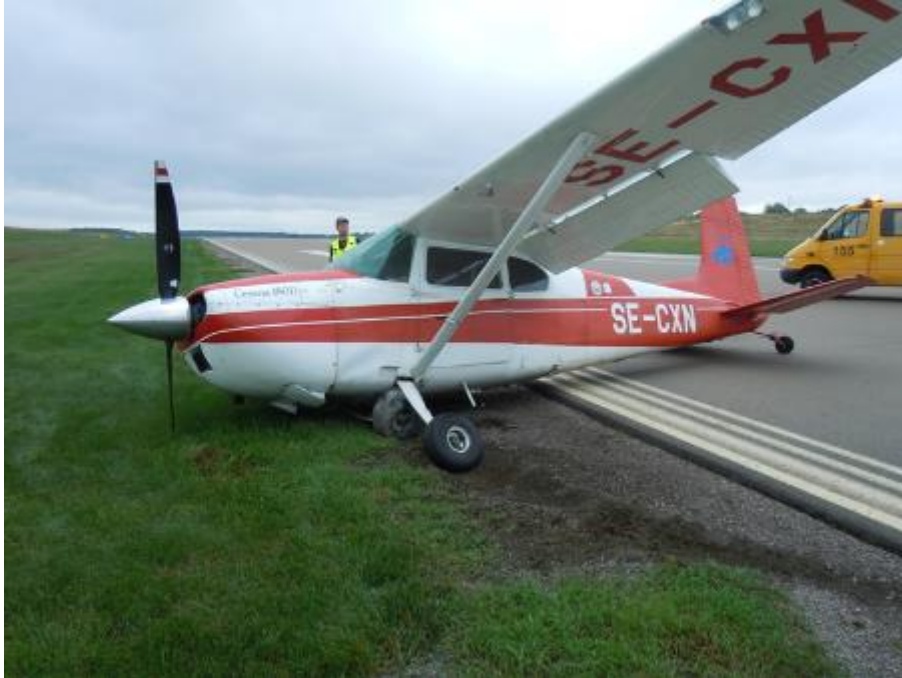
During the accident, the right landing gear was broken from its attachments to the structure of the aeroplane and folded under the fuselage (see Figure 18).

Figure 18. Right landing gear folded under the fuselage. Photo: Saab fire and rescue service.

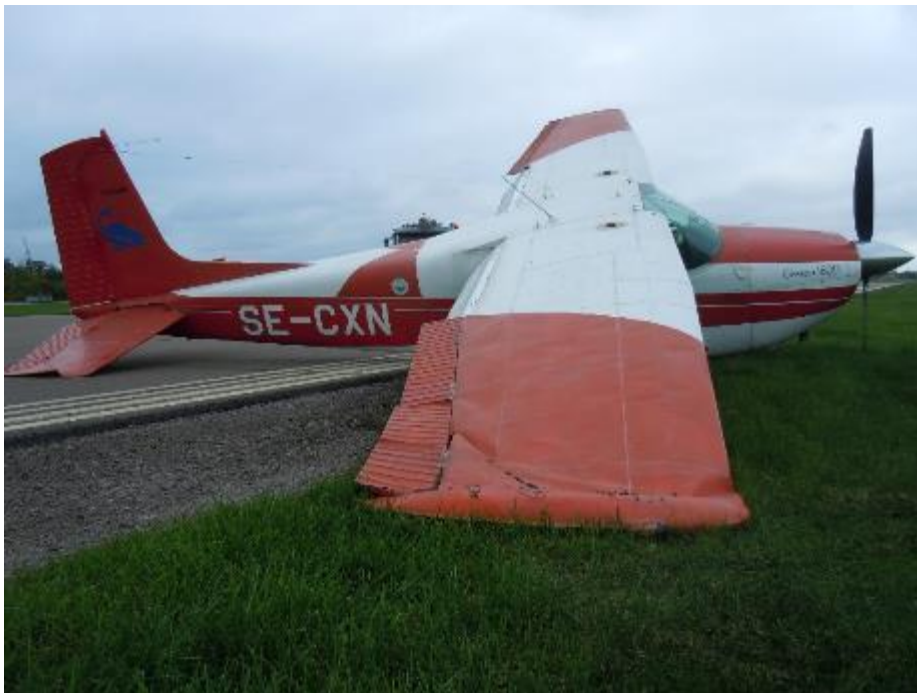
As a result of this, damage occurred to the right wing, right aileron and propeller (see Figures 18 and 19).

Figure 19. Damage to the right wing and aileron. Photo: Saab fire and rescue service.

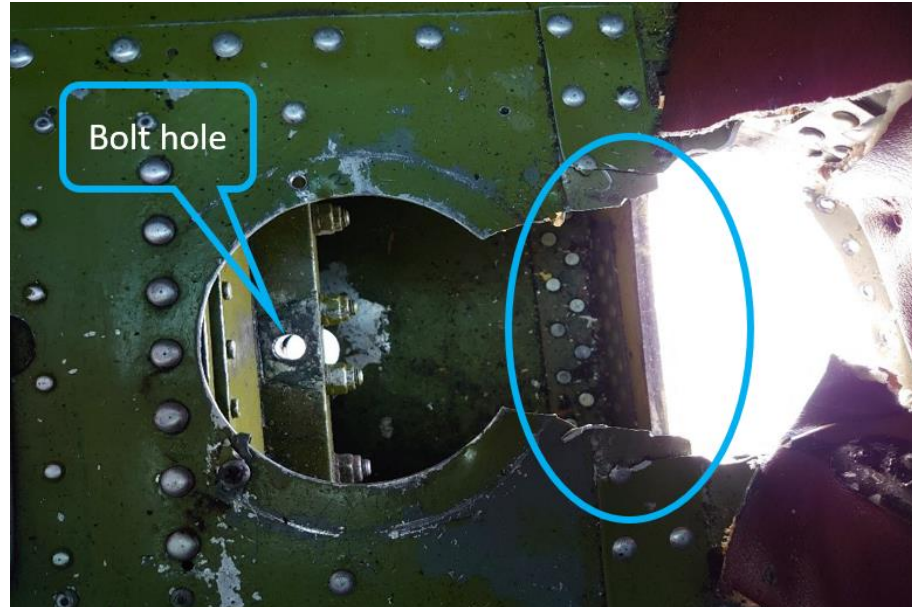
There was extensive structural damage to the fuselage area at the landing gear outboard attachment and to parts of the cockpit floor (see Figure 20). The outboard attachment, which i.e. consists of a bracket, was structurally broken.

Figure 20. Damage to the fuselage in the area of the attachment of the right landing gear. The bolt hole for the inboard attachment and damage at the outboard attachment are indicated.

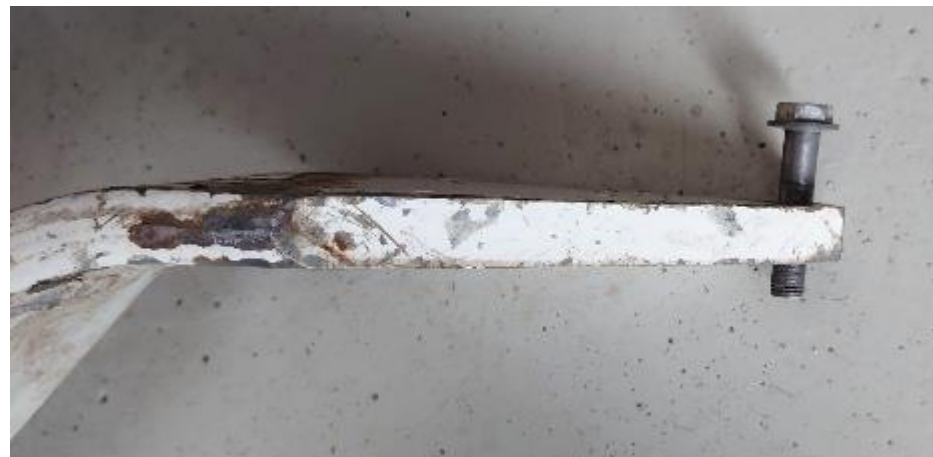
The bolt for the inboard attachment of the landing gear was bent and parts of the threads were damaged. The nut for the bolt was missing and has not been found.

Figure 21. Landing gear strut with bolt for attachment.

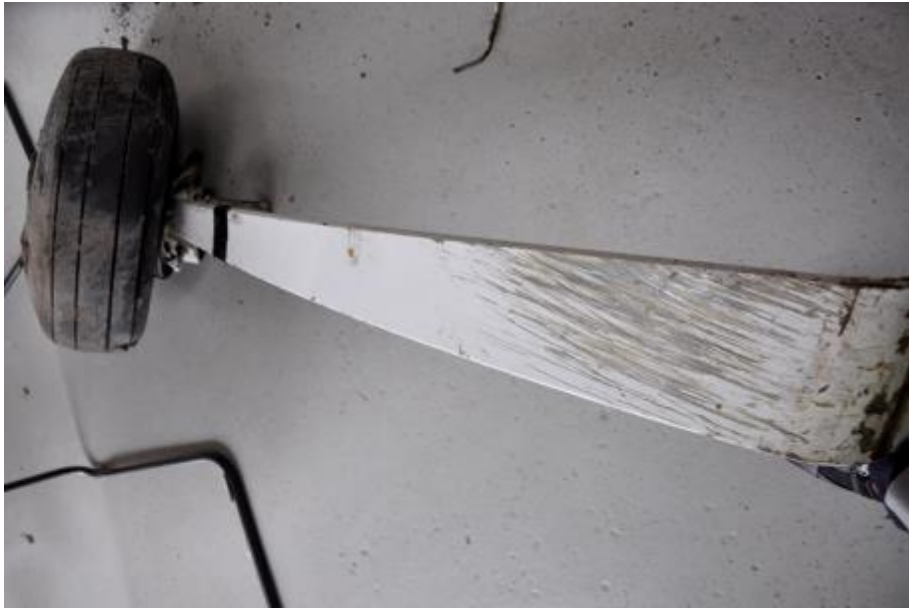
The upper side of the right landing gear had significant scrape marks that were deemed to correspond to the white marks on the runway (see Figure 22).

Figure 22. The upper side of the right landing gear.

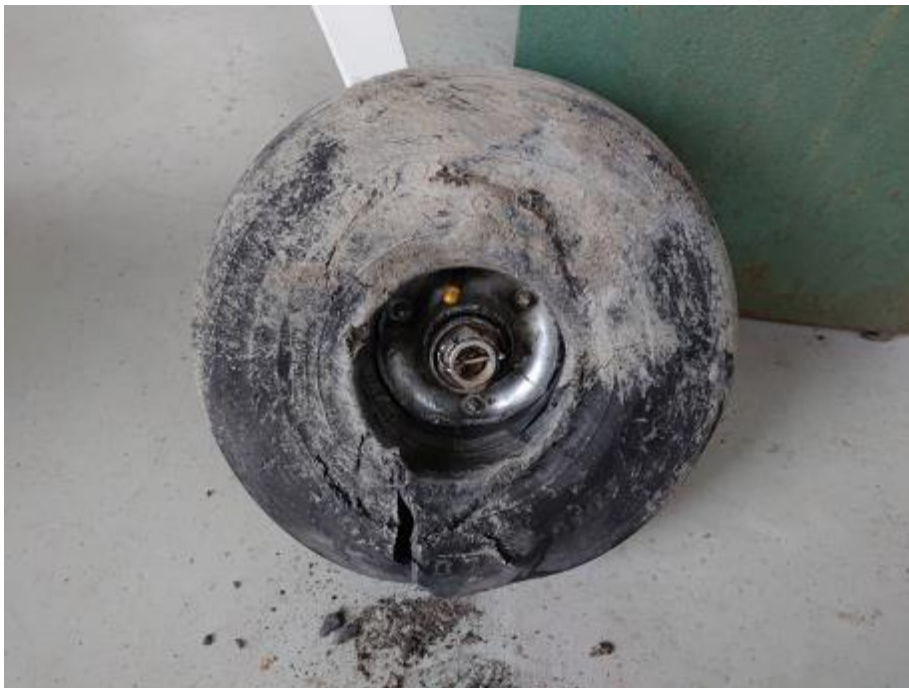
The right wheel suffered extensive damage and parts of the outer part of the rim were broken off.

Figure 23. Damaged right wheel.

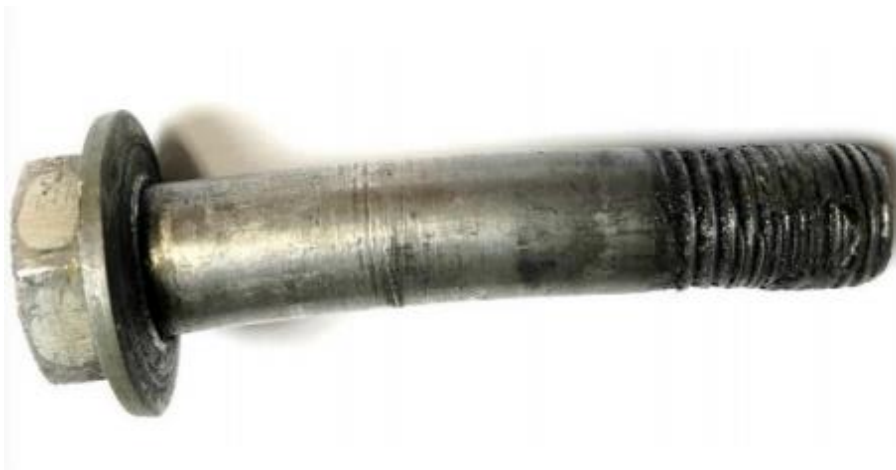
The entire bolt is bent, which means that its yield strength has been exceeded (see Figure 25).

Figure 25. The bolt for attachment of the landing gear.

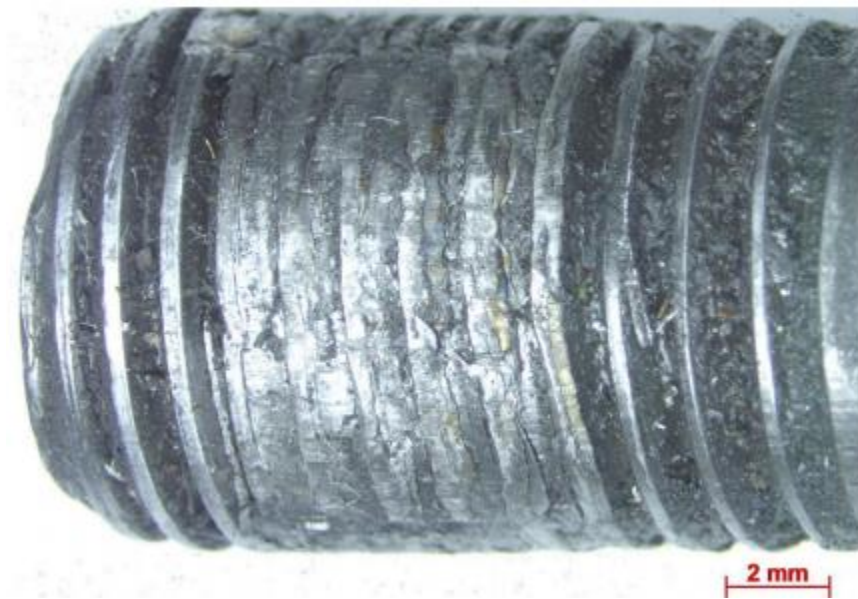
The threads on the bolt are heavily deformed along a section approximately 7 millimetres in length and, in this area, the threads are filled with metallic material (see Figure 26).

Figure 26. Enlargement of the bolt with deformed threads and metallic material in the threads.

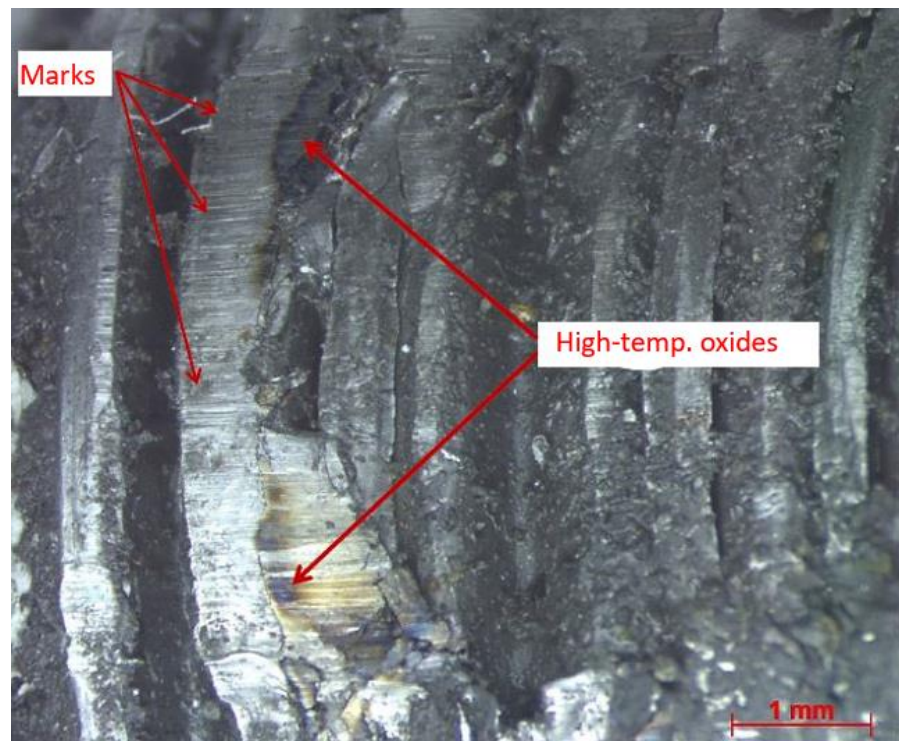
Higher magnification of the deformed threads reveals clear signs of powerful shearing between two metallic materials, with high-temperature oxides¹² and marks in the longitudinal direction of the bolt (see Figure 27). These damages indicate a high instantaneous tensile overload of the bolt.

Figure 27. Enlarged image of the threads.

The overall picture of the sequence of events in which the bolted joint was damaged suggests that the threads on the nut has broken as a result of a high instantaneous tensile overload of the bolt. The damage that occurred to the threads of the bolt indicates that the dimensions of the nut were consistent with the specifications in the aeroplane's IPC.
