Australian Transport Safety Bureau

AO-2017-032

Web update

The occurrence

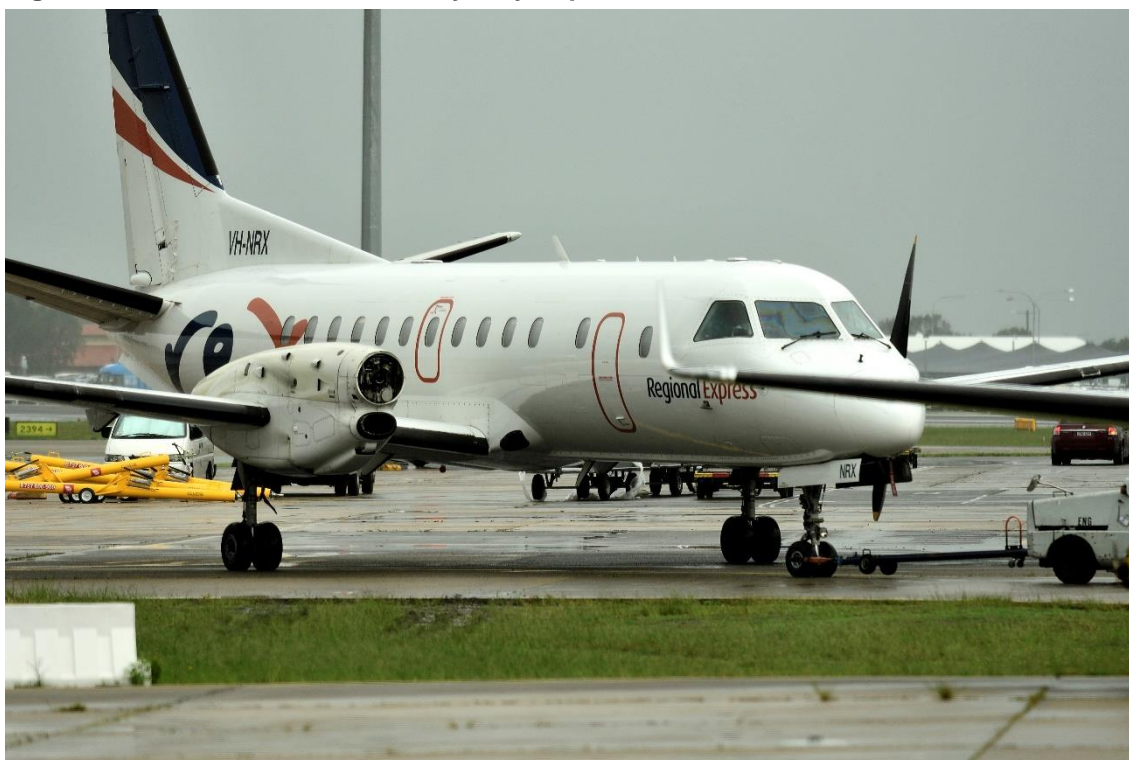
Figure 1: The aircraft, VH-NRX, at Sydney airport after the incident

An inspection of the aircraft by the ATSB at Sydney airport identified that the propeller shaft had fractured, leading to the separation of the propeller.

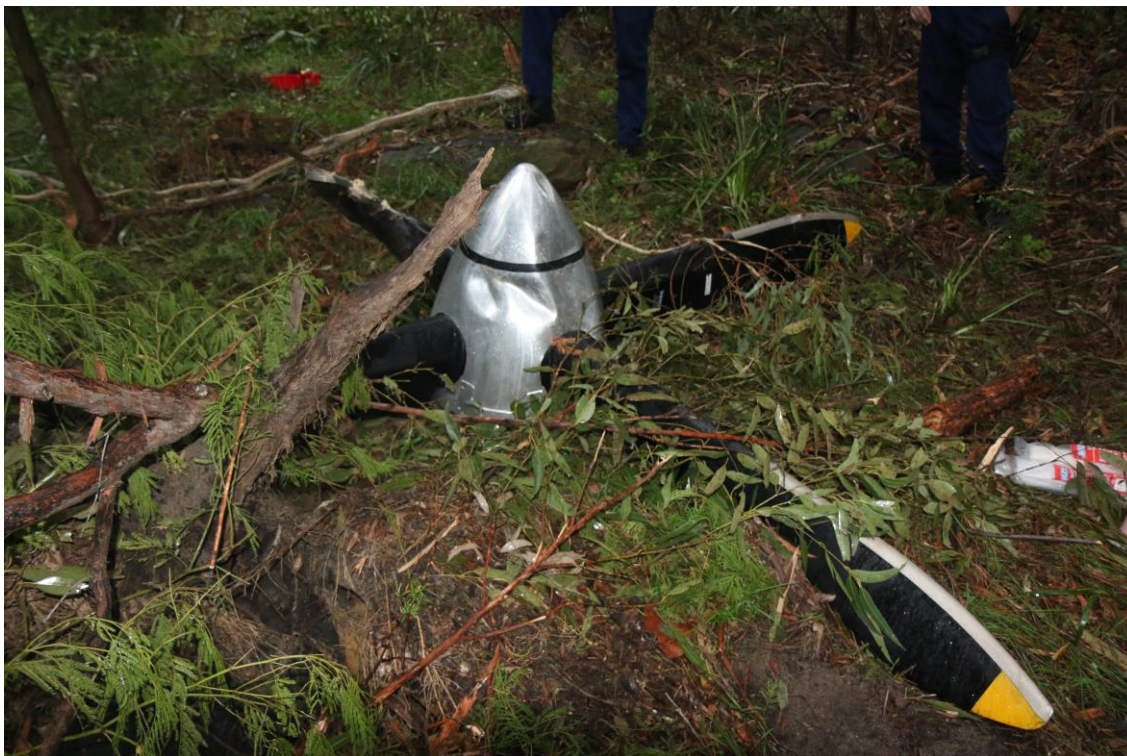
Figure 2: The propeller that had separated from VH-NRX as found by PoIAir about 8NM south-west of Sydney airport.

The propeller was found with the flange section of propeller shaft secured to the propeller assembly and a fracture through the propeller shaft. ATSB subsequently removed the remaining propeller shaft and integral flange section (Figure 4Error! Reference source not found.) for examination at its facilities in Canberra.

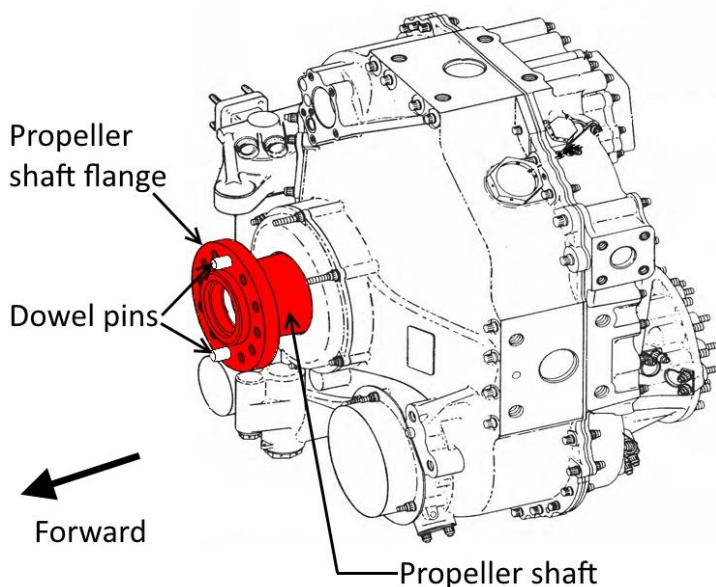
The recovered part of the propeller shaft is highlighted in Figure 3. The propeller was found properly secured to the forward-facing flange by bolts and the dowel pins pictured. The examination was conducted with representatives present from the Civil Aviation Safety Authority (CASA), SAAB, GE Aviation (engine manufacturer) and Regional Express (REX). Initial observations revealed cracking that appeared to run between the main shaft and the flange region. The part was sectioned in order to expose the crack's fracture surface.

Figure 3: Propeller gearbox schematic highlighting the recovered section of the propeller shaft

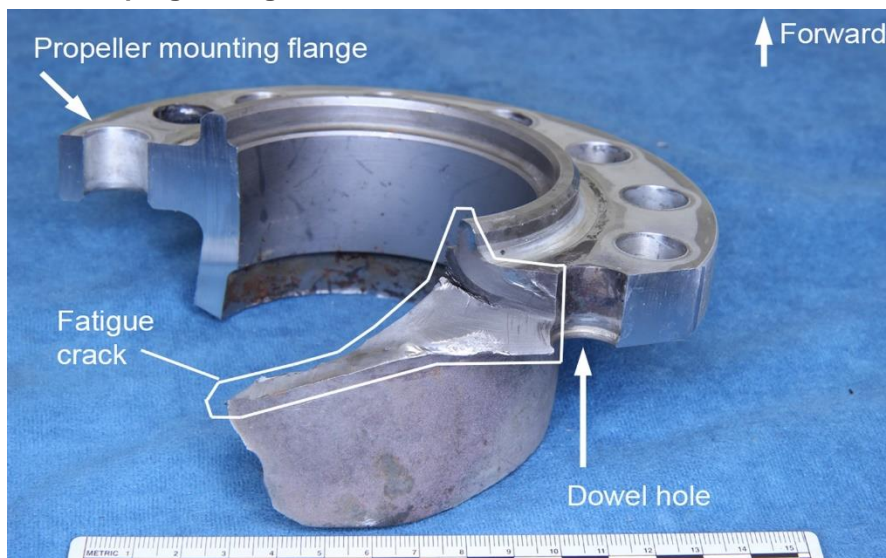
The crack was found to be a fatigue fracture that had initiated within the propeller mounting flange, and then transitioned into the shaft section (see Figure 4). The crack originated at the bore of a dowel pin near the forward face of the propeller hub flange. The dowel pin bore was corroded in parts (shown in **Figure 5**), and corrosion pitting was found near the fracture. Further work is ongoing to ascertain whether the corrosion or other factors contributed to the fracture initiation.

Figure 4: Section of the propeller shaft showing the fatigue crack originating at the dowel hole and progressing into the shaft itself

This is the first known critical failure of this type initiating within the propeller hub flange of a GE Aviation CT7-9B engine. The same propeller gearbox (PGB) is fitted to multiple variants of the CT7 engine (5A2, 7A1, 9B, 9C, and 9C3) on SAAB 340 and EADS CASA² CN-235 aircraft. There is currently no maintenance requirements specified in existing maintenance manuals for routine

Regional Express has quarantined all propeller gearboxes with propeller shafts of the same series as that installed in VH-NRX.

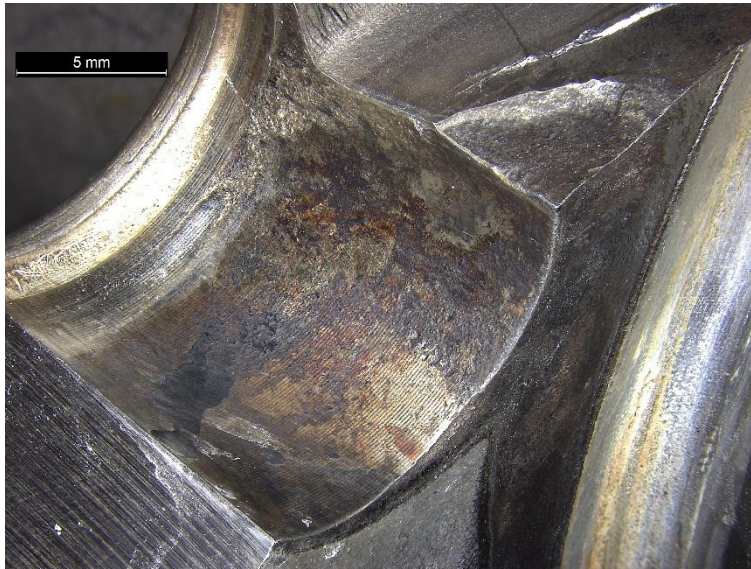
inspection within the dowel pin bores. Any corrosion or cracking within the bore may go undetected until it progresses to the surface of the flange. Other than a visual inspection of the flange during propeller removal, inspection for surface defects (via magnetic particle inspection or dye penetrant inspection) only occurs when the PGB is disassembled for maintenance at a workshop specifically approved by the engine manufacturer.

Figure 5: Corrosion observed within the bore of the dowel pin hole

The ATSB advises that those responsible for the operation and maintenance of SAAB 340 and EADS CASA CN-235 aircraft fitted with the GE Aviation CT7 engine type variants 5A2, 7A1, 9B, 9C, and 9C3 should note the facts presented in this preliminary report with a view to addressing any risks to their own operation.
