Final report RS 2014:03e

**Fatal accident on board the Morraborg in
the port of Holmsund, in the county of
Västerbotten, Sweden 3 July 2011**

File number S-95/11

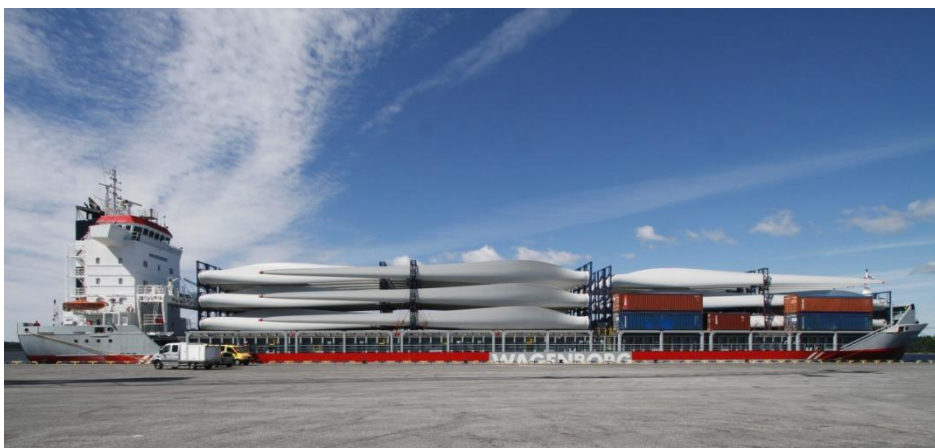
Figure 1, Morraborg berthed in Holmsund right after the accident, before discharge of the deck cargo.

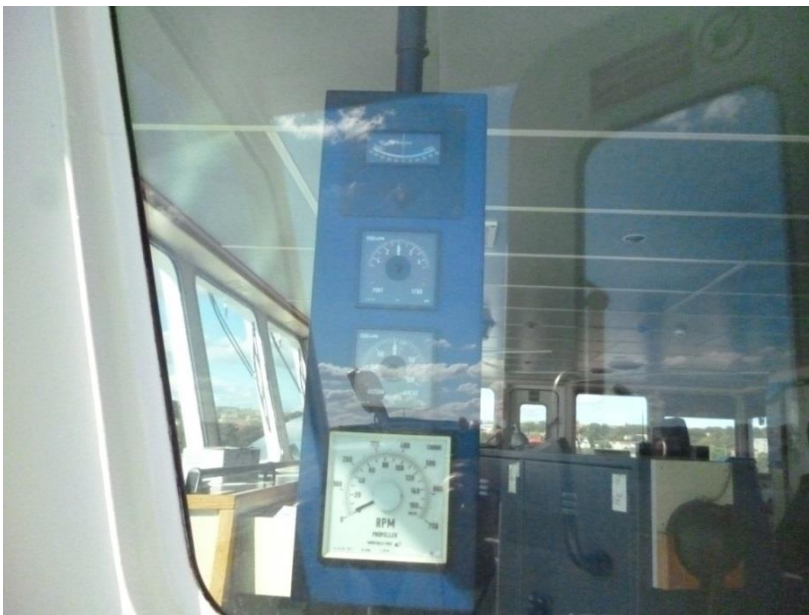
The bridge is of a traditional design with open bridge wings and a centre console for the manoeuvring. There are no bridge wing indicators fitted to show rudder position or engine applied outside, but there is a panel inside the bridge that can be turned to face the bridge wing. The panel shows rudder, pitch, engine revolutions and bow thruster. There is also a portable bridge control box that can be carried outside and used for manoeuvring the ship from either of the bridge wings.

Fig. 2, Panel with indicators that can be turned to face the bridge wing.

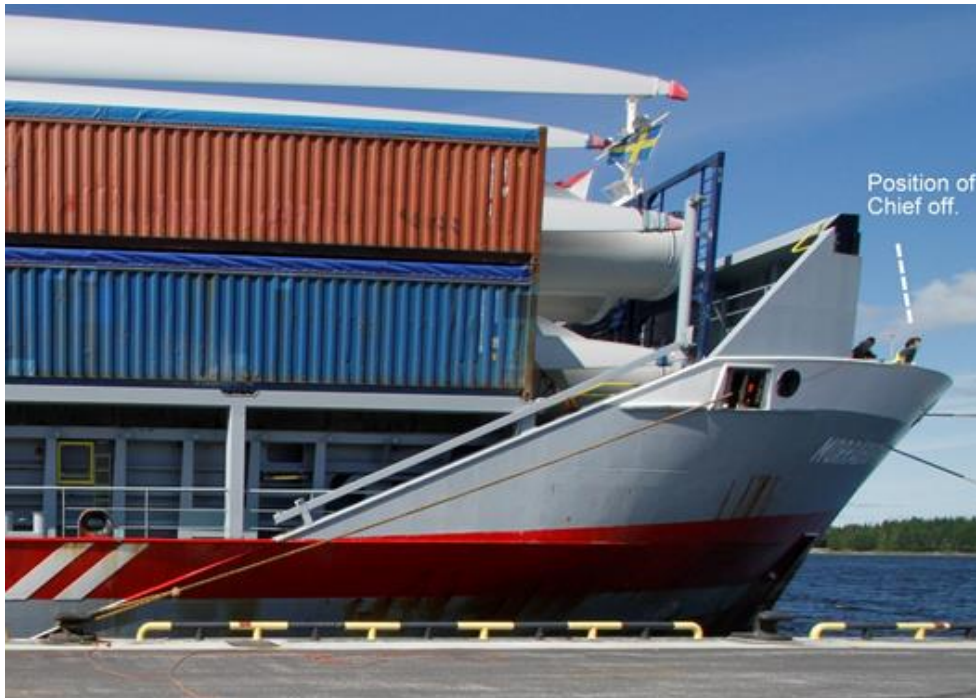
The chief officer was leading the team from a position by the bulwark, mid between the spring line and the head line fairleads. At this position there is a

Fig. 3, Morraborg after berthing in Holmsund. Another person indicates the approximate position of the chief officer at the time of the accident.

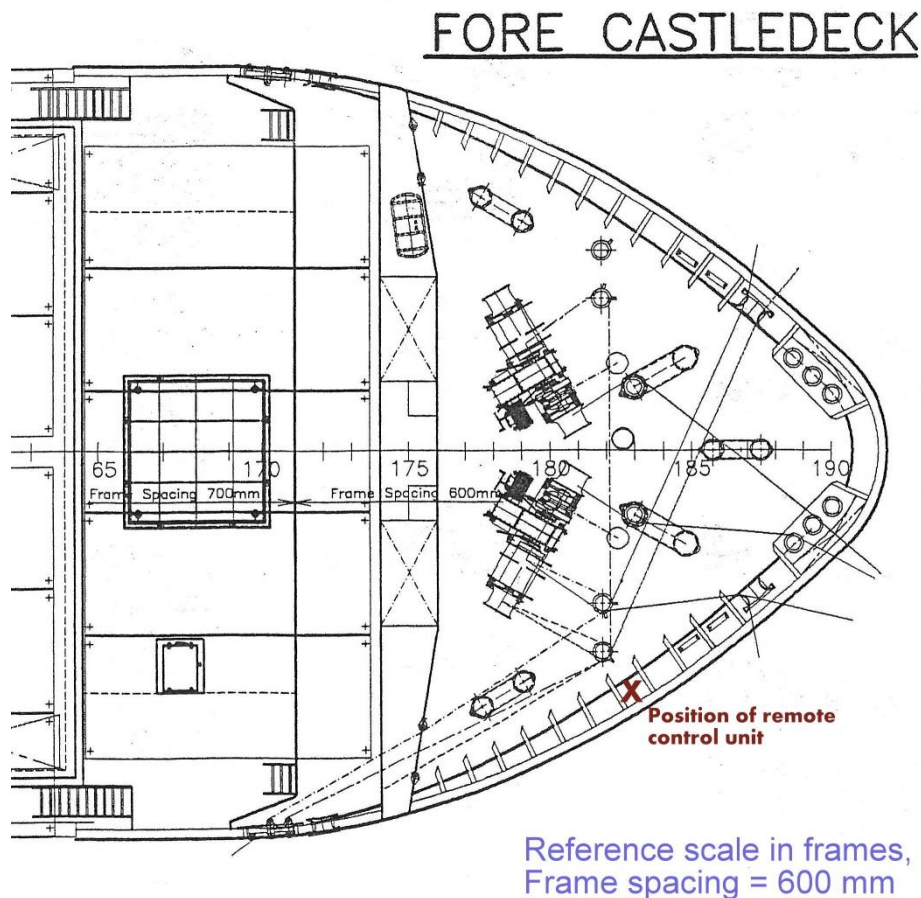
The working space between winches, pedestals and bulwark is restricted. The distance is about one meter between the remote control unit with the platform where the person supervising the mooring is supposed to stand, and the pedestal fairleads. The remote control unit was fitted when the ship was built. The area of the remote control unit and the platform is within the immediate snap back area from the spring line. There are no markings on the deck of potential snap back zones.

Figure 5, Drawing of forecastle deck showing position of windlasses and general mooring patterns.

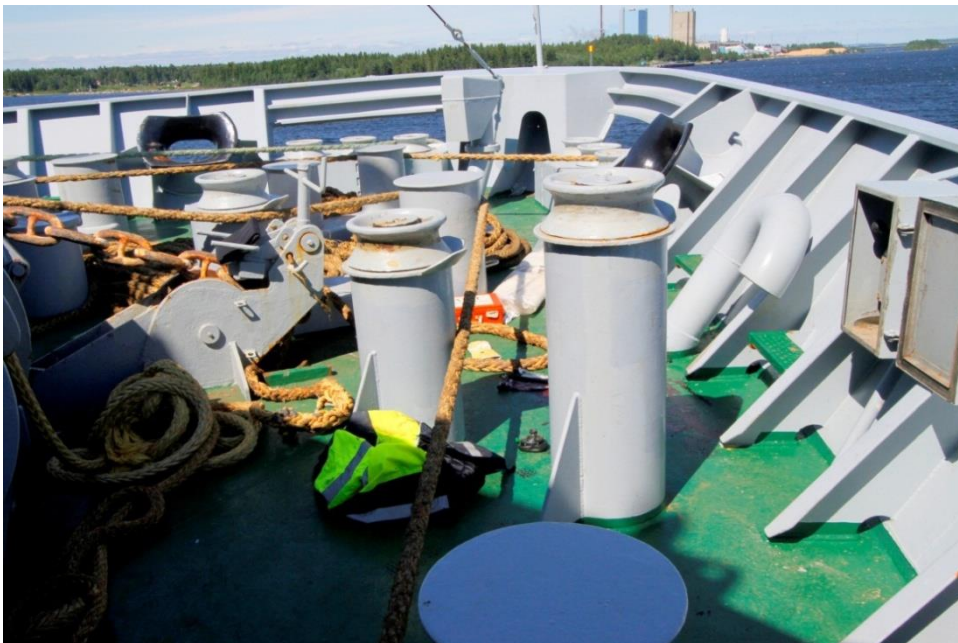
Each mooring winch can be operated either from control levers on the windlass or from a remote control unit mounted in a box on the bulwark. Nearby the box there is an elevated platform for the operator in order for him to have a view over the bulwark e.g. downwards to the quay.

Fig. 6, Forecastle deck. To the right: the position of the chief officer when the accident occurred in the area of the platform at the remote control unit. To the left; the remaining of the parted spring line, piled up at its winch drum. It should be noted that the displayed configuration of the lines was made to moor the vessel after the accident and thus no representation of the common configuration used.

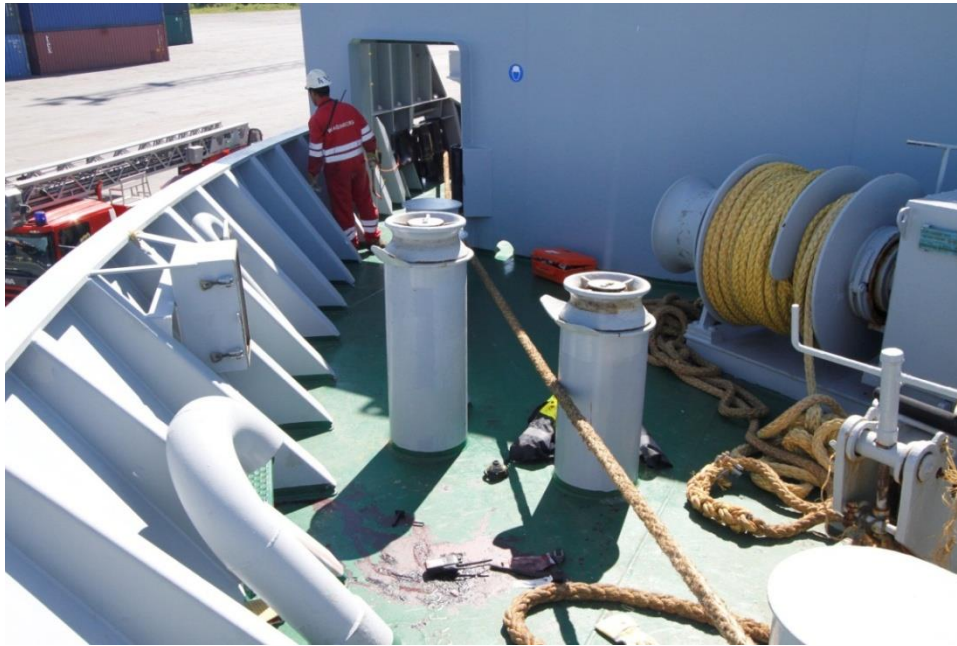
Fig.7, Forecandle deck, opposite direction. Through the opening in the bulkhead the spring line roller fairlead can be seen. It is likely that the spring line was lead over both of the pedestal fairleads seen in the middle of the picture. According to the pilot this was, despite the difference in height of the fairleads, the common way to run the spring line in the vessel series that Morraborg belonged to.

On the occasion the mooring rope of the starboard winch drum was used as a spring line. From the winch the rope was led over one or two pedestal fairleads, through a roller fairlead mounted in the bulwark, and down to a bollard on the quay. In the roller fairlead the rope run through a rectangular space between four rollers - two horizontal and two vertical. There were no sharp corners and the bends of the rope were not excessively sharp.

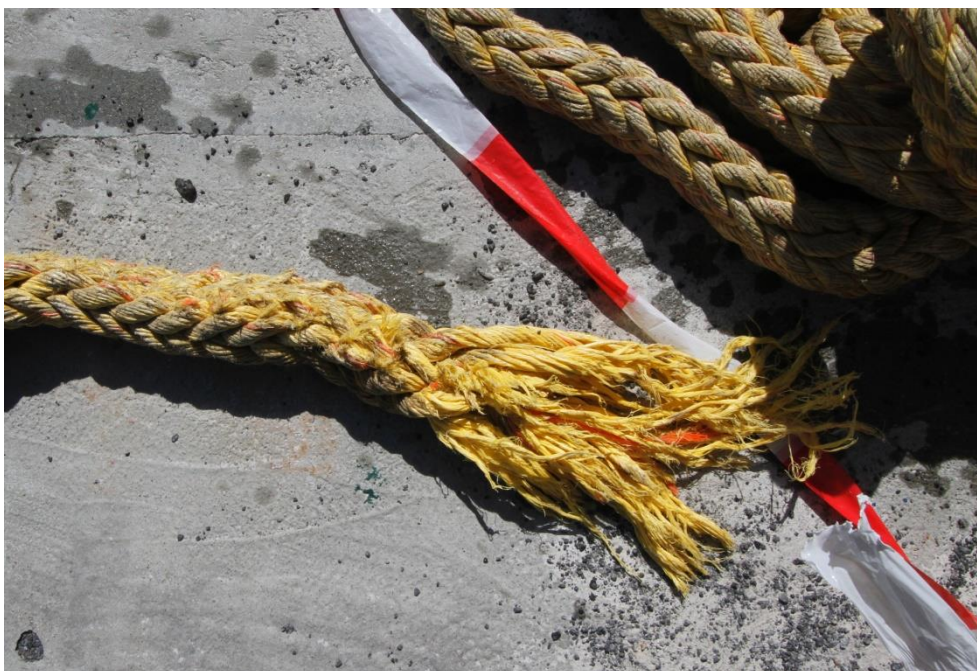
During their technical investigation on board the police had cut off parts of the rope, one section on each side of the fracture. The character of the fracture is "torn and threadbare". On the part of the rope coming from the winch there was a knot which was not tightened. The boatswain explained that he and the able seaman made the knot, a bowline, in order to send the rope ashore again to complete the mooring, but finally they choose to use another rope for the purpose.

Figure 8, quay side part of the parted spring line

Photographs taken by the police show the quay side part of the fractured rope collected/piled up close to the bollard. The amount of rope in the photograph indicates that the fracture most presumably occurred at the roller fairlead.

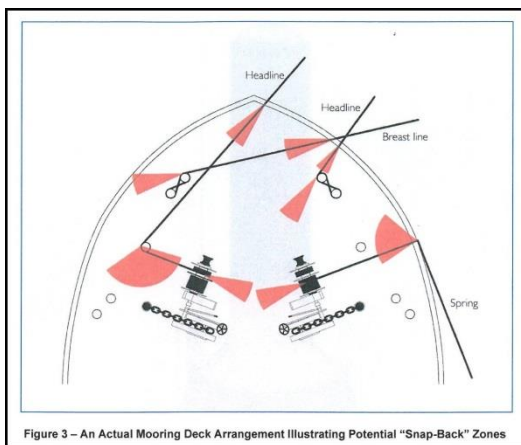
Figure 3 – An Actual Mooring Deck Arrangement Illustrating Potential “Snap-Back” Zones

- Figure 9, Description in the labour catalogue of potential snap back zones on a forecastle. The illustration is also found in, and is origin from, The Code of safe working practises for merchant seamen, 2009. Maritime Coastguard Agency, UK

There are several publications available to mariners that contain misleading information on the extent of potential snap back areas. Amongst them is the publication that was available onboard *Morraborg*. The same picture occurs also in a guideline issued by the UK Maritime and Coastguard Agency, MCA. In figure 10 the snap back areas drawn are misleading in particular when it comes to the longitudinal extension of the potential snap back area.

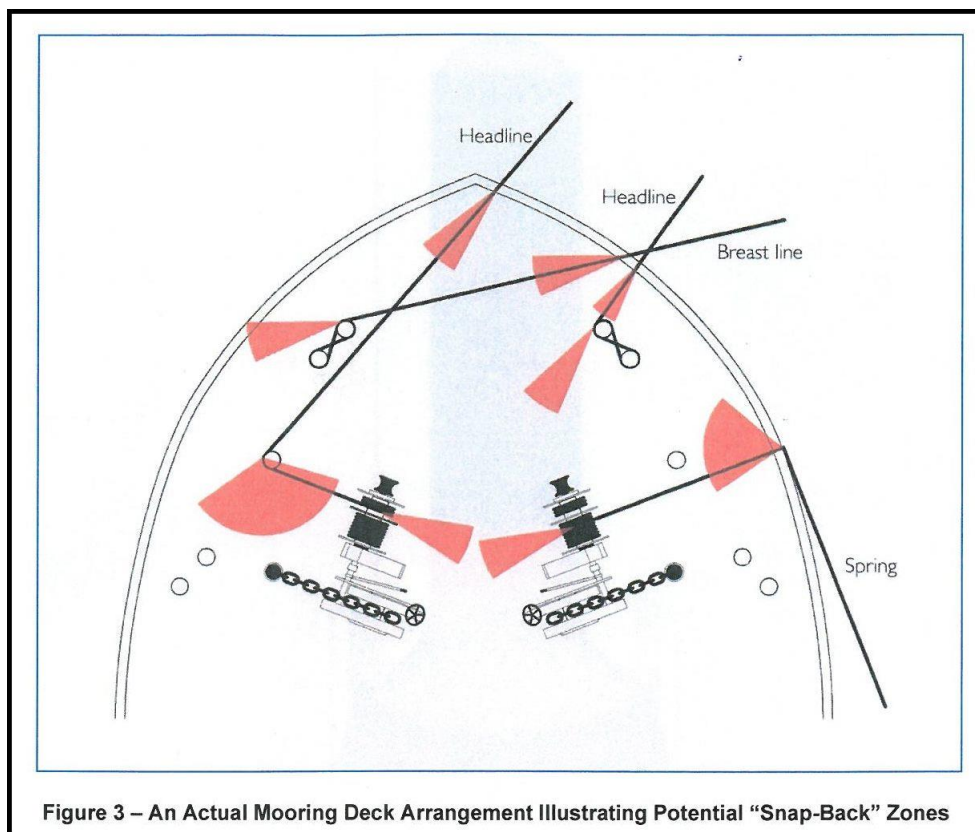
Figure 10, Snap-back zones as described in instructions onboard and in some other publications.
