## *Final report RS 2016:07e*

VICTORIA – Running aground at Fladen,  
Halland County, den 19 September 2015

File no. S-172/15

02/09/2016

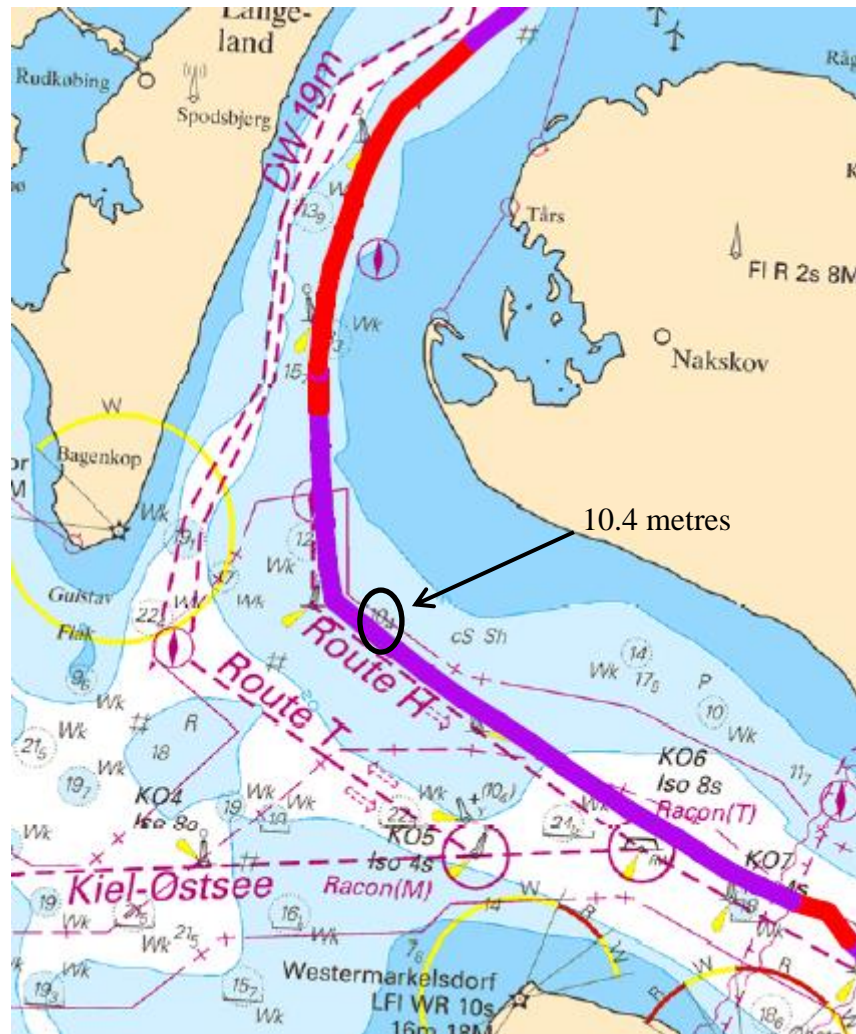
Figure 2. Route H.

Route T runs from a position 5 M north-east of Skagen to approx. 25 M west of Cape Arkona. Route T is marked with buoys, light buoys and mid-channel light buoys (fig. 8). There are two routes running through Langeland Belt; Route T, which is marked here as a deep water route with an established depth of 19 meters (DW 19) and Route H with an established depth of 12 metres and which, according to *Admiralty Sailing Directions* and Danish navigational chart 103 (INT 1303), vessels with a draught of 10 metres or less *must* follow. The IMO Ships' Routeing stated however that ships with a draft of 10 meters or less *should* choose the nationally recommended Route H. Route H only has marking in the form of mid-channel buoys with lights. At buoy 7 there is a severe turn to starboard, northbound. Just before buoy 7 there is a shoal at a depth specified in the navigational chart as 10.4 metres, which VICTORIA passed close by. At buoy 7 (where the vessel changed course), there is another shoal at a depth of 10.6 metres. Both shoals are without marking (fig. 2).

SHK recommends the Danish Maritime Authority to consider and evaluate the buoyage along Route H.

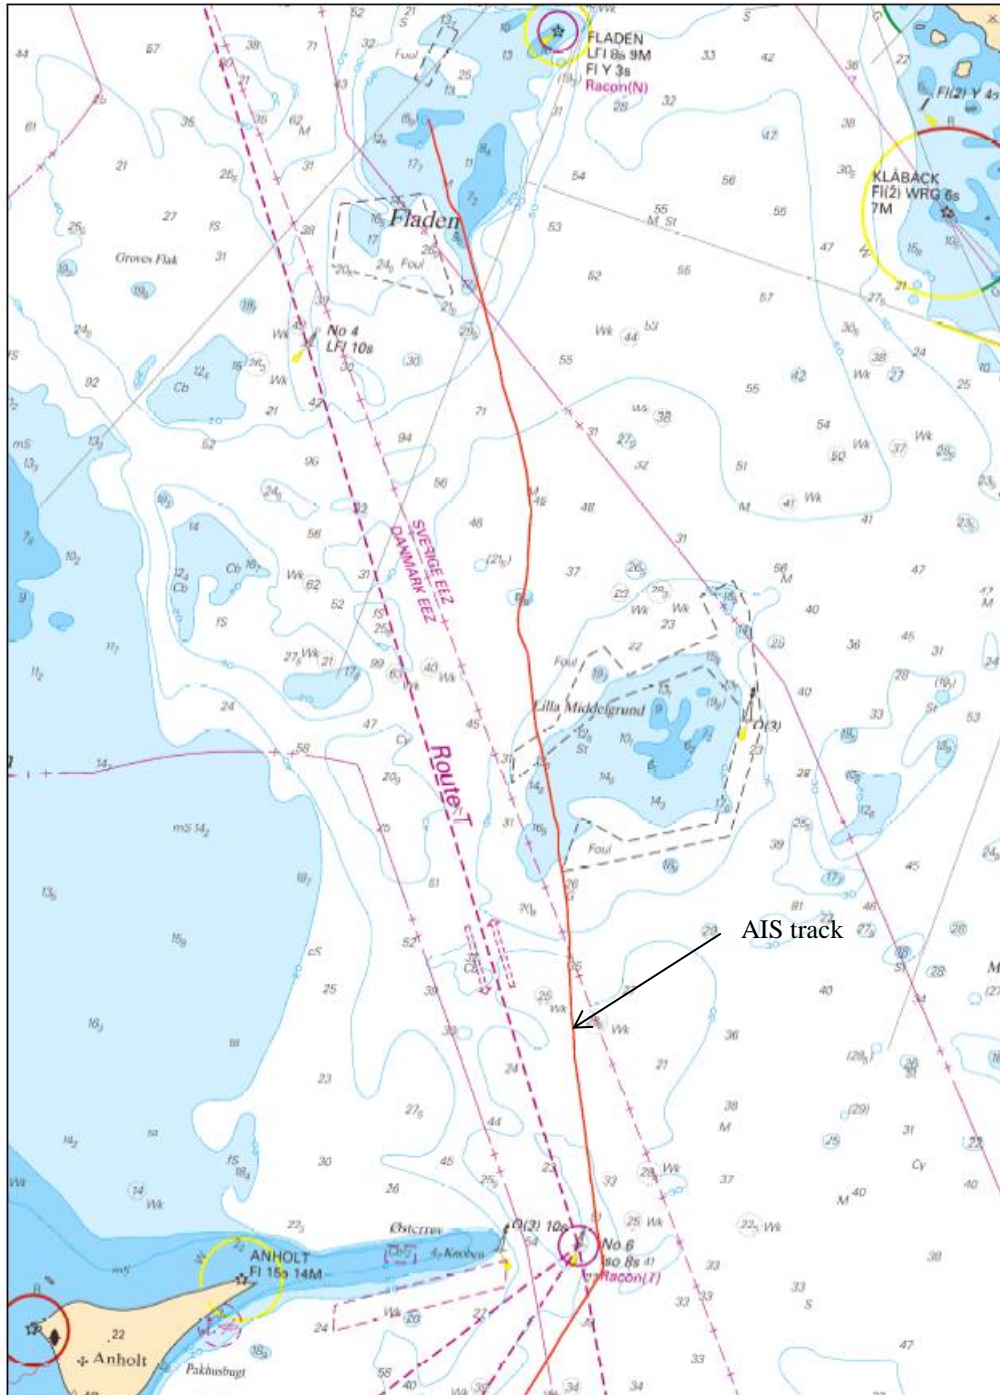
According to information given in the interviews, the chief officer ordered a change of course to 340° at buoy 6 in Route T at 16:25. From the AIS tracks, however, it is clear that VICTORIA's COG<sup>5</sup> following the change of course averaged 353° (fig. 3).

Figure 3. AIS track, marked in red after the turn at buoy 6 on Route T.

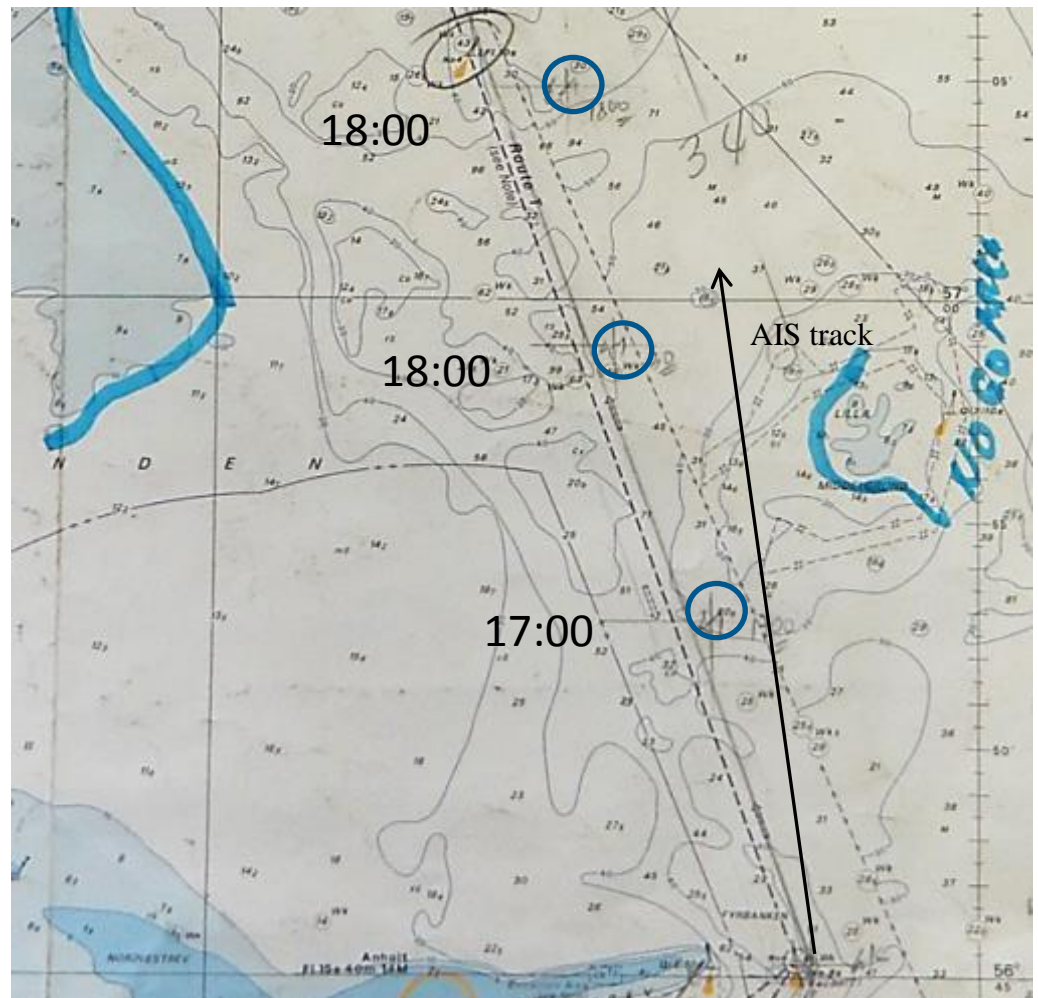
Figure 4. VICTORIA's navigational chart for the voyage with fixed positions, indicated by the blue rings. The position fix at 18:00 was made after the accident. The arrow shows the average AIS track (fig. 3).

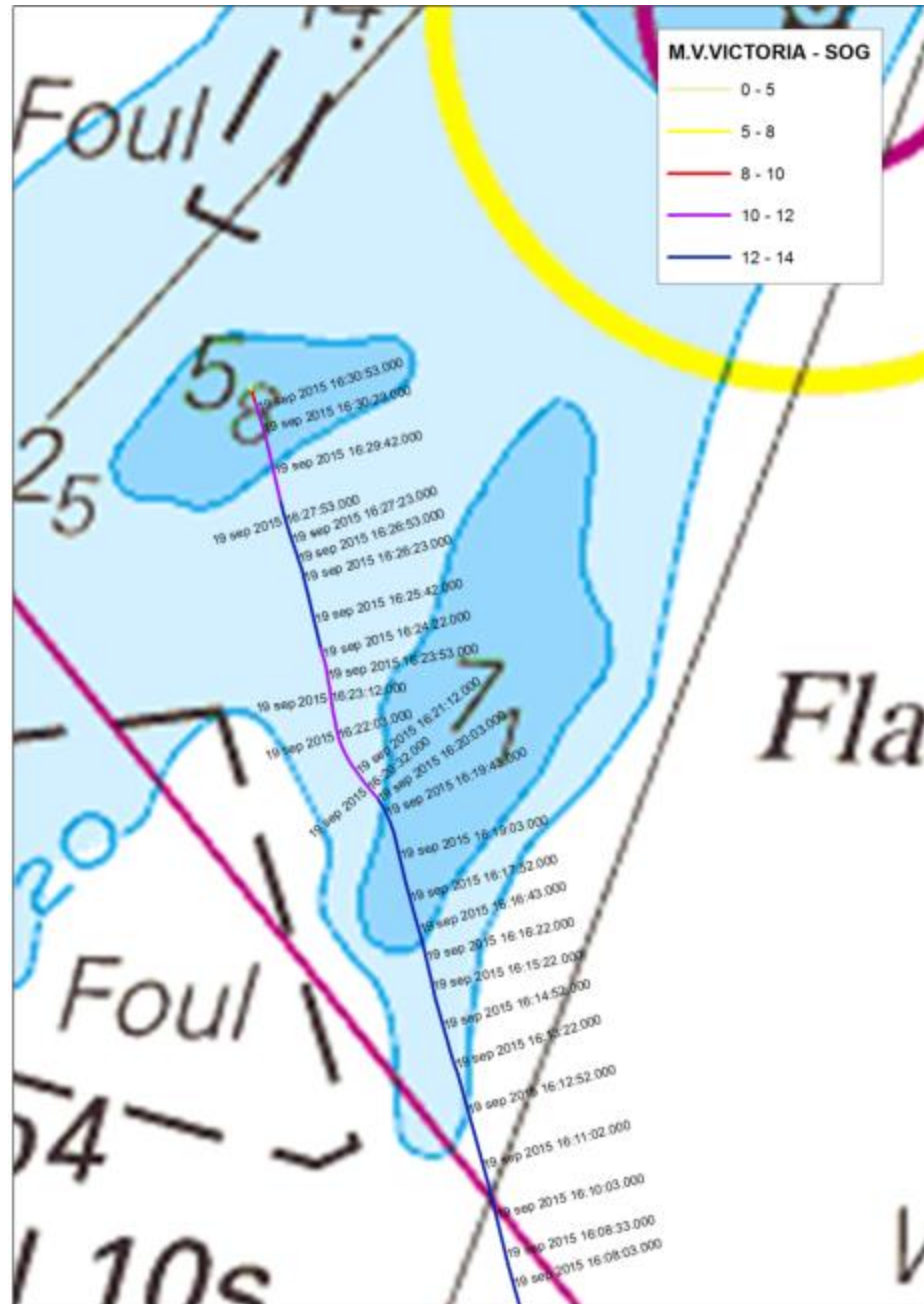
Figure 5. VICTORIA's AIS track, times in UTC.

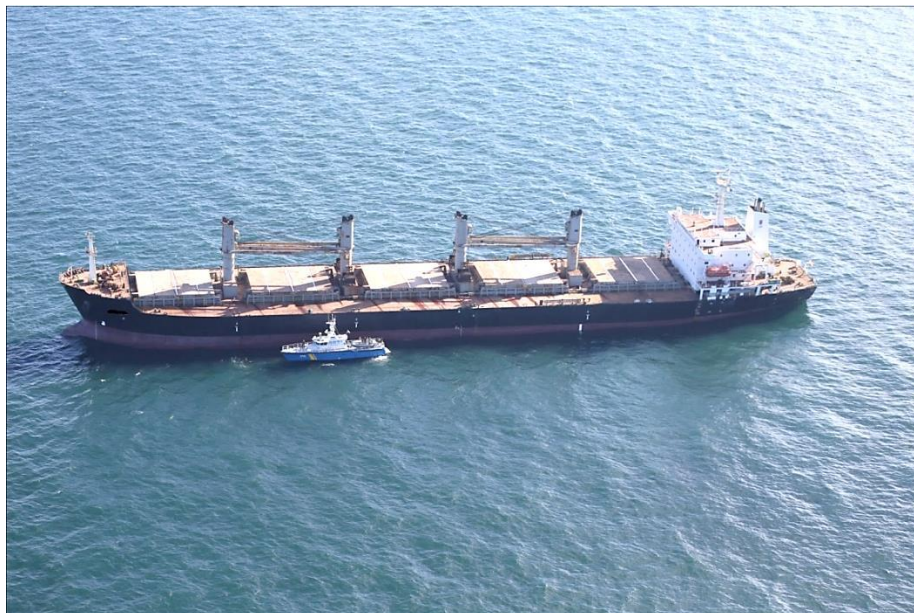
After the vessel had run aground, the crew performed a damage check of the vessel, which revealed a water leak into the bulbous bow, an empty ballast tank. No oil leakage was found. Over two hours after running aground, the master informed the shipping company that the vessel had run aground. Neither the sea rescue service nor any other Swedish authority was informed about the accident. For further information on the rescue operations, see section 1.11.

Figure 6. VICTORIA aground at Fladen Image: The Swedish Coast Guard.

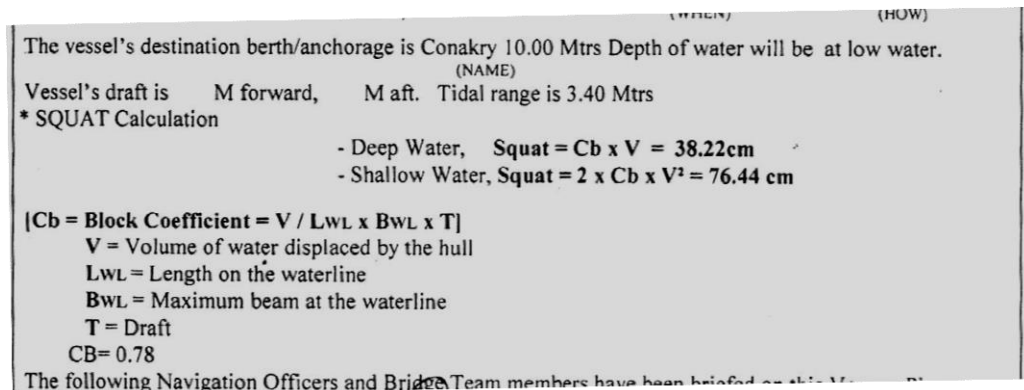
On the route plan in question, VICTORIA's draught is not specified. There is however a calculation of the squat effect, in which the draught is a parameter (fig. 13), though the formula for Squat – Deep Water is incorrect as the speed (V) should be squared. The crew has however used the correct formula in the calculation. In the squat effect calculation, the crew has factored in a speed of 7 kts and thus received a result of 38.22 cm in deep water and 76.44 cm in shallow water.

SHK has calculated the squat based on the speed specified in the route planning for passage of the Great Belt; i.e., 12 kts. The result of this calculation is 112.32 cm in deep water and 224.64 cm in shallow water.

Figure 13. Squat calculation from the route plan checklist.

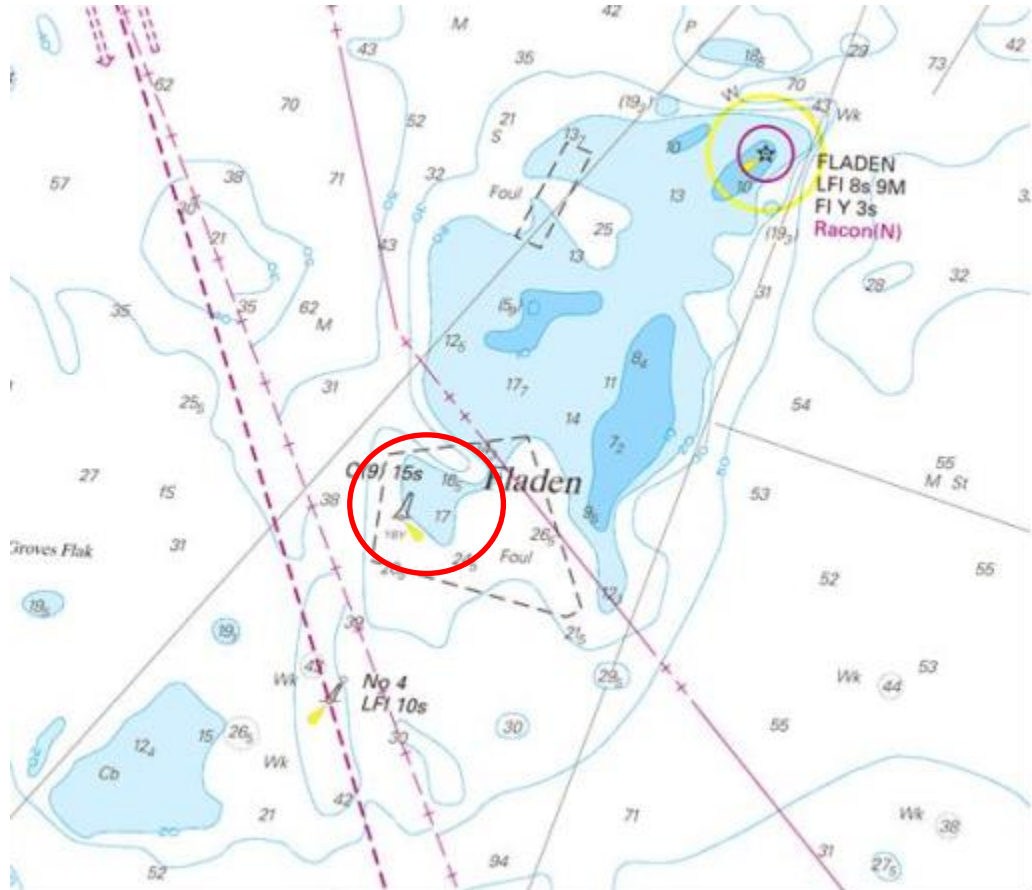
Figure 16. New buoy by Fladen (red ring).

Since the incident, the Swedish Maritime Administration has placed a light buoy west of Fladen (fig. 16).
