SERIOUS INCIDENT

Aircraft Type and Registration:	BAe ATP, G-BUUR	
No & Type of Engines:	2 Pratt & Whitney Canada PW126 turboprop engines	
Year of Manufacture:	1990 (Serial no: 2024)	
Date & Time (UTC):	26 January 2016 at 1950 hrs	
Location:	On approach to Guernsey Airport	
Type of Flight:	Commercial Air Transport (Cargo)	
Persons on Board:	Crew - 2	Passengers - None
Injuries:	Crew - None	Passengers - N/A
Nature of Damage:	None	
Commander's Licence:	Airline Transport Pilot's Licence	
Commander's Age:	60 years	
Commander's Flying Experience:	6,843 hours (of which 1,512 were on type) Last 90 days - 74 hours Last 28 days - 23 hours	
Information Source:	AAIB Field Investigation

Synopsis

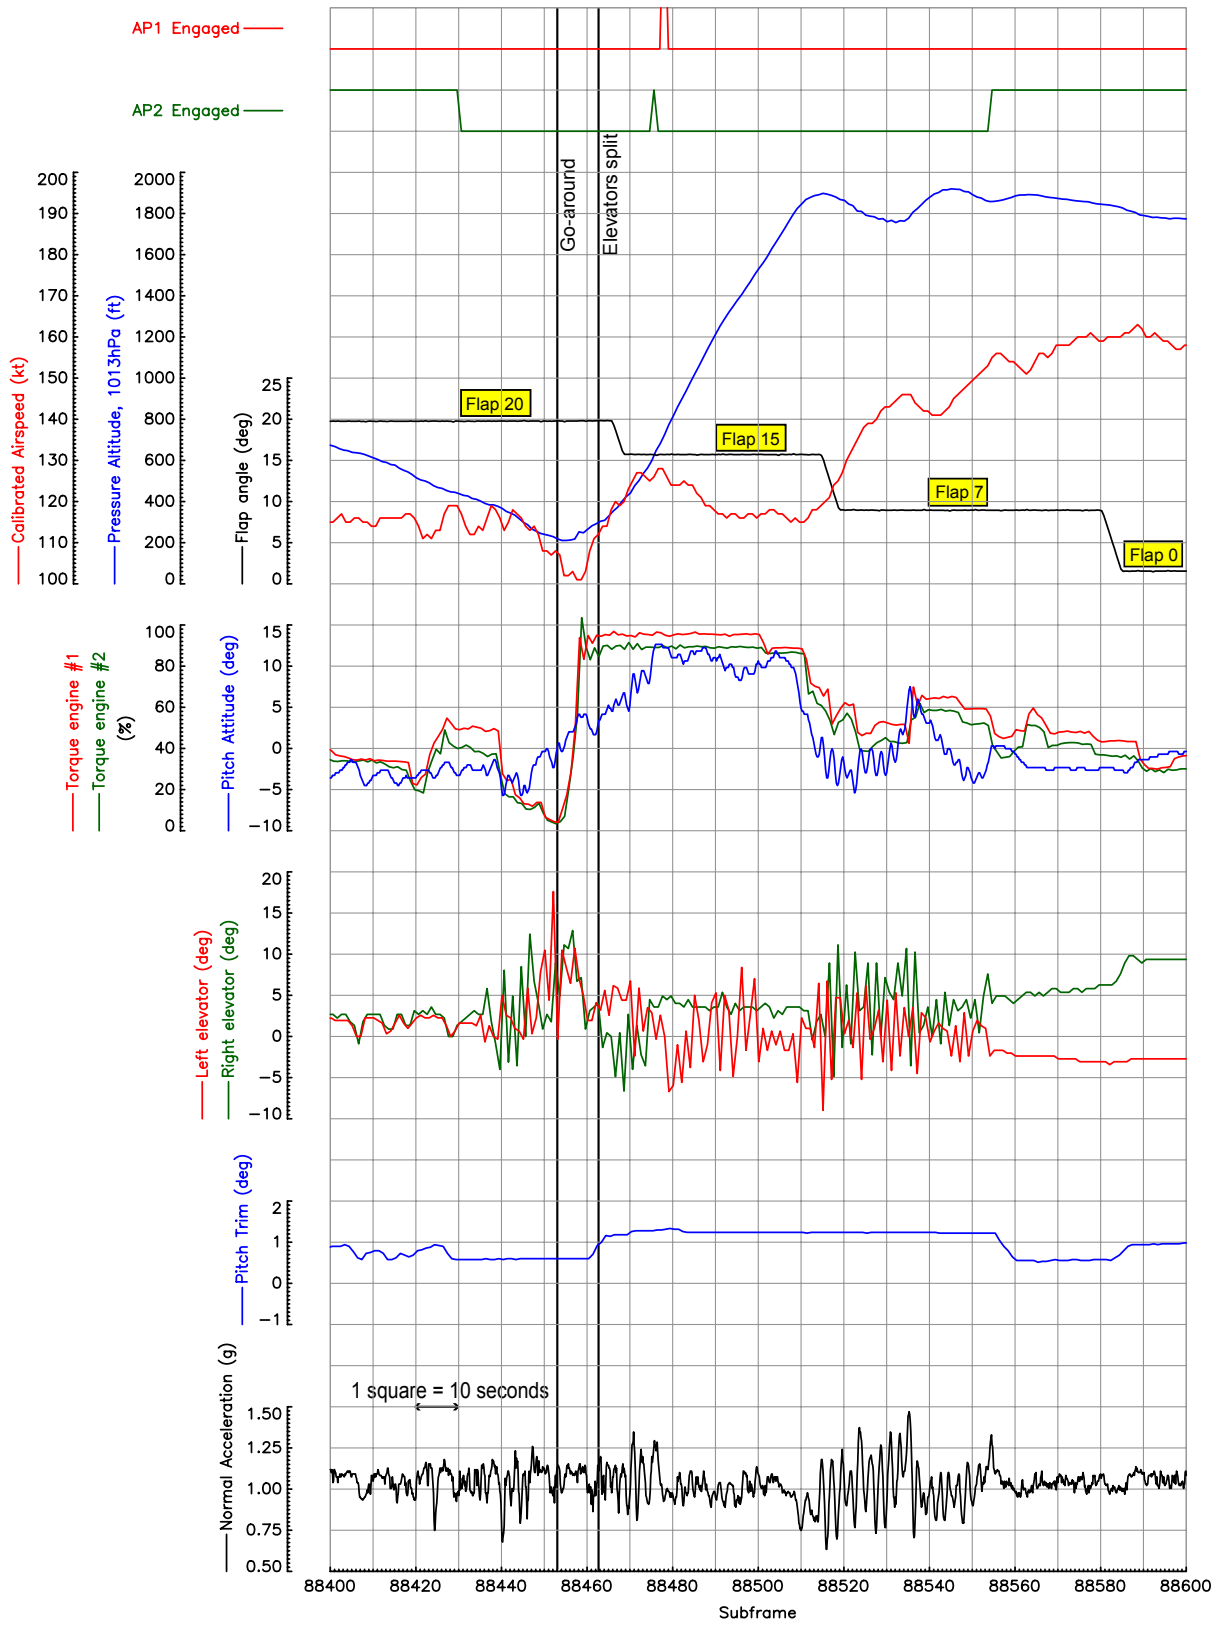
Figure 1

QAR data showing the approach and go-around at Guernsey

The data showed that AP2 was engaged as the aircraft descended through 685 ft pressure altitude⁴, equivalent to 470 ft above aerodrome level (aal)⁵, 20° of flap was selected and the aircraft's pitch attitude, although varying, averaged -3°. The aircraft's airspeed was generally steady, with only minor fluctuations, around 115 kt⁶ and engine torques were well matched at 34%. However, 19 seconds later, a reduction in torque to 22% on engine No 1 and to 20% on engine No 2 occurred as the aircraft passed through 550 ft pressure altitude (335 ft aal). At the same time the aircraft's airspeed reduced to 111 kt and an application of power was then made. This was slightly asymmetric in nature with engine No 1 leading engine No 2, torque values settled at 50% for engine No 1 and approximately 40% for engine No 2. The aircraft's airspeed increased to 119 kt. At this point, the aircraft was descending through 435 ft pressure altitude (220 ft aal⁷) and the data showed that AP2 disengaged. Prior to AP2 disengaging, the left and right elevators moved together in unison and the pitch trim was observed to modulate⁸.

After disengagement of AP2, for a period of 10 seconds, the aircraft's airspeed continued to vary between 112 kt and 119 kt but engine torques fluctuated by no more than 3%. The aircraft's pitch attitude was approximately -2°. Engine torques then reduced over 4 seconds to 15%, the initial reduction coincident with a change in pitch attitude of the aircraft to -5.7°, but thereafter pitch attitude settled at around -5°. The aircraft's airspeed, which had reduced to 113 kt, recovered back to 119 kt. Following autopilot disengagement, the activity on the elevators increased but because both elevators were sampled at different points in time and, due to a low sample rate, the precise position of the elevators, especially in relation to each other, could not be deduced. However, the trend of both elevators began to show a nose-up demand. The aircraft's pitch attitude changed, from -5° to +2° over 6 seconds, and during this time both engine torques decreased to 4%, whilst the aircraft's airspeed decayed to 102 kt. A minimum pressure altitude of 211 ft, approximately equivalent to the elevation of Guernsey's runway, was recorded before a rapid increase of torque, over 3 seconds, from 4% to a value of 95% for engine No 1 and 90% for engine No 2. The power settled at these values as the aircraft passed 250 ft pressure altitude (370 ft amsl). At 300 ft pressure altitude (420 ft amsl), a nose-down demand on both elevators was recorded and a nose-up

deflection in pitch trim then occurred. The elevator surface deflections now changed in character, with different absolute values for both elevators recorded even during periods of elevator inactivity, consistent with the elevators having split. At 355 ft pressure altitude (475 ft amsl) the flaps were retracted to 15°, the aircraft's airspeed settled at between 125 kt and 130 kt and the pitch attitude reached the maximum recorded of 12.6°. Around this point, AP2 and then AP1 both momentarily showed as engaged. The aircraft reached 1,500 ft pressure altitude (1,620 ft amsl) 24 seconds later with the pitch attitude in the climb being between 8 and 12° and the airspeed averaging 118 kt.

Both engines now reduced to 87% torque, the pitch attitude reduced to +4°, which was accompanied by a further power change on both engines to around 70% torque. After the aircraft reached 1,900 ft pressure altitude (2,020 ft amsl), with an airspeed of 120 kt, the flaps were retracted to 7°. Further reductions in engine power were then made to 48% torque on engine No 1 and 40% torque on engine No 2 and the aircraft descended back to 1,750 ft pressure altitude (1,870 ft amsl) with a pitch attitude of -2.5°. The aircraft's pitch attitude was then increased to +7°, along with a power increase to approximately 60% torque, the aircraft climbed to 1,920 ft pressure altitude (2,040 ft amsl) with the flightpath becoming more stable although the aircraft continued to accelerate. During this whole period of time, the QAR data showed significant elevator activity, but this then settled with the re-engagement of AP2, and at the same time the pitch trim surface moved nose-down. Over the next 20 seconds, the aircraft levelled at 1,775 ft pressure altitude (1,895 ft amsl) the airspeed settled at 160 kt and the flaps retracted to 0°.

The flight data indicates the autopilot disengaged at 220 ft aal, at about the point at which the co-pilot reports first pressing the autopilot disengagement switch. With the autopilot disengaged the co-pilot should not have experienced unusual resistance when he tried to move the control column. It cannot be entirely excluded that there was some intermittent fault within the autopilot system that resulted in the pilot experiencing resistance to his inputs, but subsequent tests have not revealed any defect with the system or with the flight controls.

The target approach speed was 118 kt but below decision altitude it decayed steadily in response to a power reduction, while the pitch attitude increased from approximately -5° to $+2^{\circ}$. The pilots recalled the aircraft deviating above the glidepath and the co-pilot thought he tried to lower the nose in response. The flight data indicates the airspeed decayed to 102 kt prior to initiation of the go-around. The pilots were not aware of the speed reduction at this stage, possibly because they were both looking out and distracted by the autopilot issue.

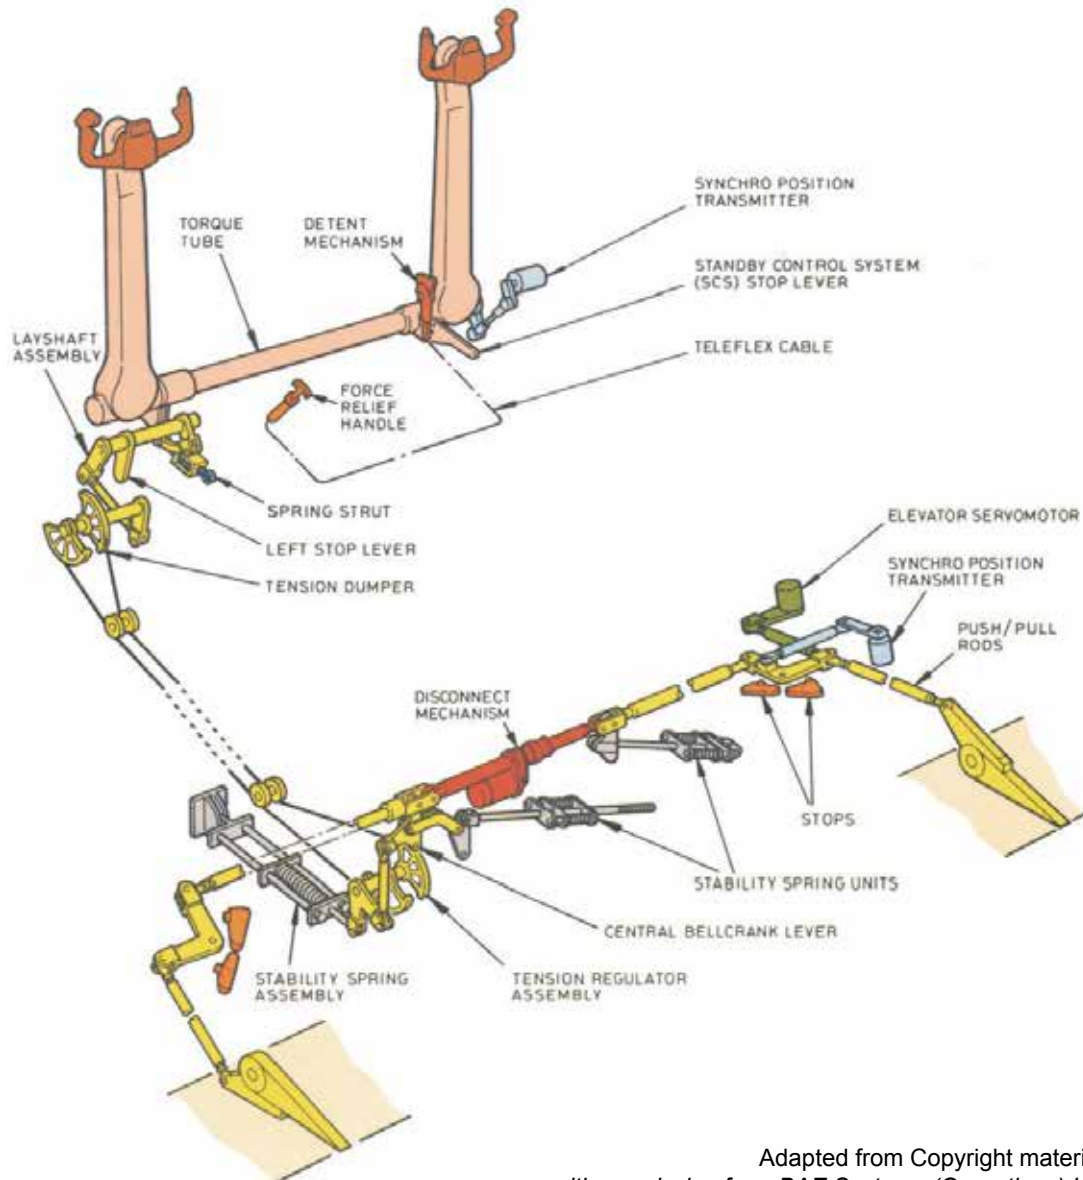
Figure 6
Elevator flying controls

The elevators are operated directly from the control columns through a system of cables, rods and levers (Figure 6). These pass under the floor, down the left side of the fuselage then via push / pull rods and bell cranks to the control surfaces. A solenoid-operated elevator release unit is fitted between the two elevators. Under normal circumstances the release unit functions as a fixed length control rod but when the solenoid is energised the unit allows the elevators to operate independently. The elevator release unit cannot be reset in flight.

The nose-up pitch trim input would have increased control column loading so, when the co-pilot pushed forwards on the right column, he may have had to exert more than 100 lb force, causing the detent mechanism to operate and the elevators to split. It is also possible the pilots applied opposing forces to their control columns for a short time and this caused the columns to separate and the elevators to split. This does not conform to the pilots'
