SERIOUS INCIDENT

Aircraft Type and Registration:	Saab 2000, G-LGNR	
No & Type of Engines:	2 Allison AE 2100A turboprop engines	
Year of Manufacture:	1995 (Serial no: 2000-004)	
Date & Time (UTC):	6 November 2015 at 1700 hrs	
Location:	On takeoff from Manchester Airport	
Type of Flight:	Commercial Air Transport (Passenger)	
Persons on Board:	Crew - 3	Passengers - 29
Injuries:	Crew - None	Passengers - None
Nature of Damage:	None	
Commander's Licence:	Airline Transport Pilot's Licence	
Commander's Age:	42 years	
Commander's Flying Experience:	4,200 hours (of which 420 were on type) Last 90 days - 110 hours Last 28 days - 28 hours	
Information Source:	AAIB Field Investigation

Synopsis

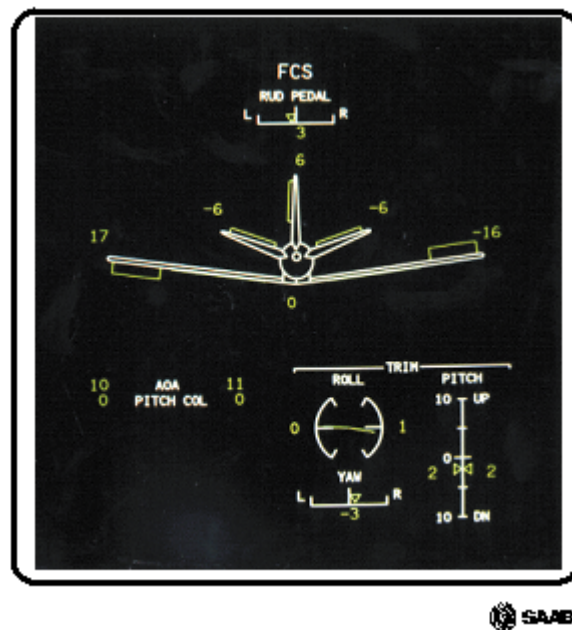
Figure 1

The PF decided to disconnect the autopilot, bracing the controls for the jolt he expected when doing so with an aileron mistrim. The jolt was more pronounced than usual and he had difficulty maintaining straight and level flight, finding that the aileron controls felt “sloppy” and unresponsive. He reduced airspeed to below 200 KIAS, and the PM viewed the Flight Control System (FCS) synoptic page on the Secondary EICAS Display (SED) (Figure 1). The pilots recalled that the FCS diagram indicated both of the aircraft’s ailerons were deflected upwards, with the left aileron up 8° and the right aileron up 5°, and that whilst they were looking at the display both aileron depictions briefly deflected upwards to 17°.

Example of FCS presentation on the SED Synoptic page

Following the disengagement of the autopilot, and before the aileron disconnect (ROLL handle) was operated, the pilots reported that both ailerons moved upwards by several degrees. This was also seen on the QAR data. As the aircraft slowed for landing, both ailerons appeared to move upwards to approximately 17° , which discussion with the manufacturer indicates should have caused the aircraft to pitch nose-up. However, data from the QAR shows that there had been no impact on the flight path; moreover there was no corresponding change in the elevator position to counter the effect of the ailerons.

This suggests that at least one of the aileron position transducers was producing an erroneous signal.
