DUTCH
SAFETY BOARD

Runway excursion after leakage in hydraulic system

30 September 2015

The Hague, December 2016

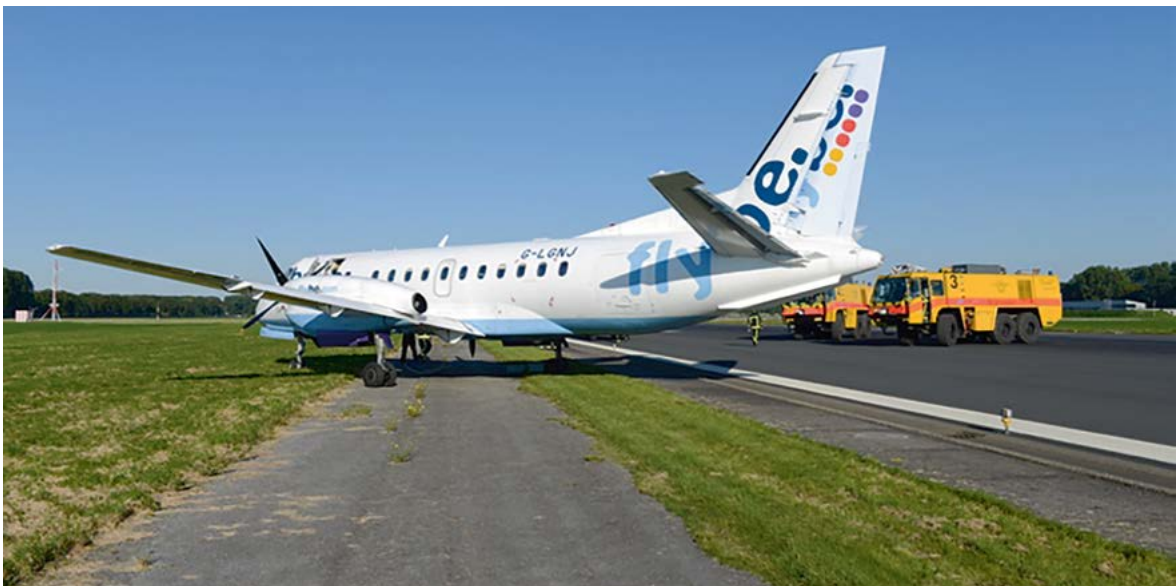
The flight crew executed the shutdown items on the normal checklist. Halfway the checklist (just prior to the checklist item "condition lever start") the captain informed the passengers that the engines would be shut down on the runway. Then, the condition lever was moved to the start position whereupon the aircraft started to roll uncontrollable to the shoulder of the runway. The aircraft came to a full stop partly in the grass (see figure 1).

Figure 1: The location where the aircraft came to a stop. (Source: Rotterdam The Hague Airport)

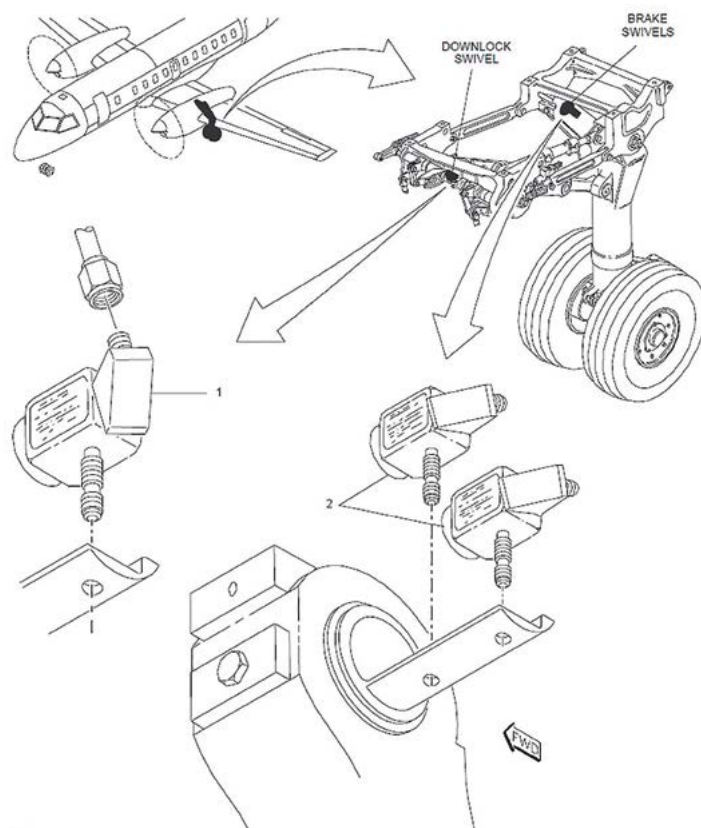
Figure 4: Saab 340B landing gear swivels.

After the incident the operator found that the aluminum shaft of one of the swivels was broken. The broken swivel was a down lock swivel and guided the hydraulic fluid and accompanied pressure towards the down locks.

This specific down lock swivel was fabricated in December 1987. Element Amsterdam² investigated the broken swivel in order to determine the failure mechanism of the broken shaft from the hydraulic swivel. The swivel was broken due to fatigue. The swivels had been in place since the delivery of the aircraft in 1987.

After inquiry at Saab Aircraft a total of eleven events, including this incident, due to broken aluminum swivels were reported since 2002. Saab Aircraft issued a Service Bulletin 340-32-142, LANDING GEAR - INTRODUCTION OF NEW HYDRAULIC SWIVELS Mod No. 3493 on 15 January 2013.

effort to replace the remaining pre-modified aluminum swivels in their fleet and that the remaining pre-modified aluminum swivels will be replaced by modified swivels before the Final Report's publication date.
