STATE MARINE ACCIDENT INVESTIGATION COMMISSION

FINAL REPORT 46/15

TUG BOAT *ZEUS*

The fire of the tug boat berthed in the port of Sölvesborg
on the day of 23 September 2015

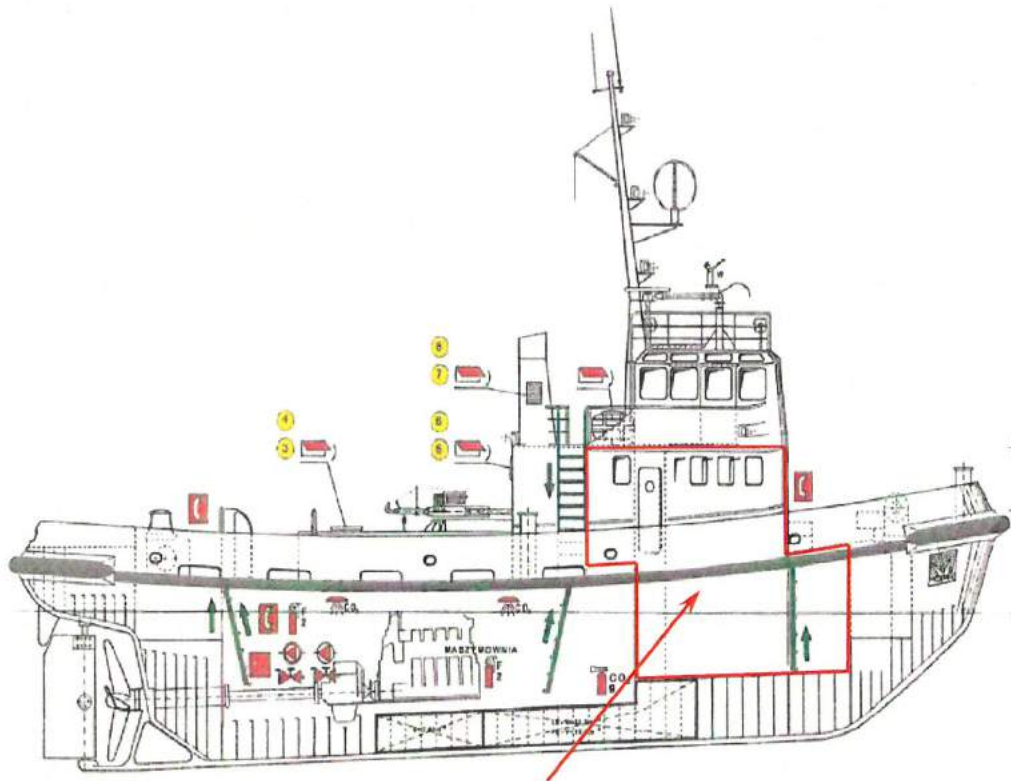
Figure 2: The area enveloped by the fire

Firefighting lasted more than two and a half hours. The fire enveloped part of accommodation and part of the superstructure containing the galley, mess room, and the entrance alleyway to the tug boat.

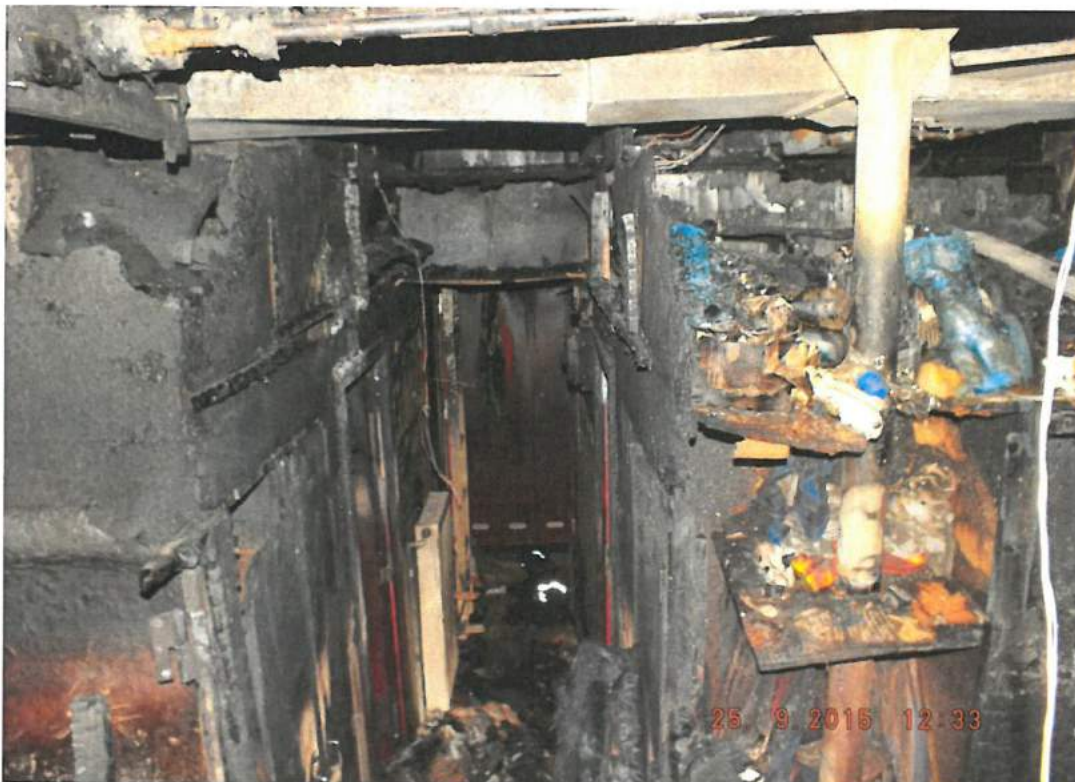
Photograph 10: The alleyway between the crew cabins

It was from that cabin the fire spread through the open door to the alleyway (Photograph 10),

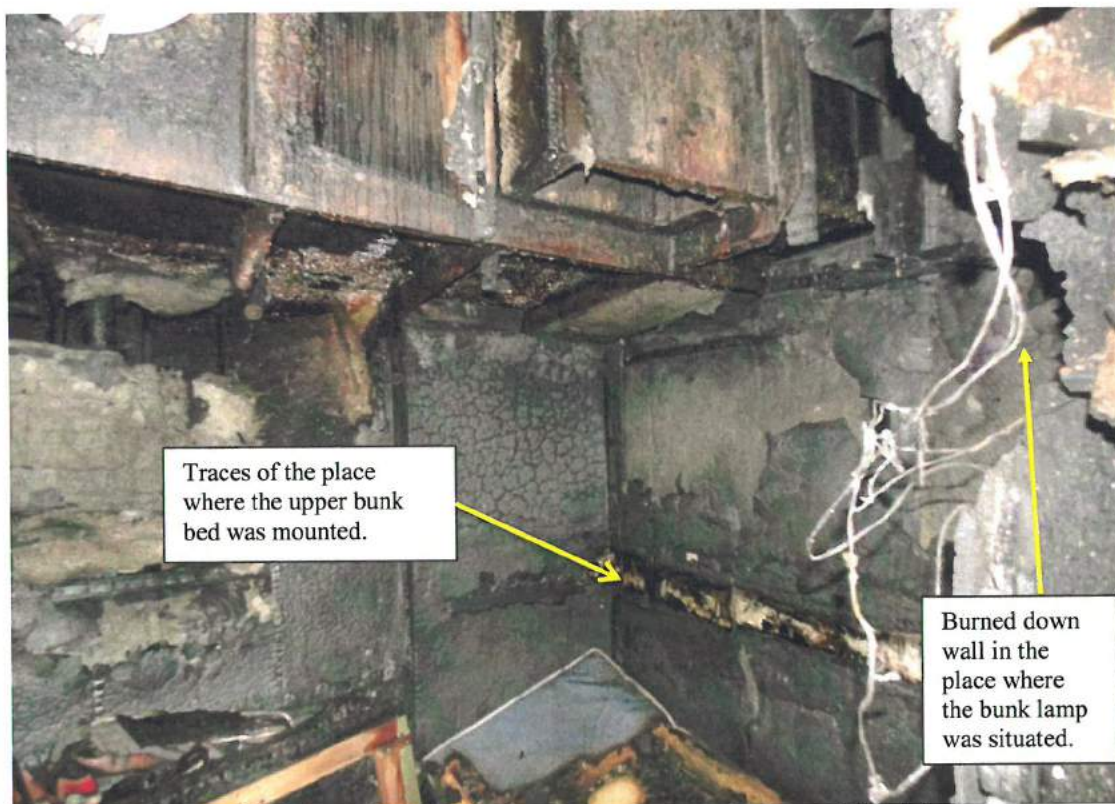
Photograph 11: The watch officer's cabin – a part with bunk beds

In order to determine what could have been the cause of the fire, the Commission inspected the cabin of the watch officer thoroughly. In the cabin, the partition wall separating it from the adjacent cabin (belonging to the tug boat master), wood lining, furniture and the whole equipment were burnt. The inspection showed extensive scorch-marks on the right side of the cabin, looking from the entrance, in the area of the bunk beds⁸ (Photographs 11, 12 and 13).

The wooden frame of the upper bunk bed was completely burned. Photograph 11 shows traces of the place where the bunk bed was mounted to the wall. The polyurethane foam mattress of the top bunk bed put on the frame with steel springs, was burned (melted) and fell down on to the bottom bunk bed (Photographs 11 and 12).

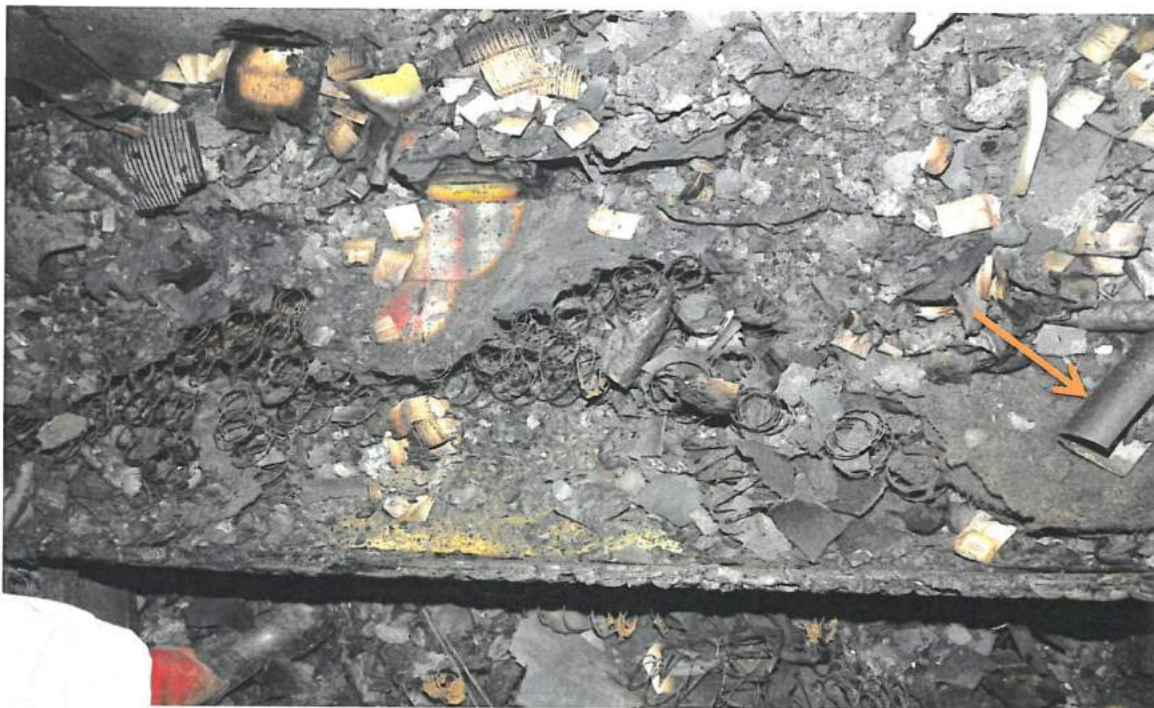
Photograph 12: Burned top mattress on the bottom bunk bed and remaining of the upper bunk lamp

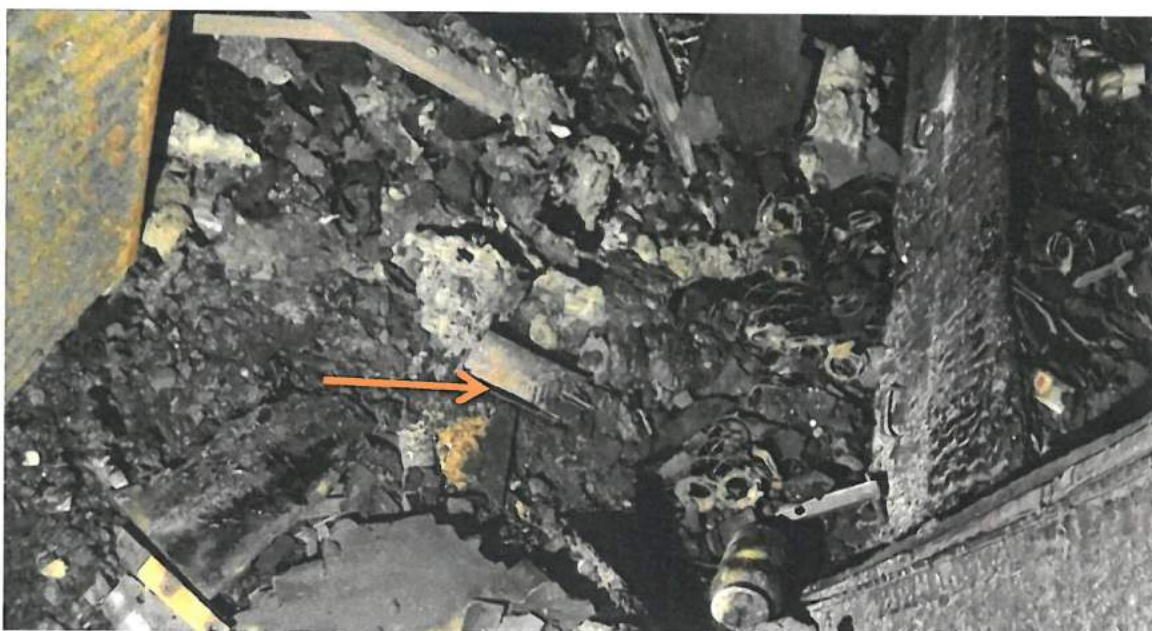
The falling metal frame with a mattress from the upper bunk probably hit and broke off the mounted to the wall the lower bunk lamp. This bunk lamp was found in the conflagration on the floor of the watch officer cabin⁹ (Photograph 13).

Zdjęcie nr 13. The lower bunk lamp in the conflagration of the cabin floor

⁹ The Commission concluded that this bunk lamp was put back over there by the firemen, after taking it ashore in order to get examined by the police experts, who decided it was not a source of a fire.

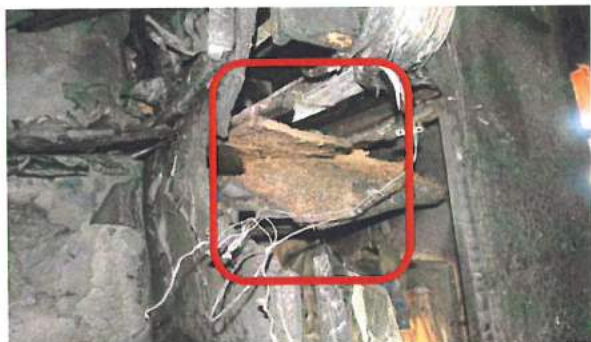
There remained a burned out place with protruding burned electric cables¹⁰ (Photograph 11 and 14) where the night-lamp (bunk lamp) socket was mounted with incandescent source of light above the level of the top bunk bed, on the wall closer to the cabin door.

Deep, local patches of scorched wall of the watch officer's cabin where the incandescent socket was mounted indicate that the cause of the fire was most likely the direct contact of the flammable material (e.g. clothing or bedding) with a heated up glass lamp bulb¹¹.

Photograph 14: A hole after burning of the bunk lamp over the top bunk bed in the watch officer's cabin

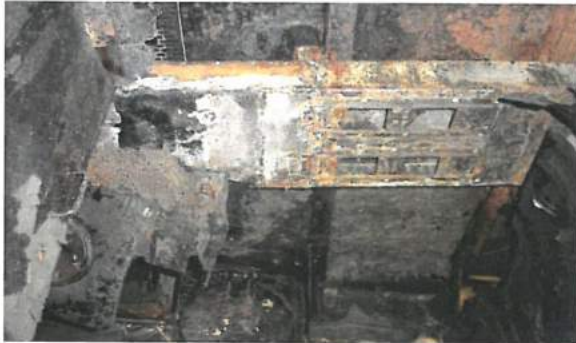
The fire of the ceiling in the watch officer's cabin was facilitated by direct access of air from the ventilation duct. It is manifested by the lack of soot in the vicinity of the ventilation duct outlet grate (Photograph 16).

Photograph 16: Burned soot around the air inlet in the ceiling ventilation duct

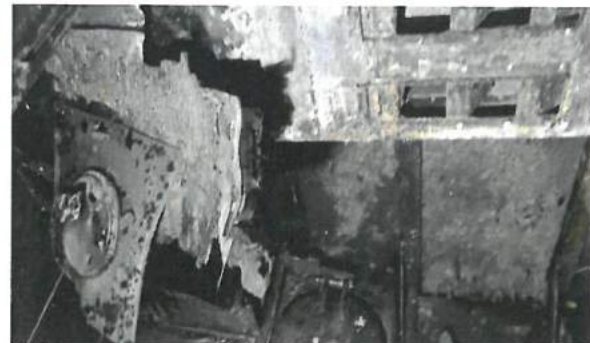
Following the analysis of the directions of spreading of fire in the watch officer's cabin, the Commission accepted that when the flames reached the ceiling which was made of and covered with flammable materials (chipboard and wooden slats), the dust and combustible dirt (remnants of sawdust) found in the space above the ceiling over the crew cabins caught fire and caused that it quickly spread onto the ceilings in all the remaining cabins completely consuming the ceiling in the watch officer's cabin (Photograph 16) and the ceiling over the alleyway (Photograph 10); most of the ceiling over the central cabin on the starboard side (Photograph 17) and a part of the ceiling above the last (stern) cabin on the port side.

Photograph 17: Completely burned out ceiling in the central cabin on starboard side

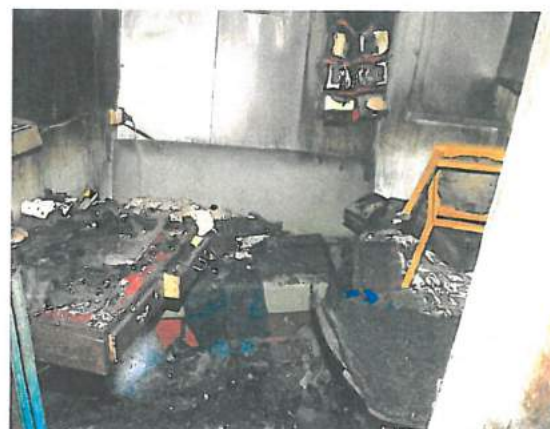
The greatest damage, apart from the cabin where the fire originated, occurred in the central cabin (belonging to the tug boat master) situated on the starboard side (Photograph 19) adjacent to the watch officer's cabin.

Photograph 19: The cabin of the tug boat master

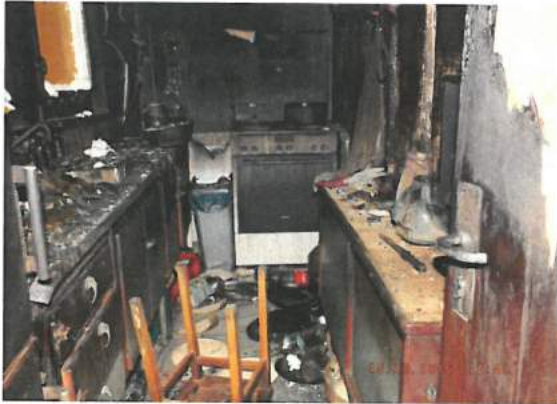
Fire from the ceiling over the alleyway located between the residential cabins moved to the staircase leading to the main deck of the superstructure and caused ignition of the ceiling in the alleyway and in the space connected with the galley and the mess room. The main deck over the cabin where the fire started - heated to a high temperature by burning framework and the ceiling cover - was deformed. In the galley, the ceramic tiles cracked and the carpet lying in the mess room melted. Walls, furniture, as well as kitchen and mess room equipment suffered thermal destruction (Photographs 22 and 23).

Photograph 22: Thermal destruction in the galley

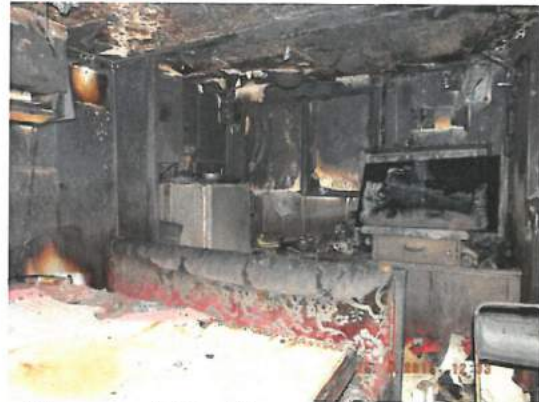
Photograph 23: Thermal destruction in the mess room

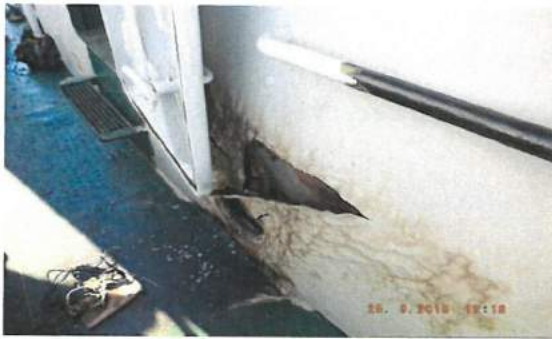
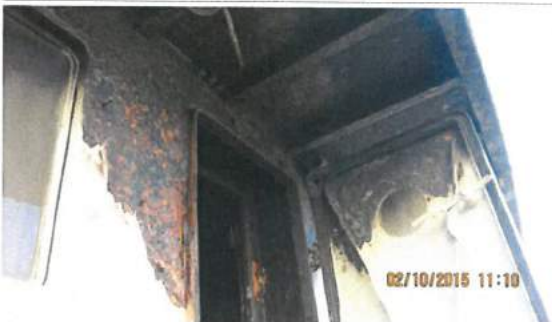
Photograph 24: Effects of high temperature

The high temperature destroyed the side scuttle of the watch officer's cabin and deformed the main deck above it. Fire flames burnt out the inner wooden door leading to the tug boat and get out through the outer steel doors (Photograph 24).

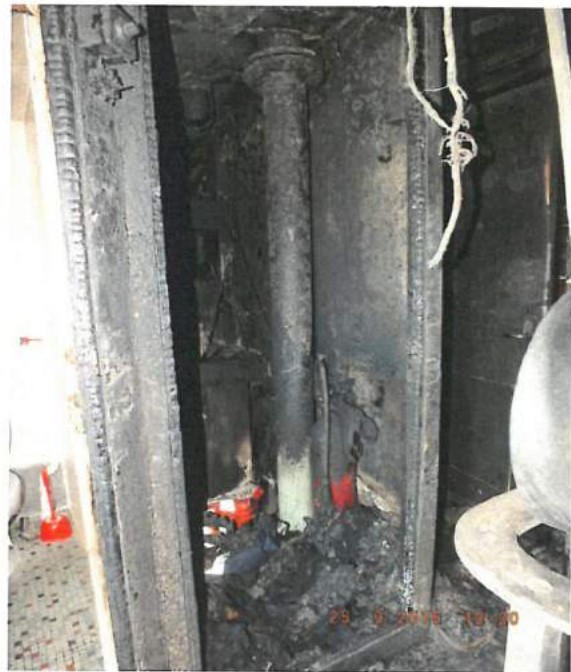
Photograph 25: Destroyed fire locker

The fire consumed the equipment deposited in the storage situated in the alleyway in the superstructure on the main deck (Photograph 25). Two sets of firefighter's outfits composed of a breathing apparatus with a set of spare bottles, helmets and protective clothing including the fire-belts were stored at the mess room.

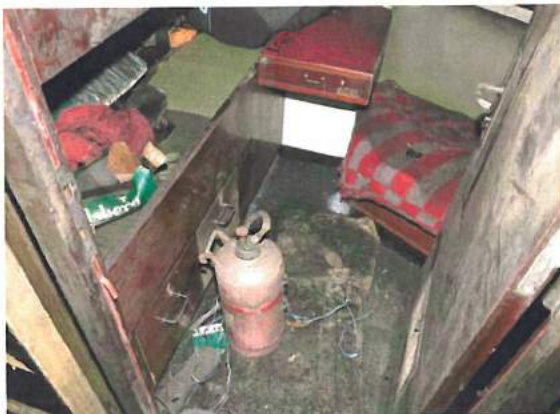
No fire-fighting equipment located in close proximity of the cabins and the source of fire had been used to extinguish the fire²². The fire extinguisher which was fixed by the stairs leading to the crew cabins was left untouched in its bracket (Photograph 30). The second extinguisher, fixed on the wall between the first and the second cabin at the port side (Photograph 29) had been found by the firemen inside the first cabin on the floor (Photograph 28). It means that the crew member who occupied this cabin probably went outside the cabin, grabbed the extinguisher, which was nearby, but was not able to use it, as he was forced by smoke or flames to return to his cabin.

Photograph 28. Fire extinguisher found in the first cabin (from the bow) at the port side.

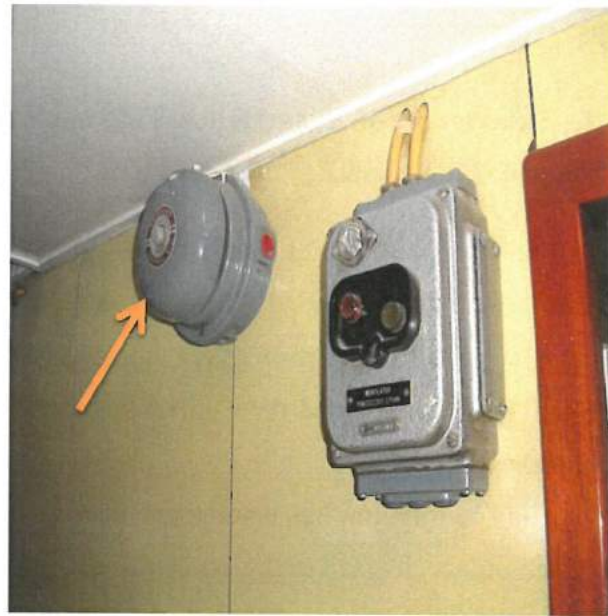
accommodation (Photograph 31), but the button activating alarm-bells was on the bridge. The investigation shows that the fire developed very quickly. It can therefore not be concluded with certainty that the crewmembers that remained in their cabins (see Figure 4) would have had a better possibility to get out in time if someone had gone to the bridge and activated the alarm-bell instead of directly yelling in the corridor. It can though be concluded that the crewmembers that did wake up had their doors open. The fact that they had their doors open may have made it easier for them both to hear the screams and to get out quickly enough.

Photograph 31: The alarm-bell on the wall of the alleyway near the crew cabins; a photograph from a sister tug boat "Cyklop"
