Danish Maritime Accident
Investigation Board

MARINE ACCIDENT REPORT

February 2015

STENA NAUTICA
Allision on 8 July 2014

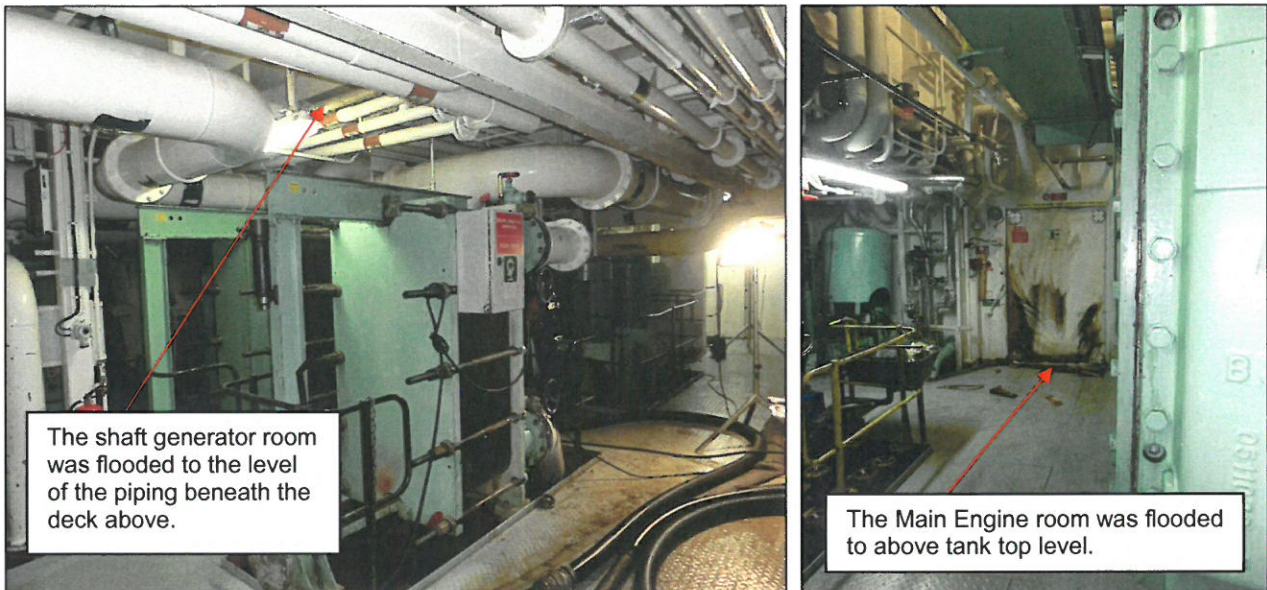
At the same time, at around 0020, the bilge pumps were started but these could not keep up with the amount of water leaking into the room. Because they were located in the main engine room, it was not possible to deploy direct suction by the largest seawater pumps; the emergency bilge suction. The shaft generator room was quickly flooded up to tank top level. Because the shaft generator room also contained other vital equipment, such as fuel supply pumps, booster units, fuel oil separators, HT and LT cooling pumps, it was decided to close the watertight doors to the room to prevent flooding of the main engine room. The water level in the shaft generator room kept rising and soon reached the level of the electrical motors, approximately one metre above tank top level. Eventually, the room was flooded up to approximately 0.5 metres below the deck above (figures 7 and 8).

Figure 7: Left: Shaft generator room. Right: Main engine room. Approximate water levels indicated.
Source: DMAIB

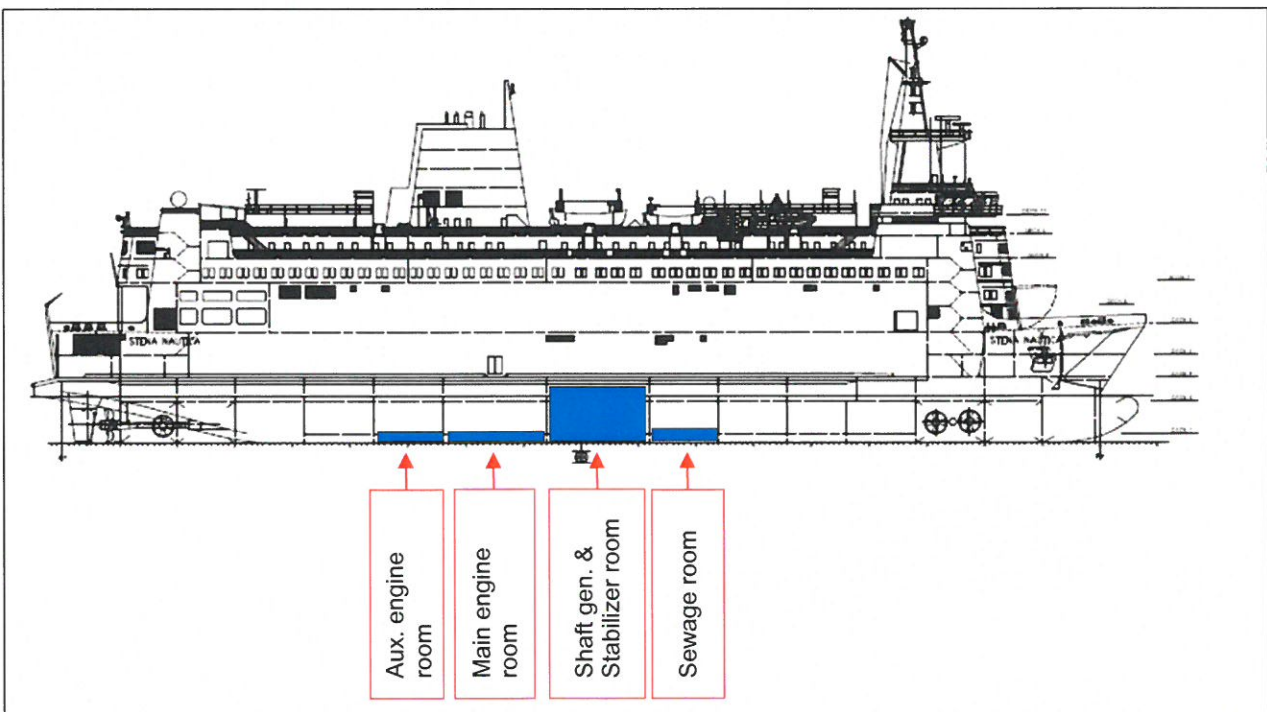
Although the watertight doors had been closed, sea water leaked into the main engine room and the sewage room, located just aft and forward of the shaft generator room, respectively. The engine crew observed water ingress through the watertight doors, and the water level in the adjoining rooms eventually rose until it reached about 10 cm above tank top level at approximately 0217.

Figure 8: Side view of STENA NAUTICA. Approximate flooding levels in engine rooms indicated.
Source: STENA AB / DMAIB

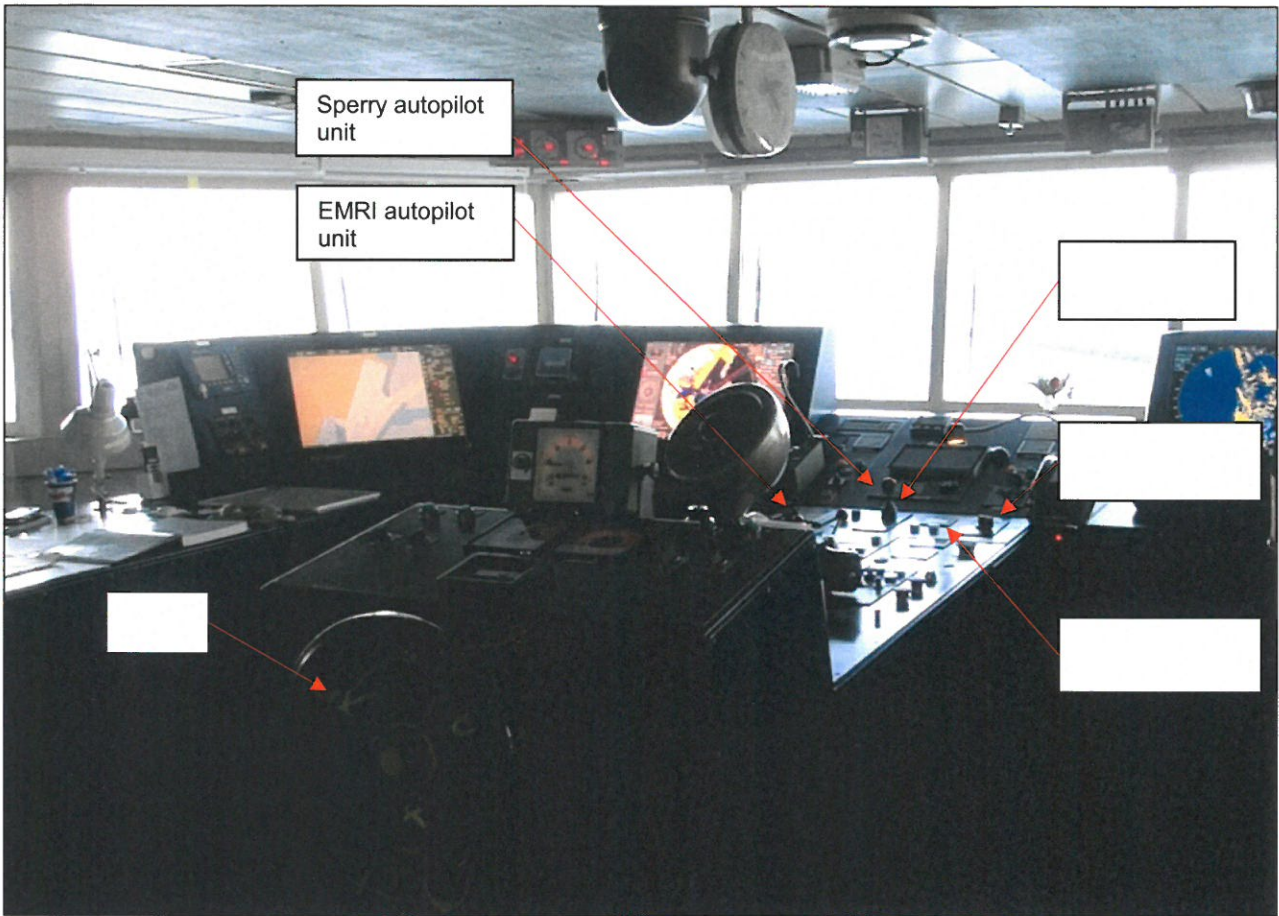
Figure 9: Overview of centre console. Elements of steering system indicated.
Source: DMAIB

The accident revealed a weakness in the overall design of the bridge layout. The position of the override steering made some officers prefer one system over another, because they wanted to avoid accidentally activating the rudder. In addition, when the bridge officers and ratings were applying different strategies for operating the system, it would at some point lead to confusion caused by a fixation on which mode the system was in. The strategy applied by the bridge crew was to repeatedly confirm that it was switched to helm, while in fact it had already been switched over.

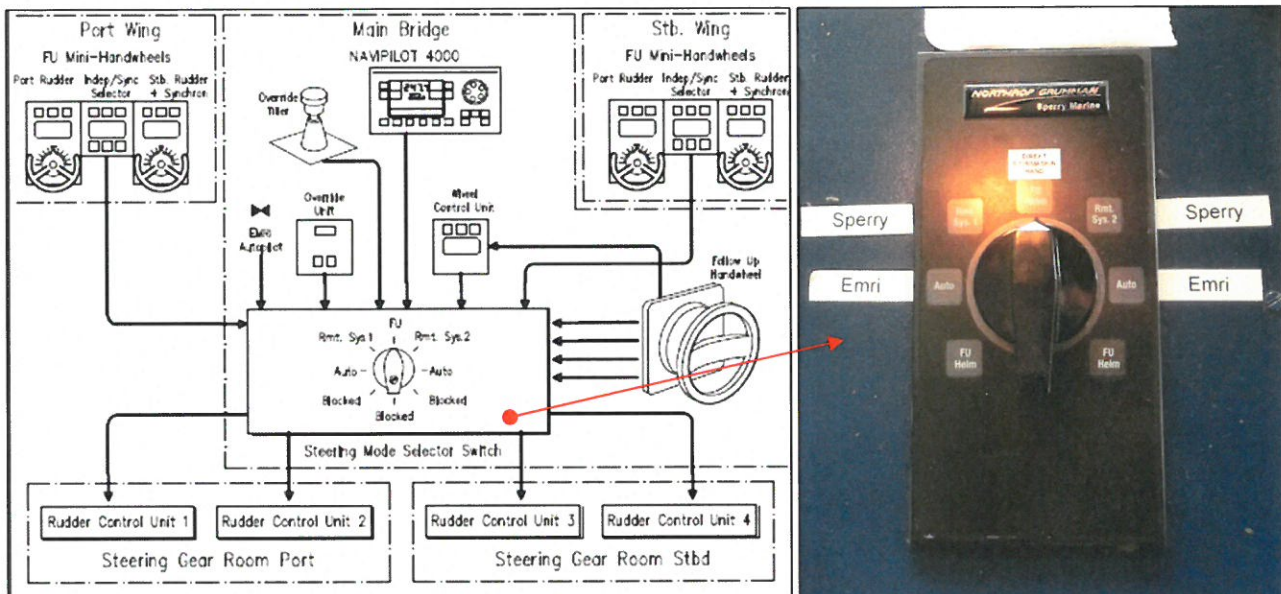
Figure 11: Left: Diagram of steering setup. Right: Steering mode selector switch on the bridge of STENA NAUTICA. Source: STENA AB/DMAIB

The combined steering mode selector switch for the Sperry and EMRI systems had five active settings: The *Rmt. Sys. 1 & 2* settings allowed steering by the Sperry autopilot and both bridge wing consoles. The two settings marked *Auto* allowed steering by the EMRI autopilot, and the top setting, *FU Helm*, was for helm steering. The control of steering was switched to the centre and bridge wing consoles, respectively, by pressing the *TAKE OVER* buttons located on the consoles (figures 12 and 10). In addition, there was an override unit controlled by a tiller (joystick) which was ready for immediate action, without operating other switches or buttons.

The design and operation of STENA NAUTICA's steering arrangement was vulnerable to erroneous actions. The arrangement allowed the switch from one control station to another without the watchkeeping crew having full knowledge of the helm and rudder positions. The system did not clearly indicate the helm's actual position (in this case hard starboard) before switching to centre manual steering. Further, no common procedure was followed when the control was shifted from bridge wings to centre hand steering: Some helmsmen operated the switch button themselves, while others did not. On the day of the accident, the helmsman had specifically asked the 2nd officer to operate the switch to ensure that it was done correctly.

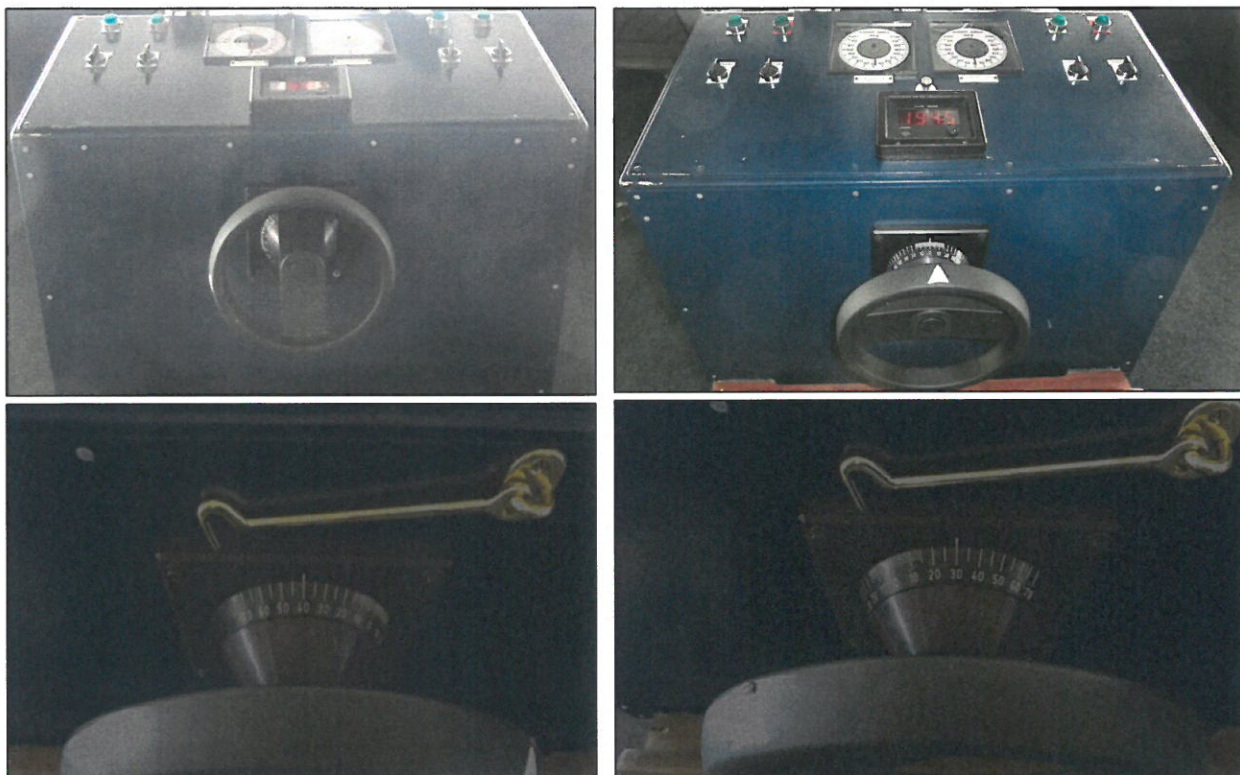
As a part of the installation of the new steering system, the helm had been replaced with a new one which was smaller than the original one. It was designed with a turn indicator placed on the helm itself. The helm was not fitted with a counterweight or spring which meant that the helm would stay in the position to which it was turned. There were no mechanical or procedural features that could ensure that the helm was in neutral when hand steering was used. Although back lighting was fitted, it was difficult to visually establish the actual position of the helm, especially at night (figure 13).

Figure 13: Hand steering wheel. Top left: Hard to port. Top right: Neutral/centered. Bottom left: Hard starboard. Bottom right: Hard port.(Brass hook fitted after the accident).
Source: DMAIB

The design of the centre helm was such that its position (port, starboard or centre) was not clearly indicated, especially at night. During the process of changing the steering mode, there was no indication of what action the helmsman took, because the other crewmembers could not visually see what position the helm was in.

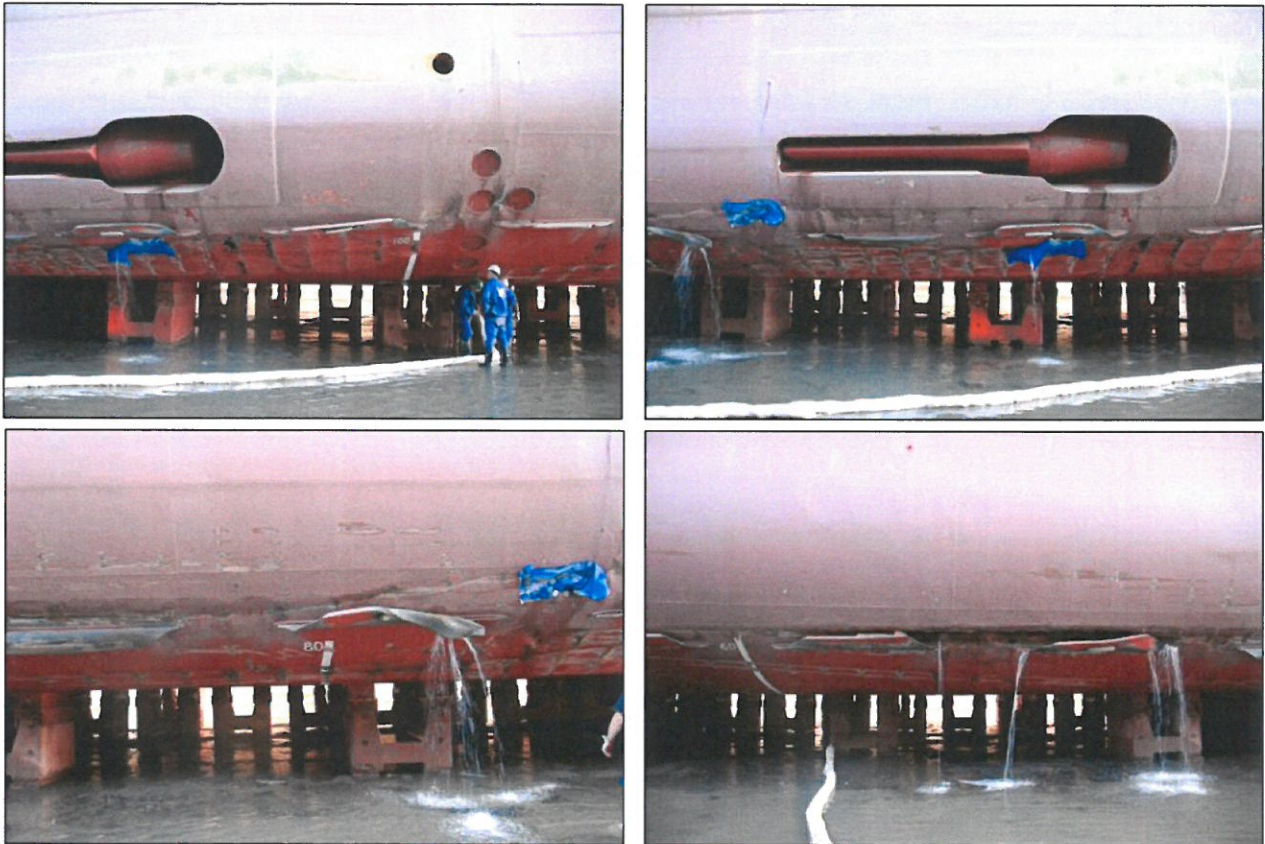
At 0315, salvage divers came on board, and at 0400 they entered the water to assess the damage. At around 0420, the divers reported that the ship had a hull penetration stretching from frame 70 to frame 85, approx. 180 mm in height.

The ship had suffered substantial damage to machinery, including both shaft generators and their gears, high and low temperature systems, fuel plant, stabilizer controlling units, electrical installations in general, propeller blades and the hull structure (figure 14).

Figure 14: Hull penetrations at the starboard side between frames 60 and 101.
Source: STENA LINE AB

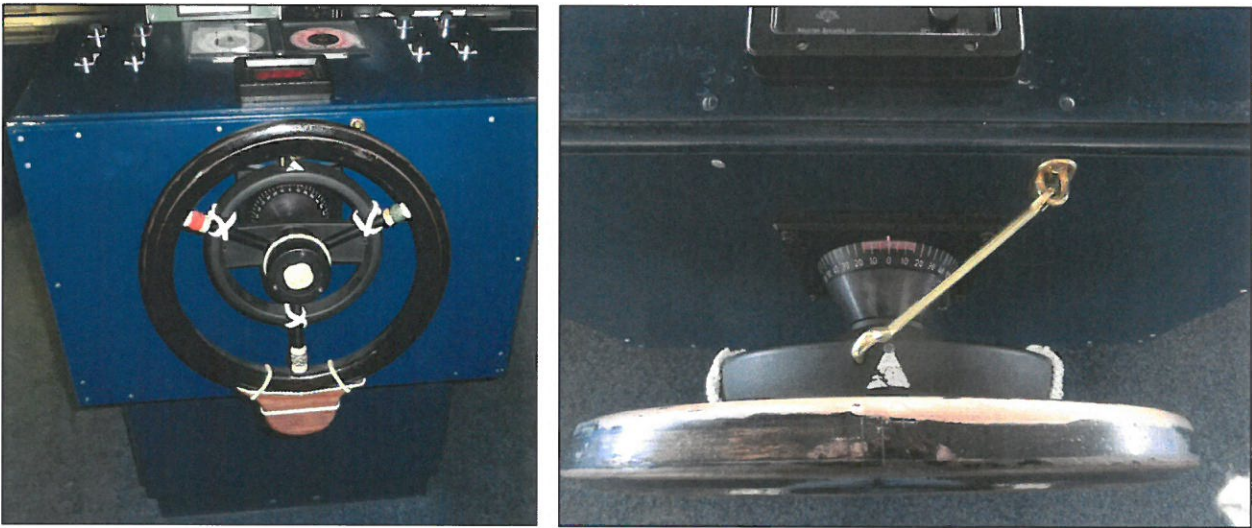
Figure 15: Hand steering wheel. Old wheel, counterweight and fixing hook fitted.
Source: DMAIB

Following the accident, the company has implemented changes to its bridge procedures to ensure that the steering wheel is centred before takeover. The procedures furthermore prescribe that the officers operate the steering mode selection switches themselves. On STENA NAUTICA, it has been decided that switch of steering position, from bridge wing to centre, is to be done outside the breakwaters.

The hand steering wheel which was removed for the refit has been remounted on top of the existing wheel as a preliminary solution (figure 15). With this configuration, it is clearer to the bridge crew whether the wheel is in neutral. Further, a counterweight has been fitted to force the wheel in neutral when not activated by the helmsman. A fixing hook has been installed to keep the wheel centred when not used to avoid confusion.
