## *Final report RL 2021:05e*

**Accident at Visby Airport, Gotland County, on 19 June 2020 involving the aircraft SE-IMY of the model TB 10, operated by private individual.**

File no. L-48/20

19 May 2021

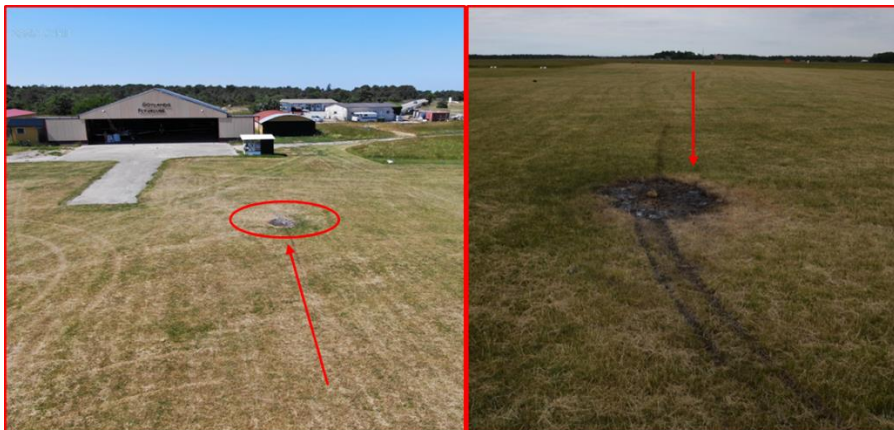
Figure 11. Left picture: Overview of the grass surface where the aircraft stopped. The arrow shows the direction of travel the last part before stopping. Red ring marks final position and marks in the grass after the fire. Right picture: Fire place and dark track in the grass after taxiing in and the arrow shows the direction of travel. Traces from the fire place on this side has been created after the fire was extinguished and the aircraft was moved.

No aircraft parts were found elsewhere at the airport. In the grass there was a black track from the left landing gear after taxiing to the parking (see Figure 11 and 12).

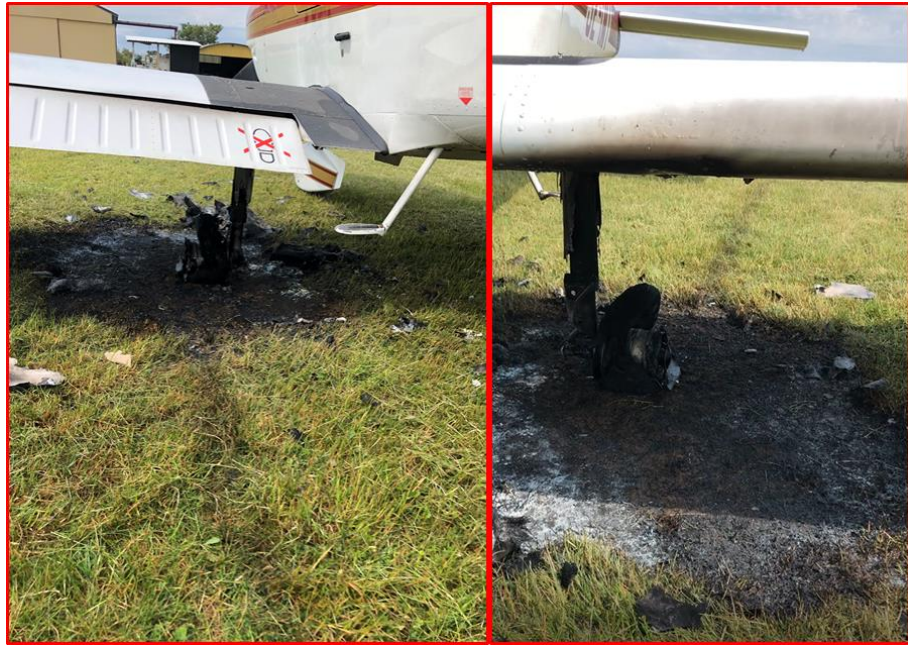
Figure 12. Final position of the aircraft after the fire. Left picture from behind. Right picture from the front. Photo: Swedavia.

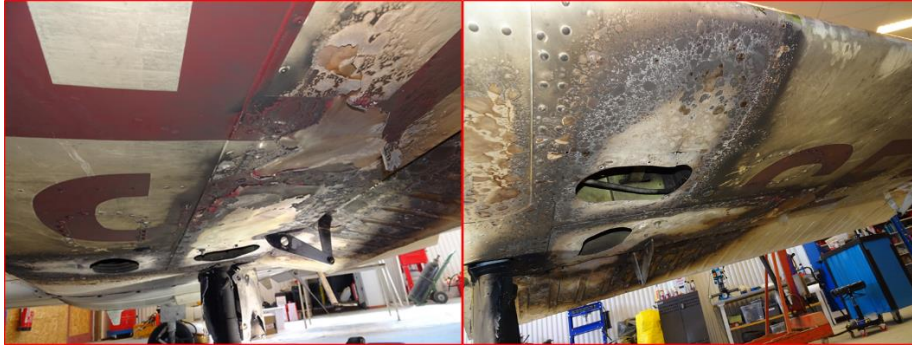
The tire and rim on the left landing gear had been ravaged by fire and parts of the rim had melted, the brake caliper cylinder had mostly melted. The fairing of the landing gear had partially melted and the brake hose for the brake caliper had burned up, only the metal nipples remained. The sheet metal skin on the underside of the left-hand wing and the ribs were affected by high temperatures.

Figure 13. Pictures on the underside of the wing that had been ravaged by fire.

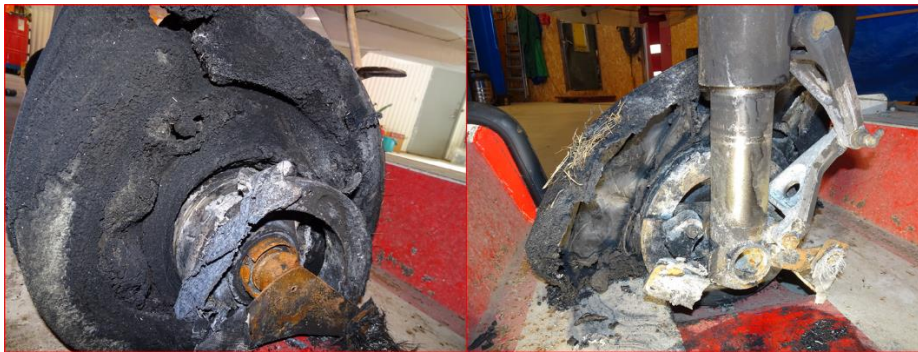
The left main wheel, brake caliper, landing gear and the lower skin and ribs on the left wing were damaged by fire and affected by high temperatures. Most of the brake caliper was melted into a lump and did not remain on the aircraft. The wheel fairing had burned out and only a few metal parts and fiberglass remained.

Figure 14. Pictures on the left landing gear, rim, tire and brake that had been ravaged by fire.

At the technical examination carried out on the aircraft, it could be established that the left landing gear had been ravaged by fire. The damage caused to the inside of the tire and rim, as well as the fact that the brake caliper had mostly melted, indicate that it was in this area that the fire first started. The fact that the brake caliper melted indicates that it has been exposed to high temperatures for a long time, because the magnesium alloy has a melting point of at least 421°C.

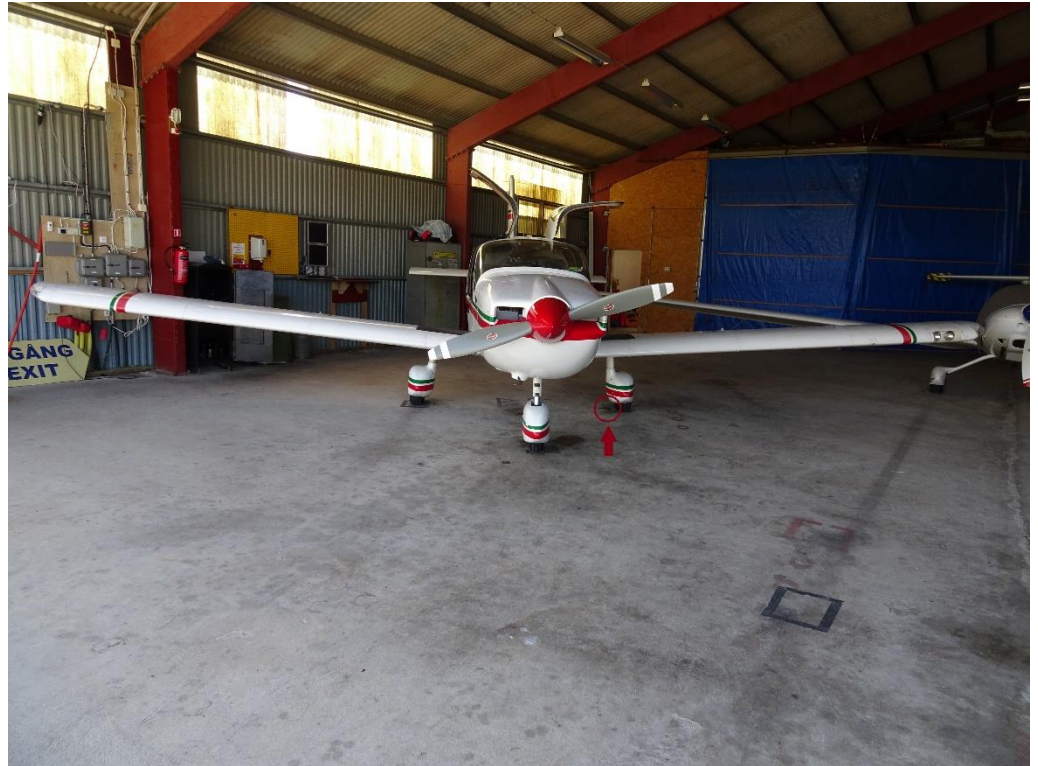
After the accident, a stain was found in the parking lot on the hangar floor where the left landing gear had been positioned. The fluid had to some extent been absorbed by the concrete floor, but based on the fluids colour, smell and appearance it was judged that it resembled hydraulic oil. The texture of the fluid was sticky with a greasy surface.

Figure 15. The parking in the hangar illustrated with another aircraft of the same model. At the left landing gear, the stain is marked with a red circle.

After the accident, a spot was found in the aircraft's parking space in the hangar where the left landing gear had been positioned. From the colour, odour, appearance, consistency and position of the fluid, SHK assesses that it was most likely residues from a mineral oil of the same type used in the brake system or in the shock absorber of the landing gear leg.

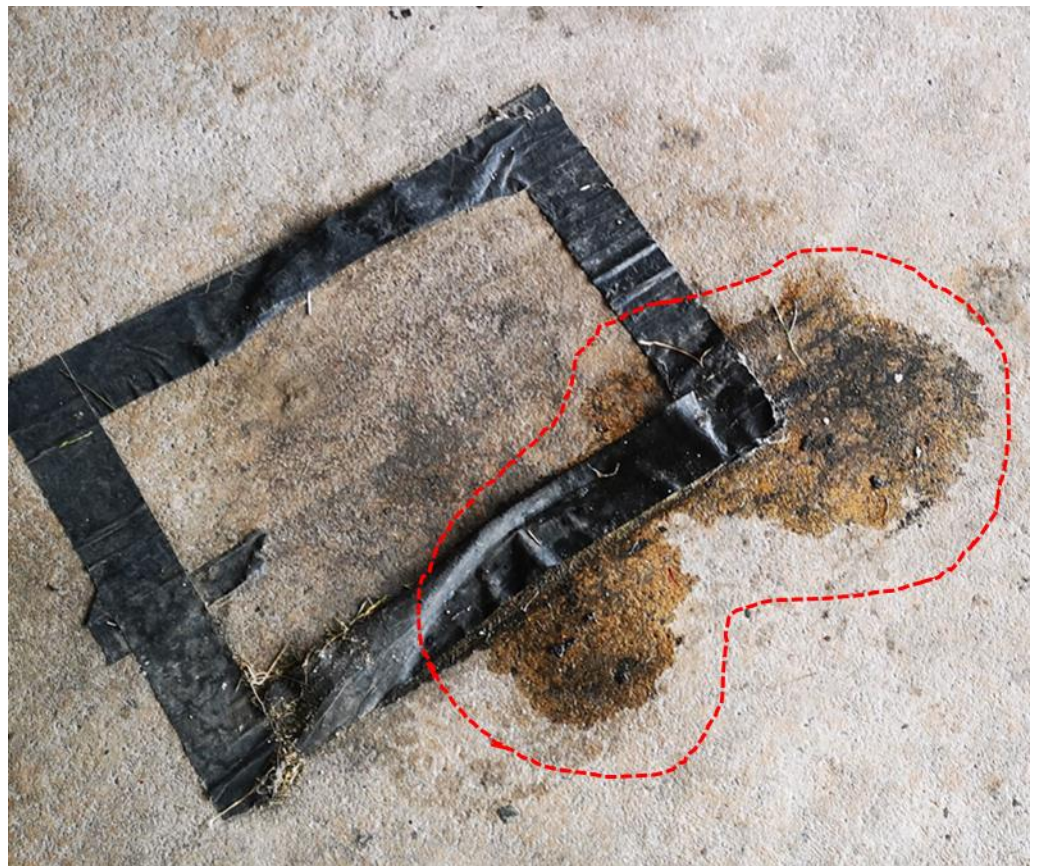
Figure 16. Stain on the hangar floor. Picture: The Pilot.

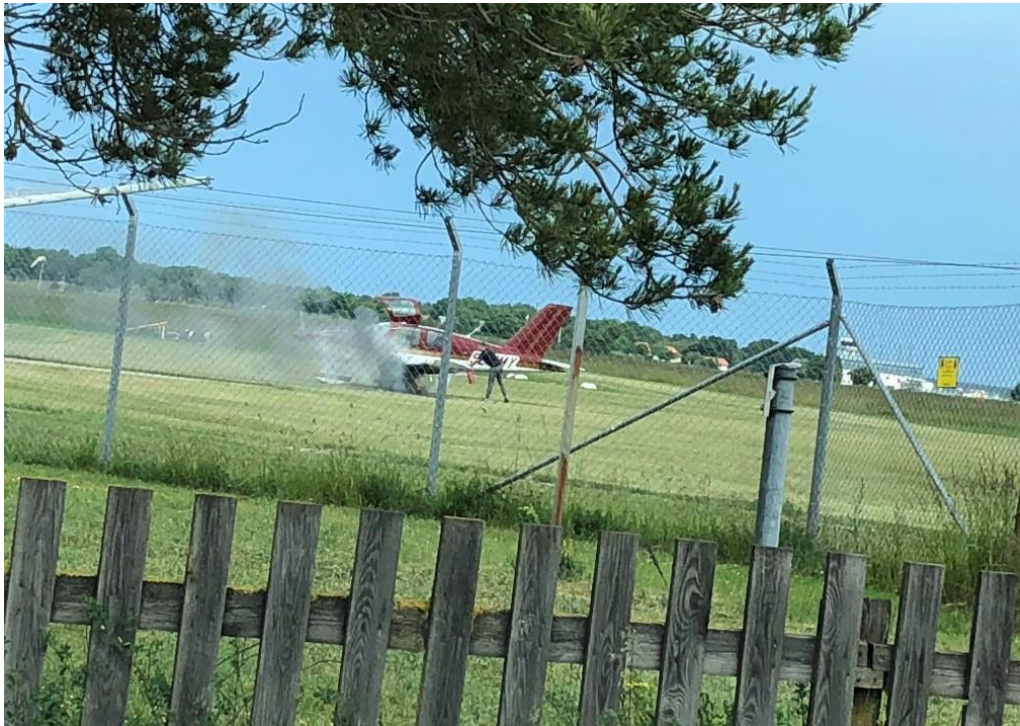
Before the municipal rescue service arrived at the scene, the pilot first tried to extinguish the fire with a fire extinguisher from the aircraft. After this, the pilot retrieved two fire extinguishers from the hangar and extinguished the fire to embers, but shortly afterwards the fire started again.

Figure 17. The pilot fighting the fire. Photo: Swedavia.
