Final report RL 2017:07e

**Accident at Åre Östersund Airport,
Jämtland county on 13 June 2016
involving the helicopter SE-JVP of type
AS 350, operated by a private person.**

File no. L-59/16

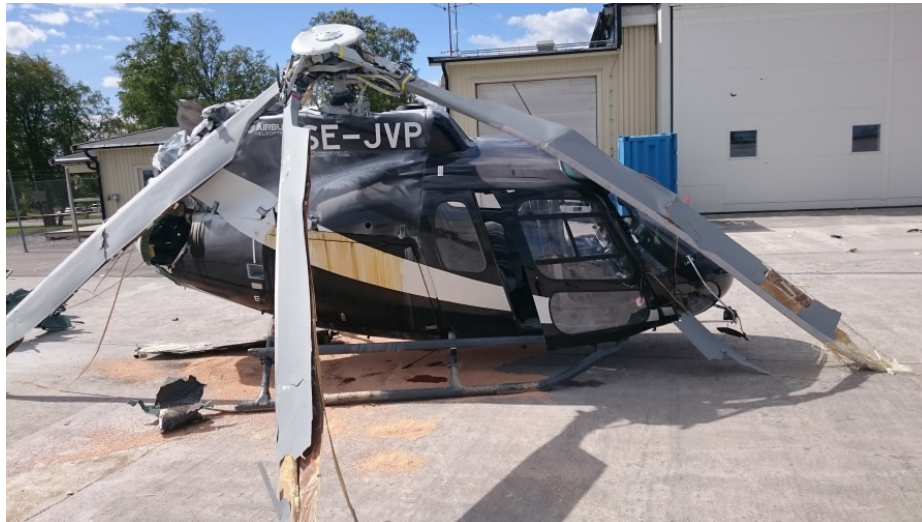
Substantially damaged, see figure 1.

Figure 1. The helicopter after the accident. Photo: SHK.

All damage noted during the wreckage examination is assessed to have arisen upon impact. SHK has not found any signs of previous technical deficiencies that might have affected the sequence of events.

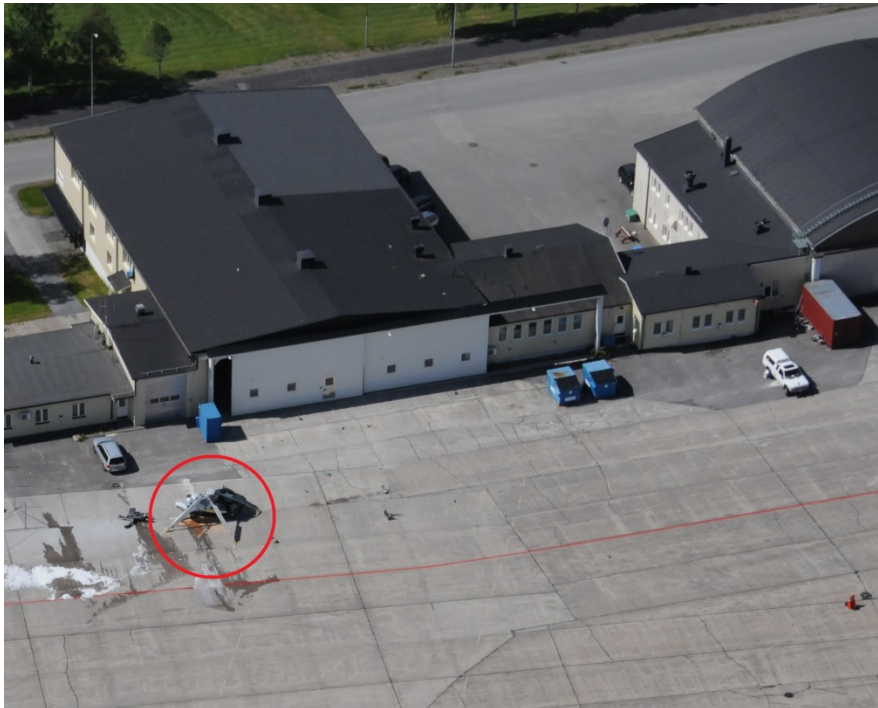
Figure 3. The accident site market with a red ring and located approximately 50 meters from the intended parking site. Photo: Swedish Police.
