Final Report RL 2017:06e

**Accident at Nynäs Fallet, Örebro County,
on 10 May 2016 involving the hot air bal-
loon SE-ZOU of the model LBL 120A,
operated by Ballongflyg i Väst AB.**

Reference no. L-46/16

2 June 2017

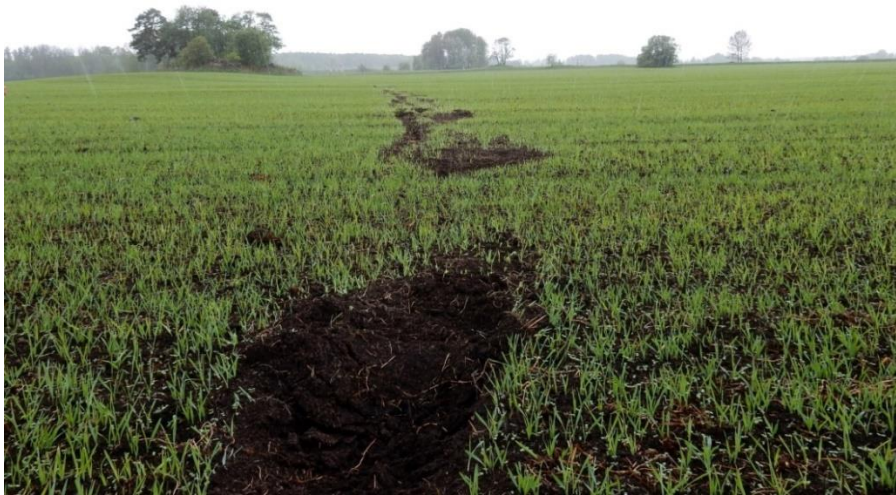
Figure 2. Ground tracks from the second touchdown.

In order to prevent a new hard touchdown, the pilot reactivated the burners, but the second touchdown was also hard (see Figure 2). The balloon was then dragged by the wind at high speed along the ground with short airborne intervals. About 400 metres after the second touchdown, the pilot fell out of the balloon basket in conjunction with a hard ground contact.

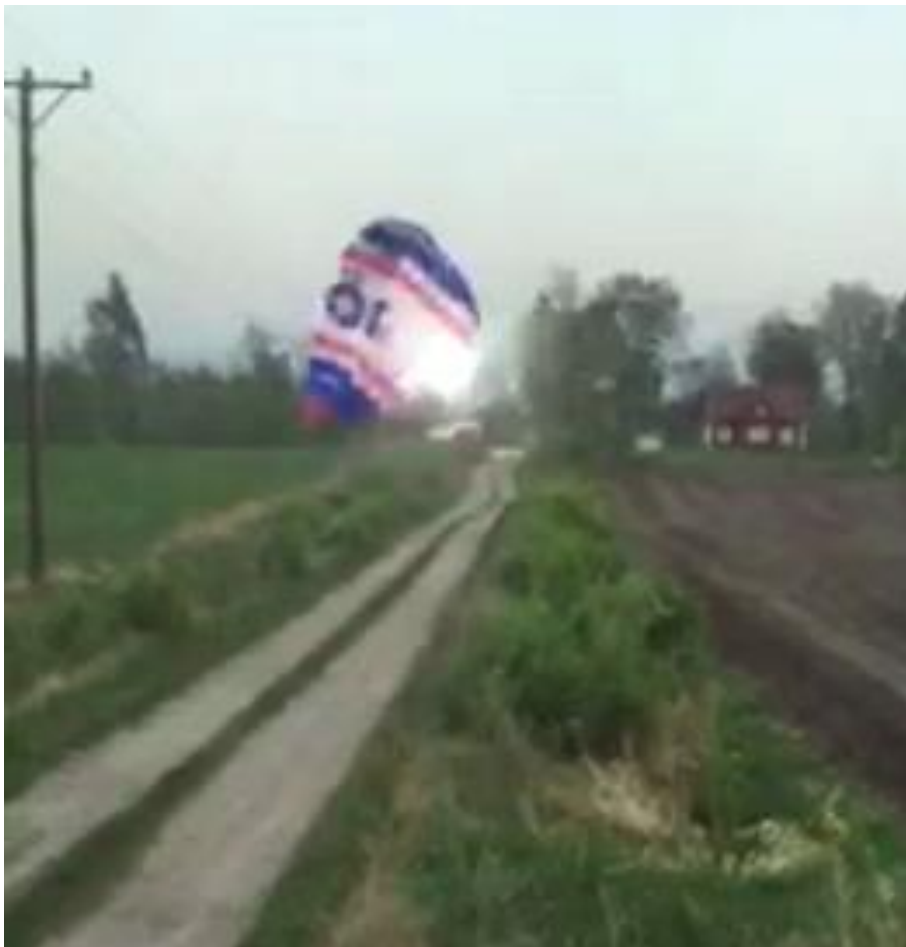
Figure 3. The moment when the balloon envelope hit the power line. Photo: Emil Axelsson.

The passengers then decided to leave the balloon basket, which was still being dragged by the wind at high speed. The first passenger became caught for a short time between the basket and the ground. When the second passenger was leaving the basket, his foot became entangled in an operating line. Held fast by the line, the passenger was dragged behind the balloon at high speed, at times in the air and at times on the ground, for several hundred metres before the balloon drifted into a power line and stopped (see Figure 3).

The accident caused damage to a 10 kV power line that resulted in a power outage that lasted for two hours until 23:20 hrs. In addition to this, there was damage to several fences.

- The balloon envelope sustained tears to several panels and burns to panels on the upper and lower parts of the envelope.
- The burns on the envelope's upper parts have probably been caused by arcing when the balloon hit the power line.
- The structure of the balloon basket sustained substantial damage.

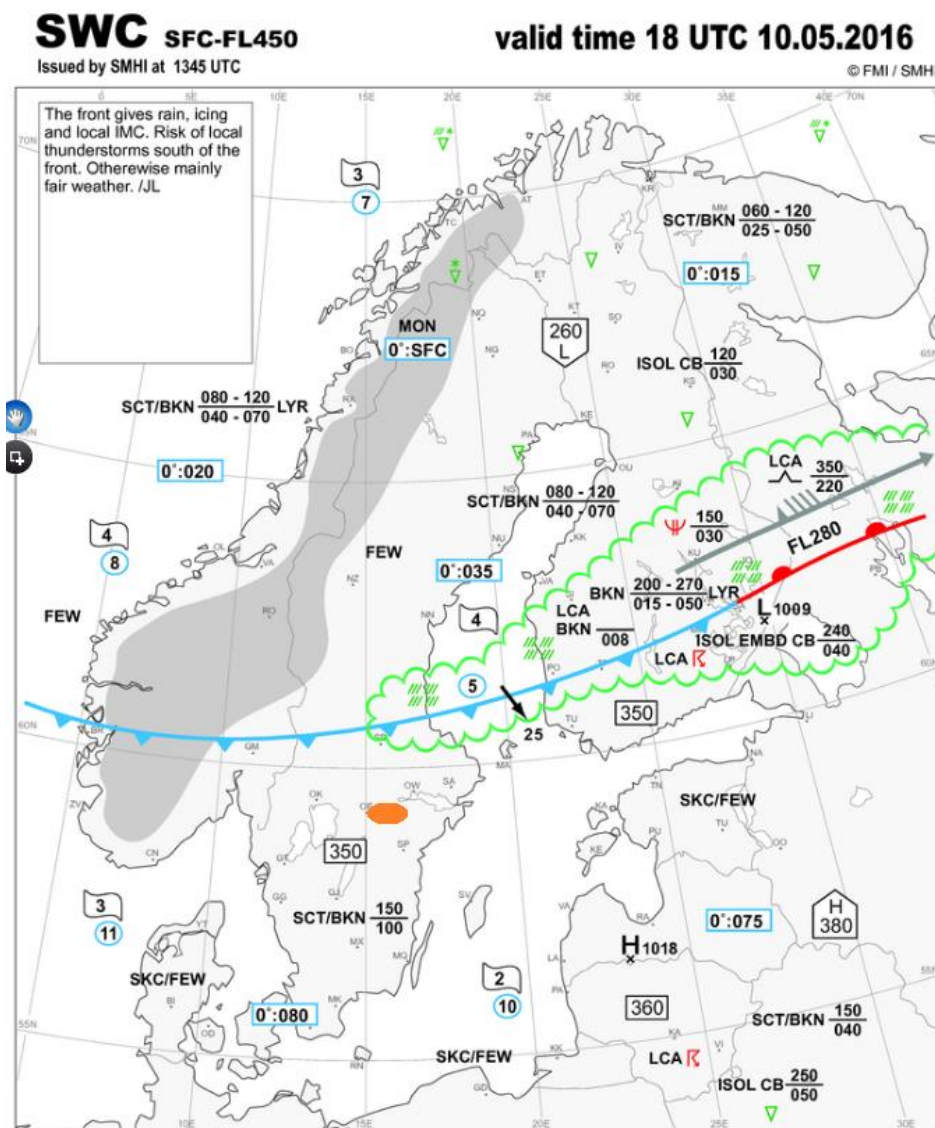
The SWC issued on 10 May at 15:45 hrs that was valid for 20:00 hrs showed a sharp cold front that was moving south (see Figure 4).

SMHI's overview chart for significant weather conditions issued at 15:45 hrs showed that a sharp cold front that would pose a risk of thunderstorms moved south across Svealand during the afternoon and evening. The weather forecasts that the pilot used for flight planning indicated though only a moderate wind (6-8 knots) from the northwest up until 21:00 hrs. However, according to the forecasts, the wind would then change direction and increase in strength at 22:00 hrs. According to the forecast that was available at 15:00 hrs on the weather application yr.no, the wind at 22:00 hrs would increase to 18 knots. However, in the forecast that was available at 18:00 hrs, the wind strength was revised to 14 knots (see Section 1.7.2).

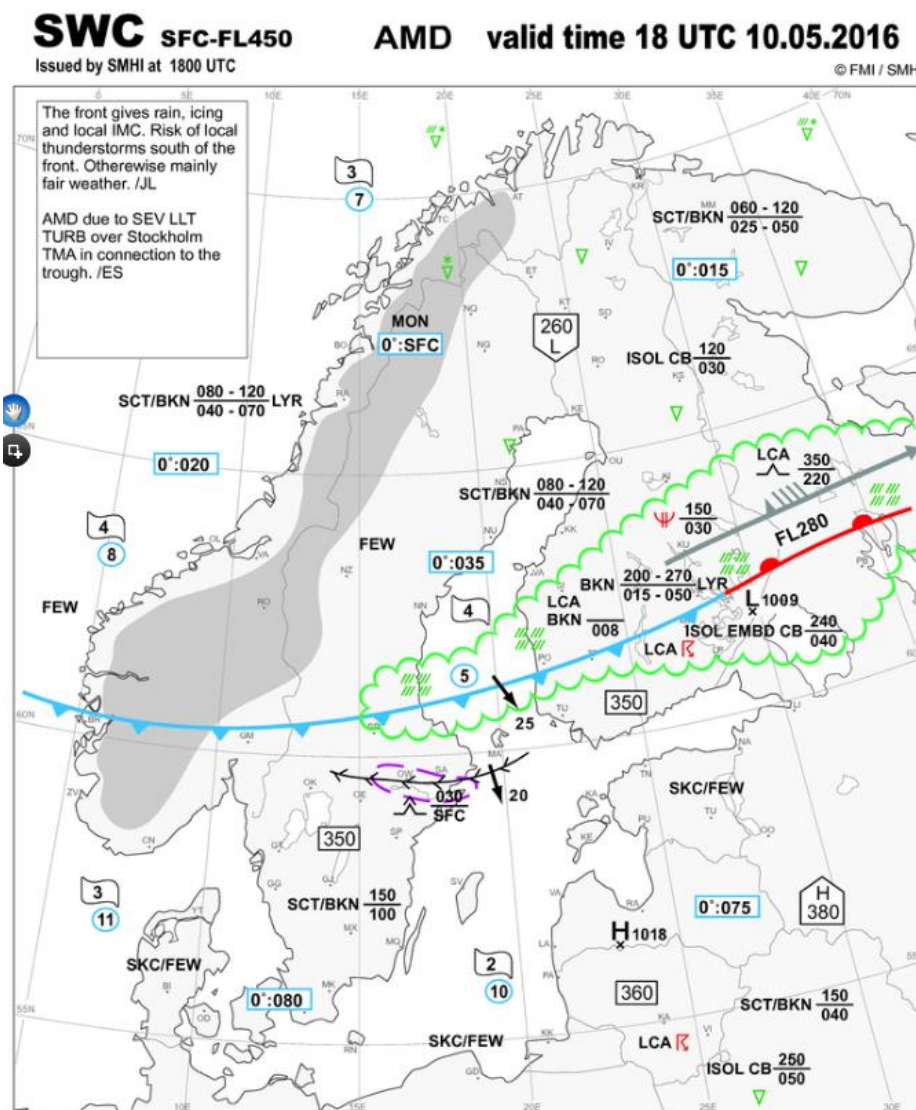
Figure 5. Printout of the SWC. Source: SMHI.

An amended SWC issued at 20:00 hrs and valid for the same time showed a trough line just north of the area of the accident with severe turbulence at low altitude (see Figure 5). A trough or a trough line is an elongated area with lower air pressure, characterized by thunderclouds. A trough line can move at speeds of twenty to sixty knots and lead to sudden and surprising weather conditions, such as from sunshine to rain showers and powerful, gusty winds in a very short time.

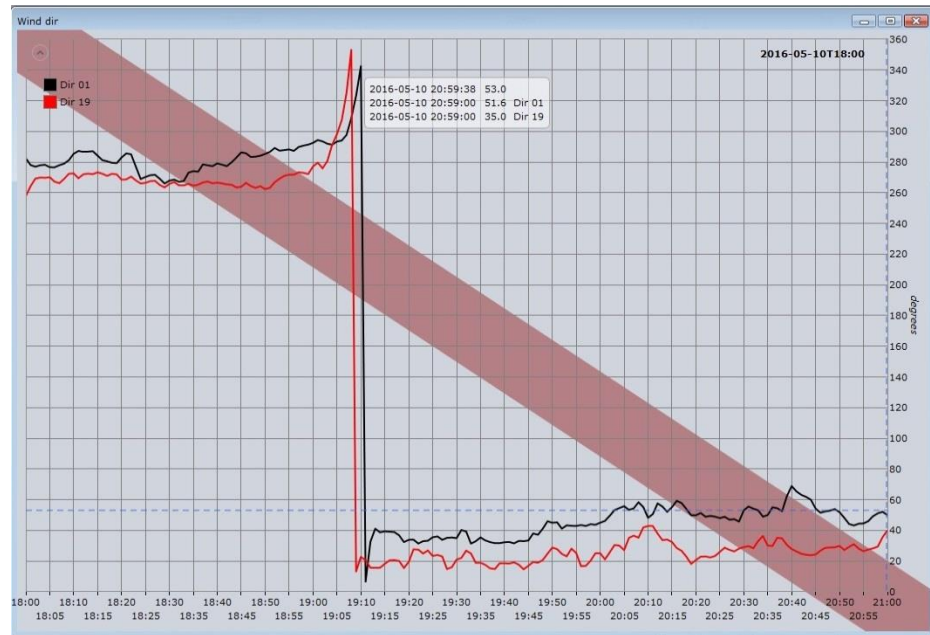
Measurements at Örebro Airport show that the wind turned quickly from west to northeast at 21:10 hrs (see Figure 6), at the same time as the wind speed increased to 25-30 knots in the gusts (see Figure 7).

Figure 6. Wind direction on runways 01 and 19 at Örebro Airport. The time is given in UTC. The figure clearly shows how quickly the wind changed direction at the time of the accident. Source: Örebro Airport.

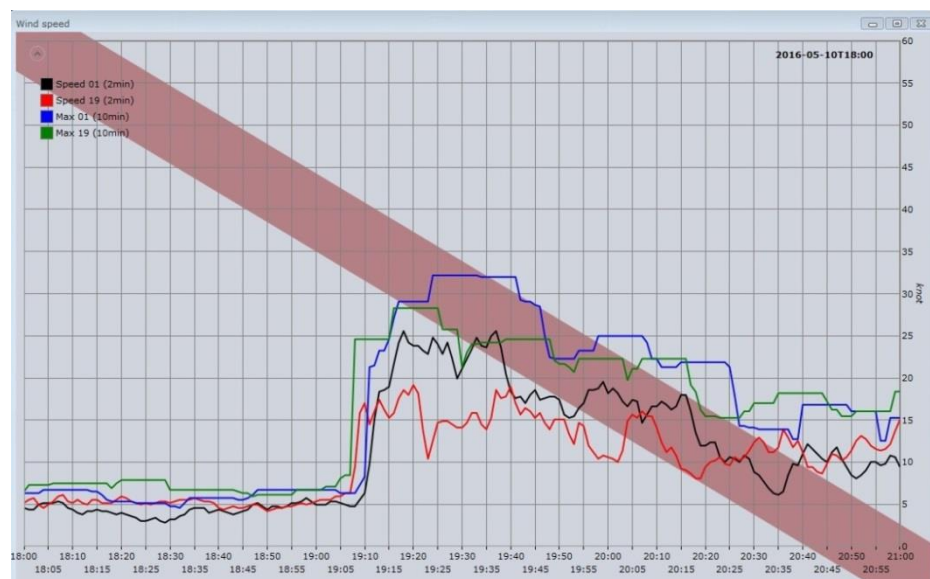
Figure 7. Wind speed on runways 01 and 19 at Örebro Airport. The time is given in UTC. The figure shows how quickly the wind increased in strength at the time of the accident. Source: Örebro Airport.

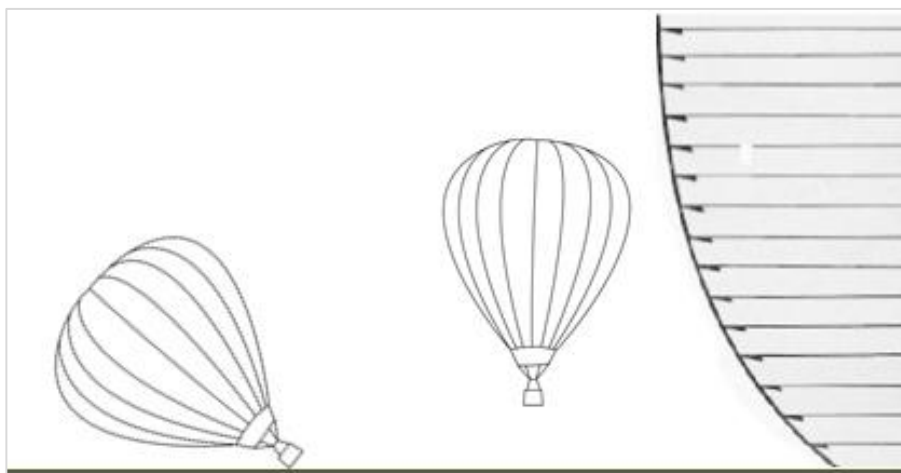
The wind's friction against the surface of the ground entails that the wind speed is lower closest to the ground, but increases with height. This effect (the wind gradient) varies with the wind strength and acts from the surface of the ground and up to an altitude of a few hundred metres. The wind gradient means that an air flow is formed over the balloon envelope. Due to the curved shape of the envelope, an area of low pressure is created over the top of the balloon envelope. This results in the creation of an additional aerodynamic lift that contributes to the balloon climbing.

Figure 8. Sketch showing the principle of the wind gradient's effect on a balloon before and after landing.

In the final stage of approach, when the altitude had become low and the balloon entered the wind gradient (see Section 1.7.4), an aerodynamic lift was created that caused the balloon to climb. The pilot counteracted this by opening the top vent and releasing hot air. When the balloon had climbed out of the wind gradient, the aerodynamic lift ceased. This resulted in a high rate of descent and a hard touchdown somewhat before the designated landing site.

Upon the touchdown, the balloon was slowed down, which caused a high rate of airflow over the balloon envelope that meant that the aerodynamic lift again increased. It is also probable that the balloon was not sufficiently deflated of hot air. In addition, the burners were inadvertently brought to full power in conjunction with the hard touchdown. All in all, this led to the balloon climbing up to a height of 30-50 metres. The pilot then closed the valves to the fuel tanks.

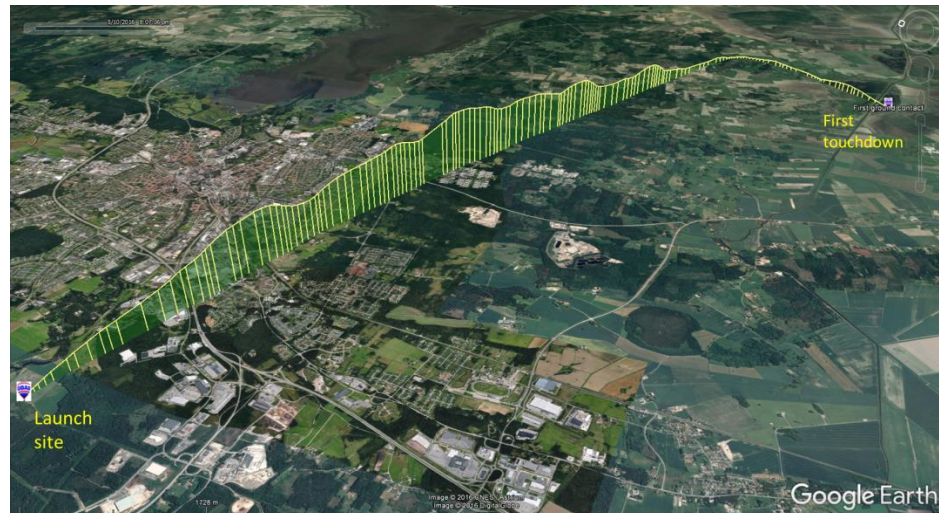
The balloon was equipped with navigation equipment capable of recording parameters from a laptop computer with GPS to a server. The equipment fell out of the balloon in conjunction with the first touchdown. SHK has reviewed the navigation information. The balloon's route is shown in Figure 9.

Figure 9. The balloon's route is shown by the yellow line. The first touchdown is marked. Image: Google Earth. Map data: © Lantmäteriet Ref no R61749-13002.

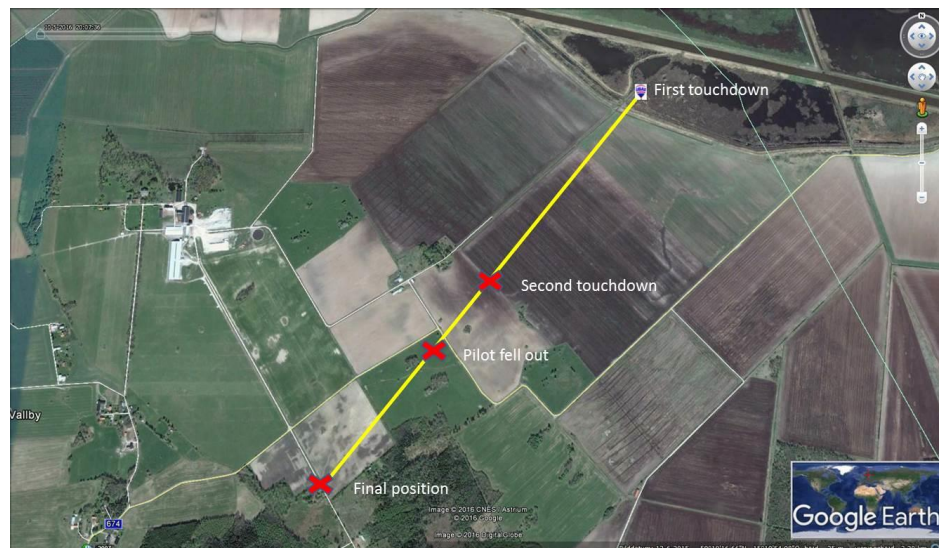
The first touchdown was made in the southern part of the Västra Kvismaren nature reserve. The balloon then continued in a southwesterly direction. A second touchdown was made after about 1 000 metres. The balloon was then dragged along the ground or through the air for a further 1 000 metres. It finally stopped at a power line near a residential building (see Figure 10). The area at the accident site mainly consisted of open fields and pastures.

Figure 10. Marked route from first touchdown until final position. Map image: Google Earth. Map data: © Lantmäteriet Ref no R61749-13002.
