Final report RL 2020:09e

Accident at Visby Airport, Gotland County, on 30 October 2019 involving the helicopter SE-JRM of the type AW139, operated by the Swedish Maritime Administration.

File no. L-156/19

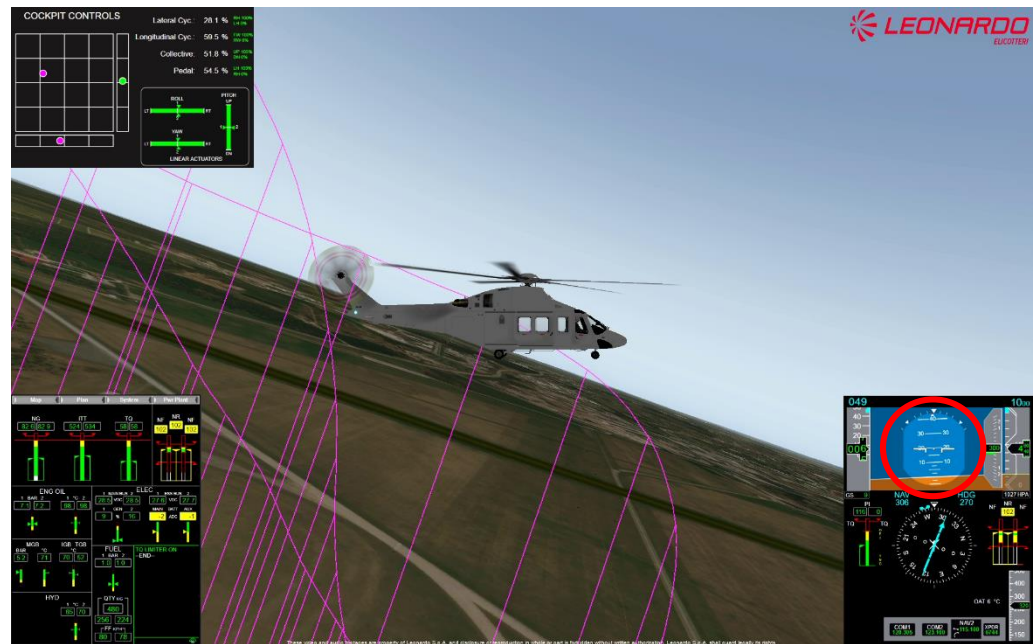
When the instructor activated the training mode for simulating flight with one engine inoperative, the indicator for engine output showed a simulated loss of power in one engine. The student pilot reported 'torque split' and pushed the collective forward so that the nose was dropped markedly with the aim of transitioning from reverse motion to forward motion. The rate of descent increased and soon after the pilot raised the nose markedly, up to 20 degrees nose up, in order to reduce the effect of the preceding manoeuvre. At this stage, the student pilot again lost sight of the landing site. Immediately after this, the crew felt a large and unexpected descent (see Figure 5).

Figure 5. The helicopter's attitude immediately prior to the large vertical descent that followed the high nose position, the low speed and the limited power output. Source: FDR data and animation from Leonardo Helicopters.

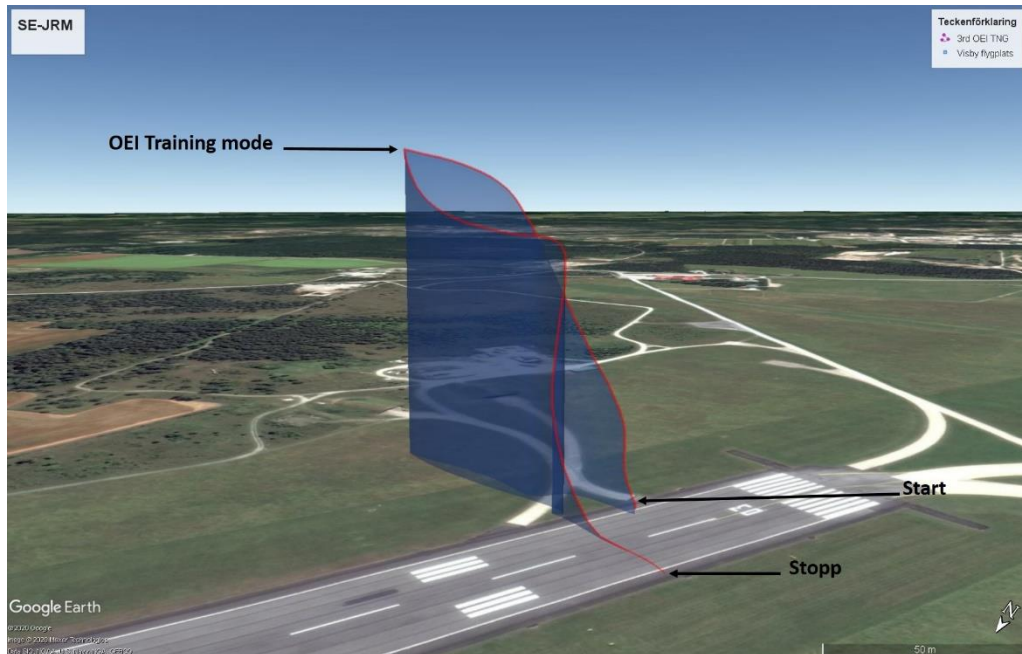
Figure 6. The red line shows the movement of the helicopter during the flight based on data from the FDR. Source: Leonardo Helicopters and Google Earth.

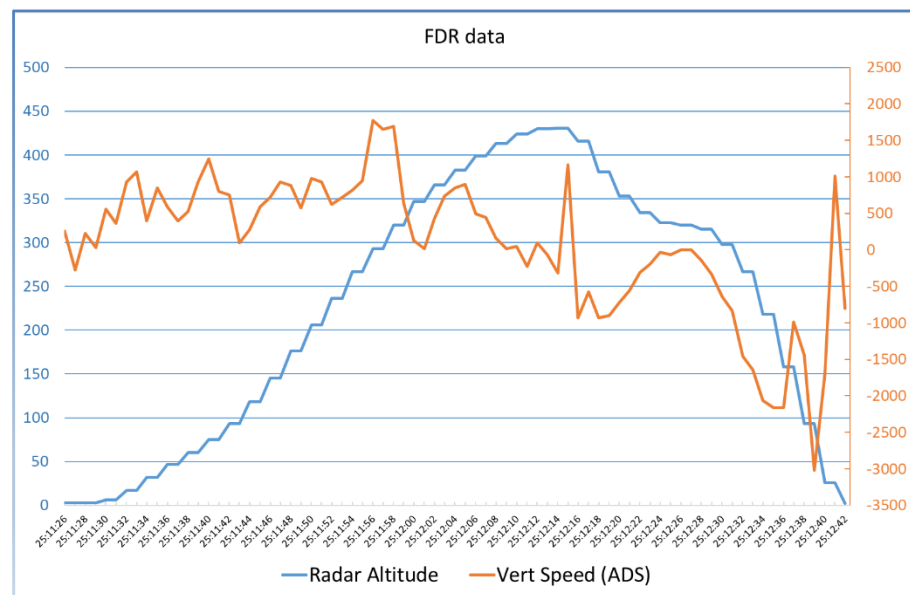
The rotor speed of 102 % was maintained down to 270 feet and the vertical speed (V/S), ‘the descent’, increased to 1,650 feet/min. For a short time the vertical speed increased to over 2,000 feet/min. A nose-down movement was initiated, which resulted in vertical speed of over 3,000 feet/min., at the same time as some forward motion was being obtained. The collective was raised and the rotor speed fell to 87.1 %, which causes the OEI training mode to deactivate automatically, at that same time, the FDR data recorded that the rotor speed was low (‘Rotor Low’).

Figure 9. Shows how the radar altitude and vertical speed varied from take-off to the accident.

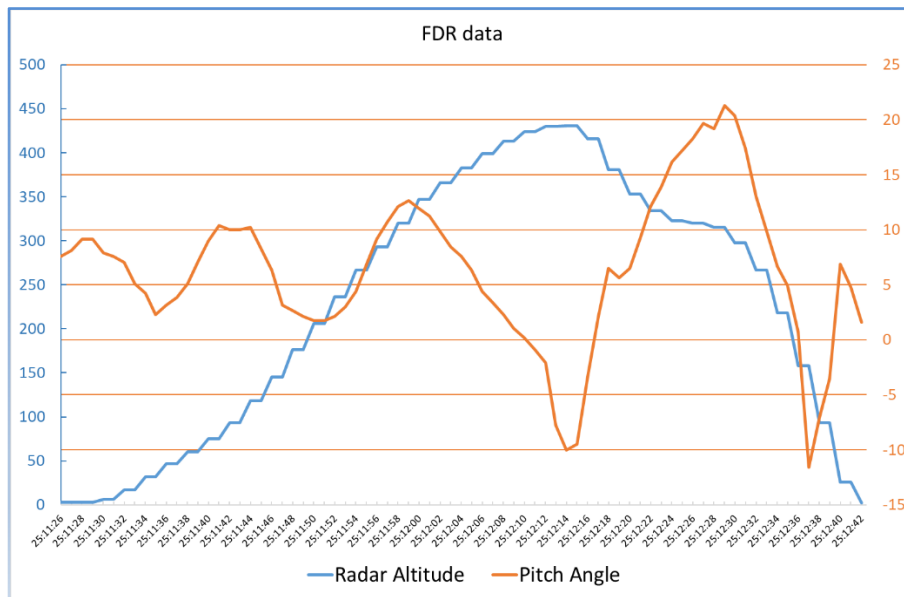
Figure 10. Shows how the radar altitude and the pitch angle (nose up and nose down) varied from take-off to the accident.

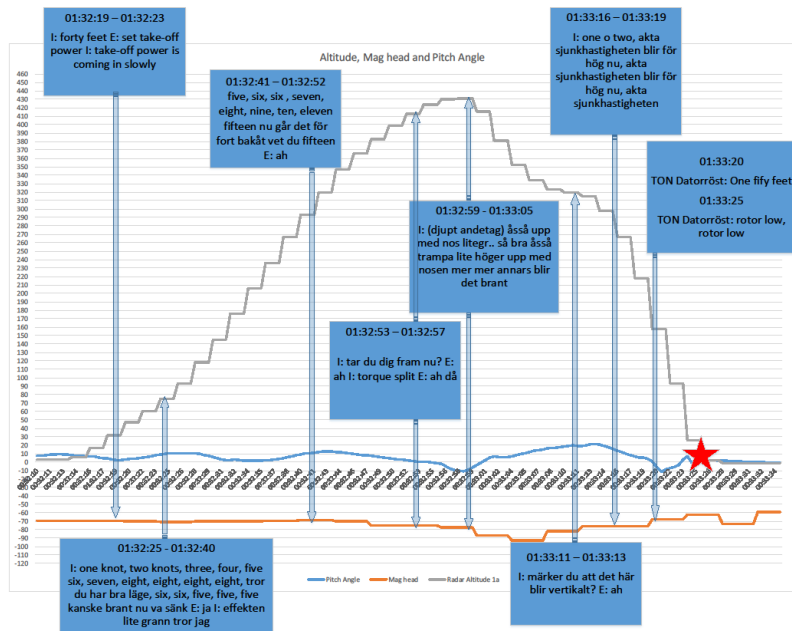
The voice recording indicates that communication has functioned as intended during the flight but that the dialogue between the pilots ceased during a critical element immediately prior to the accident. It has not been possible to record control of the helicopter being taken over.

Figure 11. Shows the communication in the cockpit from the final take-off to the hard touch-down.

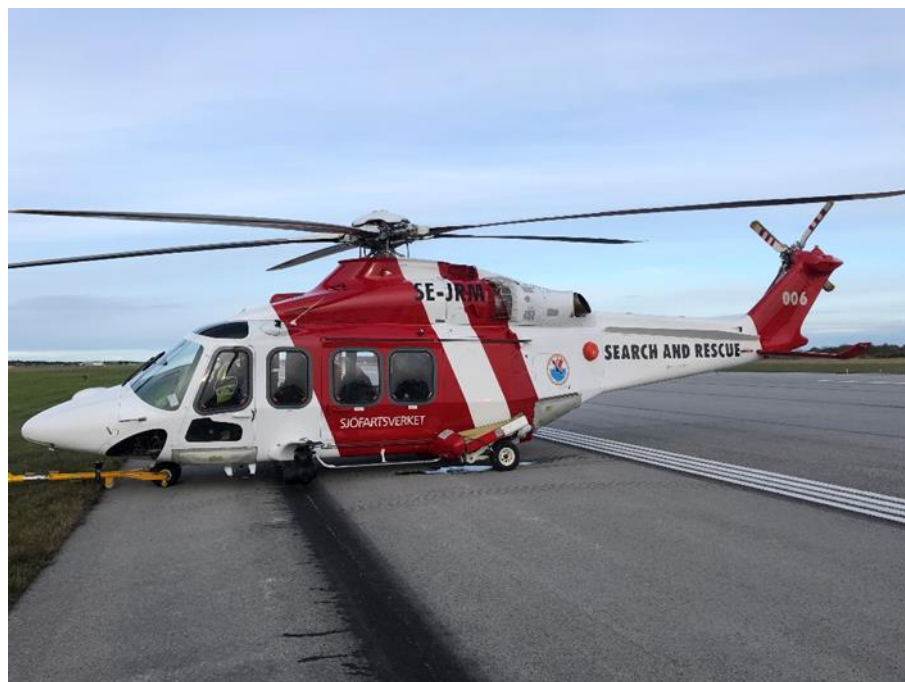
Figure 13. The helicopter's position after the occurrence.

The damage sustained by the helicopter was substantial. Following the occurrence, the helicopter was standing on its landing gear but leaning to the left. Structural damage occurred to the left landing gear and its attachments to the fuselage. Damage also occurred to panels and beams around the fuel compartment in the cabin. All of the structural damage

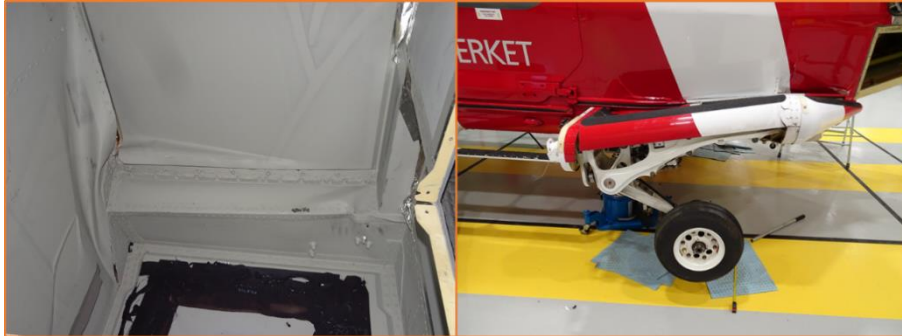
was between fuselage stations 5700 and 7200, which is the area that begins behind the cabin door and ends at the beam for the rearmost attachment of the landing gear.

Figure 14. Right image: The damaged main landing gear and surrounding structure. Left image: Structural damage from the inside of the fuel compartment.
