## *Final report RS 2019:02e*

MIGNON – Cargo hold fire on 4 April 2018

File no. S-59/18

28 March 2019

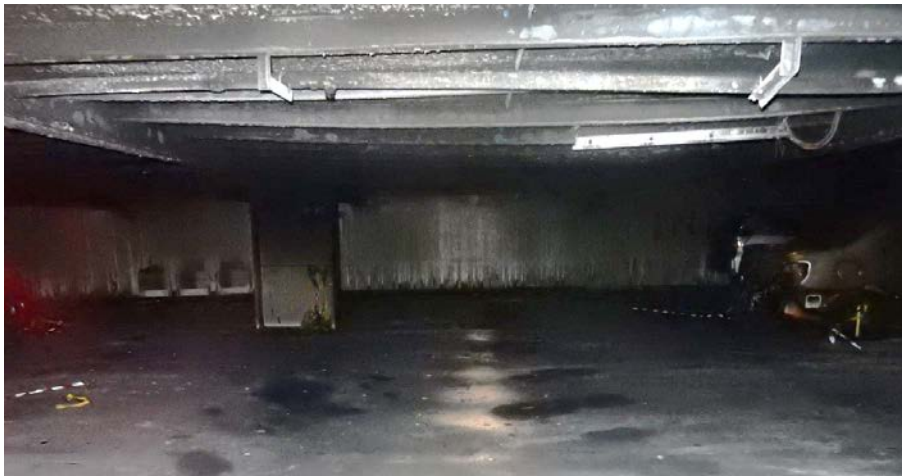
The fire resulted in structural damage to decks 2 and 3. Approximately 360 square metres of steel on deck 2 and approximately 300 square metres on deck 3 was replaced during the shipyard repairs. Deck 2 had been deformed both upwards and downwards roughly at the centre line, with a difference between the highest and lowest point of around 40 cm. Cables and pipes for hydraulics and pneumatics had also been burned off. The cut cables meant that lighting and fire alarm were not functional on decks 1 and 2. The damage to the hydraulic lines meant that the valves for the ballast and bunker tanks could not be actuated.

Figure 3. The underside of deck 2, above where the burning cars were standing. The plates and the beams of the deck have been deformed both upwards and downwards.

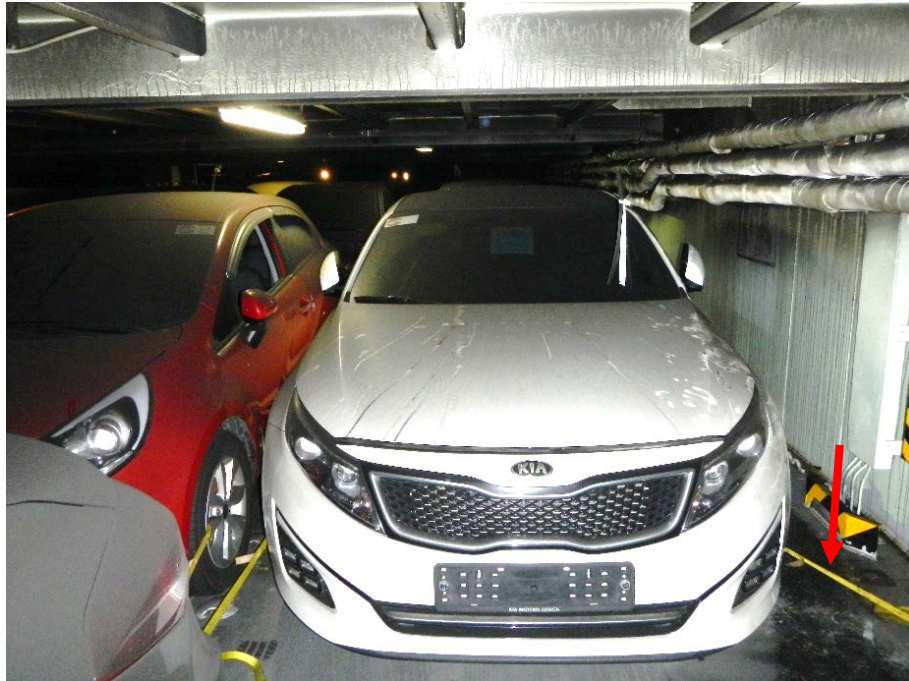
Deck 1 was fully loaded with used passenger cars, while deck 2 was only partially loaded with cars (see figures 10 and 11). The cars were parked very close together, with lashings on all wheels. Often, the spaces between the cars were so narrow that it was not possible to pass through at all, but in some cases it was possible to pass sideways. The lashings were fastened to the deck and to the top half of the wheel, stretching out a bit from the cars (see figure 12). For this reason, it was difficult to move around among the cars, as there was a risk of tripping over the lashings. A firefighting operation where smoke divers would have to pass the cars would thus entail a very great risk for the crew.

Figure 12. The cars were parked very close together. Also visible in the photo are the yellow lashings between the deck and the wheels, see arrow on the right.

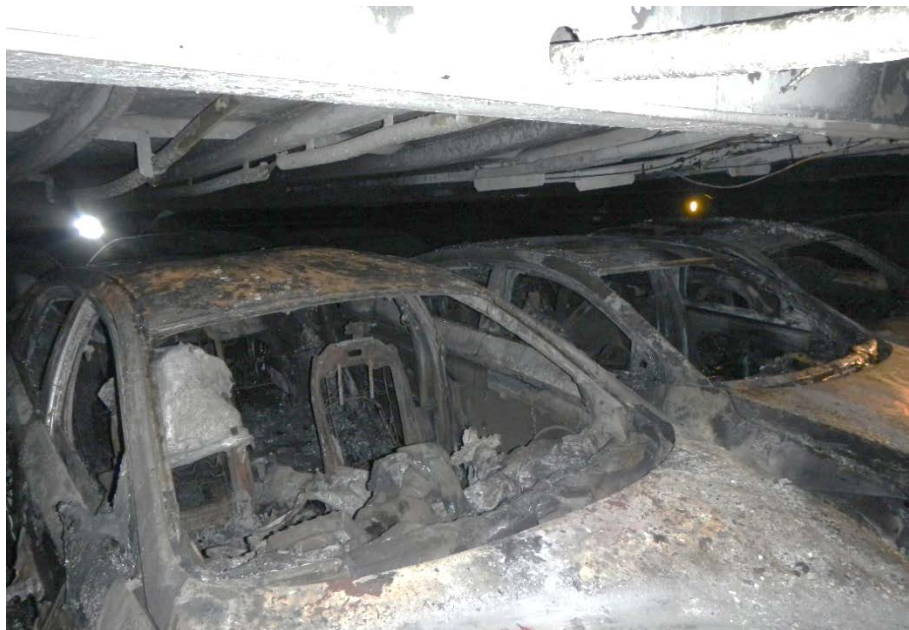
The fire started on deck 1. It then spread to cars on the deck above. Some twenty passenger cars were completely burned out and, according to the shipping company, more than 500 cars incurred fire and smoke damage (see figure 13). Hydraulic oil from a fire-damaged pipe in the vessel had also ignited. There was substantial smoke development with significantly reduced visibility.

Figure 13. Fire-damaged car on deck 1. Note how the deckhead is bulging downwards.

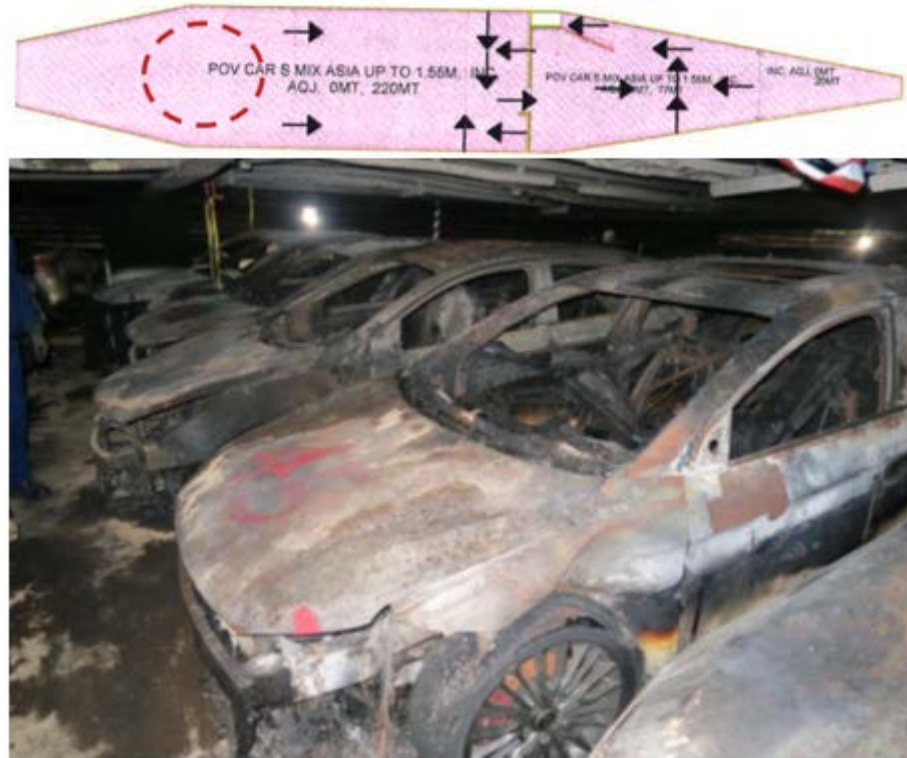
The fire damage to the cars on deck 2 was not as extensive as on the cars on deck 1, and the damages clearly indicated that the fire had impacted the cars from below. It could therefore be ruled out that the fire would have started on deck 2.

Figure 17. The likely starting point of the fire is in the area circled with a broken line on the deck drawing. Also shown in the image is the marking, the numbers on the hood, that was done on the cars in order to identify the different cars more easily.

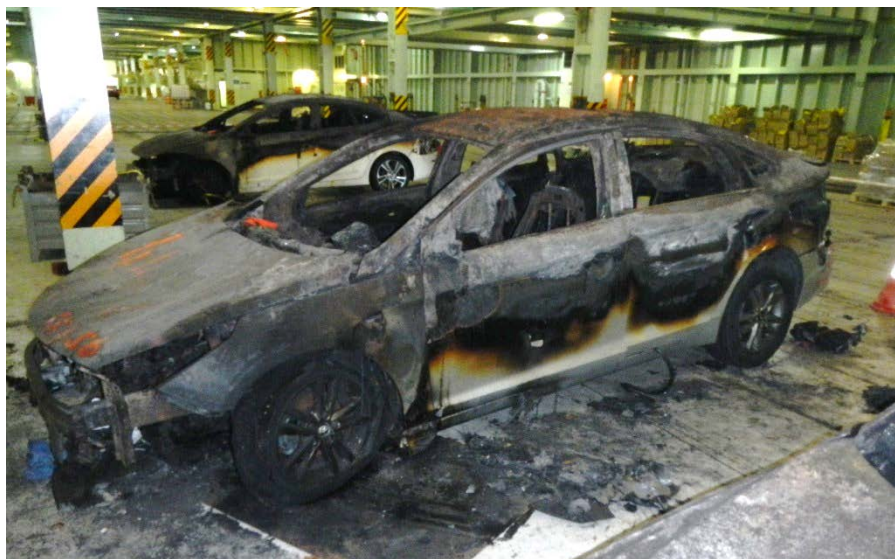
Eleven cars had very extensive damage, and some cars were completely burned out. Focus was placed on determining whether the cause of the fire was in one of these cars. After a more detailed examination of the eleven cars, the efforts could finally be directed to one car. The car in question had fire damage further down in the front section than the other cars, and the fire damage to the other cars was inclined towards that car. The passenger and engine compartments of this car were examined in detail, which, along with an investigation of the outside fire damage, led to the conclusion that the fire had likely started in the engine compartment (see images 18 and 19).

Figure 18. The fire pattern on the car where the fire likely started. In this image, the cars have been moved from deck 1 to an undamaged deck higher up in the vessel for further investigation.

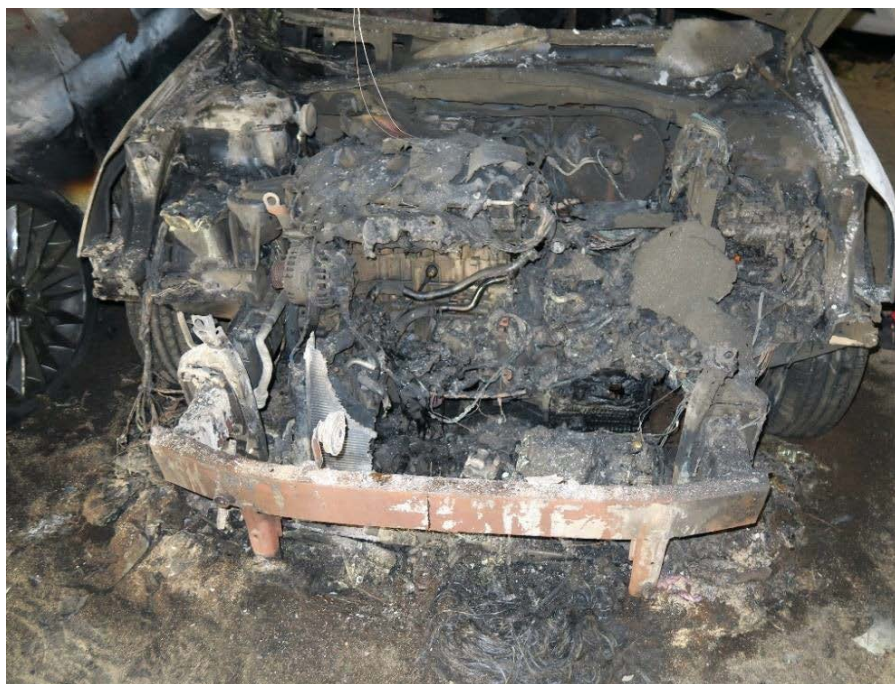
Figure 19. The engine room of the car where the fire likely started.

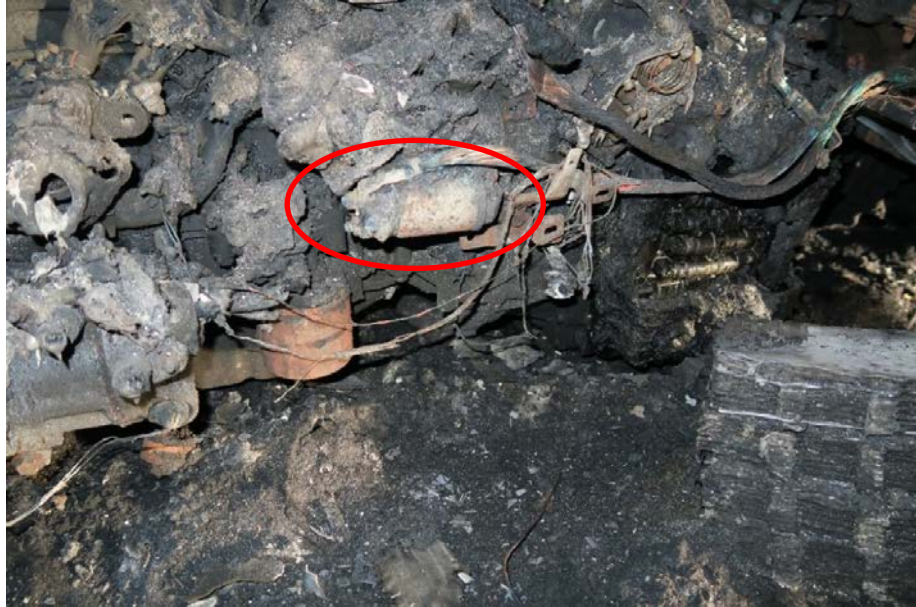
three components were disassembled and a melted copper plate was found in the solenoid<sup>13</sup> of the starting motor (see figures 20–23). The other components showed no clear signs of the fire potentially starting there.

Figure 20. The solenoid of the starting motor where the fire most likely started.

New procedures have been introduced for the loading of used cars in South Korea. The negative pole of the car battery is always disconnected now. In addition, it is noted what propulsion system the vehicle is using and where it is placed.

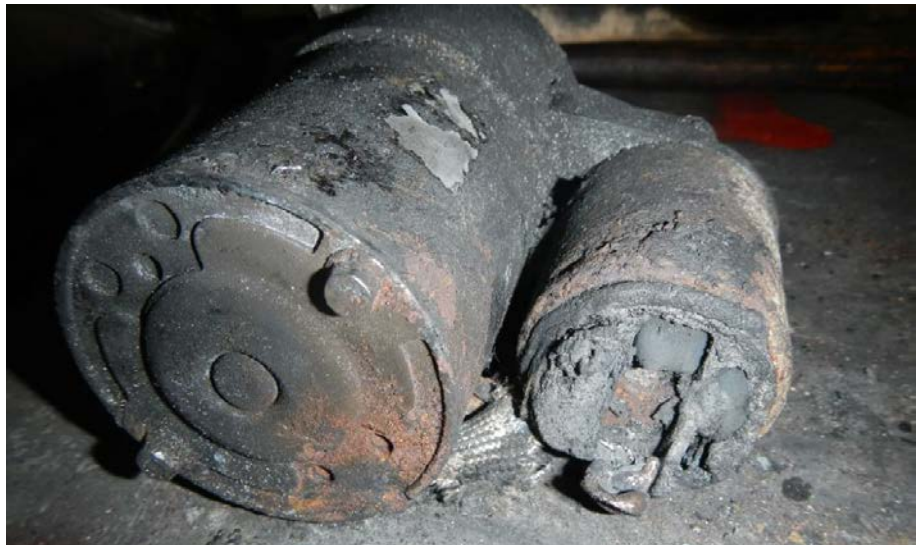
Figure 21. The starting motor with the solenoid to the right.

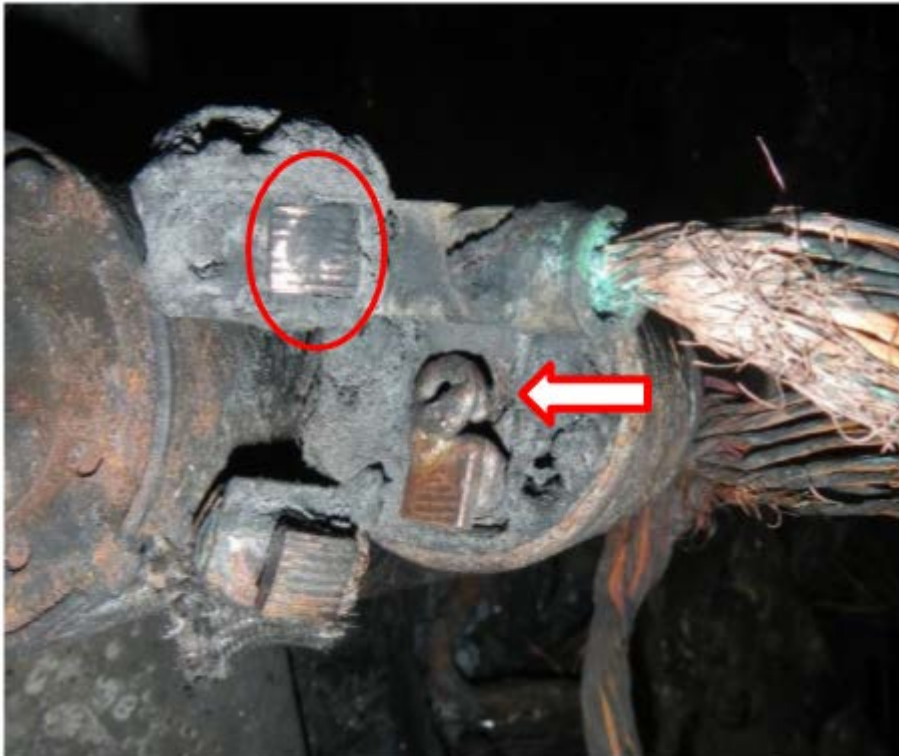
Figure 22. The contacts of the solenoid where the short circuit occurred. The position of the starting motor in the image corresponds roughly to its placement in the car. It can be seen in this image how the copper plate has melted and spilled downwards (arrow). Also note the soot on the upper contact surface (circled), which indicates poor contact between that surface and the copper plate.

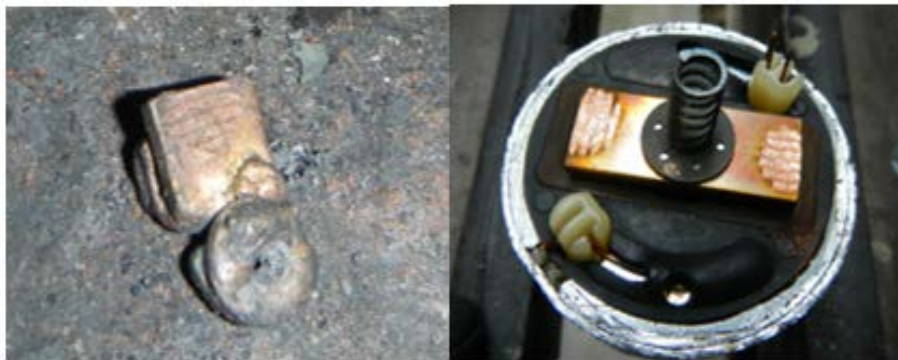
Figure 23. The short-circuited copper plate removed from the solenoid on the left and a copper plate from an undamaged starting motor of the same type on the right.

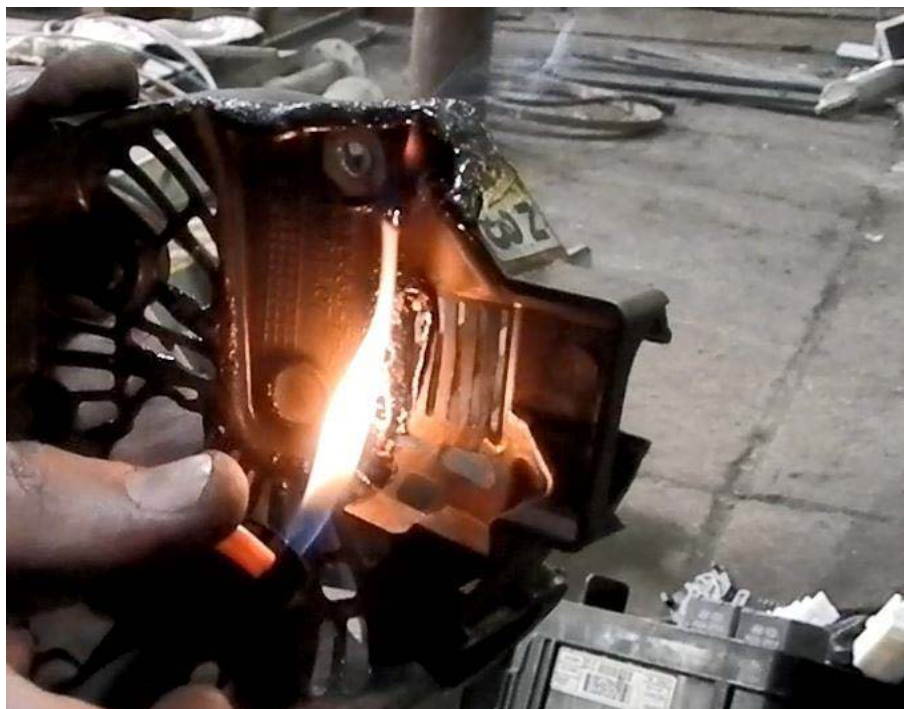
Figure 24. Example of one of the simple fire tests performed. The image shows the generator cover being tested. The cover could be ignited, but self-extinguished when the flame was removed.

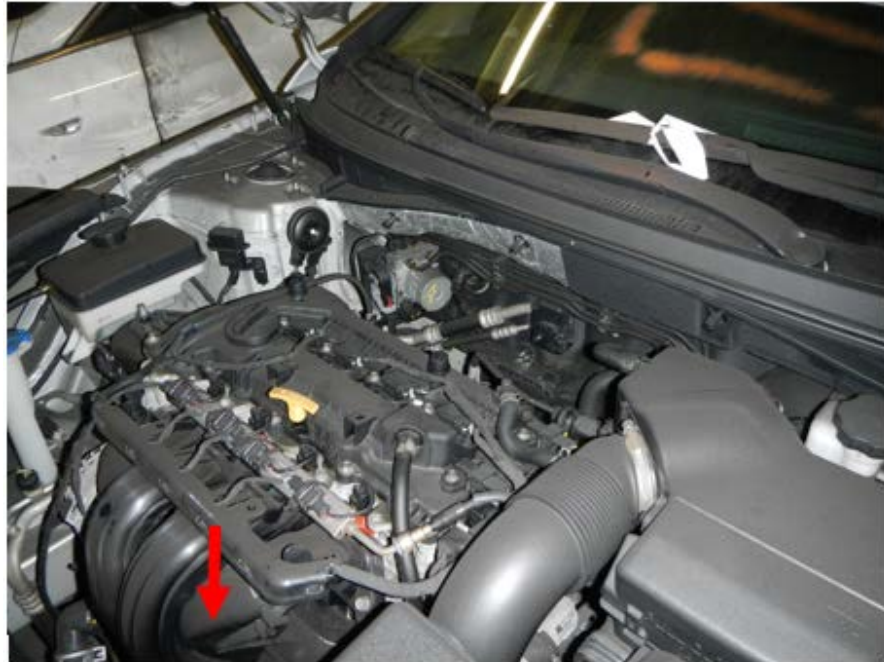
There was a large quantity of plastic details in the engine compartment, and a few centimetres above the solenoid of the reference vehicle, there was a plastic inlet manifold (see figure 25). This was removed and tested with the disposable lighter in the same manner as the other plastic details (see above). The inlet manifold burned without self-extinguishing and also started dripping burning plastic. Once the inlet manifold was ignited, it was thus possible for the fire to spread to the other flammable parts of the engine compartment. Even if certain plastic details of the engine compartment were self-extinguishing, this property did not limit the spread of the fire, as fire in other parts kept supplying flames and heat. As the inlet manifold released droplets of burning plastic, it is likely that the fire could also spread downwards at an early stage.

Figure 25. The engine compartment of the reference car. The arrow marks the plastic inlet pipe and the approximate positions of the solenoid and the starting motor below it.

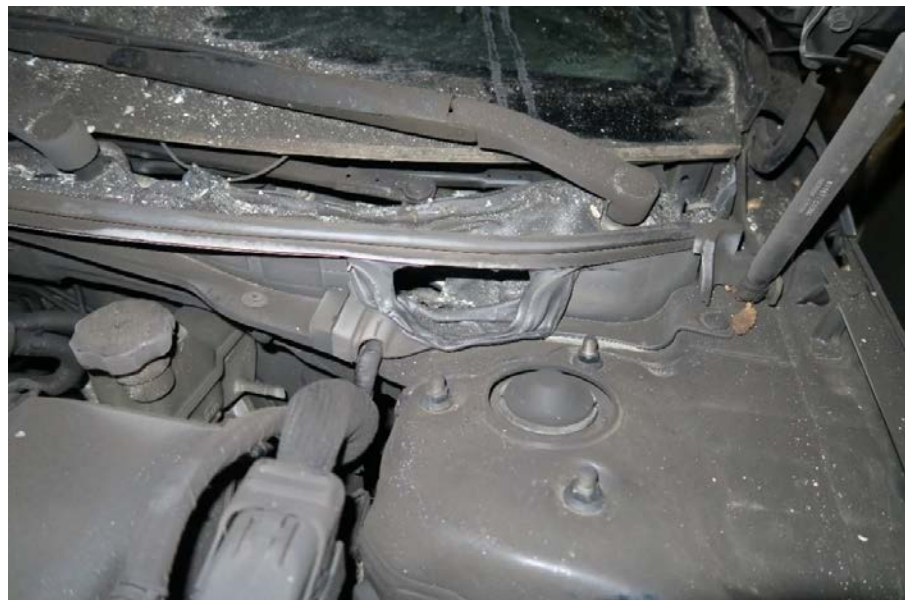
The metal “firewall” between the engine and passenger compartments had cavities that were covered in plastic. After the plastic had melted or burned off, the fire has thus been able to spread to the passenger compartment through these openings (see figure 26).

Figure 26. Openings between the engine and passenger compartments, where the plastic has melted.

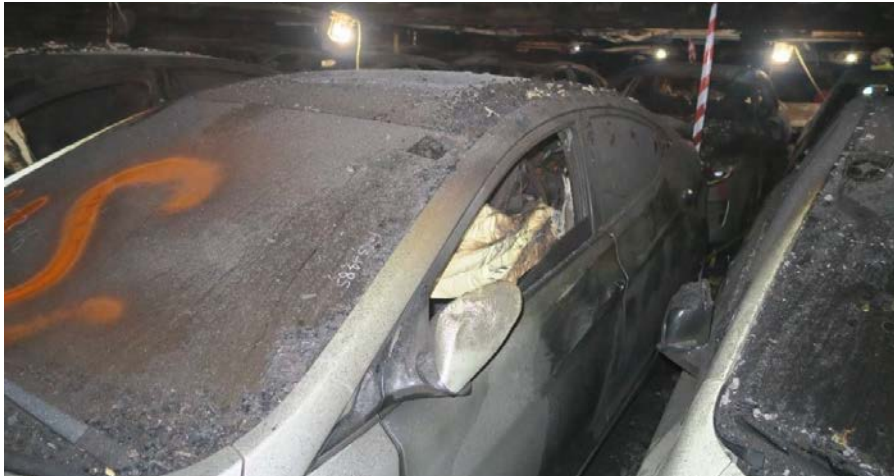
Once the fire had spread to the passenger compartment, the rolled-down window had provided sufficient air supply for the fire to grow freely. The heat from the fire has then led to all the windows melting or cracking. The fire has then gradually been able to spread between the cars, as they were placed closed together and the driver’s windows were all rolled down.

Figure 27. Rolled-down driver's window. Note the deployed airbag and the short distance between the cars.

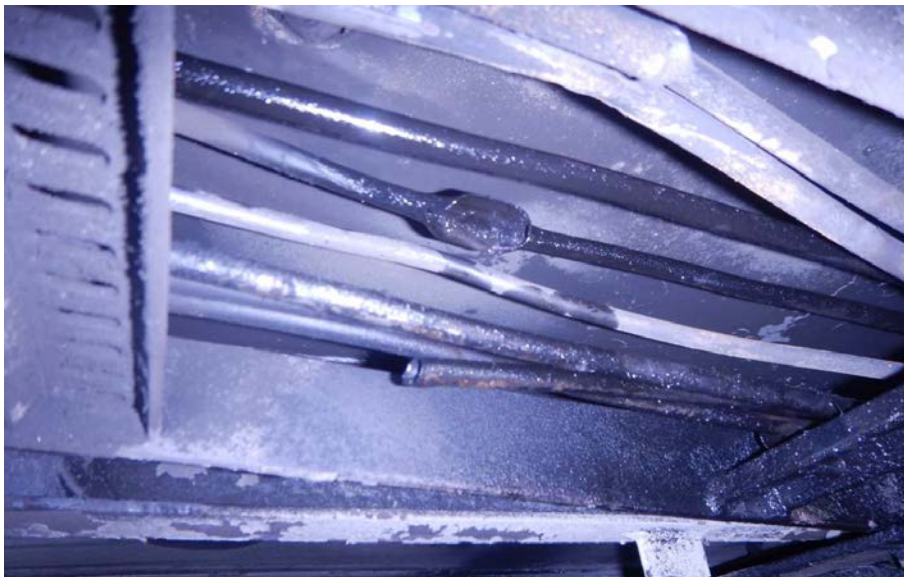
Directly above the burned cars on deck 1, there were electric cables and hydraulic lines mounted on the deckhead (see figure 28). These have been damaged by the fire and leaking hydraulic fluid has thereby further contributed to the spread of the fire. The assessment is that the rate of heat release increased markedly when approximately 100 litres of hydraulic fluid was dispersed over the vehicles and the deck. A car that was standing directly below the electric cables and hydraulic lines also had a sunroof, which meant that the fire had a substantial impact in that location (see figure 29).

Figure 28. Lines for hydraulic oil and cable ducts above the cars, which were affected by the fire.

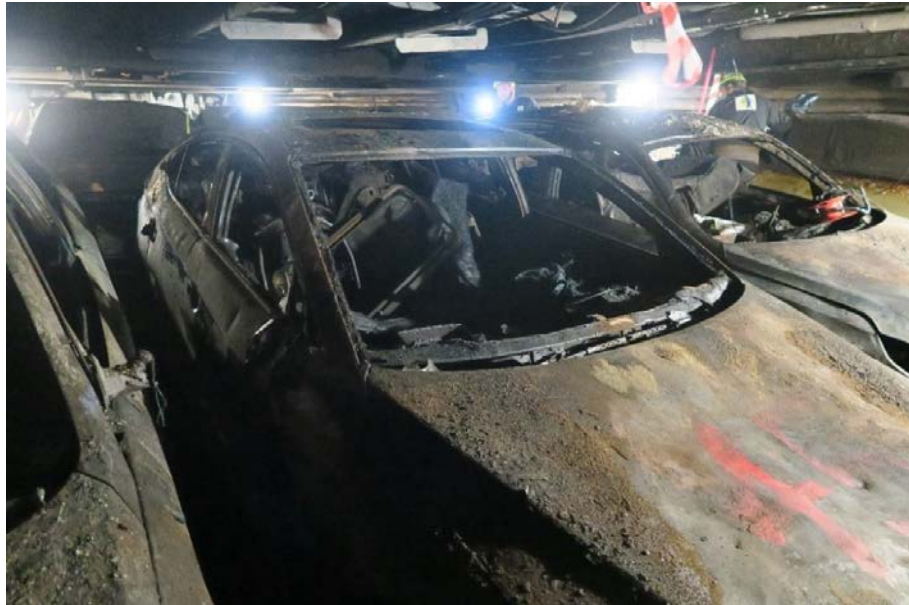
Figure 29. The car with the sunroof, where the fire inside the car affected the hydraulic lines and cables in the deckhead above.

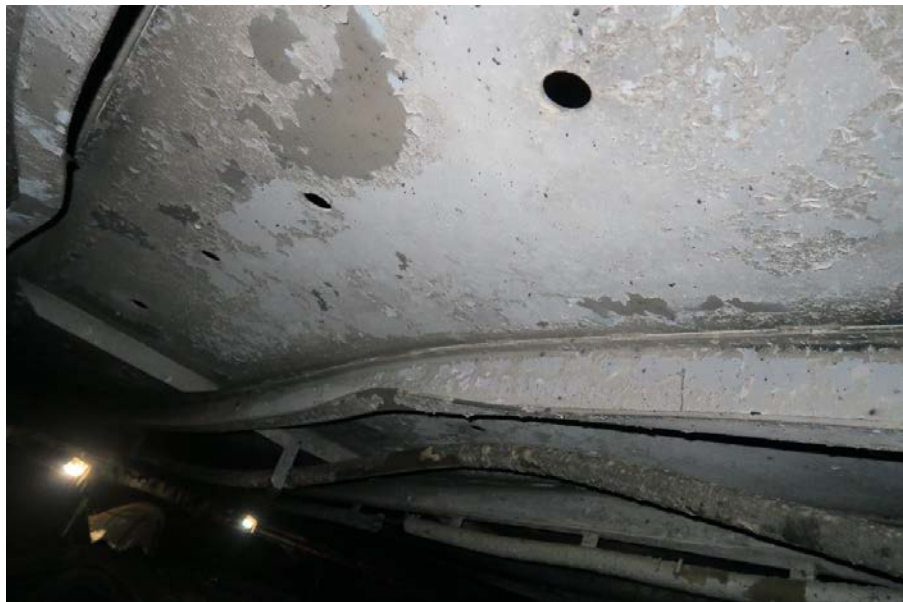
The fire also spread to cars on deck 2, above the deck where the fire started. The entire deck had holes for securing cargo at around one-metre intervals (see figure 30). The fire could thus spread through the cargo securing holes. The deck was furthermore made entirely of steel, with no fire or heat insulation. The fire has therefore likely spread to the tyres of the cars above due to heat transfer through the vessel's steel construction. The heat from the fire has also affected the integrity of the vessel's decks all the way up to deck 3. However, the heat transfer has not ignited any cars or other parts of the vessel anywhere other than in decks 1 and 2.

Figure 30. The holes for securing cargo in the deckhead to deck 2.

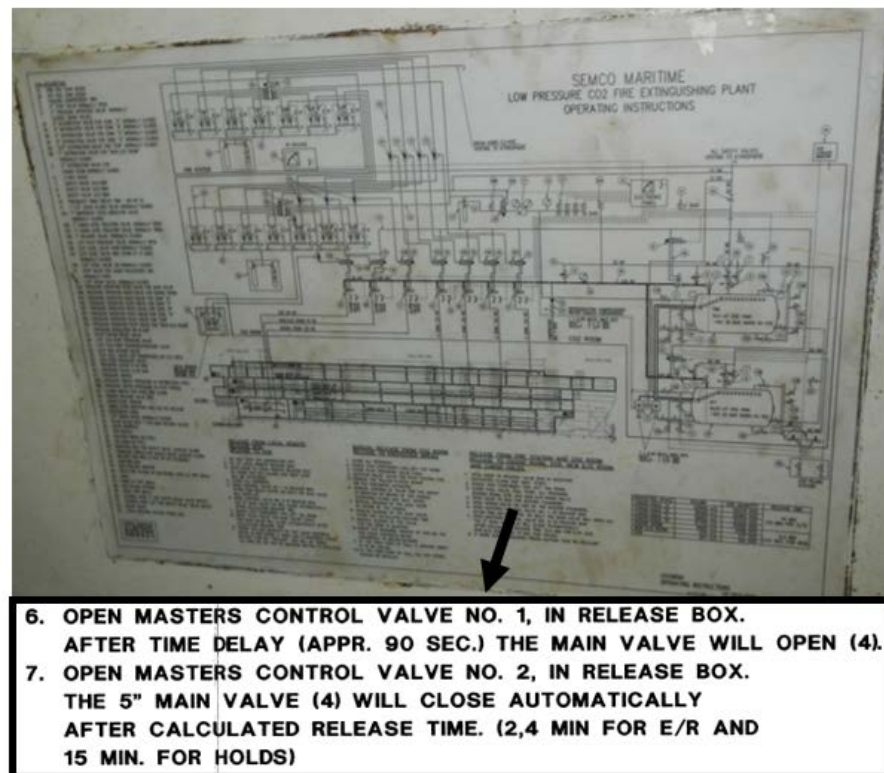
2) was then to be opened and the system would then shut down automatically after approx. 15 minutes (see figure 31).

Figure 31. Excerpt from the instruction followed by the chief engineer to activate the CO<sub>2</sub> system. The delay occurred when the main valve was not opened in accordance with step 6. The figure four within parenthesis in step 6 was also understood to mean that there may be a four-minute delay.
