Final report RS 2019:05e

ENVIK – Very serious marine casualty in
Degerhamn, Kalmar County,
on 27 November 2018

File no. S-238/18

17 October 2019

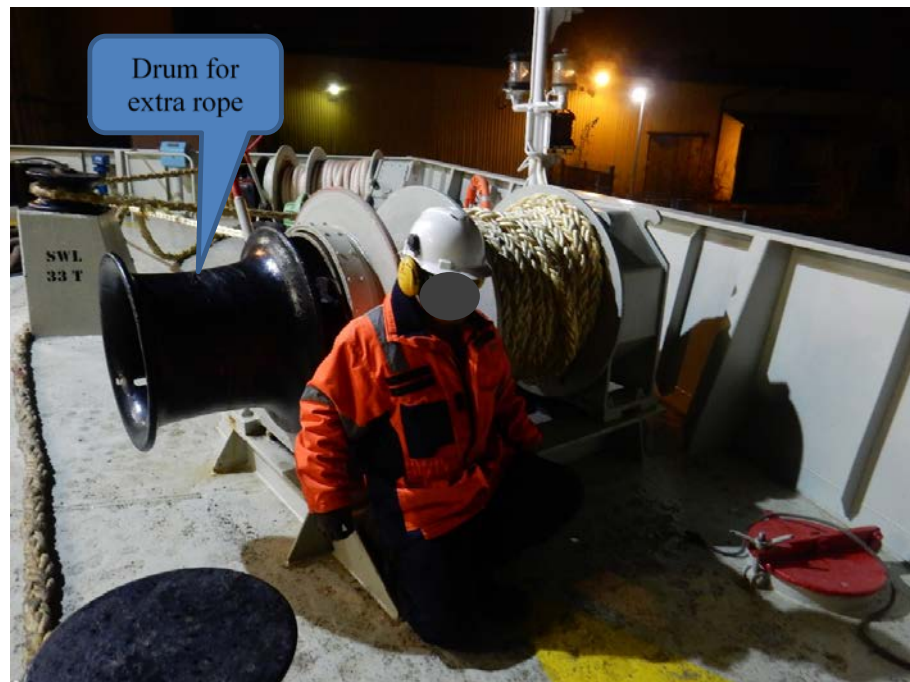
Figure 2. The position that the trapped AB was in, as demonstrated by the first person to arrive on the scene.

The trapped AB was pressed against the winch with the loose mooring rope on the winch drum wrapped twice around his chest. The AB was unresponsive and bleeding heavily from several places on his upper body. The AB who found him quickly realised that a heavy tool would

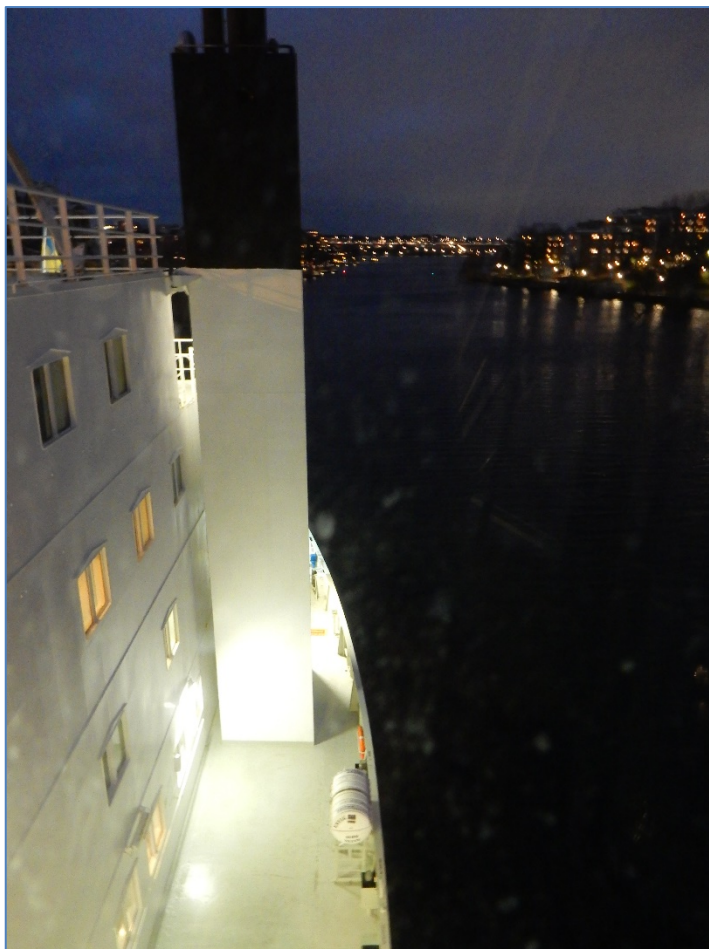
The bridge had no view of the aft mooring deck. The image in figure 6 shows the field of view from the port wing of the bridge. The stack largely obstructs the view of the poop deck and along the port side towards the stern. There was a surveillance camera showing the stern and the poop deck on the bridge. However, this did not work well in the dark hours, as the floodlights on the poop deck interfered with the image.

Figure 6. Field of view from the port wing of the bridge.

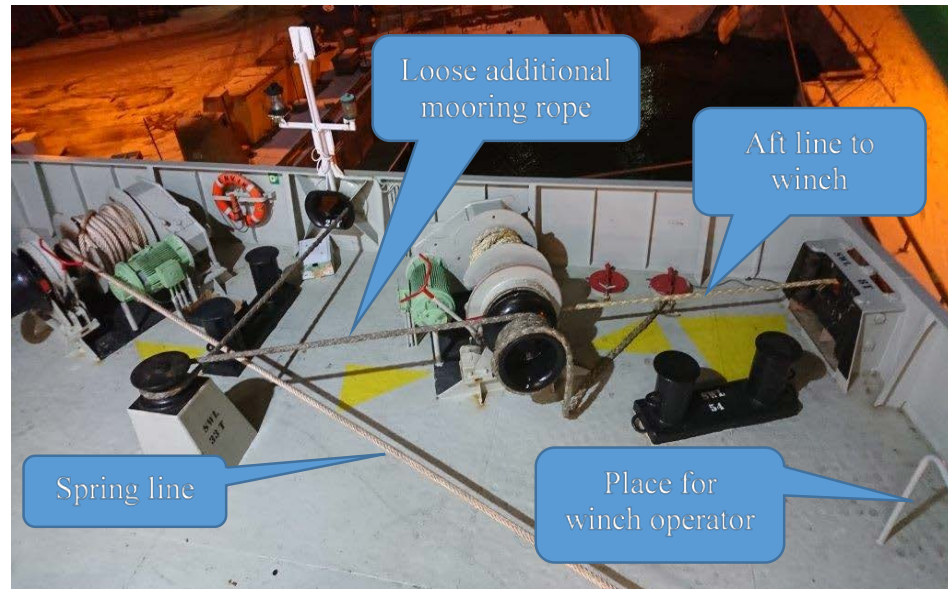
Figure 8 depicts essentially the same arrangement as the one used during the accident. A regular aft line ran from the port winch out through the fair lead of the portside bulwark. The loose aft line went out through the centre fair lead. The difference between the mooring in figure 8 and the mooring at Degerhamn at the time of the accident was that in the latter, the loose rope went over the regular mooring line to the winch, instead of under, and then down to the rope store.

Figure 8. Aft mooring deck.

At the time of the accident, as described in section 1.7.2, the loose, extra rope was going from the drum over the regular mooring line to the winch, instead of underneath, and then down to the rope store through the open deck hatch. According to the crew members who arrived on the poop deck just after the accident, there was not much of the loose rope left on deck, as it had likely been fed directly down into the rope store.

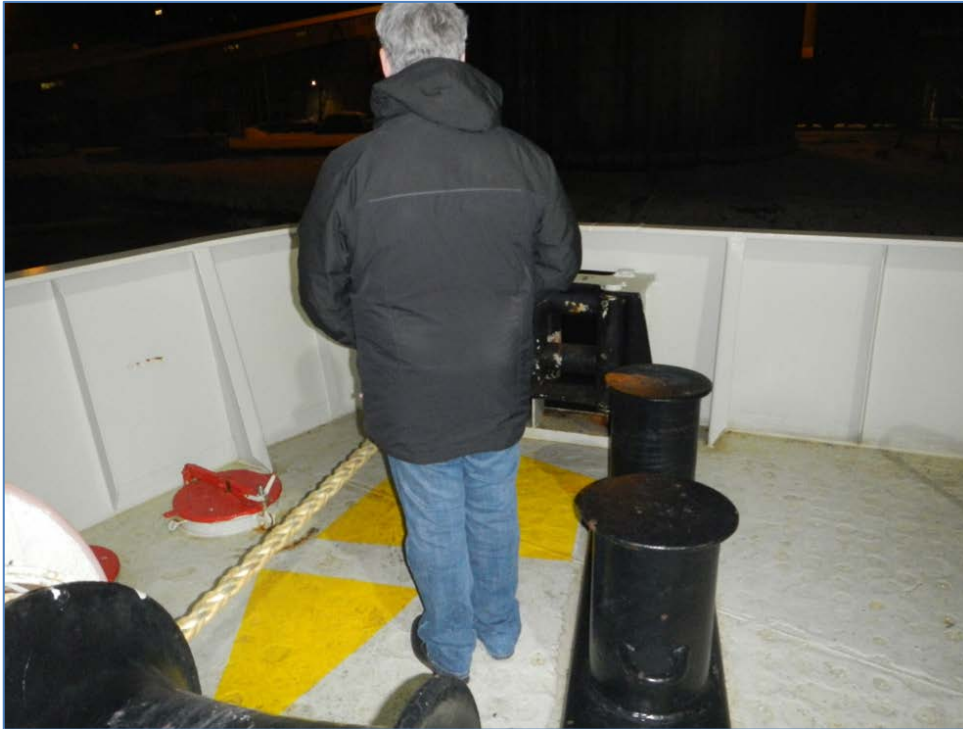
The deck surface on the poop deck around the mooring winches and bollards had been painted without any form of effective slip-protection pattern or nonslip paint. During one of SHK's visits on board the vessel, the temperature conditions were similar to those at the time of the accident. The deck was then perceived to be slippery to walk on, and the available working area was limited to some extent (see figure 13).

Figure 13. Working area between mooring winch and bollards.

If, in this situation and with the limited deck space between the winch, the bollard and the ropes running from the winch towards the bulwark, the AB has turned quickly or moved quickly towards the winch or the ropes to solve a problem, he may have slipped, been caught in the loose rope on the deck, and then been dragged up towards the winch, which was running at high speed. In such a situation, it would probably be difficult to free himself.

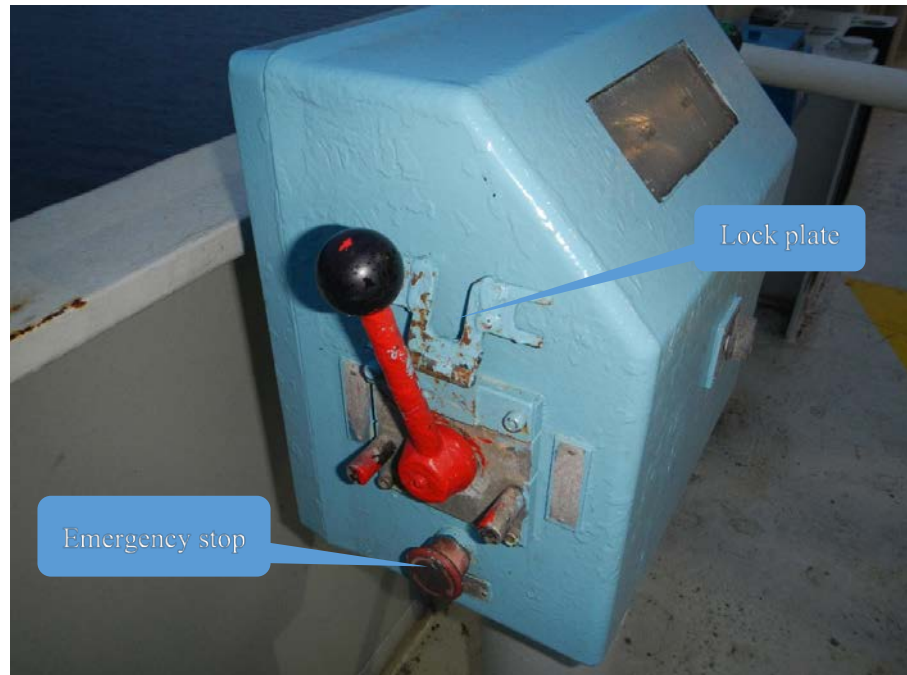
During SHK's examination of the accident site, it was noted that there was a great difference between the low and the high speed of the winch. Underneath the lever, there was an emergency stop button for the mooring winch, the same that the AB engaged when he arrived to the poop deck and found his colleague trapped by the rope against the winch.

Figure 17. Lever for the portside mooring winch.

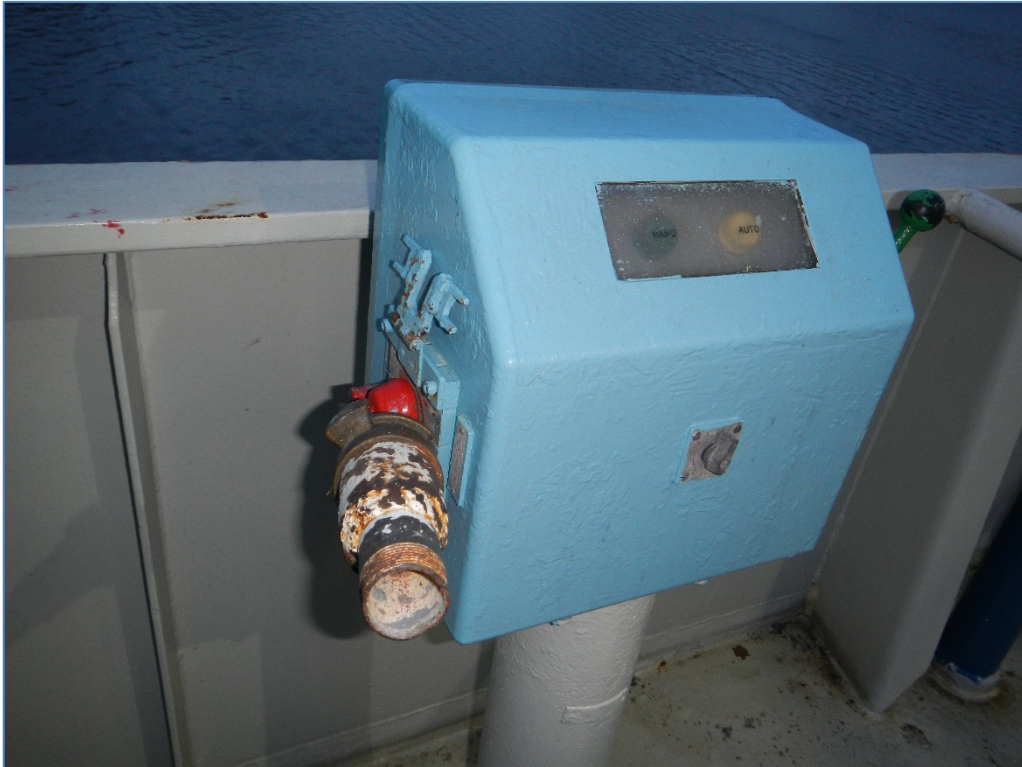
The AB noted that the lever on the control box for the port winch had been locked by means of a water adapter (see figure 18) that had been placed as a weight on the lever to keep it in the position for maximum winch speed. He also engaged the emergency stop on the winch.

The metal coupler that was used to lock the mooring winch lever on high speed at the time of the accident was a water adapter used in conjunction with bunkering fresh water. This water adapter was heavy enough to lock the lever in the end position for maximum winch speed (see figure 18). The water adapter was normally placed on a hook on the bulkhead on the starboard side of the poop deck when it was not being used (see figure 19).

Figure 18. The lever locked on high speed with the water adapter.

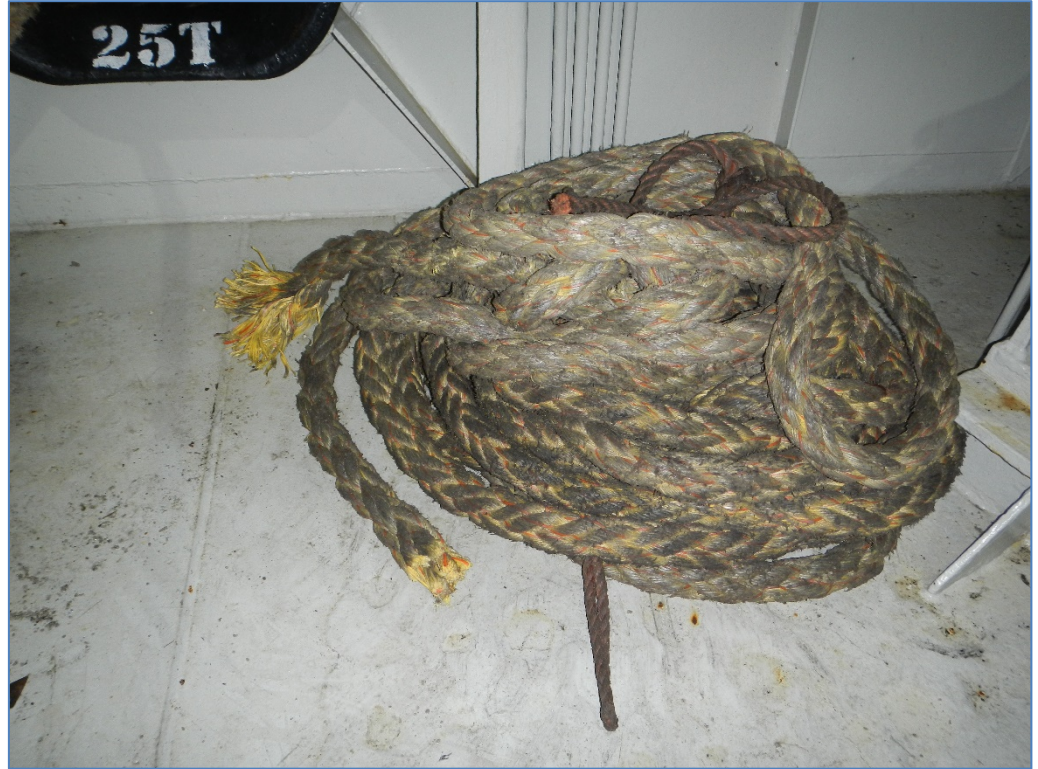
Figure 20 shows the rope (55 mm in diameter) that was used at the time of the accident and which pinned the crew member against the winch. The rope shows signs of being cut with a bowsaw.

Figure 20. The loose rope
