Final report RL 2015:12e

Serious incident in Umeå on 9 November 2014 involving helicopter SE-JRH of model Agusta Westland 139, operated by The Swedish Maritime Administration.

File no. L- 0140/14

28/08/2015

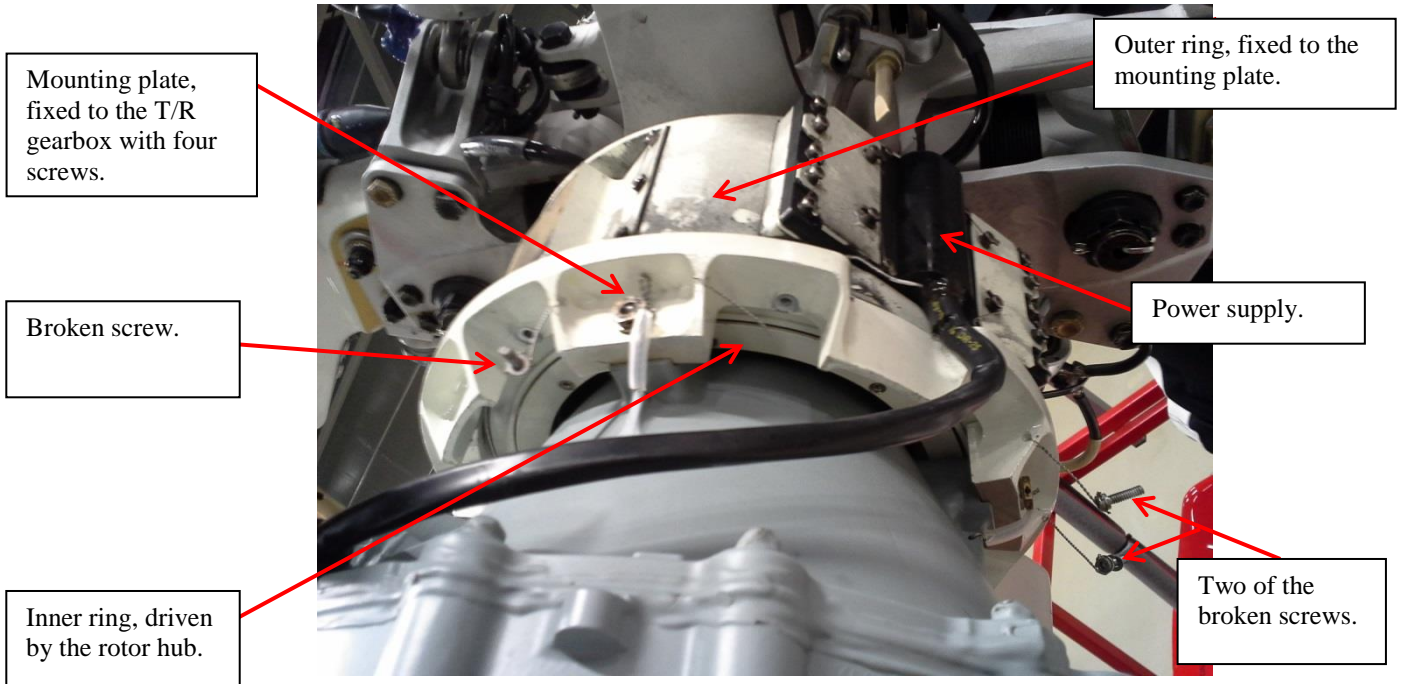
After engine shut down and in connection with fault isolation, it was discovered that the slip ring, which in its entirety weighs 5.9 kg and which was mounted adjacent to the tail rotor, had come loose, and the cables had prevented it from coming into contact with the tail rotor's moveable parts.

Figure 2. Slip ring Photo: The Swedish Maritime Administration.

The slip ring consists of the following parts: mounting plate, outer ring with electrical connections, carbon brush holder and inner ring driven by the tail rotor hub. The mounting plate is fixed with four screws to the tail rotor gearbox and to the outer ring with eight smaller screws. From the inner ring, separate electrical cables are led to the respective rotor blade's anti-icing coating.

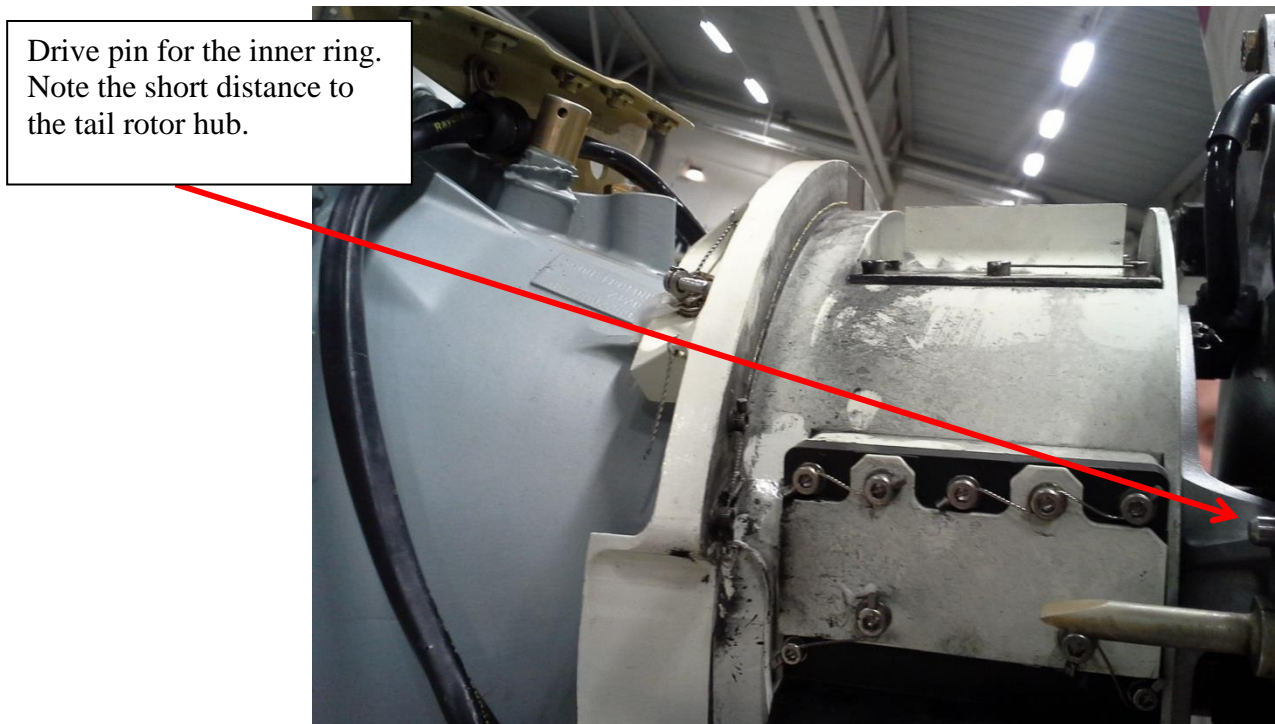
During the technical examination, it was discovered that slipring had become loose from its fix points at the tail rotor gearbox. The slipring was mounted very near the rotating parts of the tail rotor and only its electric harness prevented the solid state parts from starting to rotate and thus risk damaging the tail rotor.

Figure 3. Slip ring Photo: The Swedish Maritime Administration.

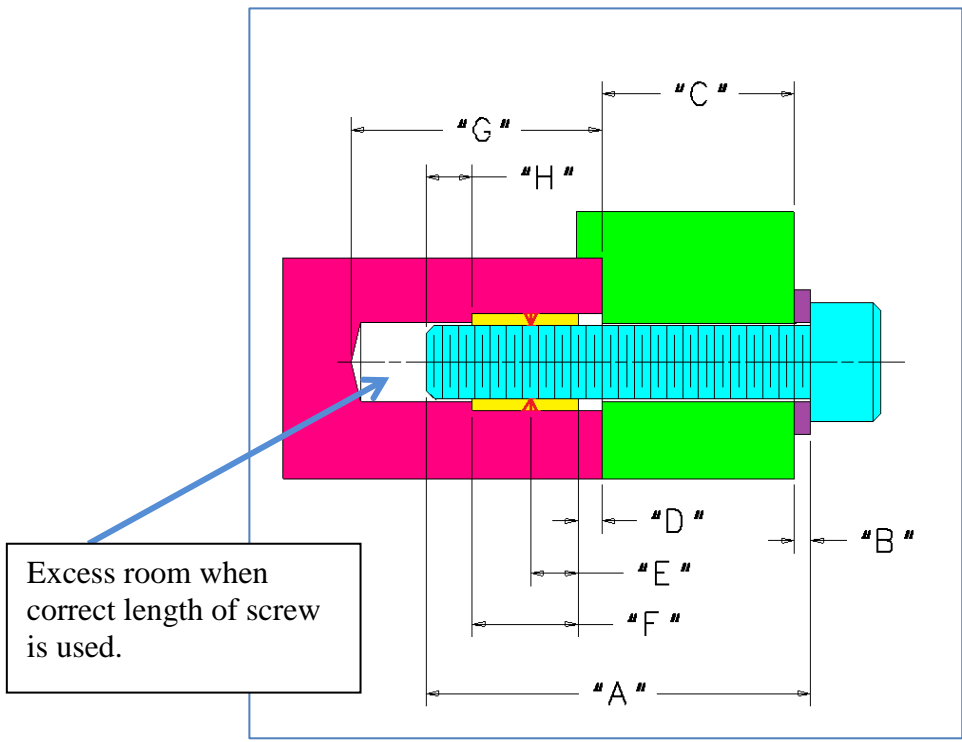
Figure 5. Diagram of the mounted screws.

The fact that the examined screws which fixed the slip ring to the mounting plate were too long meant that these bottomed out in the screw holes before the correct clamping force was achieved. Due to this, the friction between the slip ring and the mounting plate was lower than intended, which in turn meant that the screws were overloaded and finally broke from fatigue.

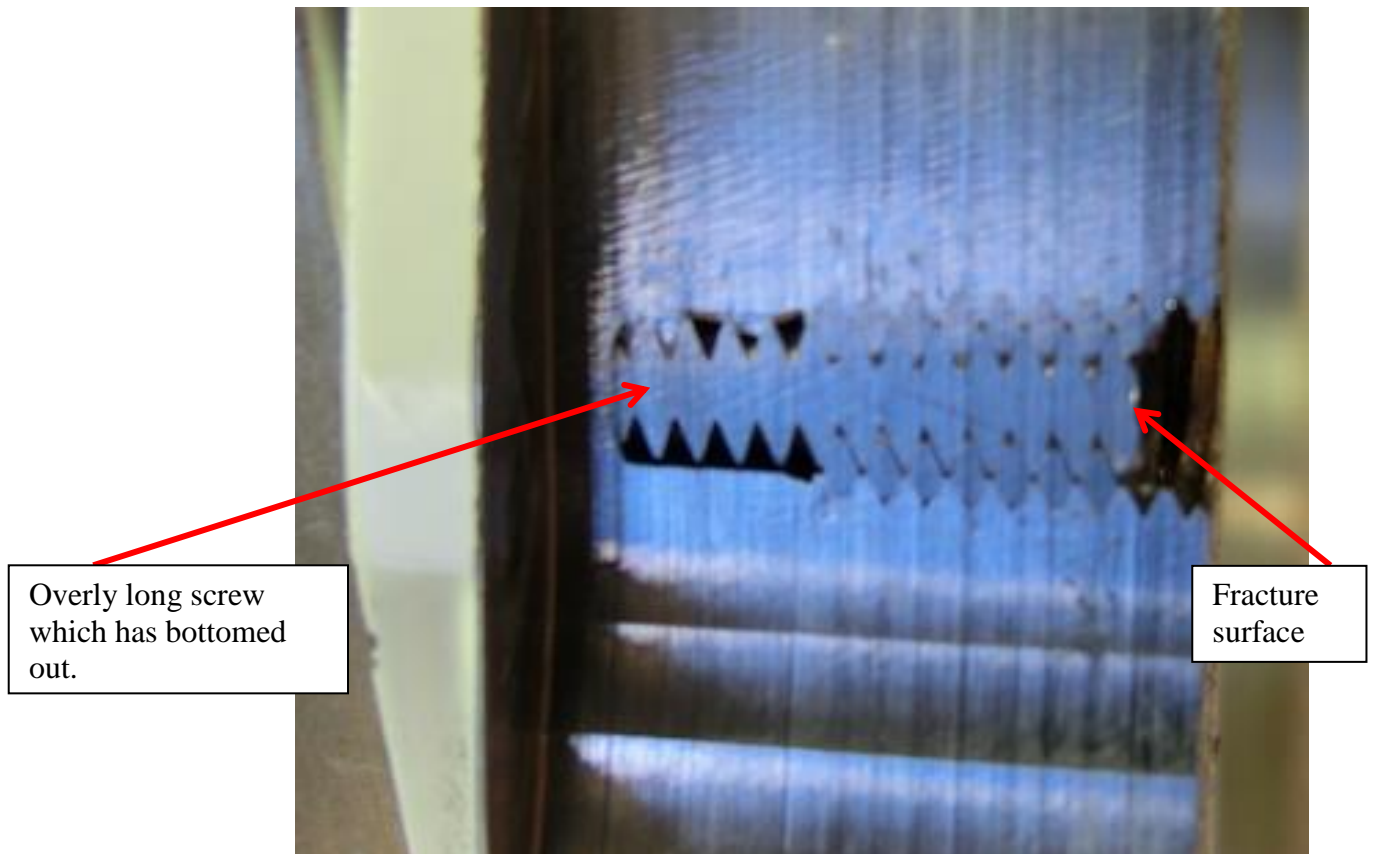
The SHK has had Exova AB to examine the mounting plate and the remaining screws examined with the purpose of assessing the type of screw fracture, etc. The mounting plate and the rest of the slip ring are made of an aluminum alloy and the screws of a steel alloy with a high tensile strength. The thread of the screws has damaged the lateral surface in the holes on the mounting plate. The examination has revealed that all screws broke due to a large number of low-level stresses. This is known as a fatigue fracture. The formation of the fracture began in the thread bottom, roughly 16 mm from the screw head of all screws, which also show signs of final fracture. According to the Exova examination, the likely cause of the fatigue fracture is excessively low prestressing of the screws.

Figure 6. One of the fractured screws which was too long.

the component. The only difference was that the screws used were 4 mm longer than the ones that should have been used.

Following the incident the type certificate holder, AgustaWestland, has published a Technical Bulletin, TB 139-404, which prescribes inspections and among other items changing certain screws in the slip ring.

The manufacturer of the slip rings has announced that they have introduced procedures for ensuring that the correct length of screw is used when assembling the component. An independent inspection is also used in order to verify that the correct screws have in fact been used. These measures are also employed in other areas of the manufacturer's production.

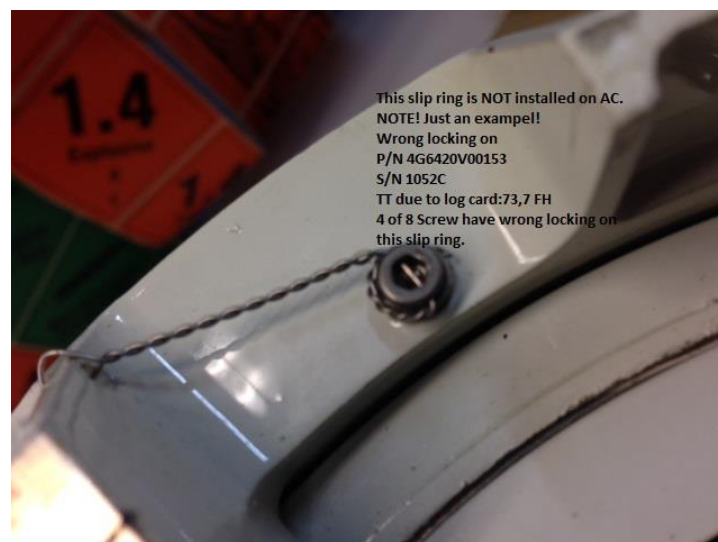
The purpose of the examination was to conduct an unbiased investigation into whether or not there were faults in the slip ring. These faults could thus have contributed to the screw fractures, e.g., via abnormally high friction between the outer and inner rings. During the dismantling and subsequent examination, it was established that the wrong type of screws were used when attaching the mounting plate to the slip ring. These screws were 4 mm longer than those intended for the position, which meant that they bottomed out in the screw holes (see figure 5 and 6). Apart from the length, these screws were identical to the correct ones. The incorrectly mounted screws were of the type used for the lid on the power connection (see figure 2). It was also noticed that a significantly lower tightening torque than that prescribed was required to loosen all eight screws on one of the reference slip rings. SHK has taken into account the great difficulty of determining the amount of tightening torque that was actually applied. Furthermore, the majority of lock-wires for the screws on both reference slip rings were set in the wrong direction (see figure 7). No other faults in the slip ring could be found.

Figure 7. Example of wrong locking in the reference component.
Photo: The Swedish Maritime Administration.

In addition, the investigation has revealed that too low a tightening torque was applied and lock-wires were set in the wrong direction. Despite this an FAA form 8130-3 was issued.
