Birdstrike involving a SAAB 340B, VH-OLM

Moruya Airport, New South Wales | 9 January 2015

ATSB Transport Safety Report
Aviation Occurrence Investigation
AO-2015-007
Final – 14 December 2017

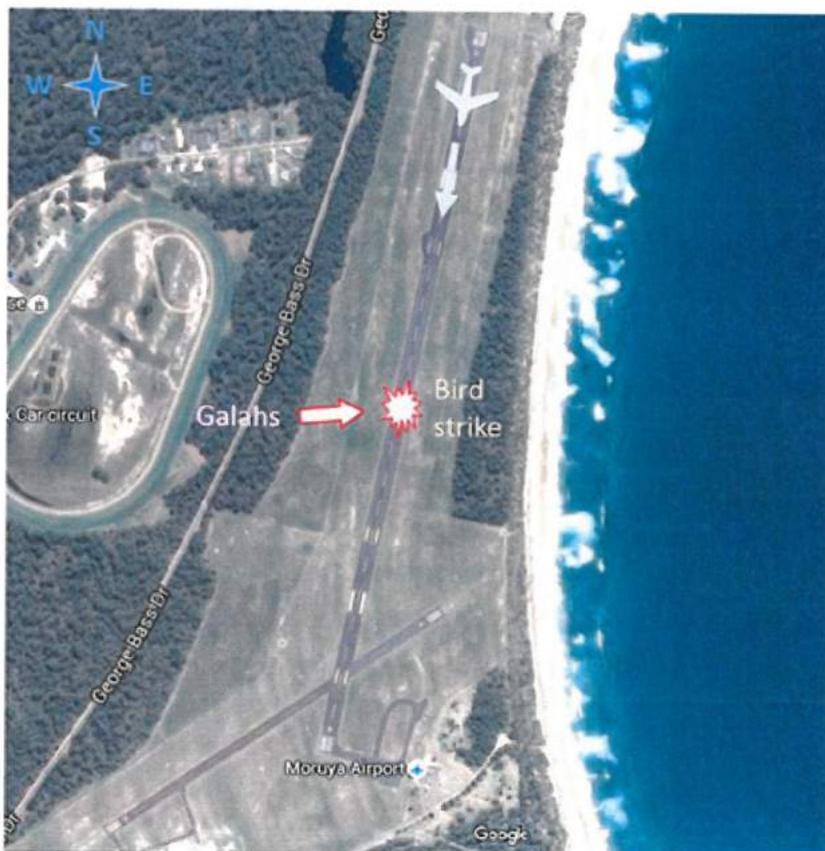
Figure 1: Moruya Airport showing aircraft and galah flock direction of travel and approximate impact point

After touchdown, as the aircraft slowed through 80 kt, the captain took control of the aircraft for the taxi to the terminal in accordance with normal company operating procedures. The crew reported that, shortly after the captain took control, a large flock of galahs² took off from the grass to the west (right) of the runway and flew at a low height over the runway eastbound (Figure 1). In anticipation of a birdstrike, the captain increased wheel braking and applied reverse thrust on both engines. Prior to reaching the galahs forward thrust was selected. Despite that action, about halfway down the runway the first officer observed birds had impacted the aircraft.

The presence of galahs to the right of the runway during the landing roll presented a high risk of impact to approaching aircraft. The captain followed appropriate actions to maximise aircraft deceleration while minimising potential impact damage through effective use of reverse thrust and aircraft wheel braking. Despite the crew's best efforts, the subsequent impact with the birds was considered unavoidable.

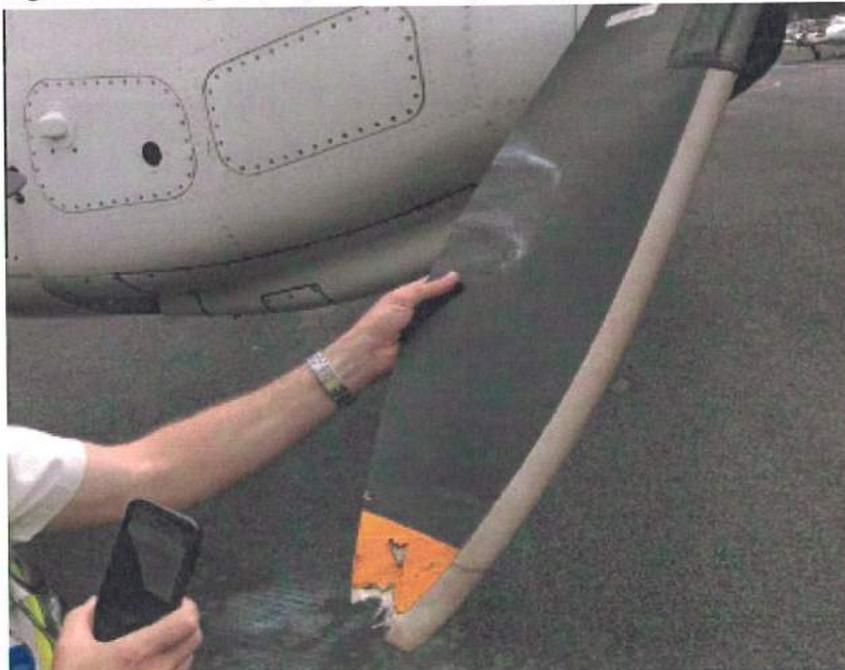
Figure 2: Left engine propeller showing damaged blade tip on arrival at Merimbula

The crew then operated the aircraft from Moruya to Merimbula. After engine shutdown at Merimbula, the first officer opened the forward left door and observed that the tip of one of the left propeller blades had detached (Figure 2). The aircraft was declared unserviceable and grounded.

There were no reported injuries to the crew or passengers. No damage to the aircraft structure was identified as a result of the loss of the blade tip.

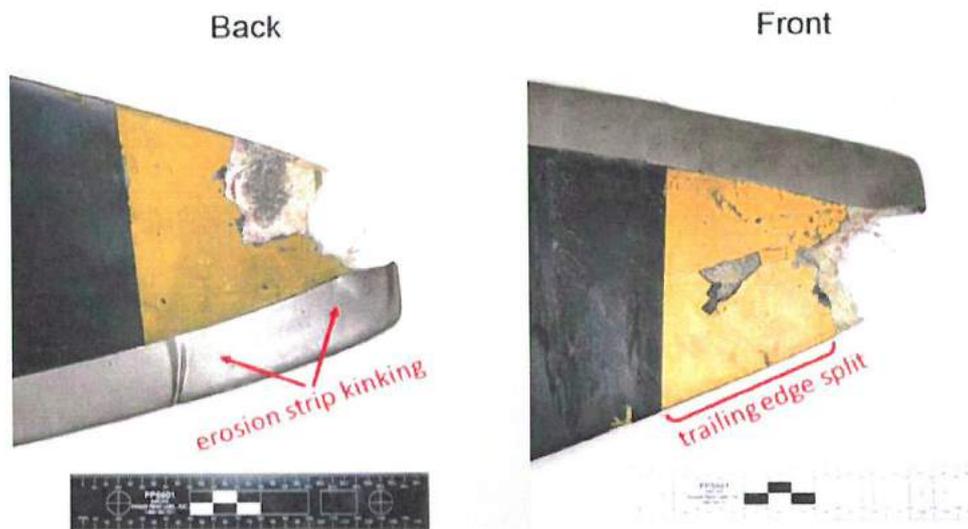
Figure 4: Left propeller blade damage showing tip separation, kinking, crack, and splitting of trailing edge

The left propeller blade presented with white powder impact marks toward the trailing edge, about 300–400 mm from the blade tip; about one third up the blade’s length. A section of blade was missing from the tip. Within the tip damage region, splitting at the trailing edge was identified (Figure 4). Damage to the leading edge erosion strip near the tip was also identified, with kinking on the back, and a corresponding crack on the front of the blade.

The propeller manufacturer concluded that the kink in the erosion strip on the back of the blade (Figure 4) was consistent with an impact on the front of the blade near the tip, bending the blade tip rearwards rather than forwards. The manufacturer considered this damage was consistent with a bird or other hard object impact. It also stated that it considered that the buckling of the guard would probably have occurred as a result of the impact rather than due to subsequent aerodynamic loading. Therefore, it believed the kink would most likely have been present at the time the blade was inspected at Moruya.

The propeller manufacturer indicated that the buckling of the blade guard would probably have occurred as a result of the impact rather than due to subsequent aerodynamic loading, and the damage to the guard would have been evident when the blade was inspected by the flight crew at Moruya.

The ATSB agrees it is plausible that the birdstrike resulted in cracking of the leading edge of the guard. However, the extent to which the damage to the guard would have been readily detectable when the blade was inspected at Moruya is unclear. Once the leading edge guard lost structural integrity, together with internal delamination damage, it is difficult to determine the nature of the subsequent loading conditions during flight.

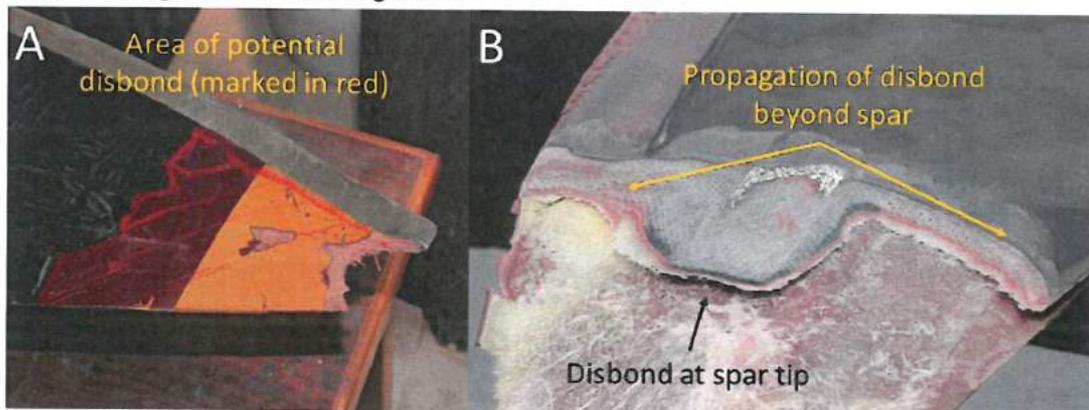
Figure 5: Region of disbonding shown

The damaged blade was sent to the ATSB for initial assessment. A visual inspection, and a 'tap test' using a metallic object were conducted on the blade. That test revealed a potential area of delamination or disbond under the surface extending from the tip separation point.

The blade was subsequently sent to a third party laboratory for NDT and destructive testing under the supervision of the ATSB. A dual probe ultrasonic tester was used over the entire surface of the blade. Disbond was detected in a region extending from the spar through to the tip of the blade (Figure 5A). Further destructive testing in the form of surface grinding was carried out to determine at which layers the disbond had occurred. That action showed disbonding at the carbon fibre spar tips. The disbond had also propagated along the glass fibre layer of the blade beyond the spars (Figure 5B).

The propeller manufacturer determined the damage was consistent with the effects of impact on the blade from the birdstrike. The most likely failure mechanism was considered to be delamination between the blade's foam core and spar barrier membrane. The delamination then progressed outboard into the fibreglass layer beyond the spar resulting in the subsequent tip failure.

Examination of the blade found that the failure mode was consistent with a bird impact. Consequently, given the failure occurred on the flight following the birdstrike, it is almost certain that impact with one or more galahs initiated the internal delamination of the blade. This led to a rapid decay of its structural integrity and subsequent separation of the tip, as the blade was subjected to aerodynamic loads during the following flight.
