# AIRCRAFT ACCIDENT REPORT 2/2016

**Report on the serious incident to  
Saab 2000, G-LGNO  
Approximately 7 nm east of Sumburgh Airport, Shetland  
15 December 2014**

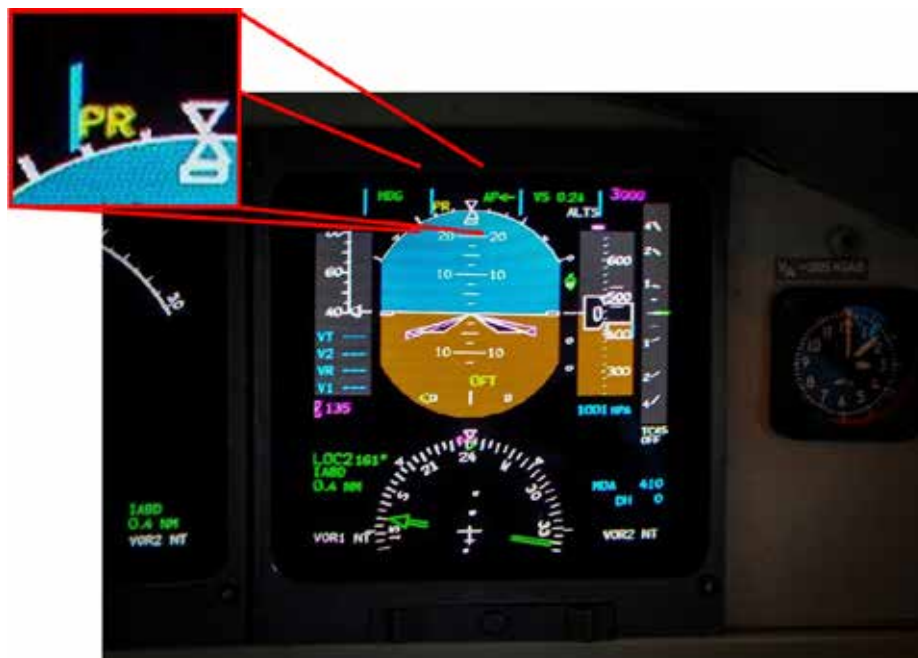
**Figure 1**

The aircraft climbed, but the commander perceived that his increasingly purposeful pitch control inputs did not appear to be having the expected effect. The co-pilot also applied nose-up pitch inputs and pitch trim inputs, but similarly perceived that the aircraft was not responding as expected. Pitch and roll mistrim indications were presented on the primary flight displays (PFDs) in the form of a flashing 'P' and an 'R' for the respective condition (Figure 1) and autopilot pitch and roll mistrim cautions were presented.

PFD showing 'P' and 'R' captions at the top of the PFD

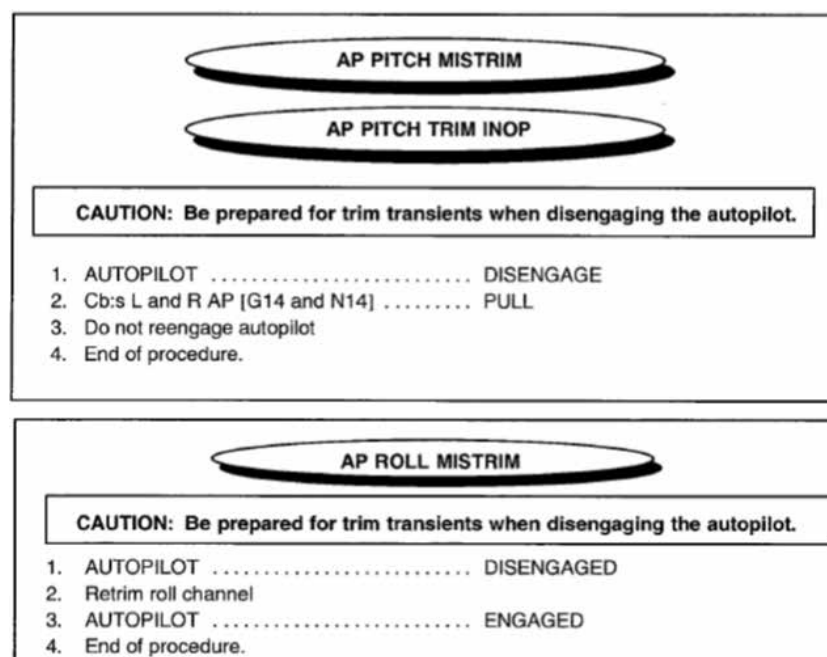
**Figure 6**

The AOM did not state that a 'P' or 'R' on the PFD could be an indication that the pilot was overriding the autopilot. There was no checklist in the AOM for the flight crew to follow for a flashing 'P' or 'R' on the PFD; however, there was a checklist to follow for the AP PITCH MISTRIM and AP ROLL MISTRIM cautions as shown in Figure 6.

Saab 2000 Malfunction Checklists for AP PITCH MISTRIM and AP ROLL MISTRIM

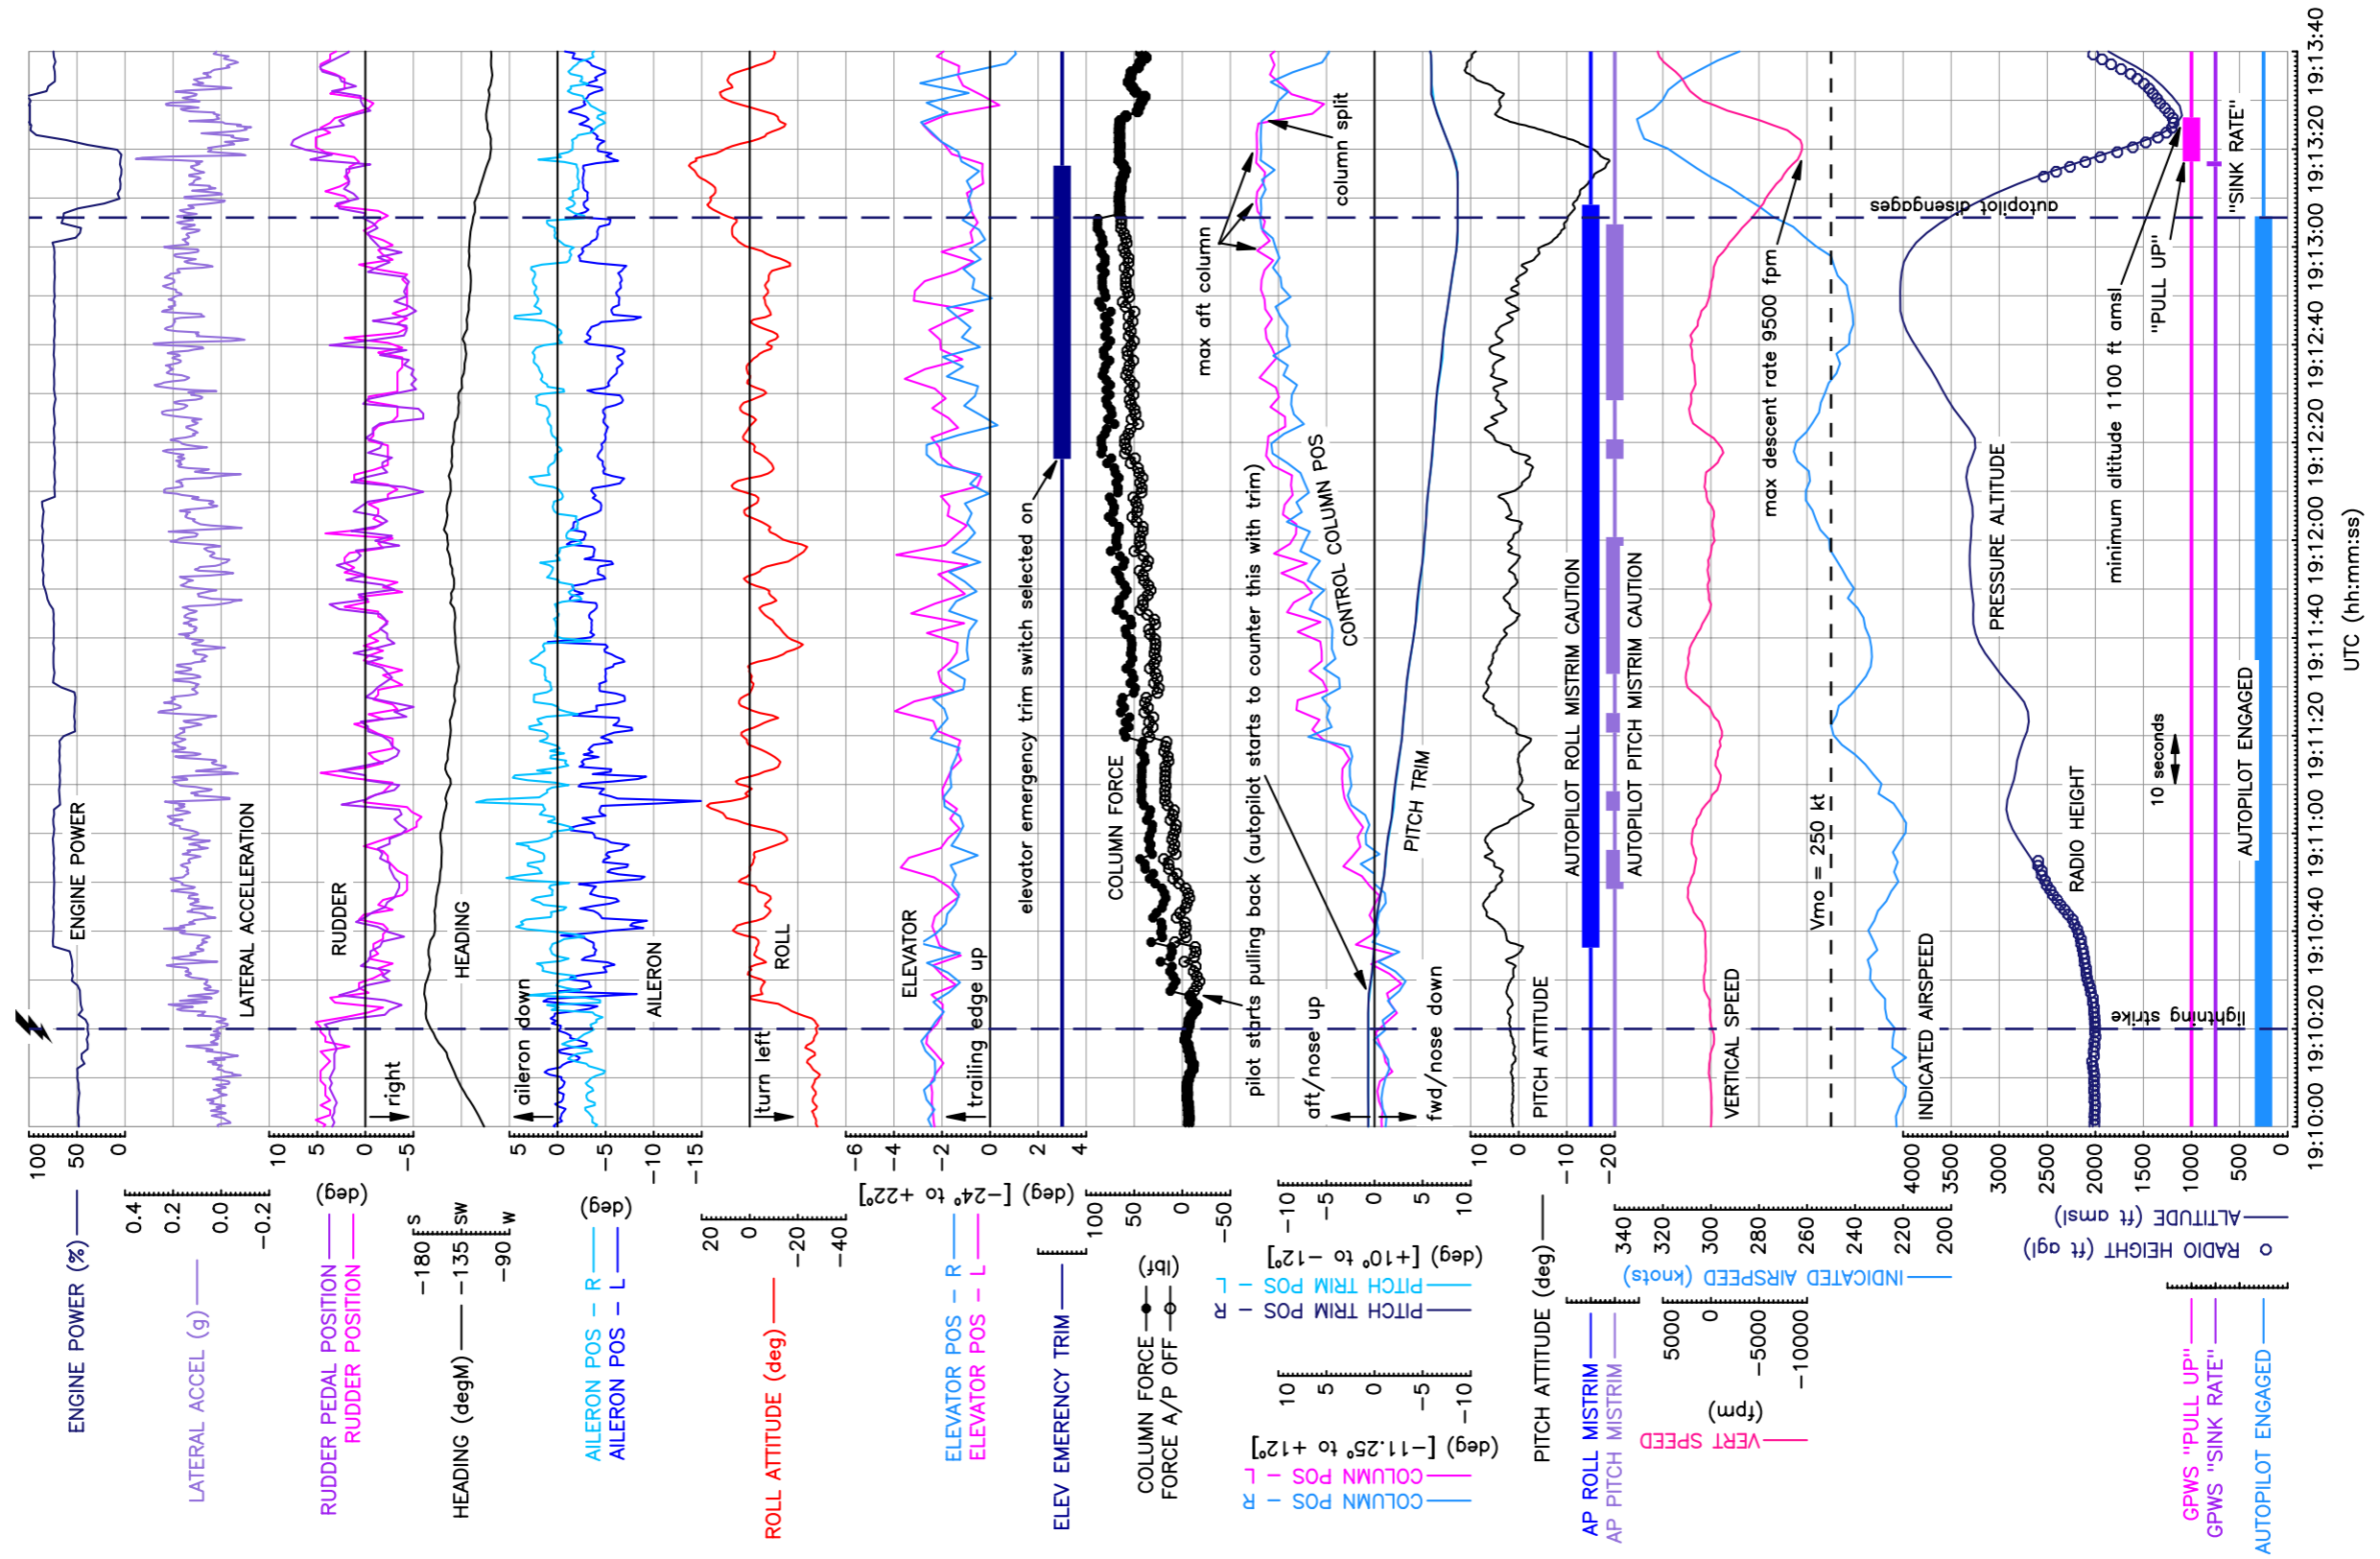
Figure 7

Immediately after the lightning strike, the aircraft rolled wings level. Aft control column pilot inputs were then made together with small increases in engine power which caused the aircraft to climb<sup>20</sup>. The pitch trim (commanded by the autopilot) then began to move in the opposite direction trying to regain the selected altitude of 2,000 ft. With the autopilot engaged, the pilots needed to apply an additional 24 lbf on top of the forces generated by the break-out and stick force unit, in order to move the elevator.

Salient flight data from FDR

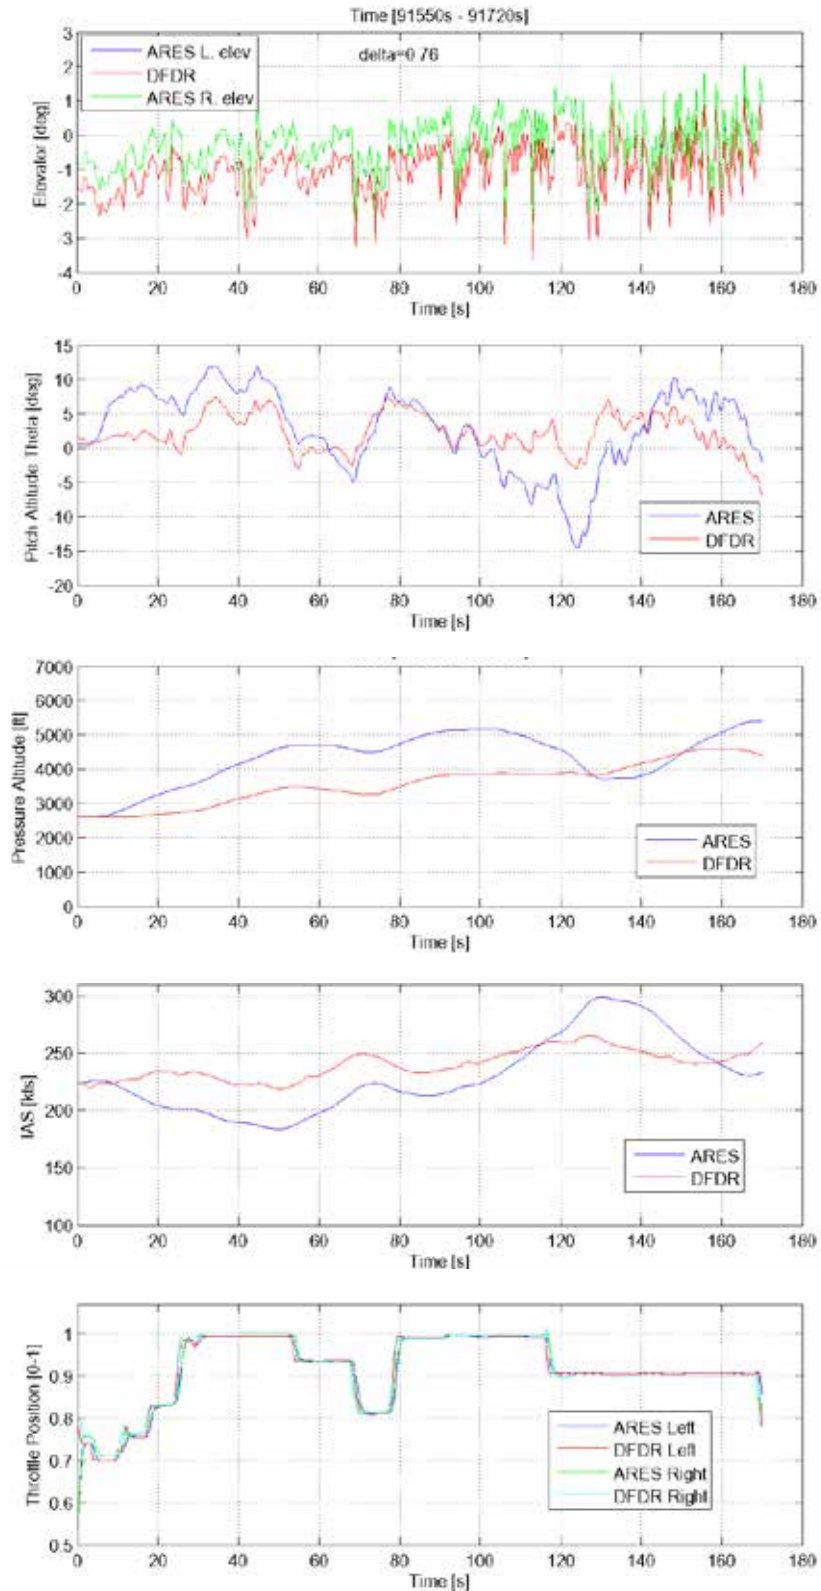
**Figure 8**

Saab ARES Saab 2000 modelling for climb post lightning strike compared to FDR data (note that the pressure altitude plotted is not corrected to amsl)

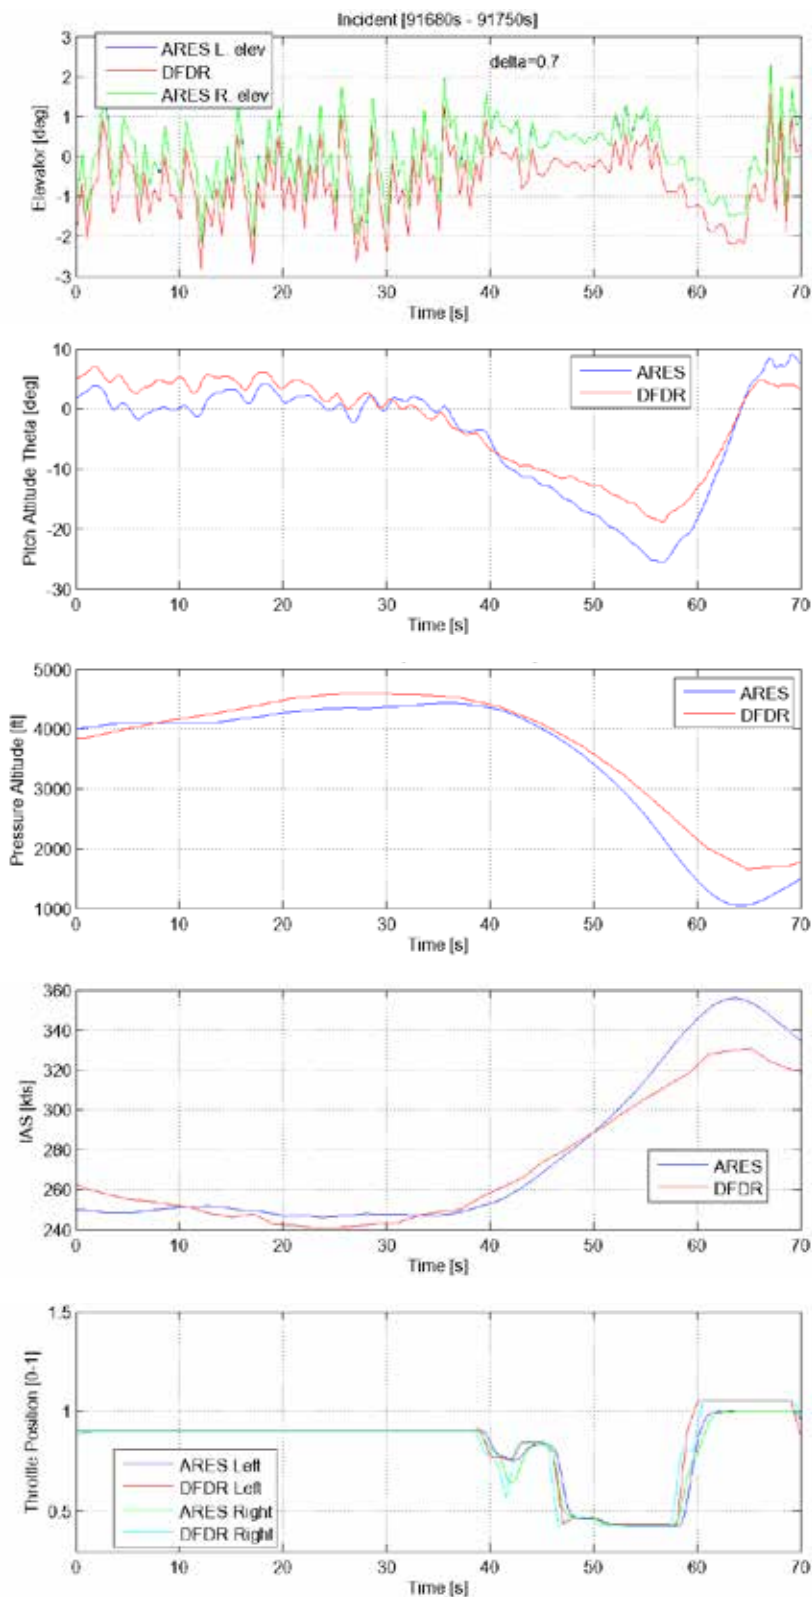
**Figure 9**

Saab ARES Saab 2000 modelling for post-lightning strike descent from 4,000 ft compared to FDR data (note that pressure altitude plotted is not corrected to amsl)
