ACCIDENT

Aircraft Type and Registration:	Cessna Citation 560XL, SE-RHJ
No & Type of Engines:	2 Pratt & Whitney PW545A turbofan engines
Year of Manufacture:	2000
Date & Time (UTC):	29 November 2015 at 1350 hrs
Location:	On descent into Farnborough Airport, Hampshire
Type of Flight:	Commercial Air Transport (Passenger)
Persons on Board:	Crew - 2 Passengers - 9
Injuries:	Crew - None Passengers - None
Nature of Damage:	Right engine upper cowling detached in flight, impact damage to horizontal and vertical stabilisers
Commander's Licence:	Airline Transport Pilot's Licence
Commander's Age:	41 years
Commander's Flying Experience:	3,700 hours (of which 2,200 were on type) Last 90 days - 4 hours Last 28 days - 4 hours
Information Source:	AAIB Field Investigation

Synopsis

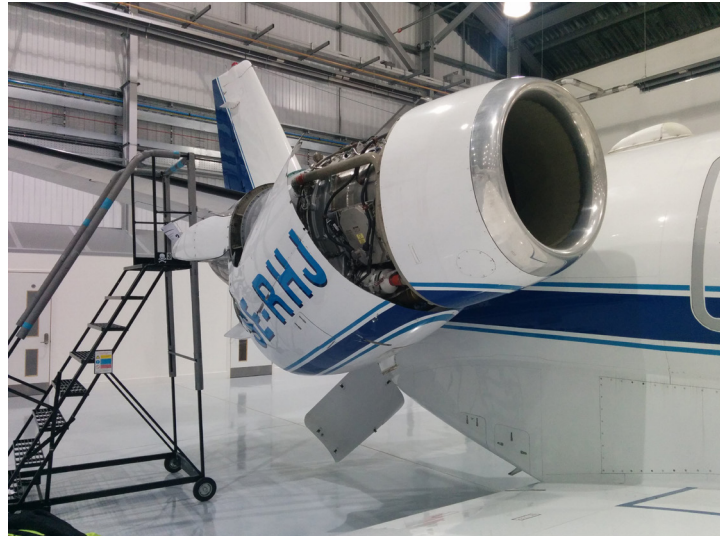
Figure 1

During the descent into Farnborough Airport the majority of the right engine upper cowling detached, damaging the leading edges of the vertical and horizontal stabilisers. The investigation concluded that the cowling probably detached because a number of the fasteners had not been secured during maintenance.

The aircraft was recovered to a local maintenance organisation where the majority of the right engine upper cowling was observed to be missing, Figure 1. Damage on the leading edges of the vertical and horizontal stabilisers was consistent with them being struck by debris.

Right engine cowlings following recovery of the aircraft to the hangar

The maintenance organisation has changed their inspection procedures to ensure that, following installation, the security of engine cowlings is checked by an independent mechanic.

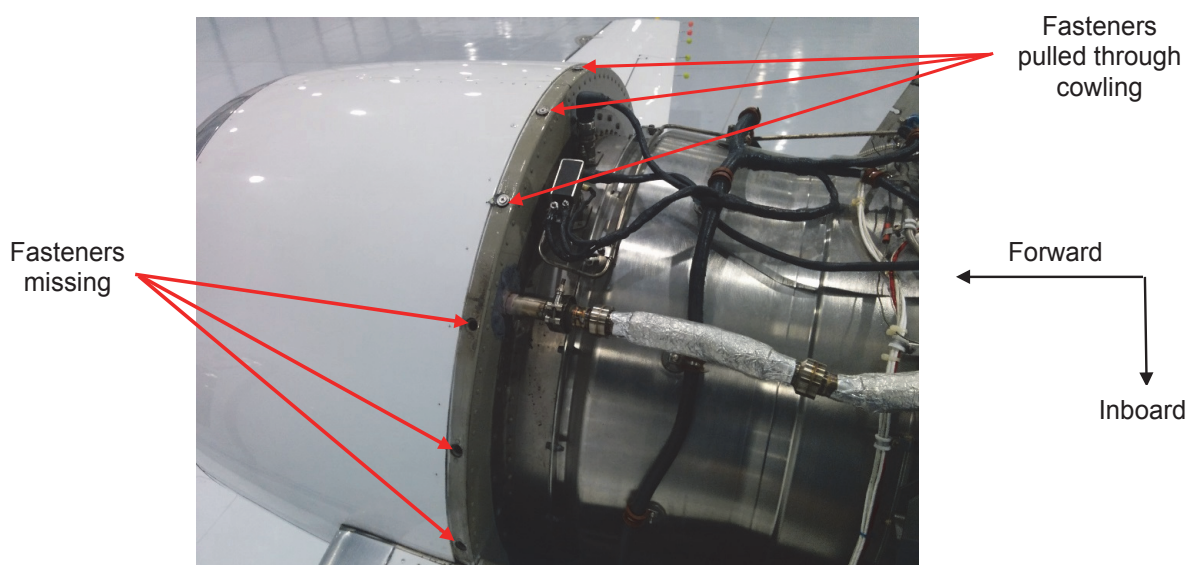
Figure 2

The remnants of the upper cowling that remained with the aircraft had been pulled from the fasteners, which, with the exception of four, remained securely locked, Figure 2. Three fasteners were missing from the inboard leading edge and one was missing from the inboard trailing edge. The empty locking receptacles were confirmed to be serviceable using a representative fastener and the surrounding structure showed no evidence of damage.

Upper cowling inboard leading edge attachment fasteners

It is unlikely that the fasteners were the wrong size or had failed in flight and investigation concluded that the cowling probably detached because a number of fasteners had not been securely fastened during maintenance.

The manufacturer highlighted the three events to their Continued Operational Safety group to assess possible options to minimise occurrences in the future. This includes a proposed video for maintenance agencies to emphasise the importance of ensuring that the quick release fasteners are secure.
